Humboldt Bay Shoreline Inventory, Mapping, and Sea Level Rise Vulnerability Assessment

Prepared for
State Coastal Conservancy
1330 Broadway, 13th Floor
Oakland, CA 94612-2530

January 2013

Humboldt Bay Sea Level Rise Adaptation Planning Project:
Phase 1
Shoreline Inventory, Mapping, and Vulnerability Assessment

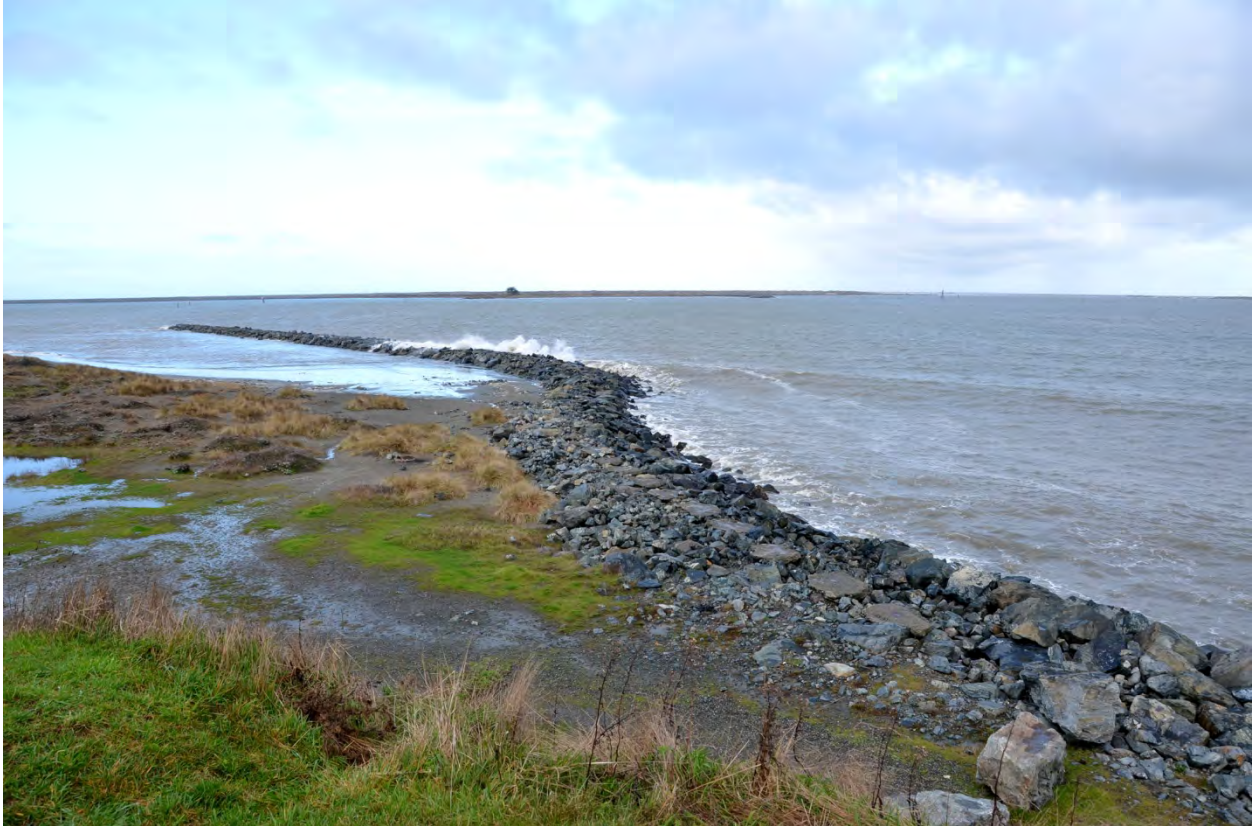
A structure, generally made of rock, that extends out into a body of water to influence the current or tide to protect the shore (Figure 22).

Figure 22. King Salmon on Eureka Bay is an example of a jetty forming the shoreline of Humboldt Bay.

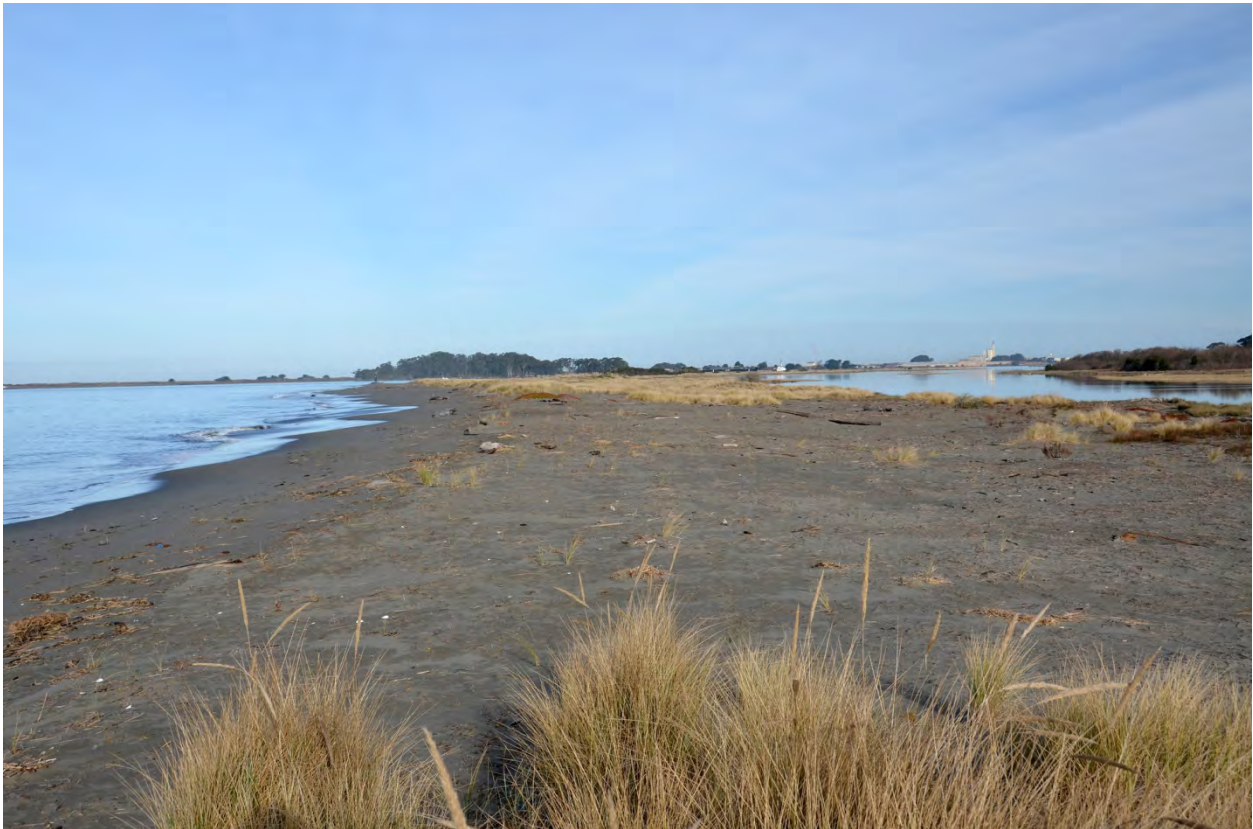
An absence of shore cover generally associated with a natural shoreline with no structure or an area of fill, without vegetation, that is not fortified or eroding (Figure 23).

Figure 23. Elk River Spit on Eureka Bay is an example of a shoreline with no cover on Humboldt Bay.

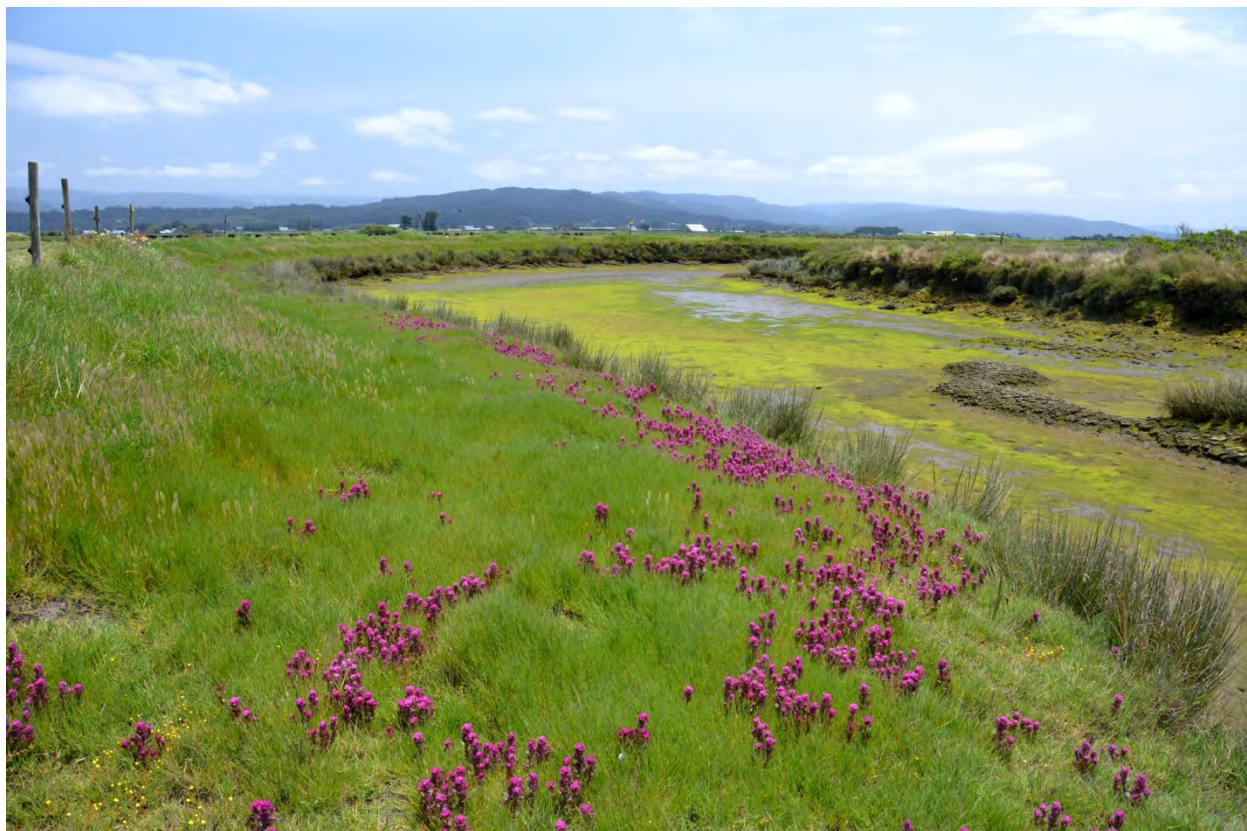
A vegetated shore is predominately covered with vegetation (Figure 24 a and b).

Figure 24a. Mad River Slough is an example of a shoreline with vegetated cover that is gazed on Humboldt Bay.

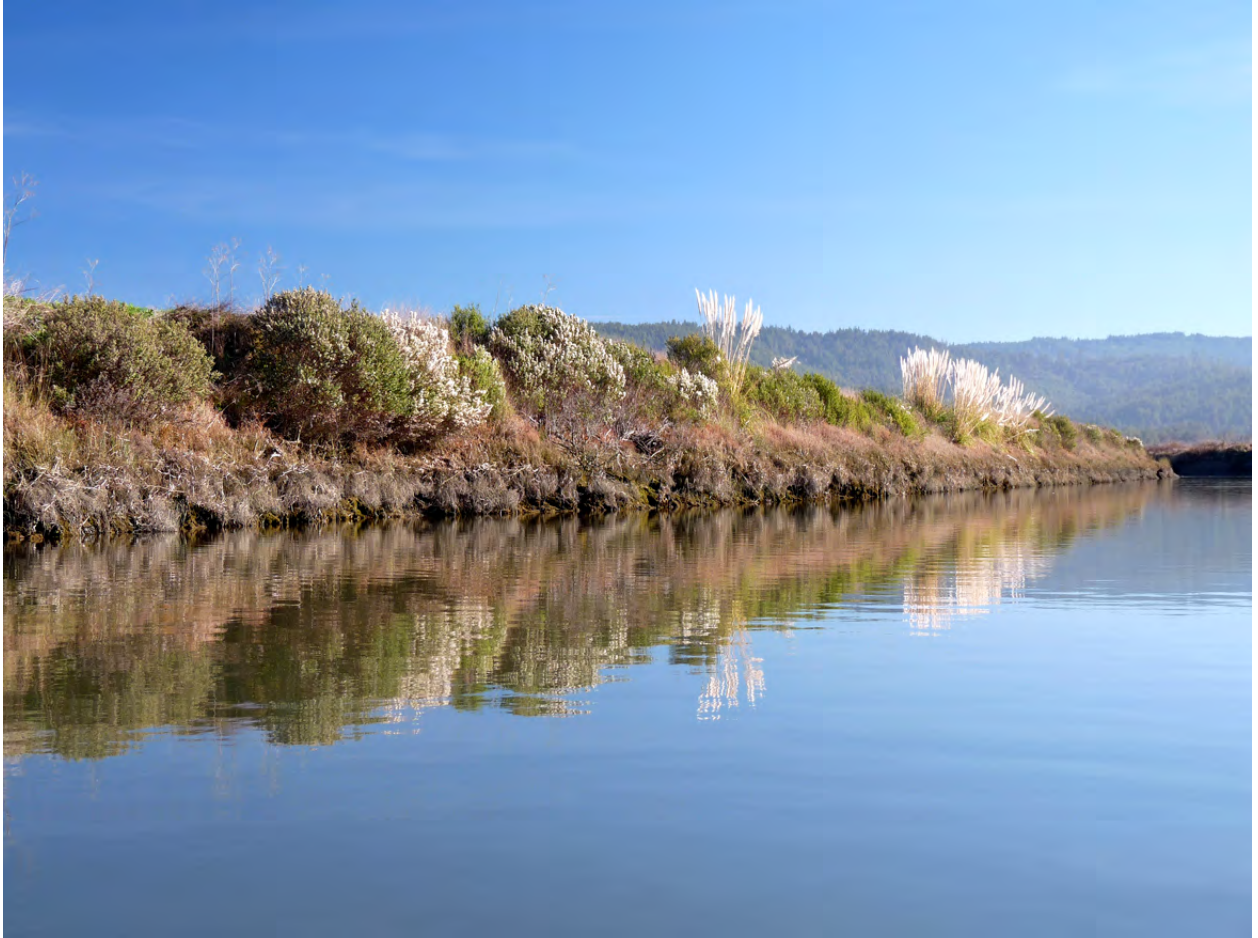
Figure 24b. Fay Slough is an example of a shoreline with vegetated cover that is not grazed on Humboldt Bay.

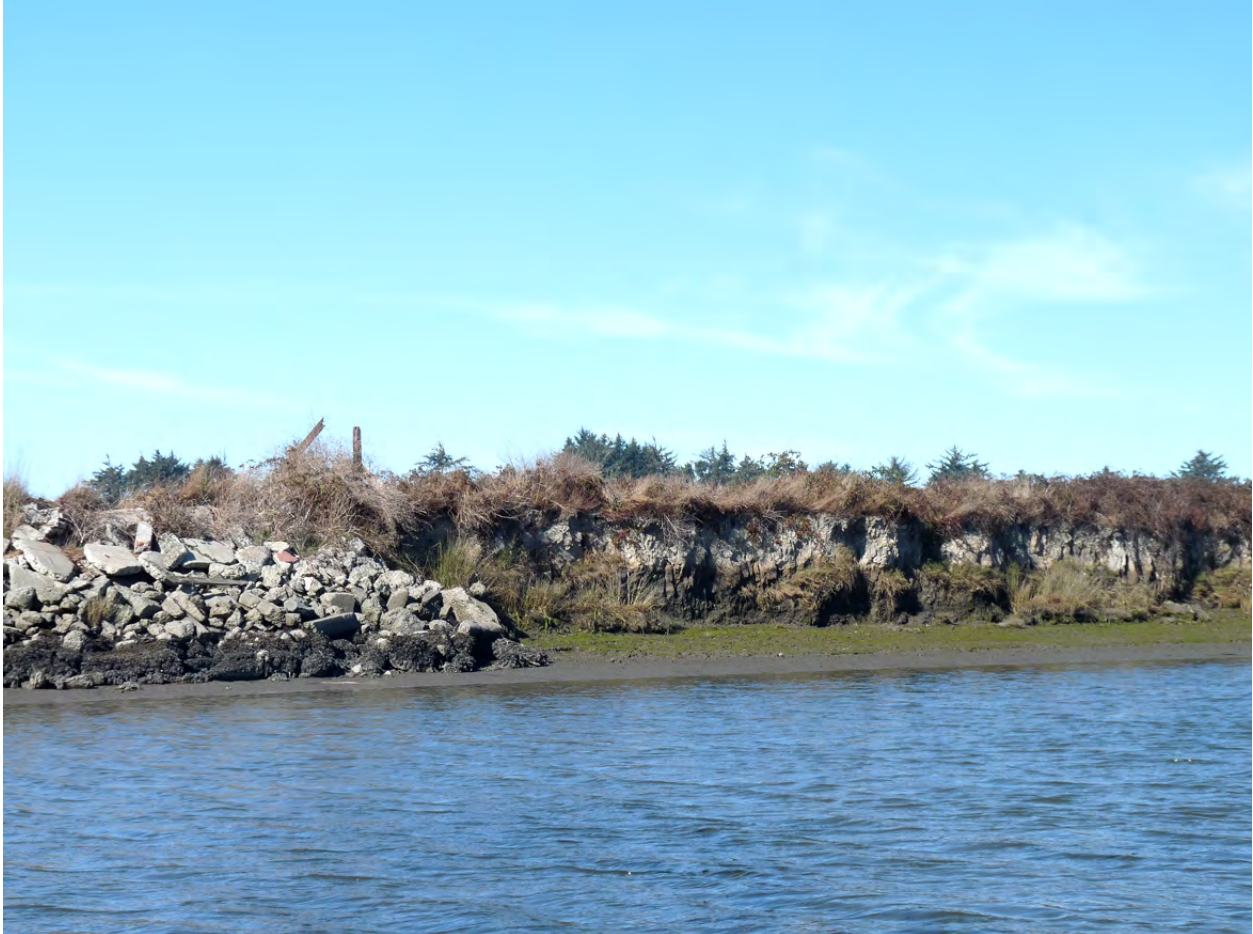
An exposed shore is one that is generally vertical and eroding and is without vegetation or armorment (Figure 25).

Figure 25. Mad River Slough is an example of contrasting shorelines one that is exposed and the other with concrete revetment on Humboldt Bay.

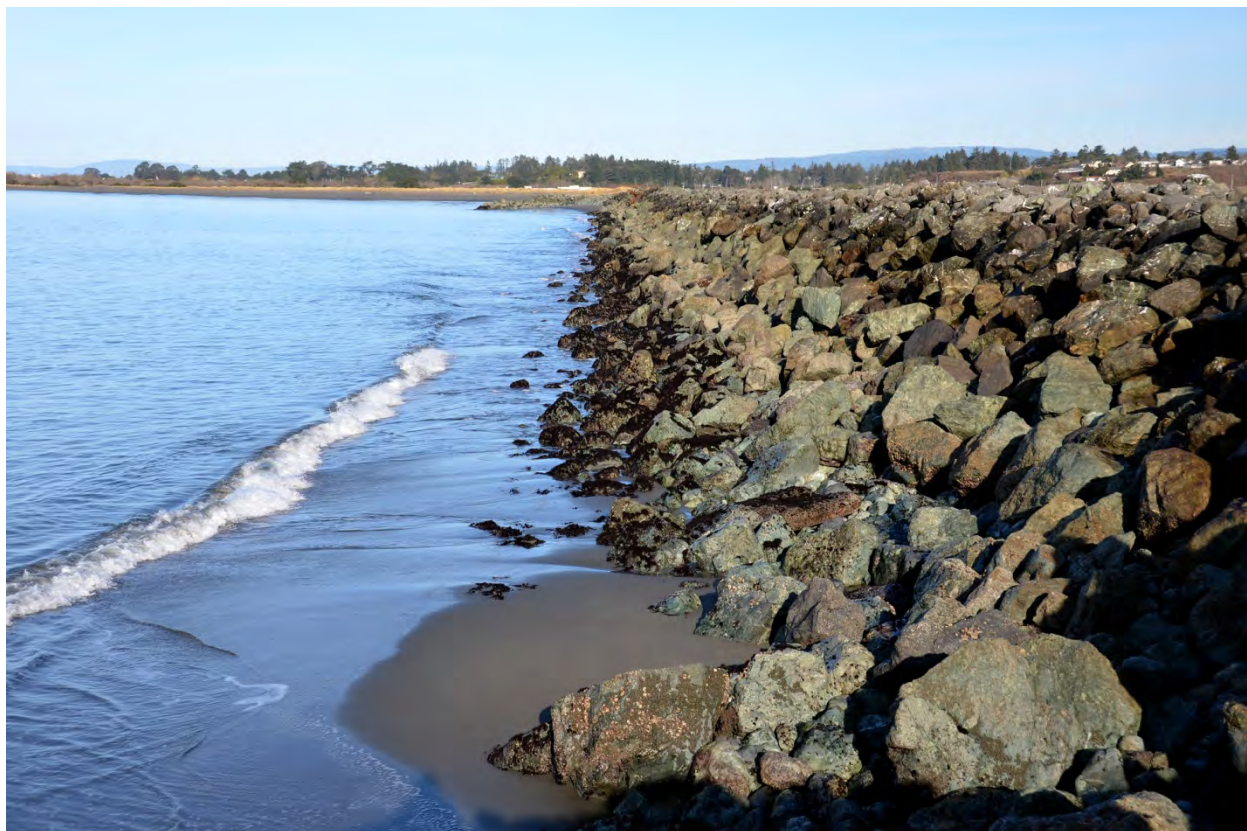
A shore fortified with rock revetment (Figure 26).

Figure 26. Eureka Bay is an example of a shoreline with rock revetment on Humboldt Bay.

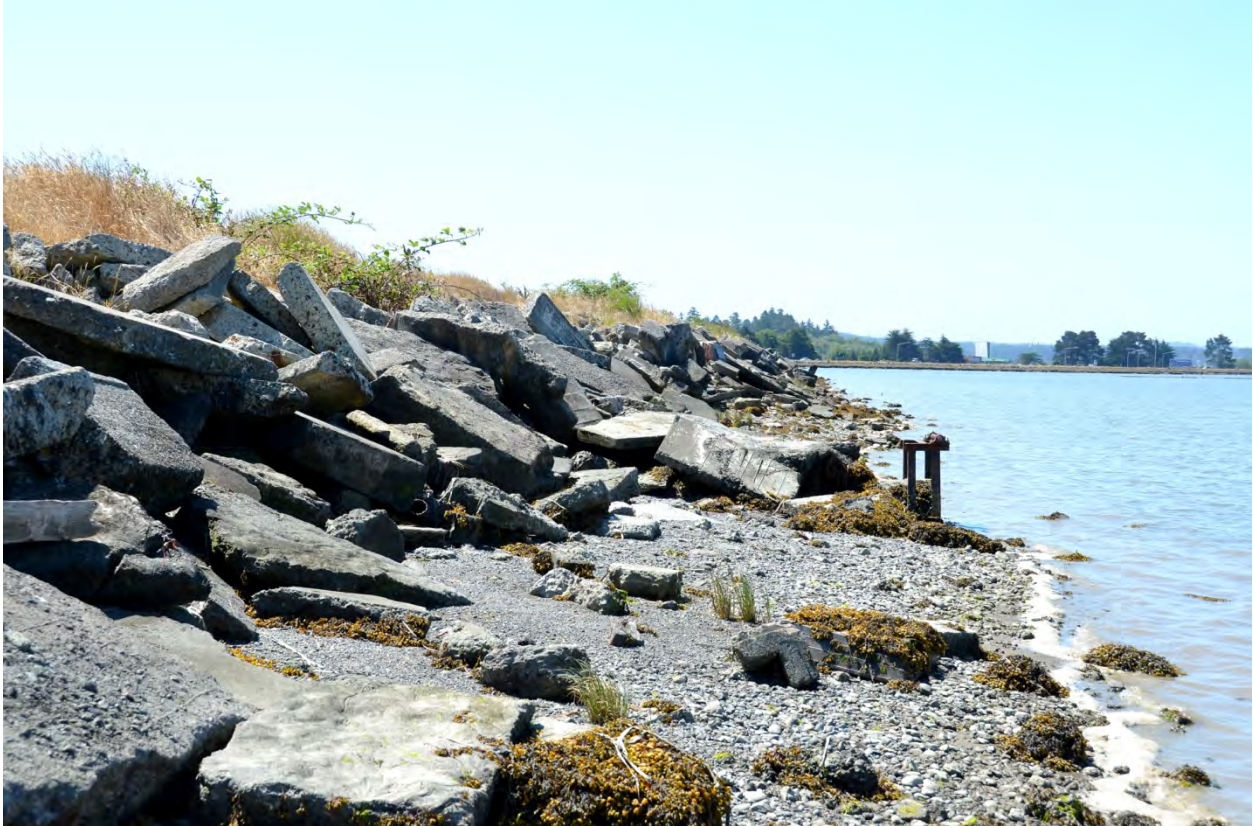
Figure 27. Arcata Bay is an example of a shoreline that is covered with concrete revetment on Humboldt Bay.

A shore fortified with broken concrete revetment or a structure constructed of concrete (Figure 27).

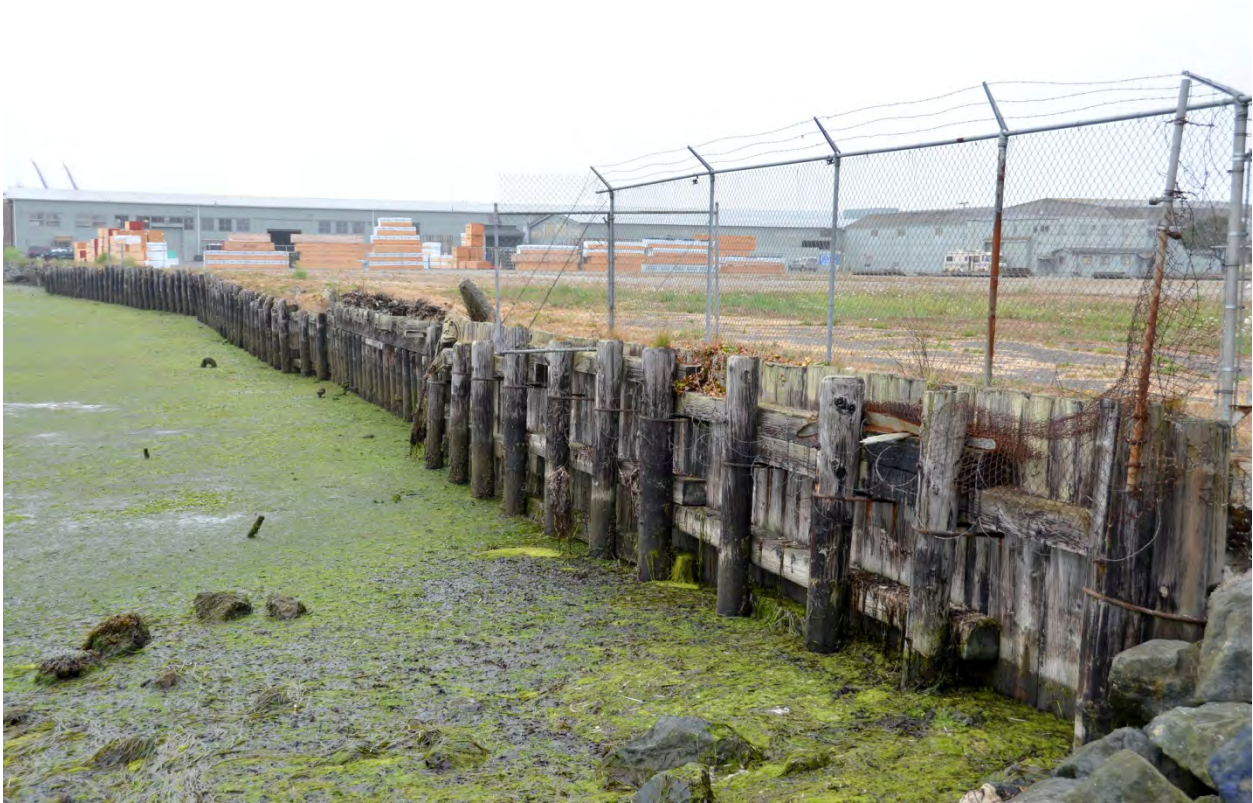
A shoreline structure constructed of wood (Figure 28).

Figure 28. Eureka Bay is an example of a shoreline that is covered by a wood bulwark on Humboldt Bay.

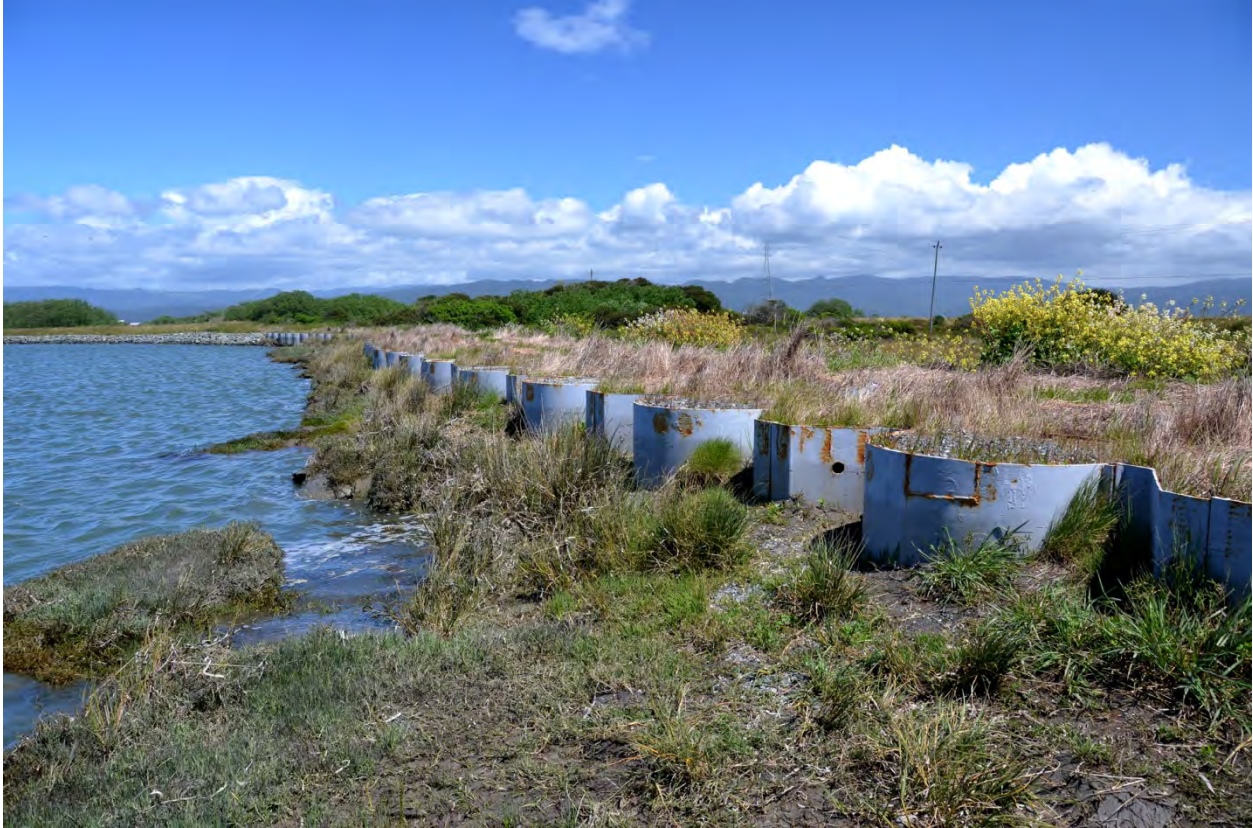
A shoreline structure constructed of steel (Figure 29).

Figure 29. Mad River Slough is an example of a shoreline that is covered by a steel bulwark on Humboldt Bay.

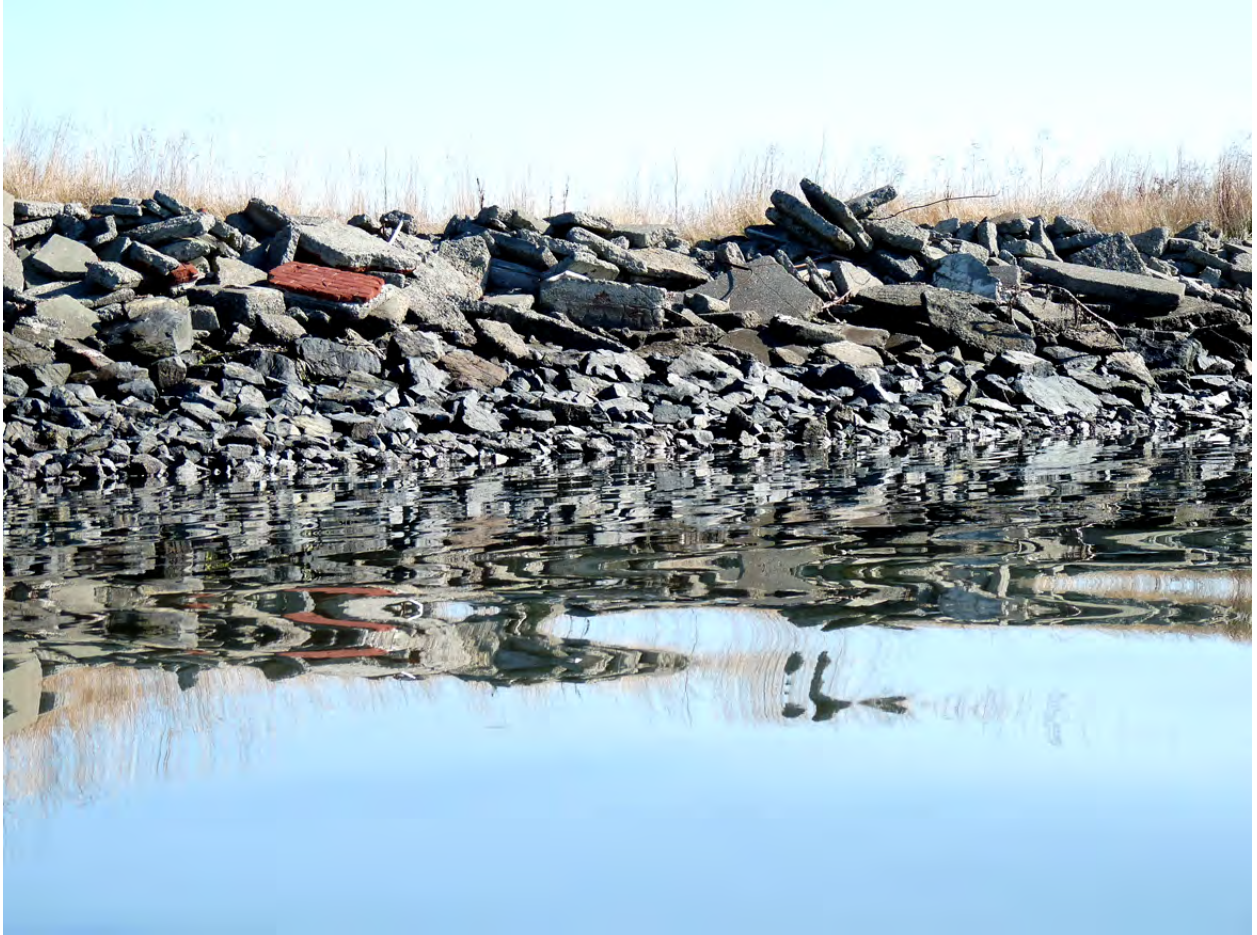
Figure 30. Arcata Bay is an example of a shoreline that is covered by a rock and concrete revetment on Humboldt Bay.

A shore fortified with rock and broken concrete revetment (Figure 30).

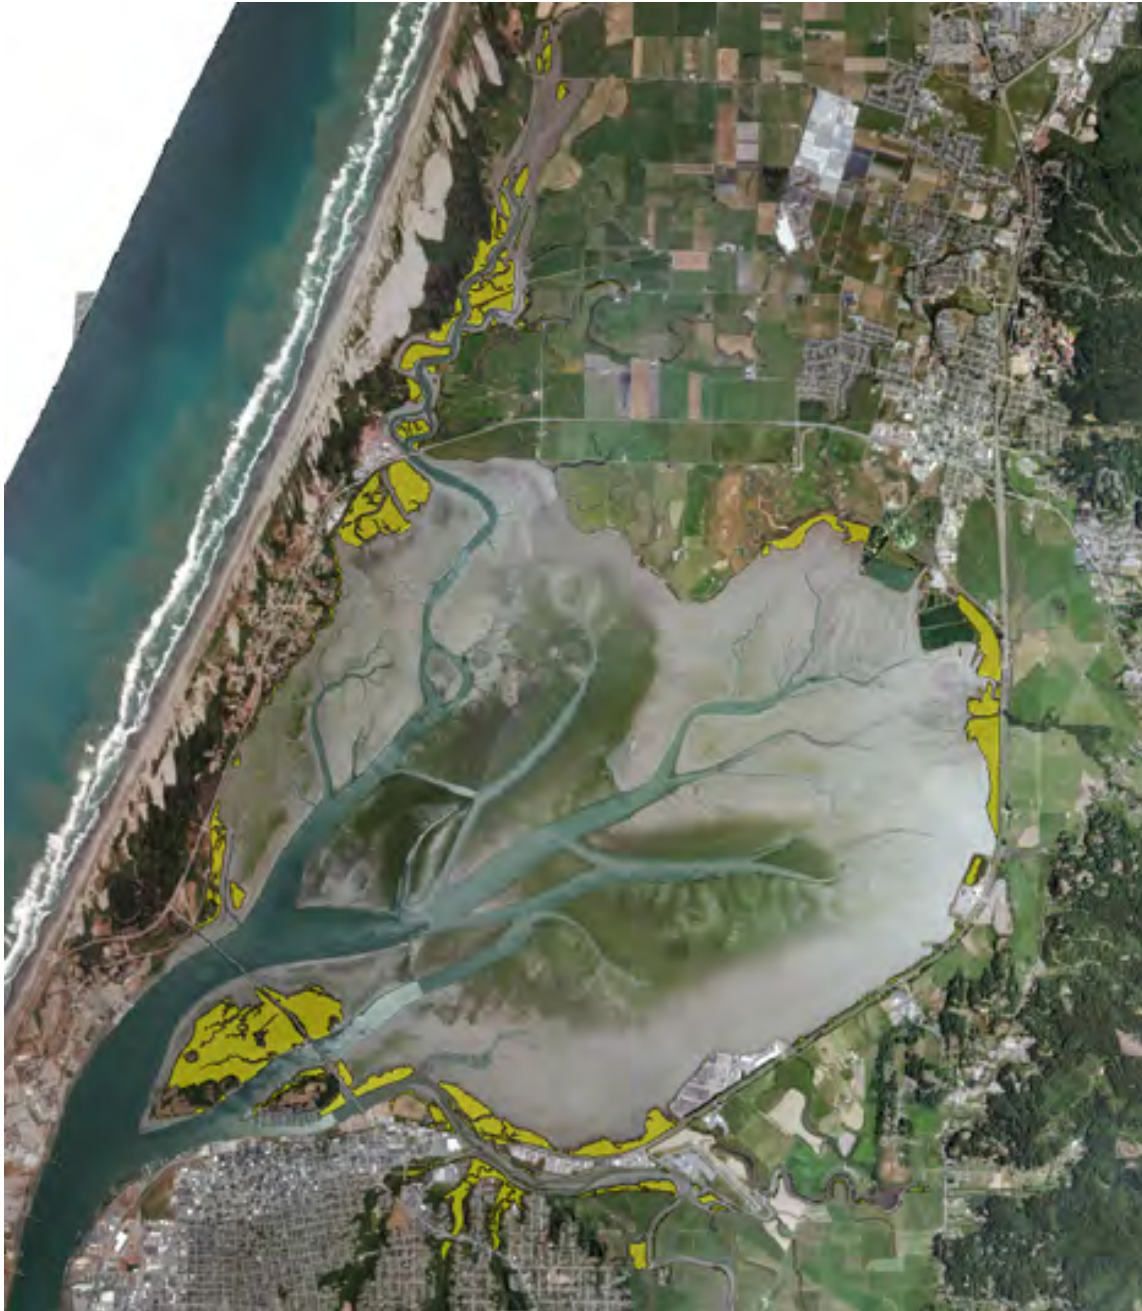
Figure 33. NOAA's Coastal Services Center's, Humboldt Bay 2009 GIS database of salt marsh habitat distribution on Humboldt Bay.

NOAA's Coastal Services Center's Humboldt Bay, California Benthic Habitats 2009 GIS database of salt marsh habitat distribution was incorporated into this project's GIS database. The area of coverage for the 2009 salt marsh survey was up to mean high water elevation on the shoreline of Humboldt Bay. Salt marshes behind dikes or water control structures were not included in the 2009 survey. Areas of salt marsh habitat that were not mapped by NOAA in 2009 but were located during the ground truthing phase of the shoreline inventory and mapping effort have been identified on a separate GIS layer. The extent of salt marsh habitat in these previously un-mapped areas has not been delineated.

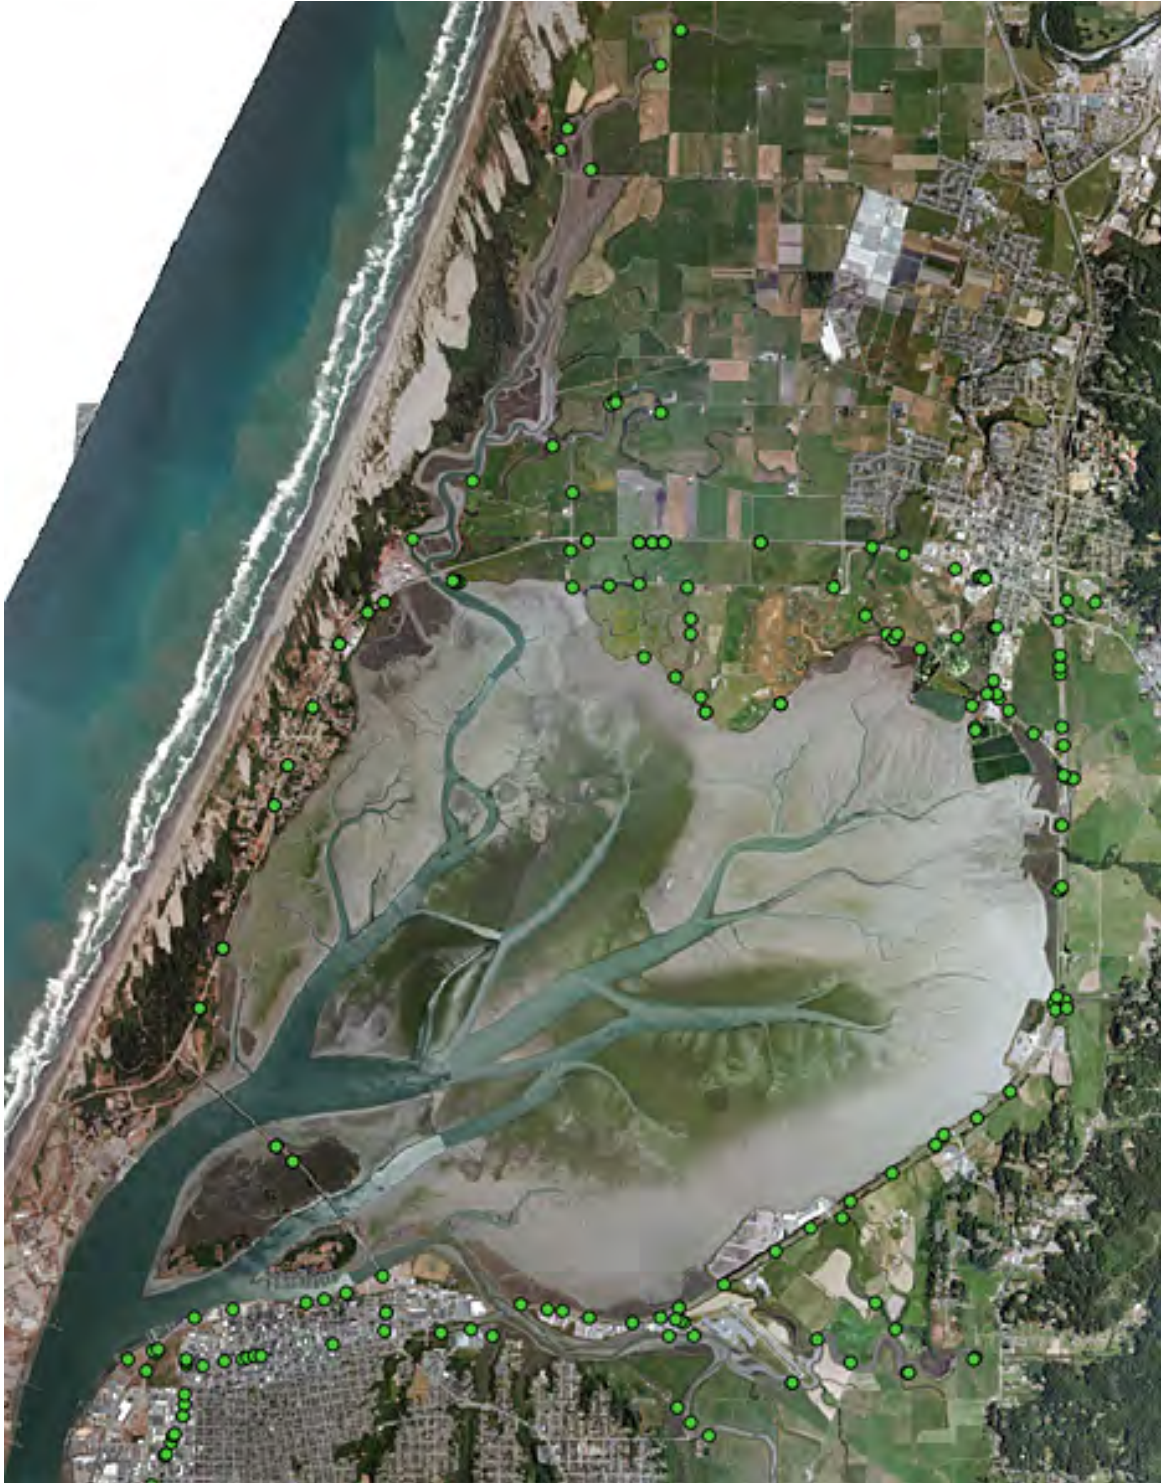
Figure 34. USFWS's 2007 GIS database, distribution of water control structures on Humboldt Bay.

The USFWS conducted a comprehensive water control structure inventory, assessment, and mapping, of Humboldt Bay (Goldsmith 2007). The survey of culverts and tidegates controlling drainage to Humboldt Bay identified the location and function of these water control structures. The original diking and draining of former tidelands around Humboldt Bay, for agricultural purposes, required the installation of tide gates. The construction of railroads, highways, and streets, required the installation of culverts or bridges at the numerous streams or slough crossings around the Bay. These structures are owned and maintained by a multitude of private, local, state, and federal, agencies. The USFWS created a GIS database containing spatial data for all tidegates, culverts, and other water control structures, surrounding Humboldt Bay (Figure 34). The USFWS incorporated existing datasets and also conducted site visits to locate and assess water control structures. The USFWS water control database includes a total of 371 structures; 164 structures were field inventoried by USFWS, and the remaining 207 structures were imported from existing datasets. A total of 79 tidegates and 282 culverts were identified, as well as 10 other structures, principally splash board weir structures. The USFWS water control GIS database has been incorporated into this project's database.

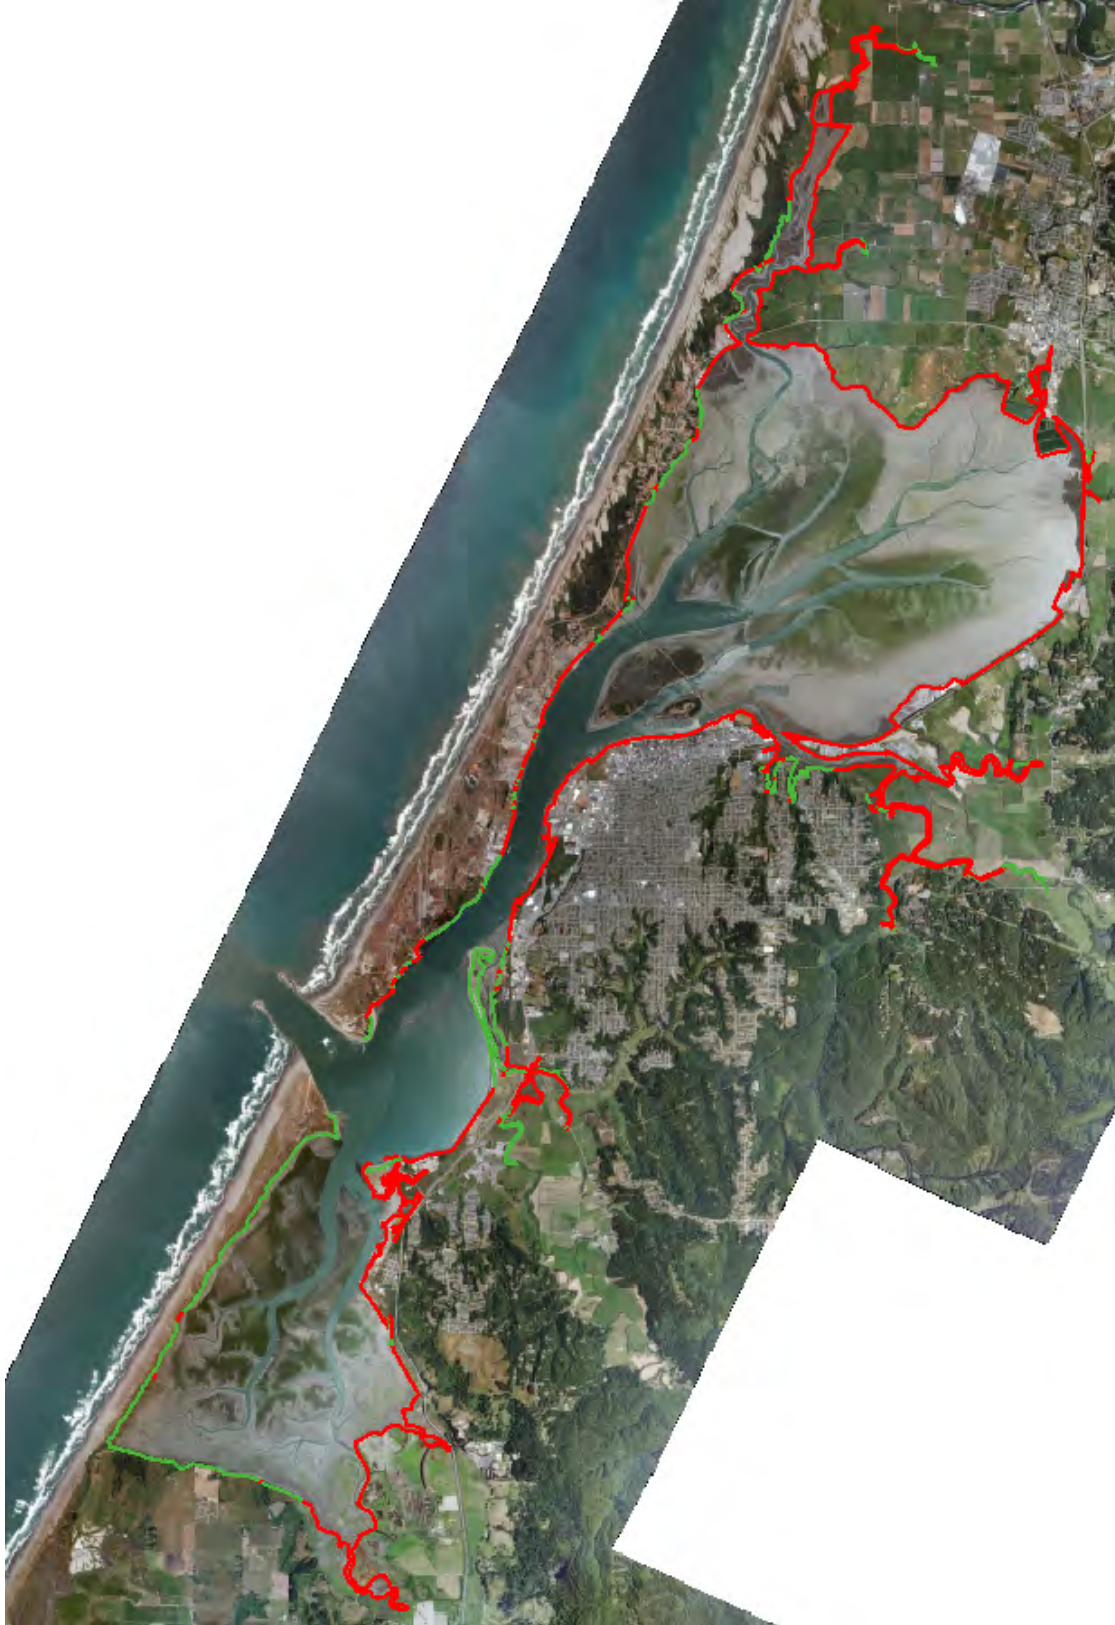
Figure 35. Humboldt Bay shoreline structure: 75% is artificial (red) and 25% is natural (green).

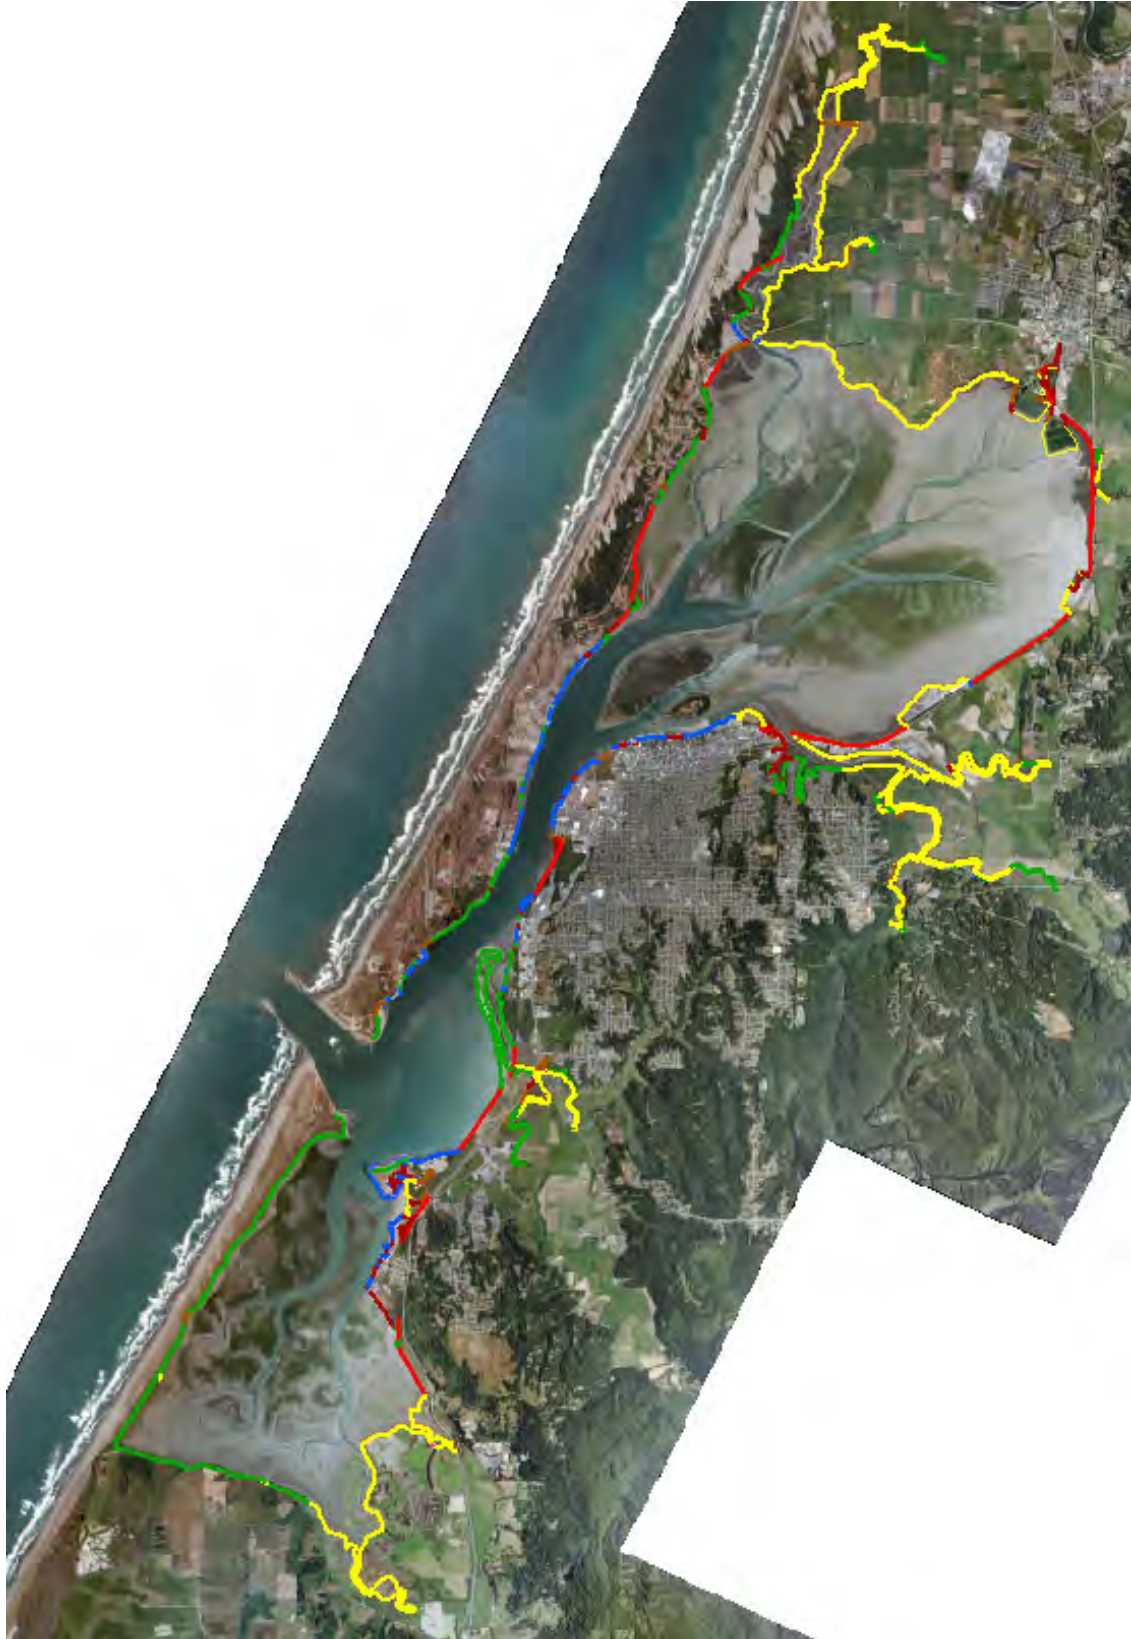
Figure 36. Distribution of shoreline structure types on Humboldt Bay: dike (yellow), natural (green), railroad (red), fill (maroon), fortified (blue), and roadway (brown).

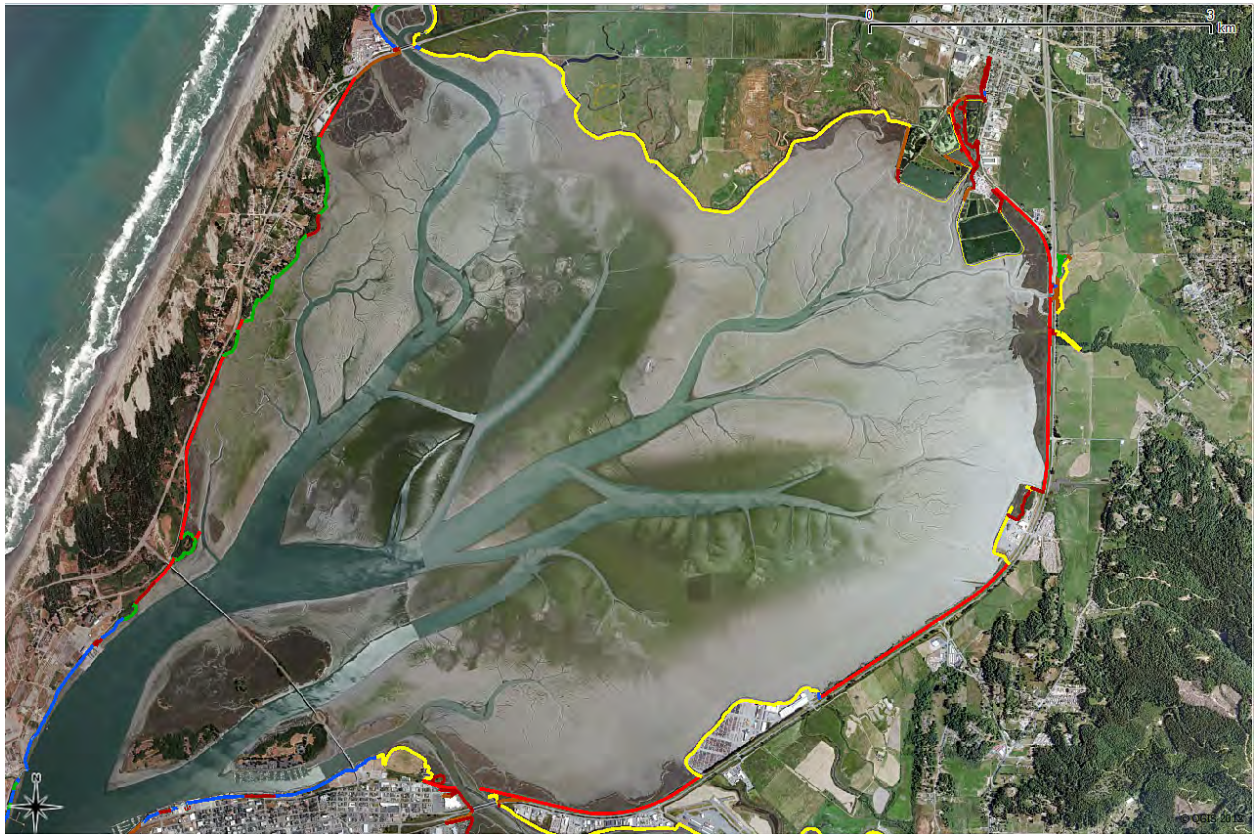
Figure 37. Distribution of shoreline structure types on Arcata Bay: dike (yellow), natural (green), railroad (red), fill (maroon), fortified (blue), and roadway (brown).

The shoreline of Arcata Bay is mostly developed; what natural shoreline remains fronts the community of Manila (Figure 37). Arcata Bay has an extensive inter-tidal area of mudflats at low tide and a few deep water channels draining the Bay. Most of Humboldt Bay's shell fish maricultural operations are located in Arcata Bay. Arcata Bay has two freshwater drainages without tide gates that have open-ended channels at the tidal-freshwater interface (Jolly Giant Creek, Jacoby Creek, and soon to be three when Janes Creek McDaniel's Slough restoration is completed in 2013). These streams provide valuable brackish water fish habitat.

The shoreline of Arcata Bay is 20.5 miles long; 91% of the shoreline is composed of artificial structures and 9% of the shoreline is natural. The two dominate shoreline structures are the NCRA grade with 6.5 miles, 32% of the shoreline (Table 4) and Reclamation District's 768 dike of 6.3 miles, 31% of the shoreline, which was rehabilitated in 2008. Other types of shorelines on Arcata Bay are fill 2.5 miles (12%), the City of Arcata's waste water treatment and marsh ponds 1.9 miles (9%), which were also rehabilitated in 2008, and roadways 1.3 miles (6%).

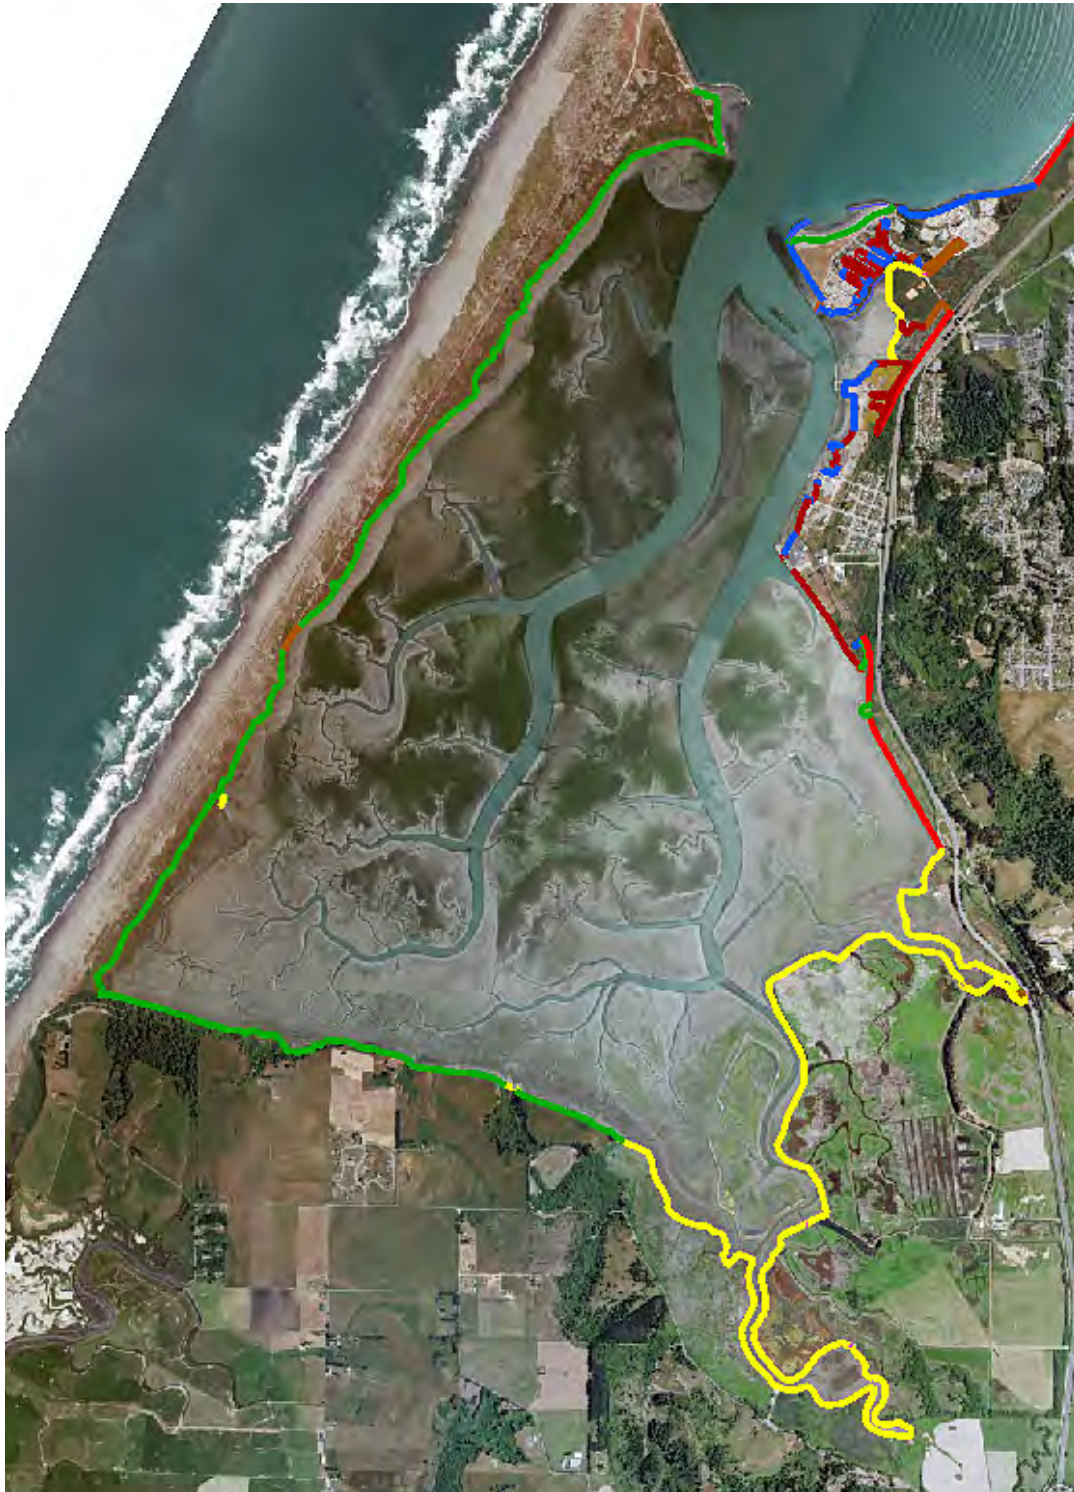
Figure 39. Distribution of shoreline structure types on South Bay: dike (yellow), natural (green), railroad (red), fill (maroon), fortified (blue), and roadway (brown).

South Bay has the greatest amount of natural shoreline and a relatively rare shoreline type along Table Bluff: cliffs. South Bay, like Arcata Bay, also has extensive inter-tidal mudflats at low tide, as well as a deep water channel to Fields Landing that is periodically dredged. South Bay also has a rather unique waterfront residential area at King Salmon: commercial waterfront in Fields Landing. There are two wildlife areas on South Bay, HBNWR and the Mike Thompson Wildlife Area on South Spit. Freshwater inflow from Salmon Creek provides valuable brackish water fish habitat at the HBNWR.
