Humboldt Bay Shoreline Inventory, Mapping, and Sea Level Rise Vulnerability Assessment

Prepared for
State Coastal Conservancy
1330 Broadway, 13th Floor
Oakland, CA 94612-2530

January 2013

Humboldt Bay Sea Level Rise Adaptation Planning Project:
Phase 1
Shoreline Inventory, Mapping, and Vulnerability Assessment

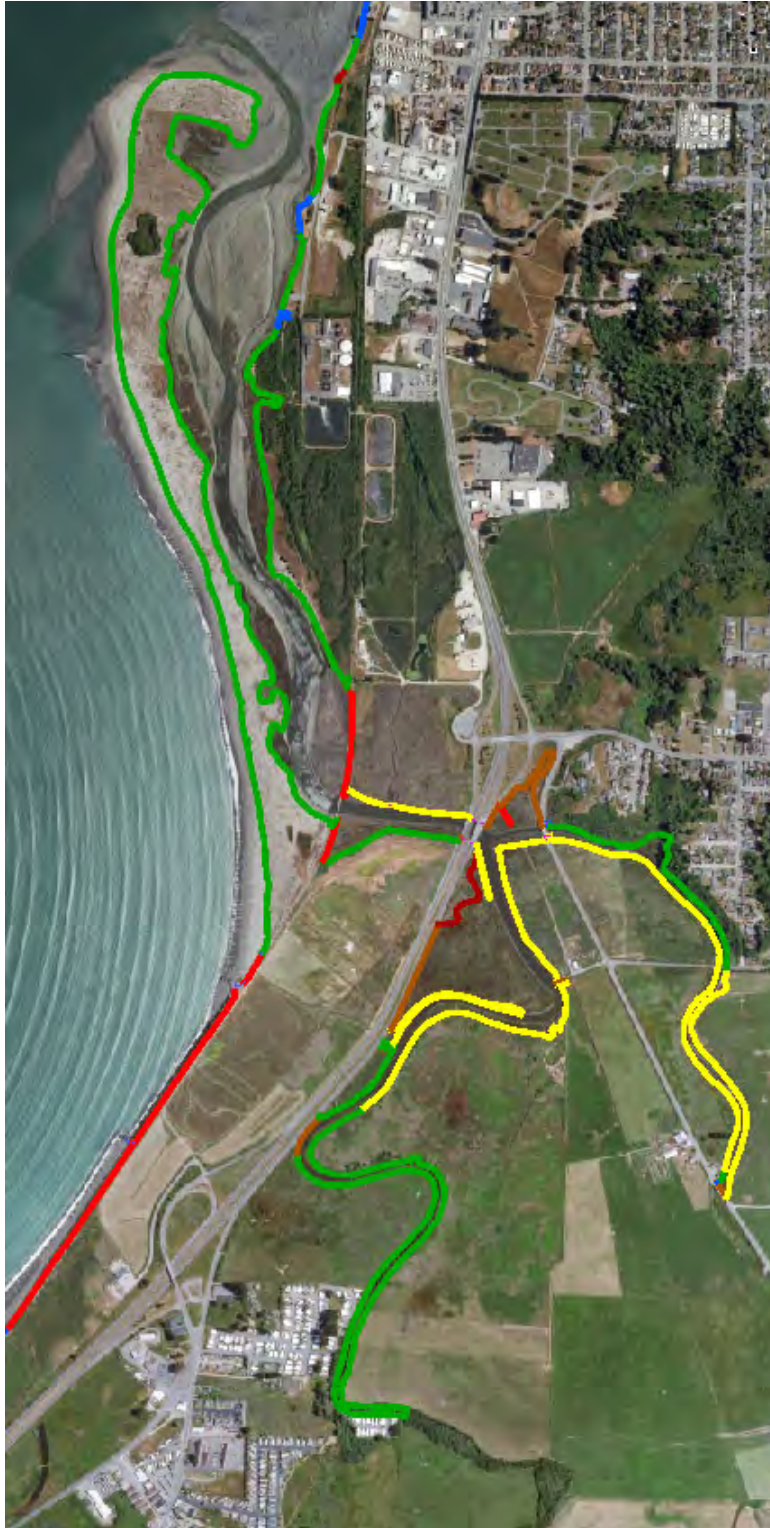
Figure 42. Distribution of shoreline structure types on Elk River Slough: dike (yellow), natural (green), railroad (red), fill (maroon), fortified (blue), and roadway (brown).

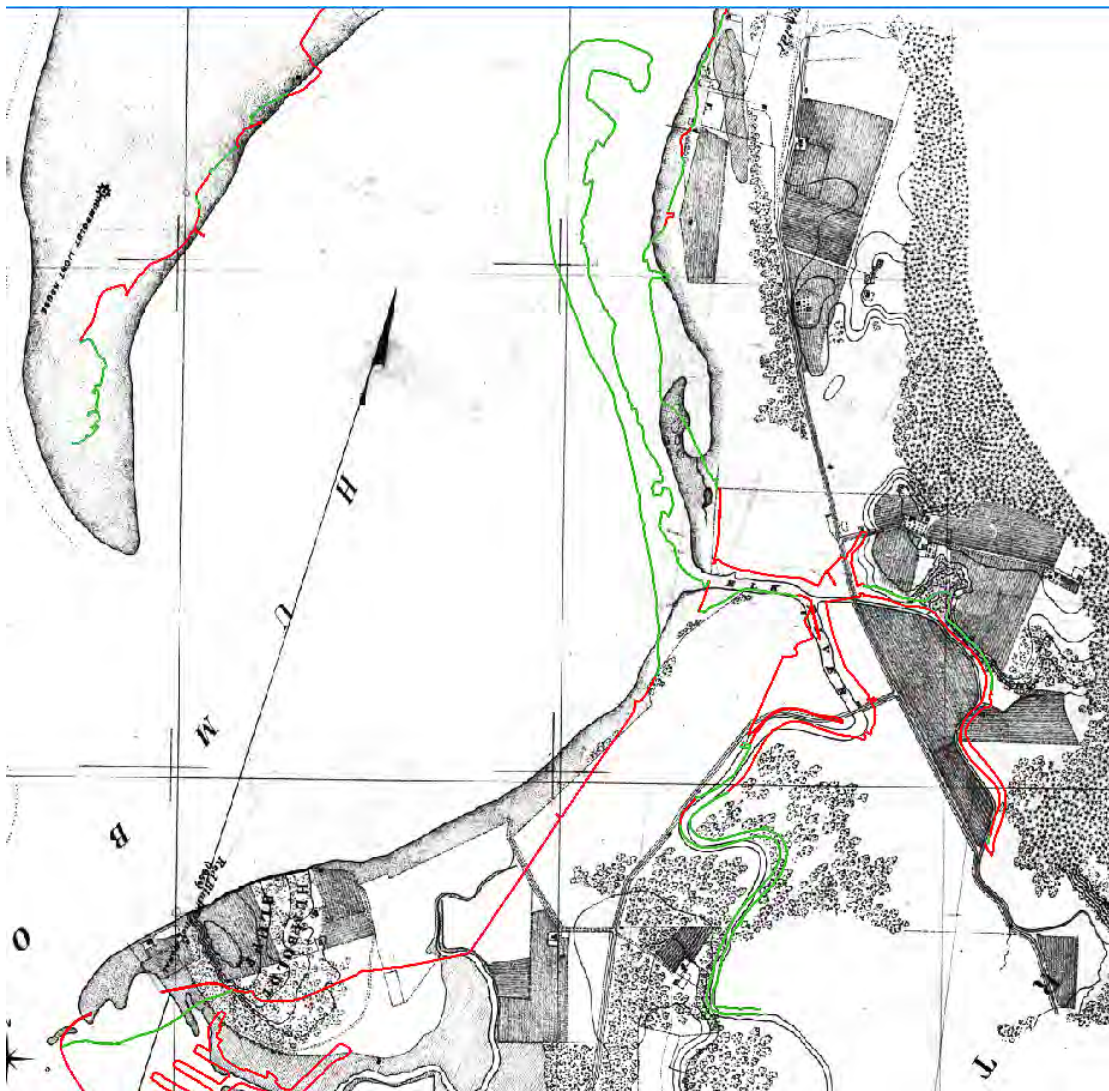
Figure 43. Elk River Slough, 2009 shoreline location overlaid on 1870 USCGS map.

Elk River Slough is unique in that historical maps do not depict extensive areas of salt marsh and tidal channel networks (Laird 2007) (Figure 43). However, the 1921 soil survey of Humboldt Bay does indicate that Elk River Slough and its valleys was a zone of tidal and freshwater interface, with salt marsh to the south and north of Elk River Slough and up the valley reaches on Elk River and Ryan Slough (Watson 1925). Salt marsh and windblown soils were overlain with overbank deposits of freshwater sediments (Figure 44). A significant portion of the shoreline along Elk River Slough is not diked, approximately 4,500 feet; it is natural bottom land. The upper end of the Slough is an open channel that traverses the floodplain until riparian forest closes in on Elk River at the upper tidal limits. Another unique landscape feature of Elk River Slough is the spit that has accreted and extended out into the shipping channel of Eureka Bay. The spit is apparently a result of the construction of the Harbor entrance jetties and dredging that caused the erosion of historic Buhne Point, whose sediments then formed Elk River's spit (pers. comm. John Winzler 2012).

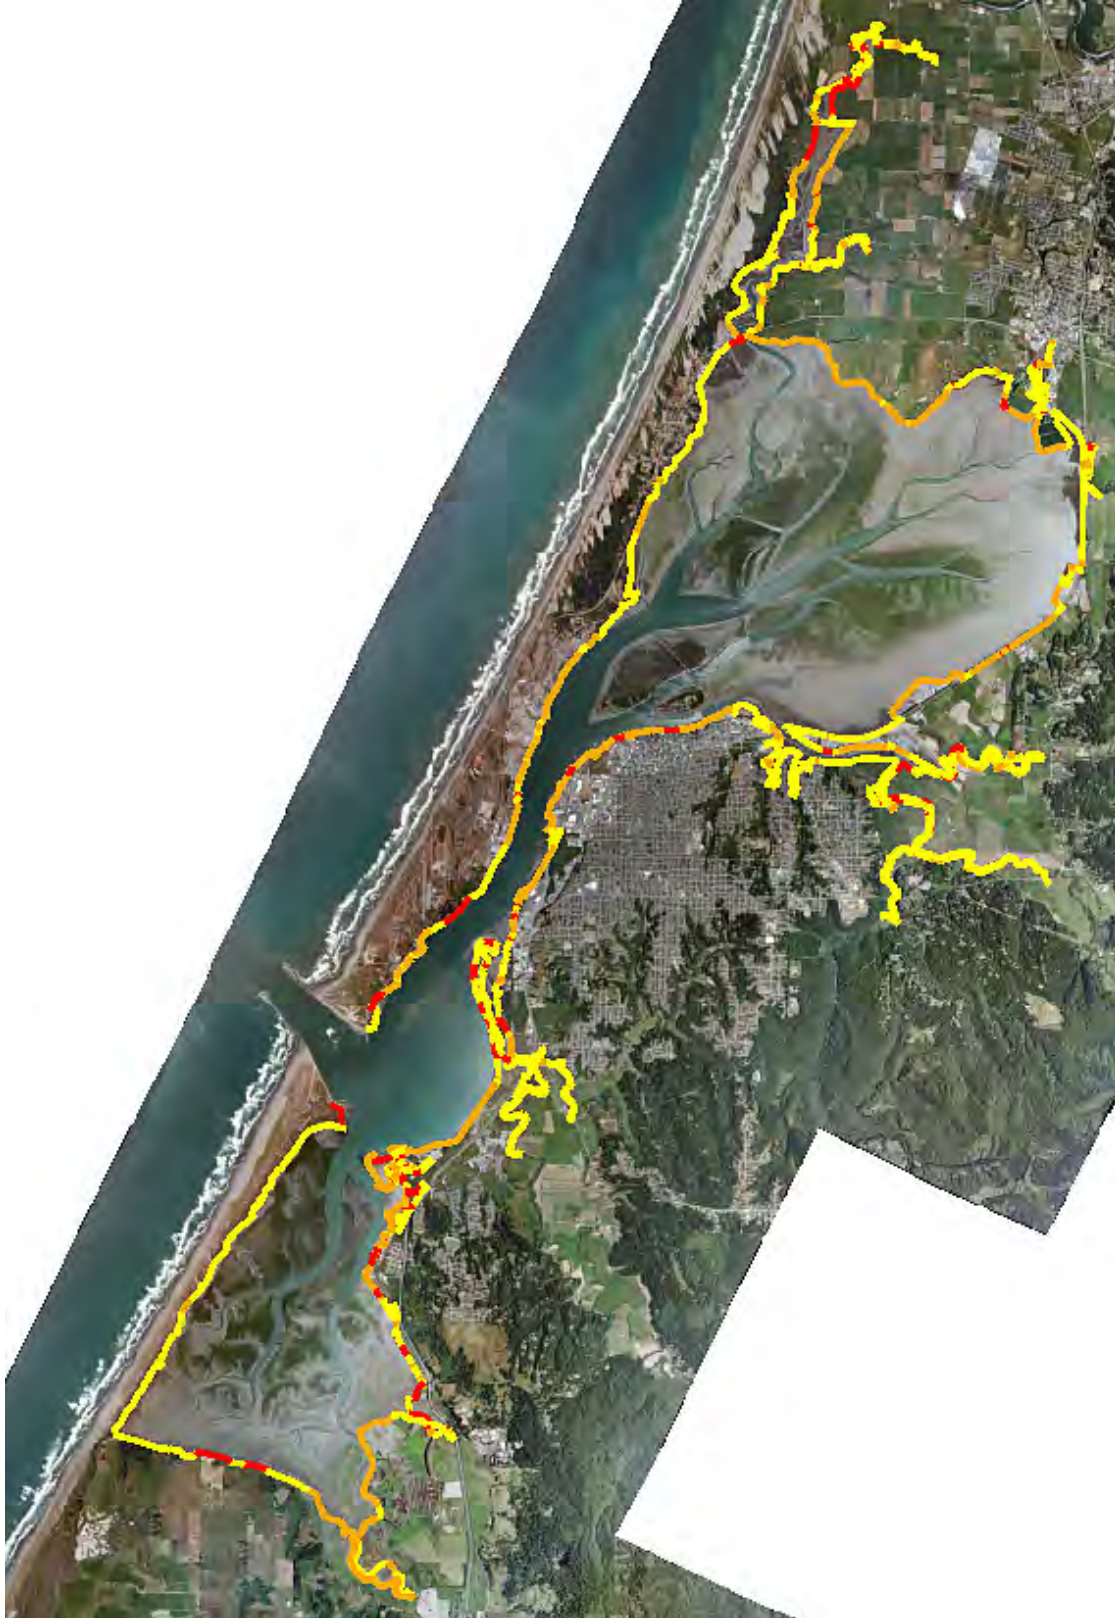
Figure 45. Distribution of shoreline cover on Humboldt Bay: vegetated (yellow), fortified (brown), and exposed (red).

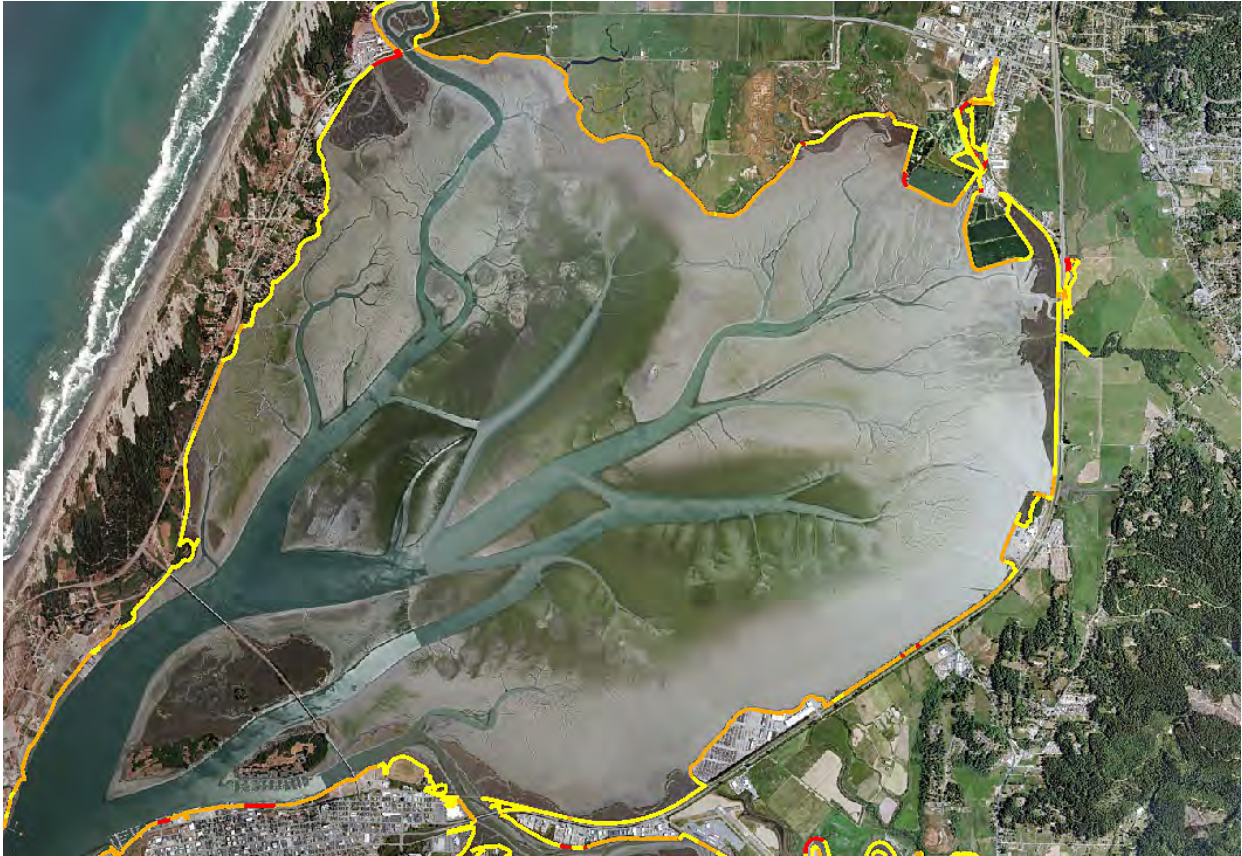
Figure 46. Distribution of shoreline cover types on Arcata Bay: vegetated (yellow), fortified (brown), and exposed (red).

The dominant shoreline cover on Arcata Bay is vegetation (12.3 miles, 60%), revetment covers 7.2 miles of shoreline (36%), and 0.8 miles is exposed or eroding (4%) (Table 14). The two dominant artificial shoreline structures on Arcata Bay are railroad grade (32%) and earthen dikes (31%). The railroad grade is mostly unfortified (4.8 miles, 73%); 4.7 miles is vegetated, 525 feet is exposed, and 1.7 miles is fortified (27%). A significant length of the dikes was recently fortified (3.9 miles, 62.8%) by Reclamation District 768 and the California Redwood Company. 2.3 miles of Arcata Bay are vegetated (36.8%), and just 116 feet are exposed.

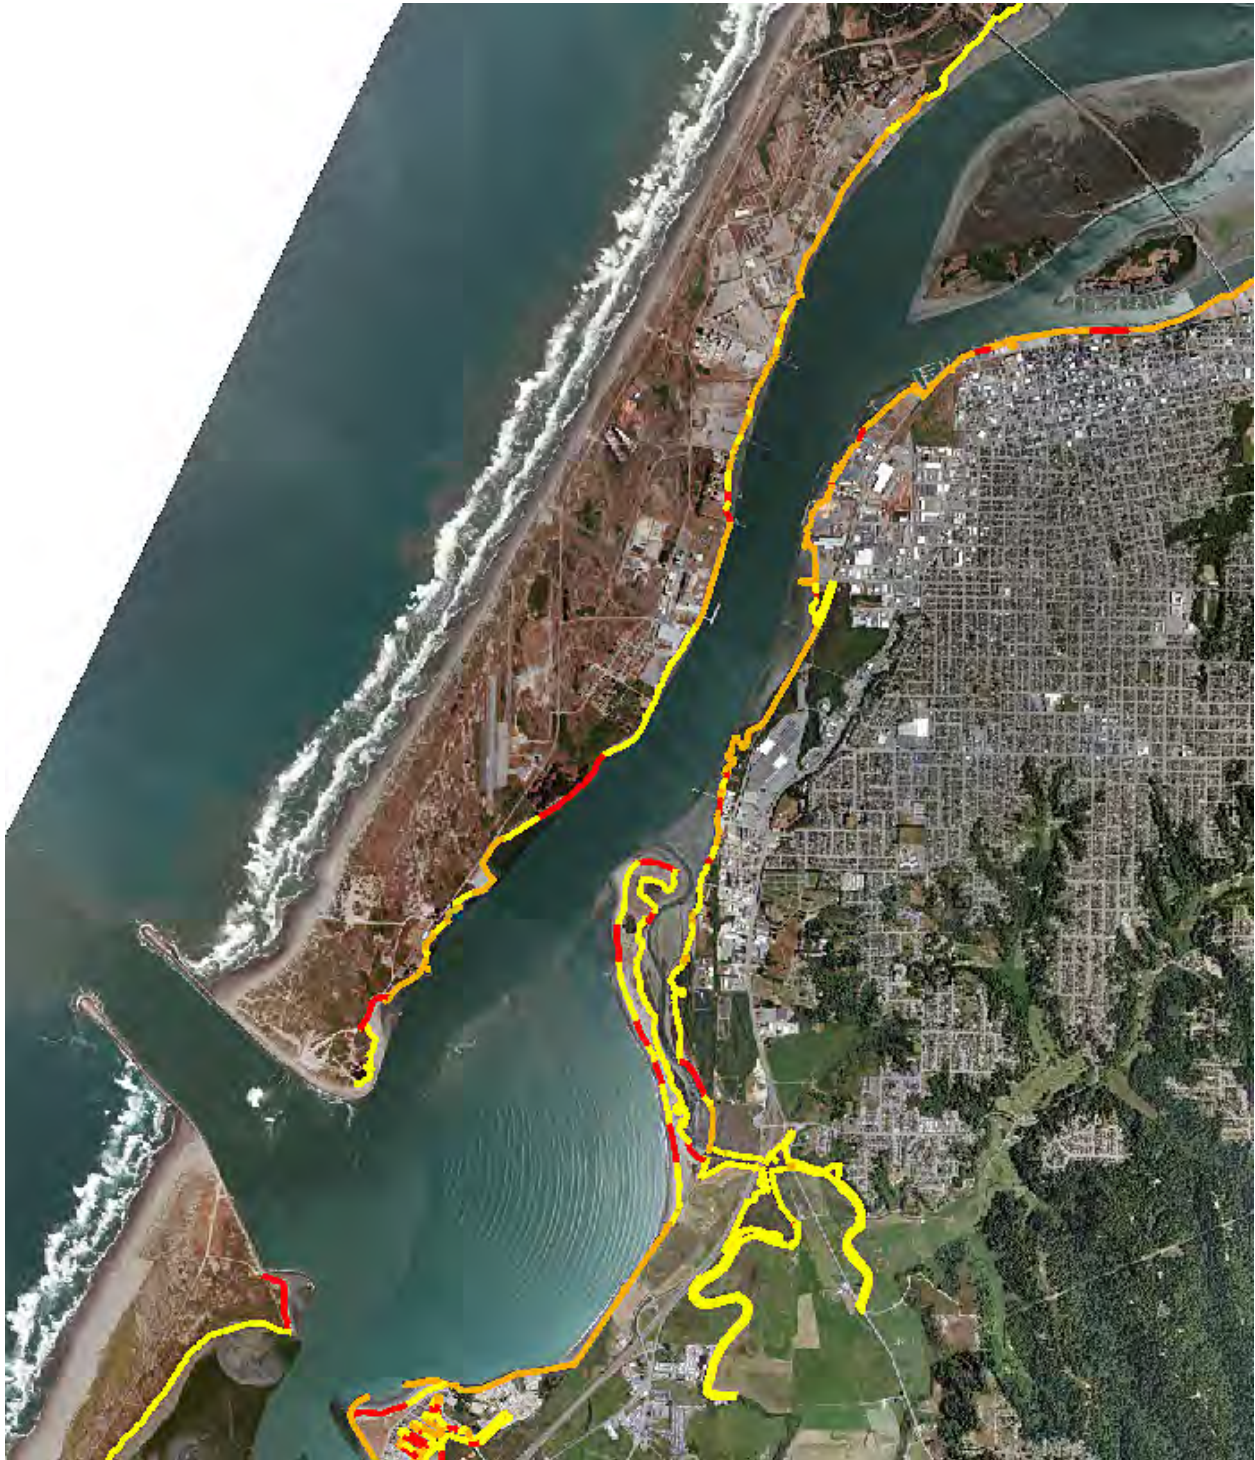
Figure 47. Distribution of shoreline cover types on Eureka Bay: vegetated (yellow), fortified (brown), and exposed (red).

The majority of the shoreline cover on Eureka Bay’s 15.9 mile shoreline is fortified (8.6 miles, 54%), while there are 7.3 miles (46%) of unfortified shoreline composed of 5.2 miles with vegetative cover (33%), 1.8 miles of exposed or eroding shoreline (11%), and 0.3 miles with no cover (2%)(Table 15). Eureka Bay’s shoreline structure is composed of 35% fortified shoreline, 10% railroad grade, 5% roadway, and only 4% dikes. The railroad’s 1.7 miles of shoreline has rock revetment covering 66% and 44% in vegetative cover. Roadways occupy 0.7 miles and are 74% rock revetment with 963 feet (25%) exposed. Dikes are on 0.6 miles of shoreline and are entirely unfortified with vegetative cover.

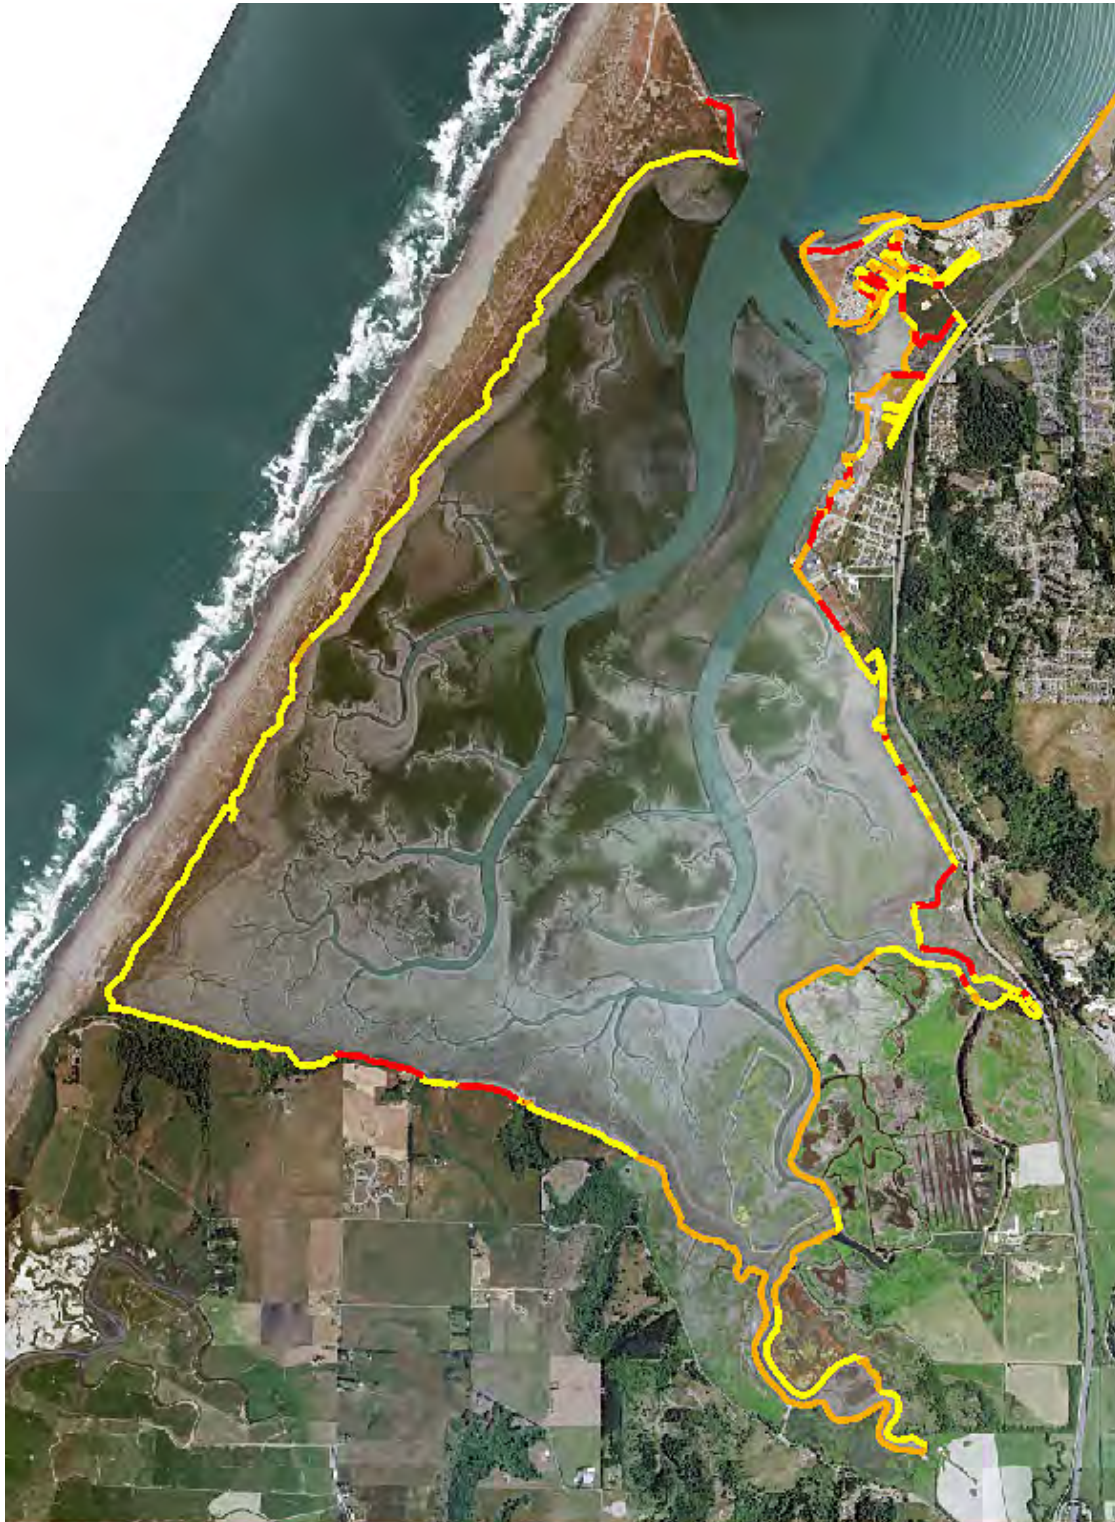
Figure 48. Distribution of shoreline cover types on South Bay: vegetated (yellow), fortified (brown), and exposed (red).

The shoreline of South Bay is 21.8 miles long and the dominant shoreline cover is vegetation (12.0 miles, 55%). Fortified cover comprises 6.7 miles of shoreline (36%), and 3.1 miles (14%) is exposed or eroding (Table 16). The dominant artificial shoreline structures on South Bay are: earthen dikes (7.6 miles), fill (2.6 miles), fortified (1.5 miles), and railroad (1.4 miles). A significant length of the dikes has been recently fortified (4.3 miles, 56%), while 2.7 miles are vegetated (12%), and 0.7 miles are exposed (3%). The 2.6 miles of filled shoreline is nearly entirely unfortified (97%): 1.3 miles with vegetative cover (51%), and 1.2 miles exposed (46%). The 1.5 miles of fortified shoreline is nearly entirely composed of revetments (93%) with 522 feet exposed (7%). The 1.4 miles of railroad has 1.1 miles of vegetative cover (80%), and 346 feet exposed (4%).

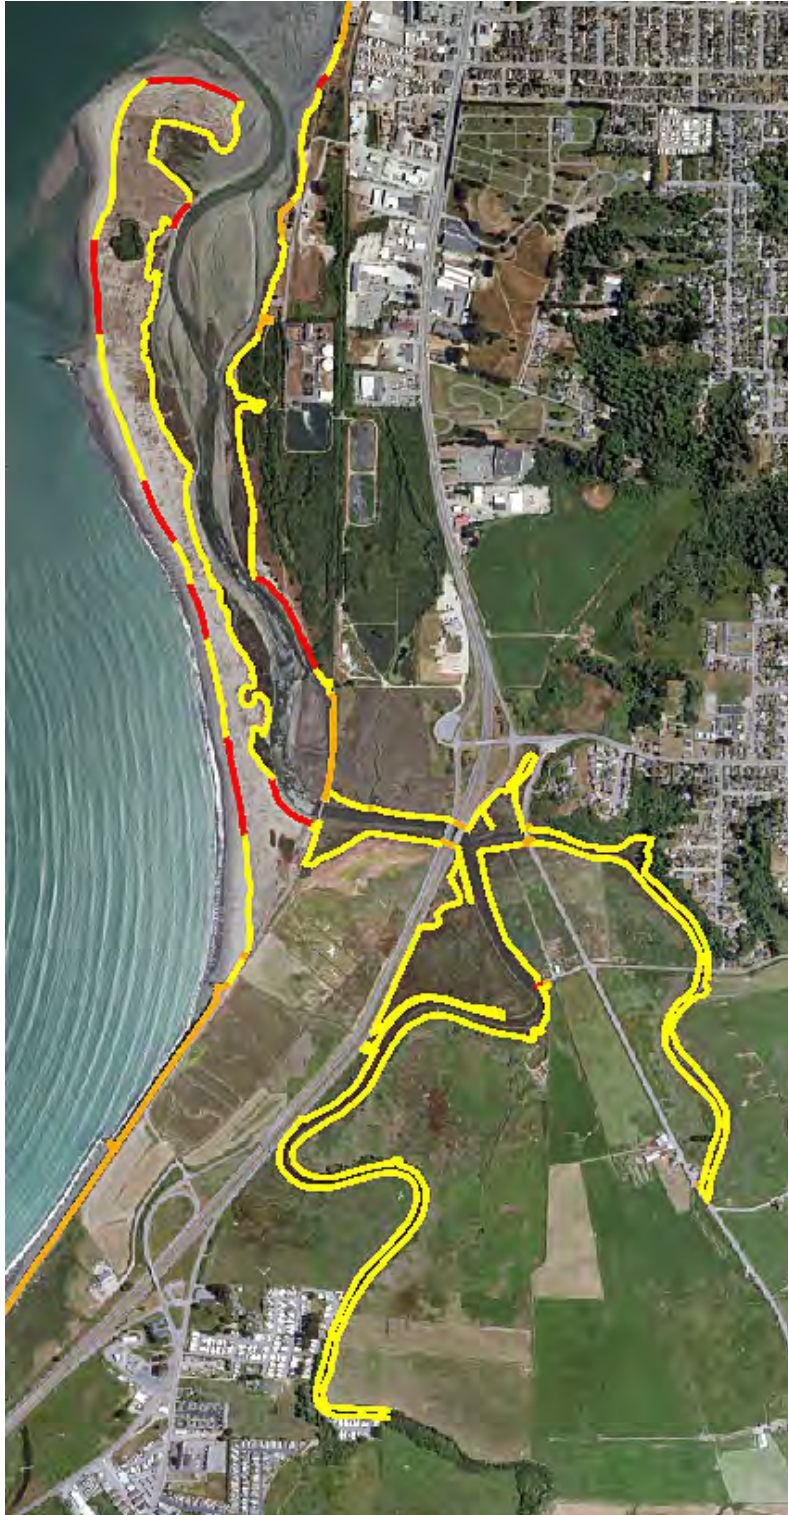
Figure 51. Distribution of shoreline cover types on Elk River slough: vegetated (yellow), fortified (brown), and exposed (red).

The 9.7 miles of shoreline on Elk River Slough is predominately natural (5.4 miles, 55%). The dominant artificial shoreline structure is earthen dikes covering 2.9 miles (30%) and the dikes are in vegetative cover for nearly their entire length (99.6%)(Table 19). Roadways occupy 0.6 miles of the shoreline and 95% is vegetatively covered, and the railroad along 0.3 miles of shoreline is nearly evenly split between rock revetment and vegetative cover.

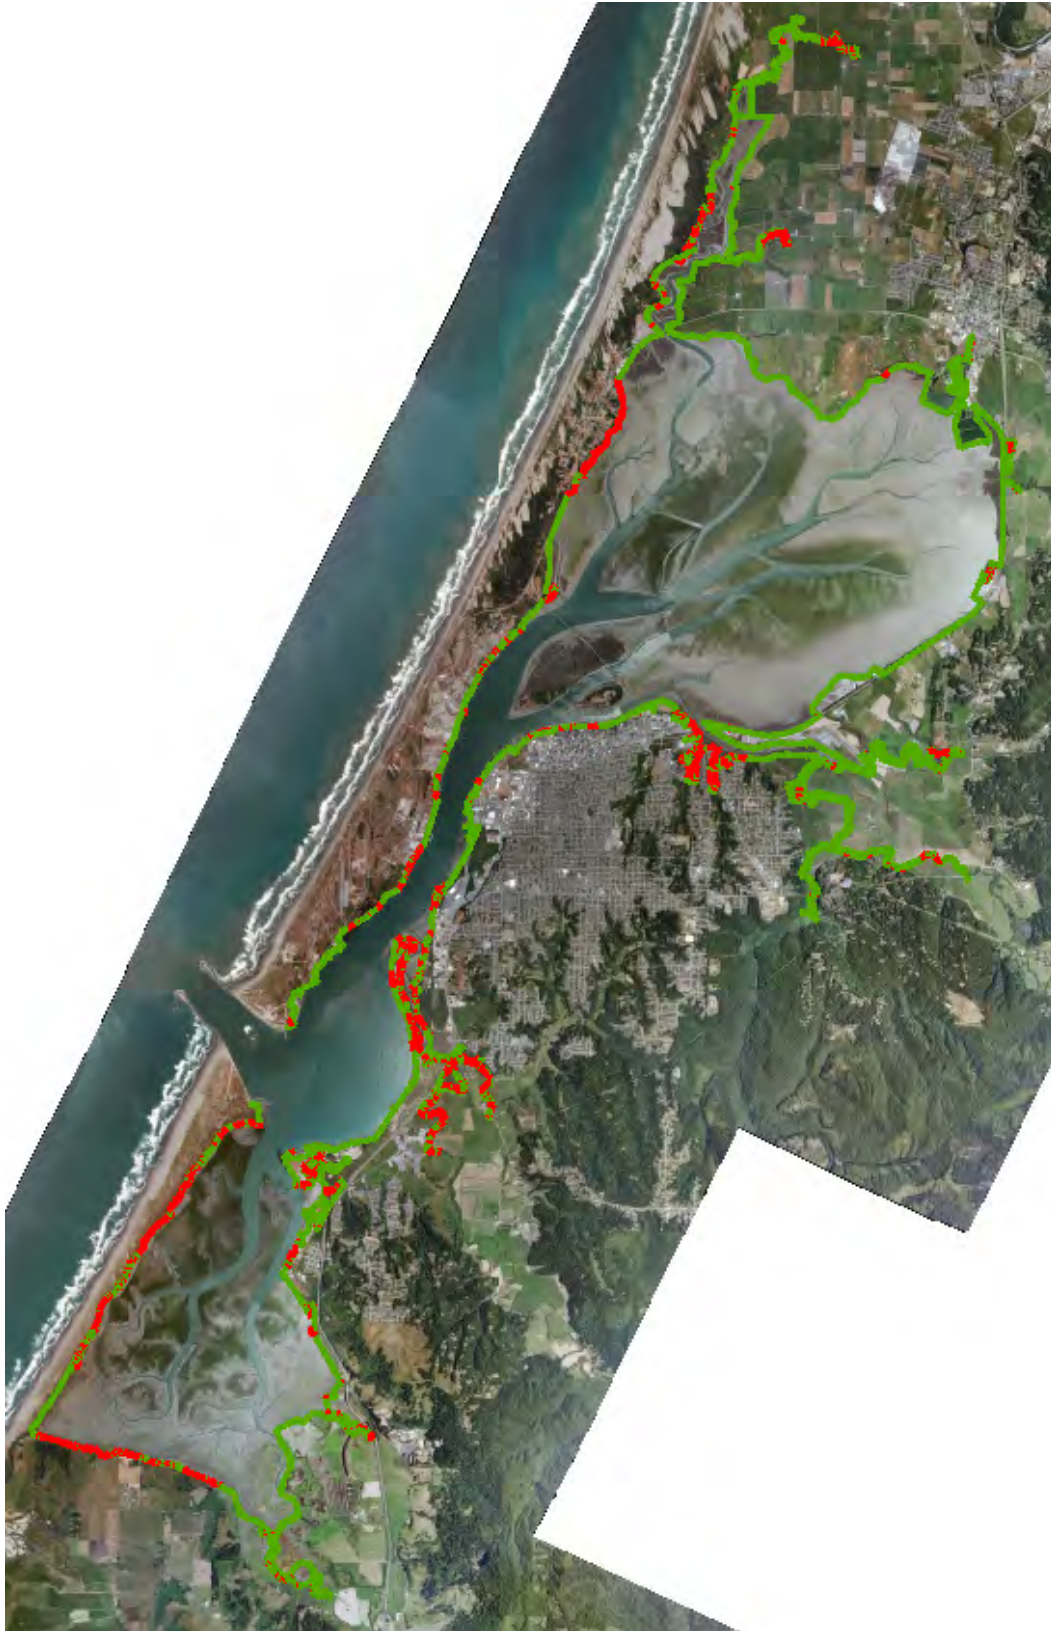
Figure 53. Humboldt Bay shoreline segments with elevations less than or equal to 8.74 feet (red), and segments that are greater than 8.74 feet in elevation (green).

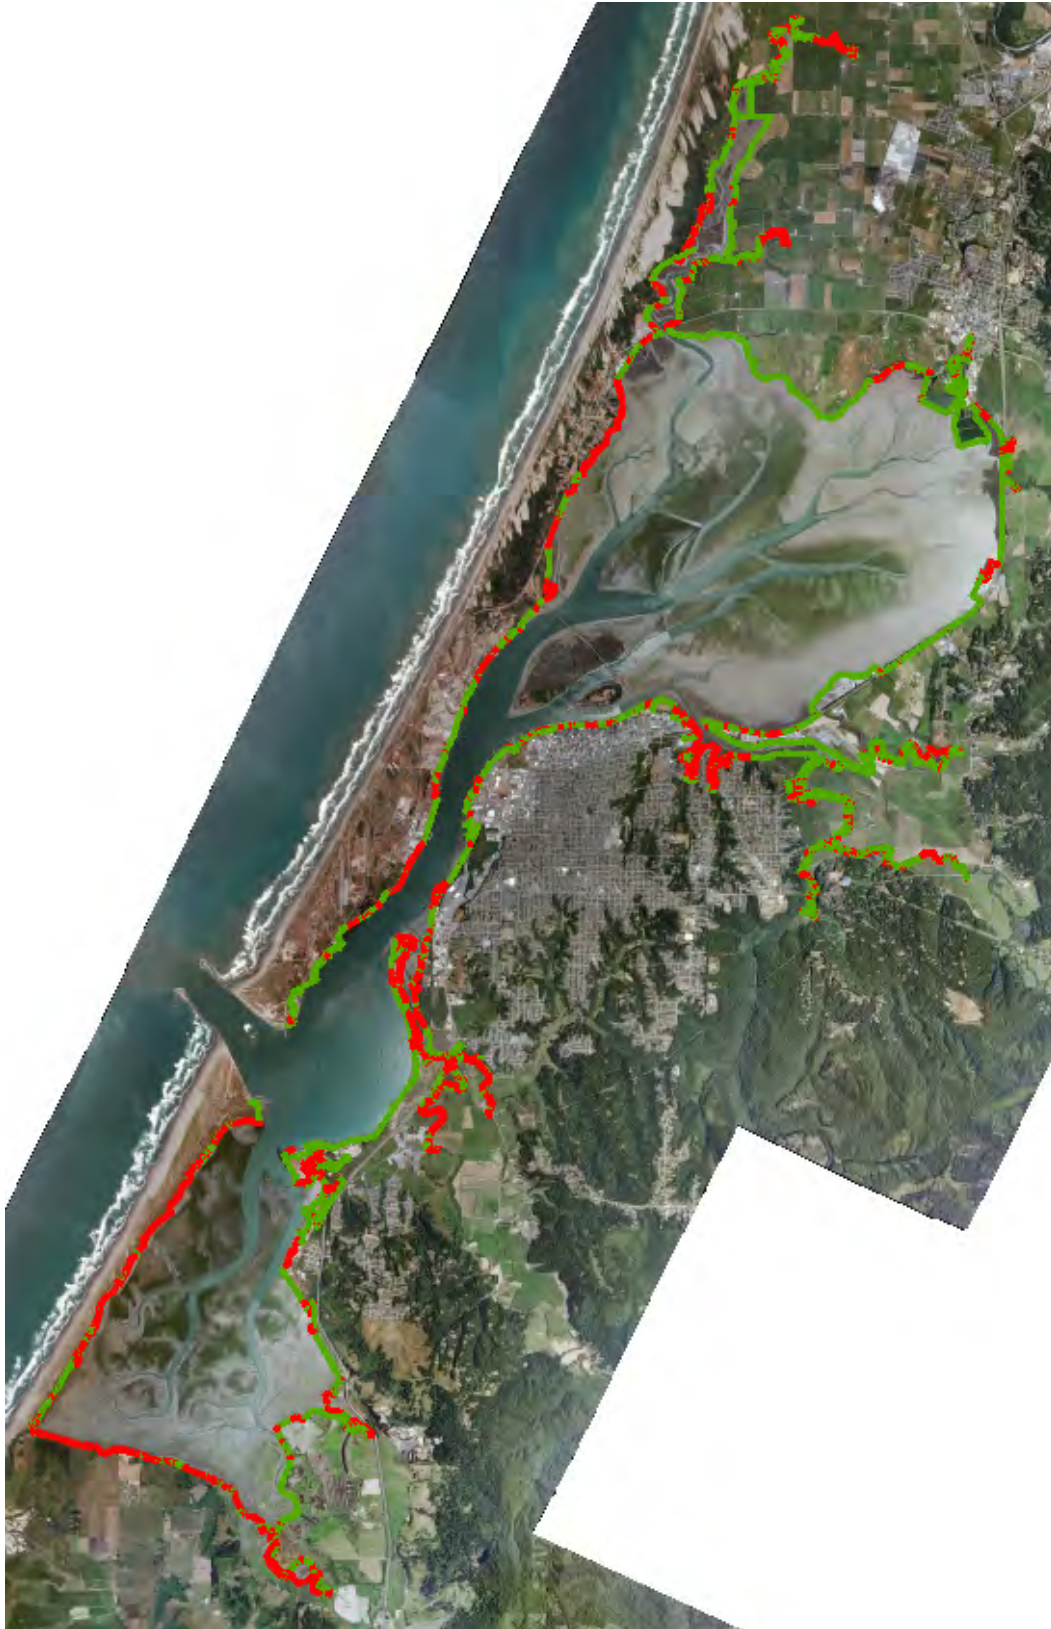
Figure 54. Humboldt Bay shoreline segments with elevations less than or equal to 9.74 feet (red) and segments that are greater than 9.74 feet in elevation (green).

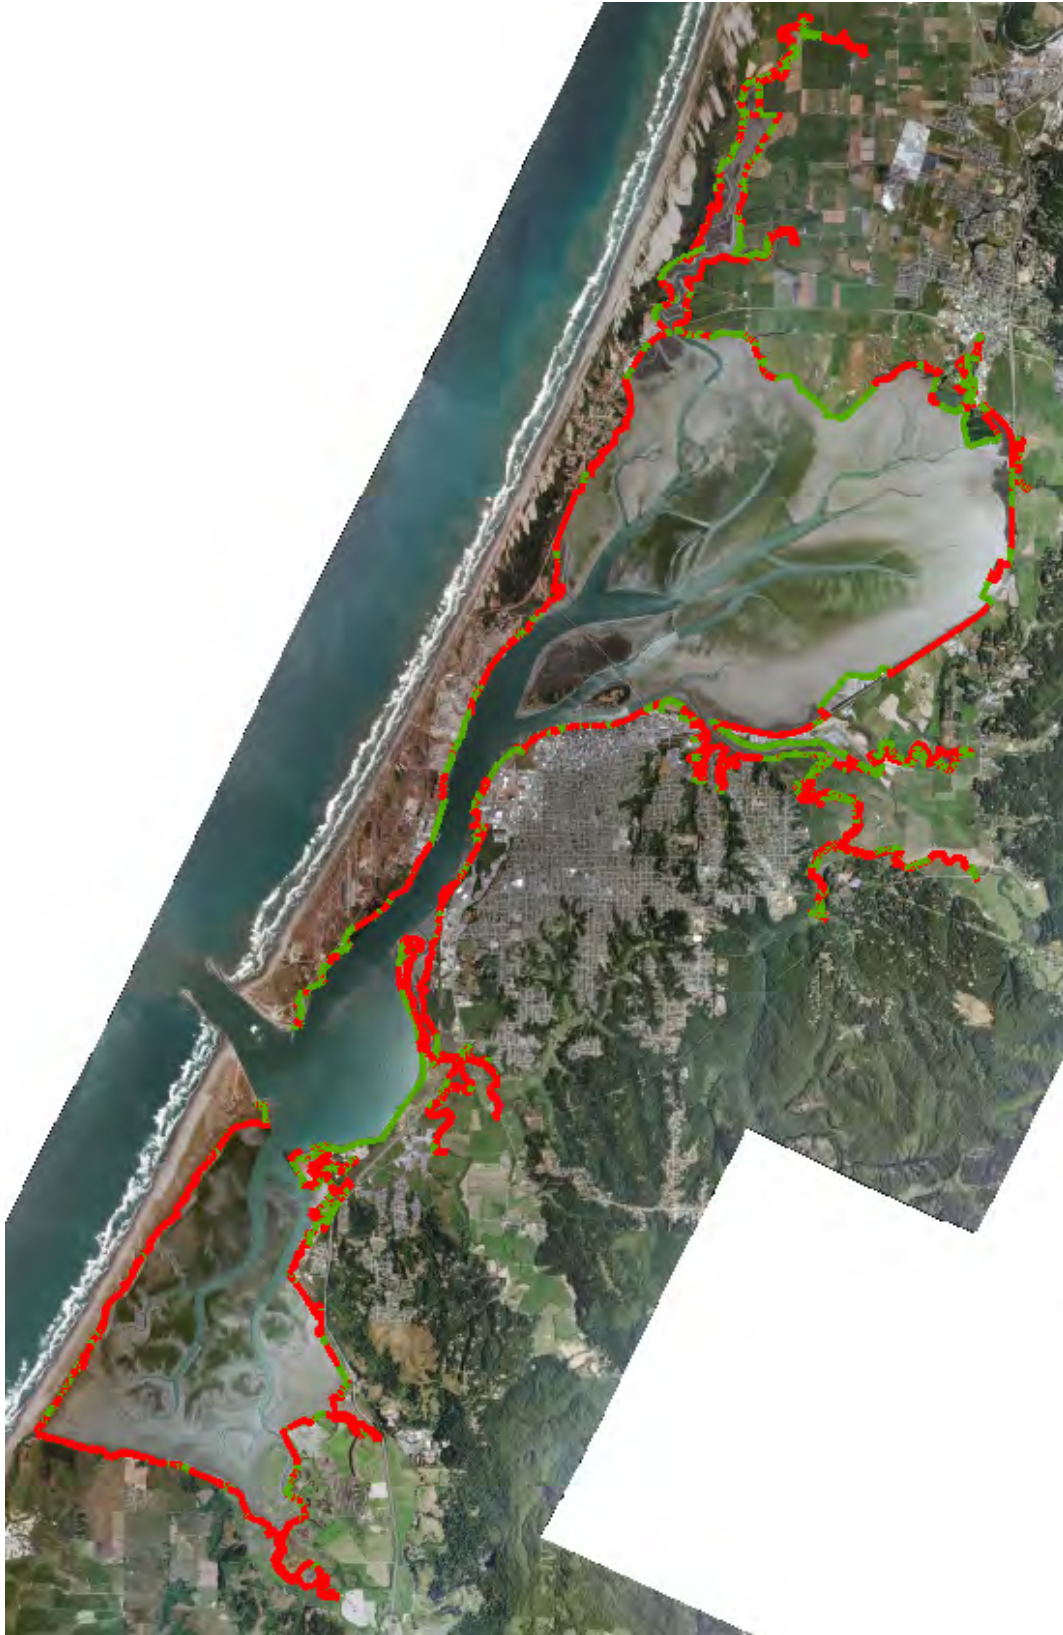
Figure 55. Humboldt Bay shoreline segments with elevations less than or equal to 10.74 feet (red) and segments that are greater than 10.74 feet in elevation (green).

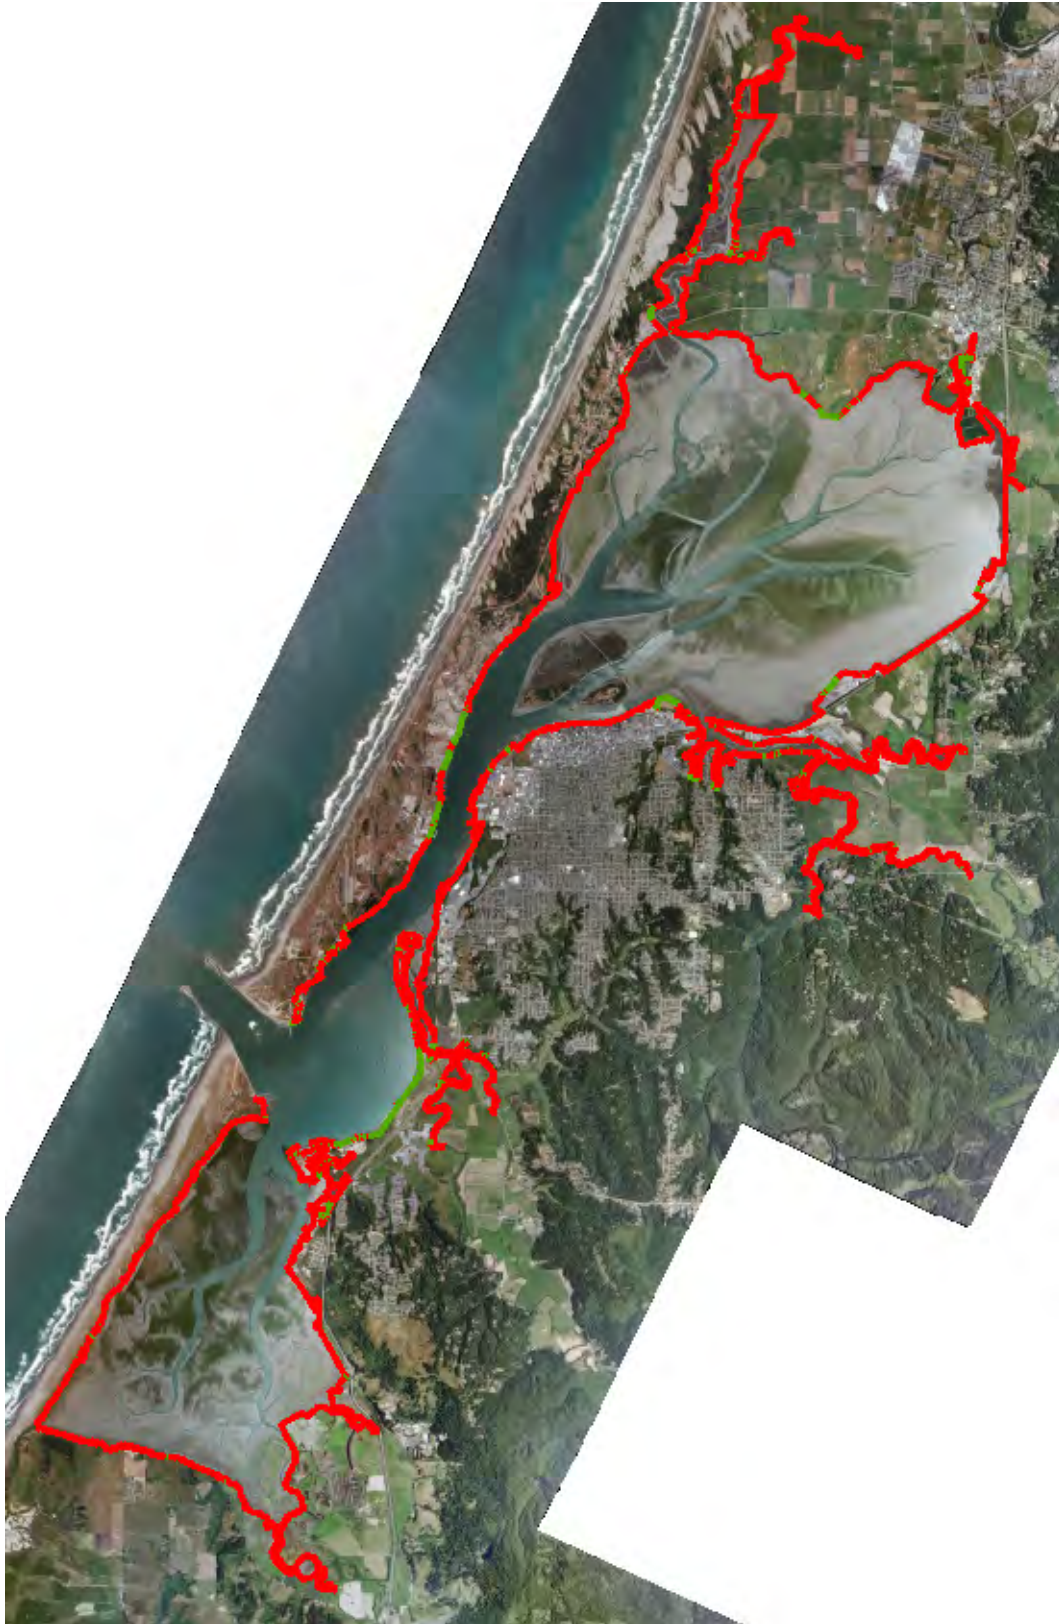
Figure 56. Humboldt Bay shoreline segments with elevations less than or equal to 13.74 feet (red) and segments that are greater than 13.74 feet in elevation (green).

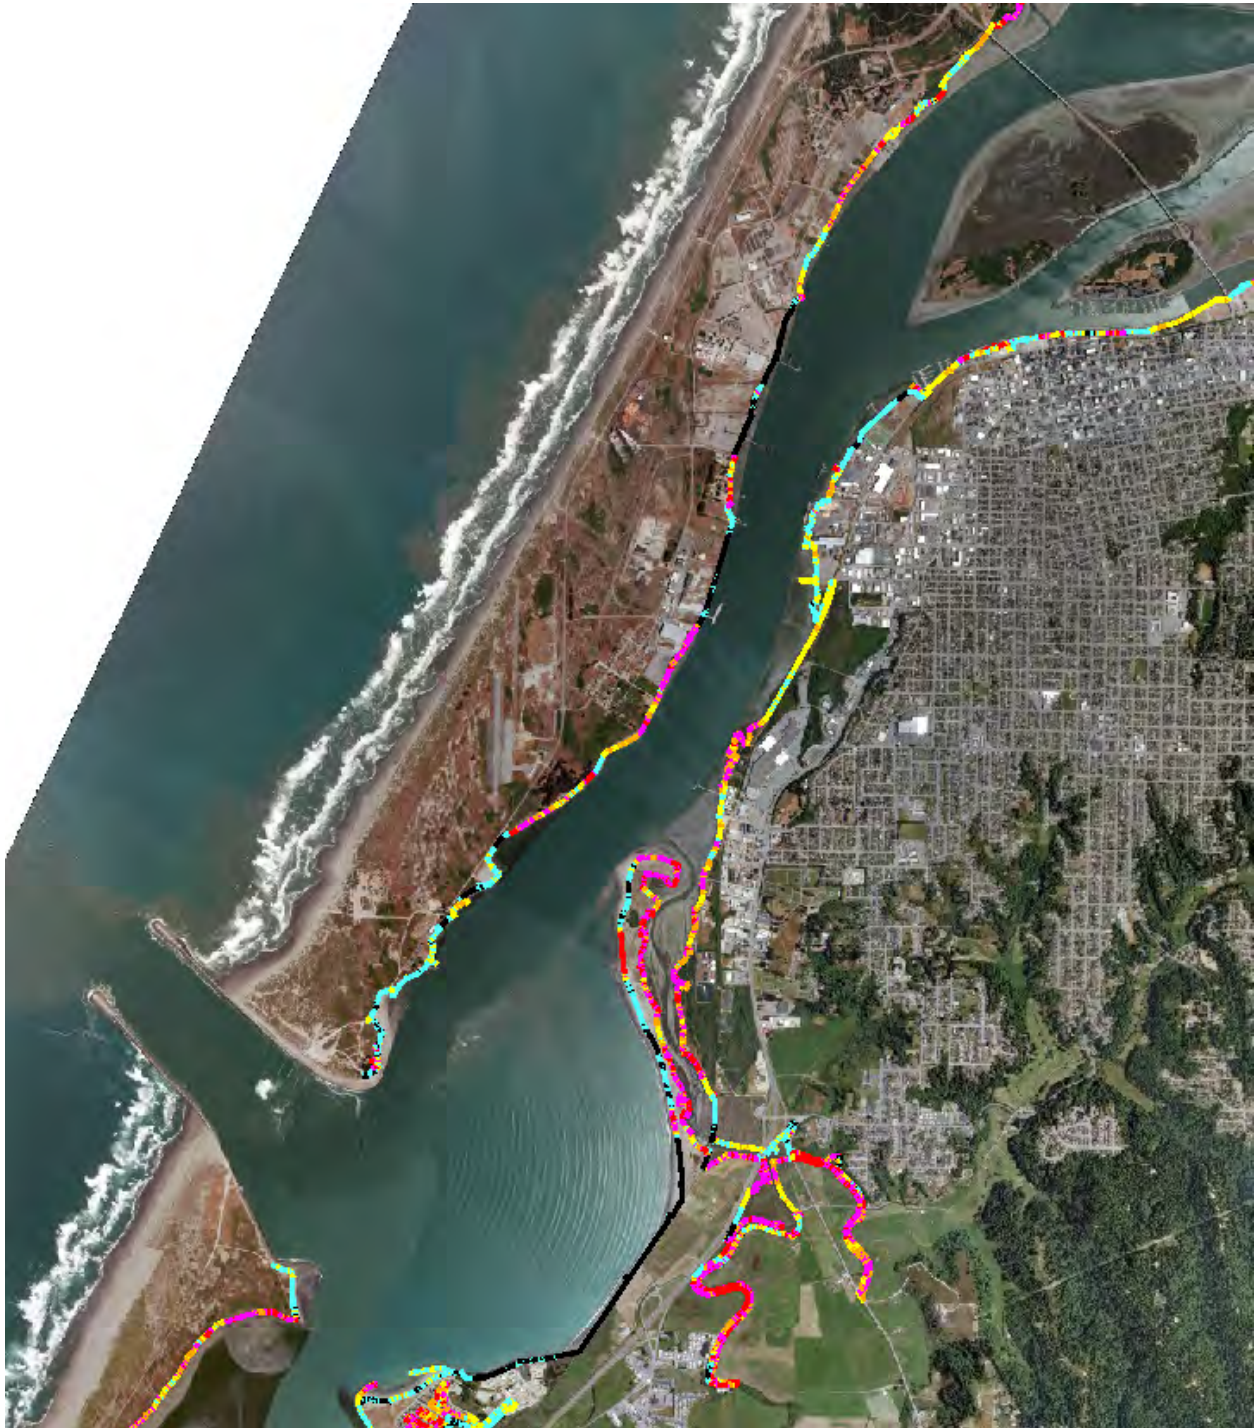
Figure 58. Distribution of shoreline elevations on Eureka Bay: 7.74 feet (red), 8.74 feet (magenta), 9.74 feet (brown), 10.74 feet (yellow), 13.74 feet (turquoise), and greater than 13.74 feet (black).

The shoreline of Eureka Bay is 15.9 miles long; 71% of the shoreline is composed of artificial structures. The dominant artificial shoreline structures on Eureka Bay are fortified (5.6 miles, 35%), railroad (1.7 miles, 10%), fill (1.2 miles, 8%), bulwark (0.7 miles, 5%), and roadways (0.7 miles, 5%)(Table 23).

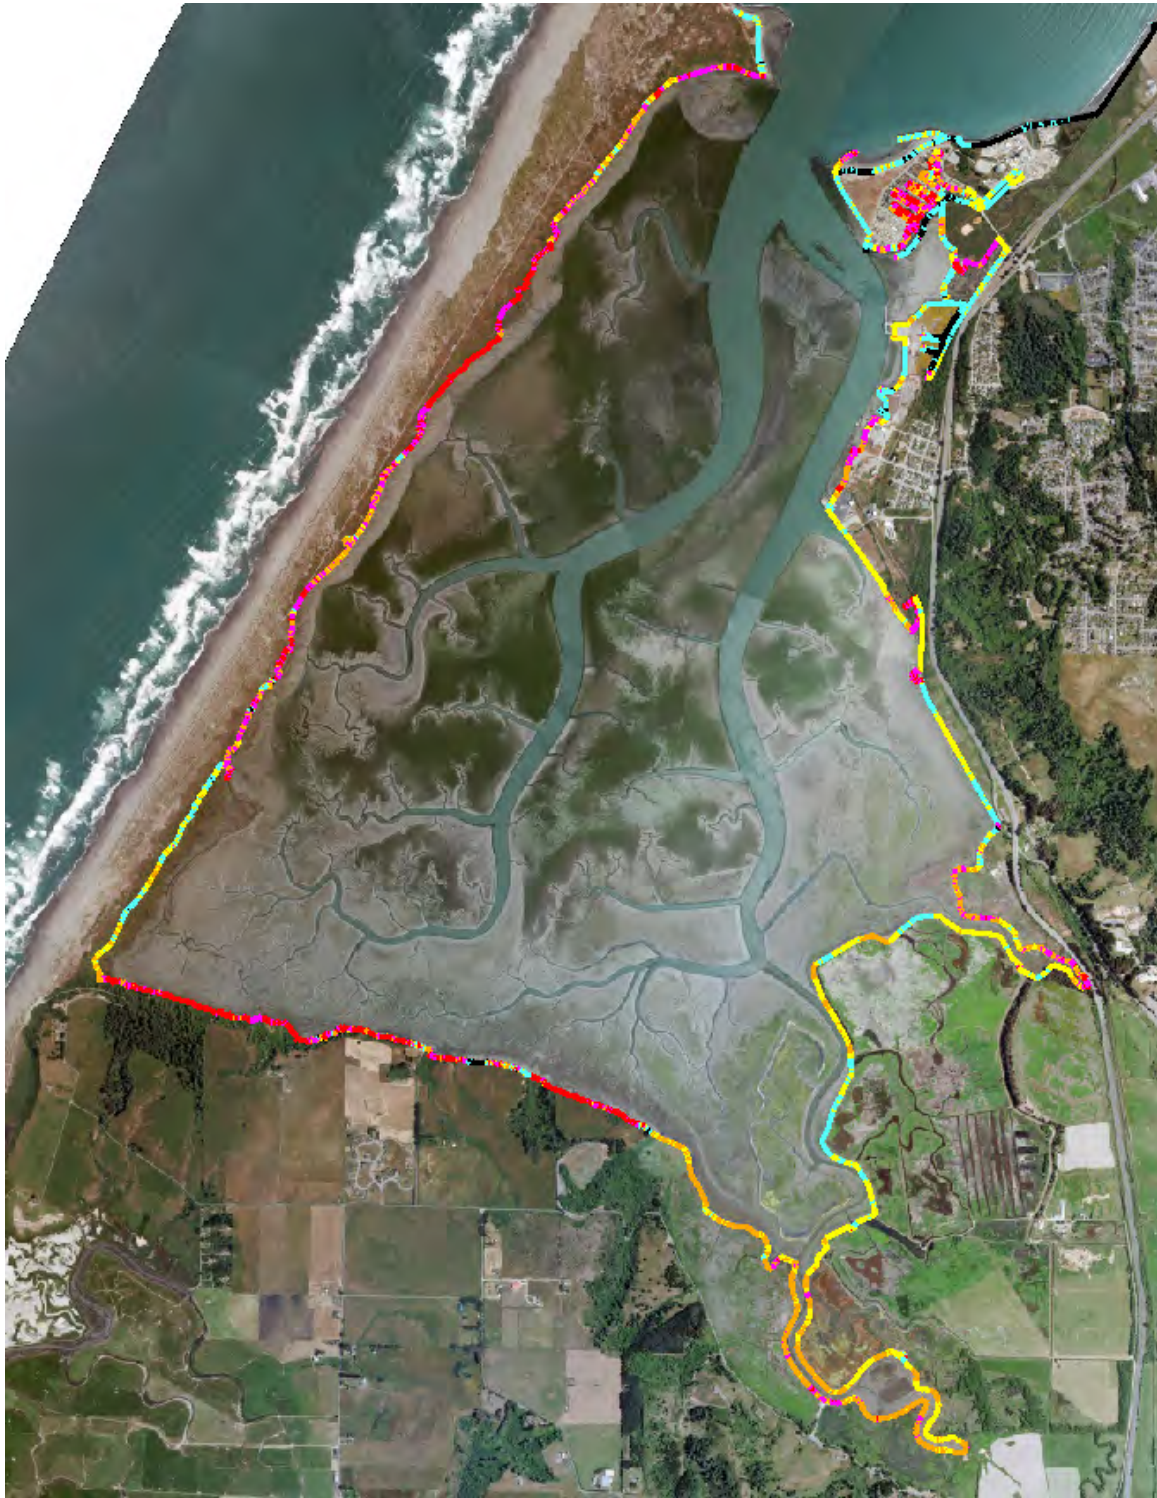
Figure 59. Distribution of shoreline elevations on South Bay: 7.74 feet (red), 8.74 feet (magenta), 9.74 feet (brown), 10.74 feet (yellow), 13.74 feet (turquoise), and greater than 13.74 feet (black).

The shoreline of South Bay is 21.8 miles long; 68% of the shoreline is composed of artificial structures. The two dominant artificial shoreline structures on South Bay are earthen dikes (7.6 miles, 35%), fill (2.6 miles, 12%), fortified (1.5 miles, 7%), and railroad (1.4 miles, 6%)(Table 24). A significant portion of the diked shoreline on South Bay is at an elevation of 9.74 feet (39.0%) or at 10.74 feet (39.0%). A significant portion of the railroad grade, 50.4%, is at an elevation of 10.74 feet.
