Humboldt Bay Shoreline Inventory, Mapping, and Sea Level Rise Vulnerability Assessment

Prepared for
State Coastal Conservancy
1330 Broadway, 13th Floor
Oakland, CA 94612-2530

January 2013

Humboldt Bay Sea Level Rise Adaptation Planning Project:
Phase 1
Shoreline Inventory, Mapping, and Vulnerability Assessment

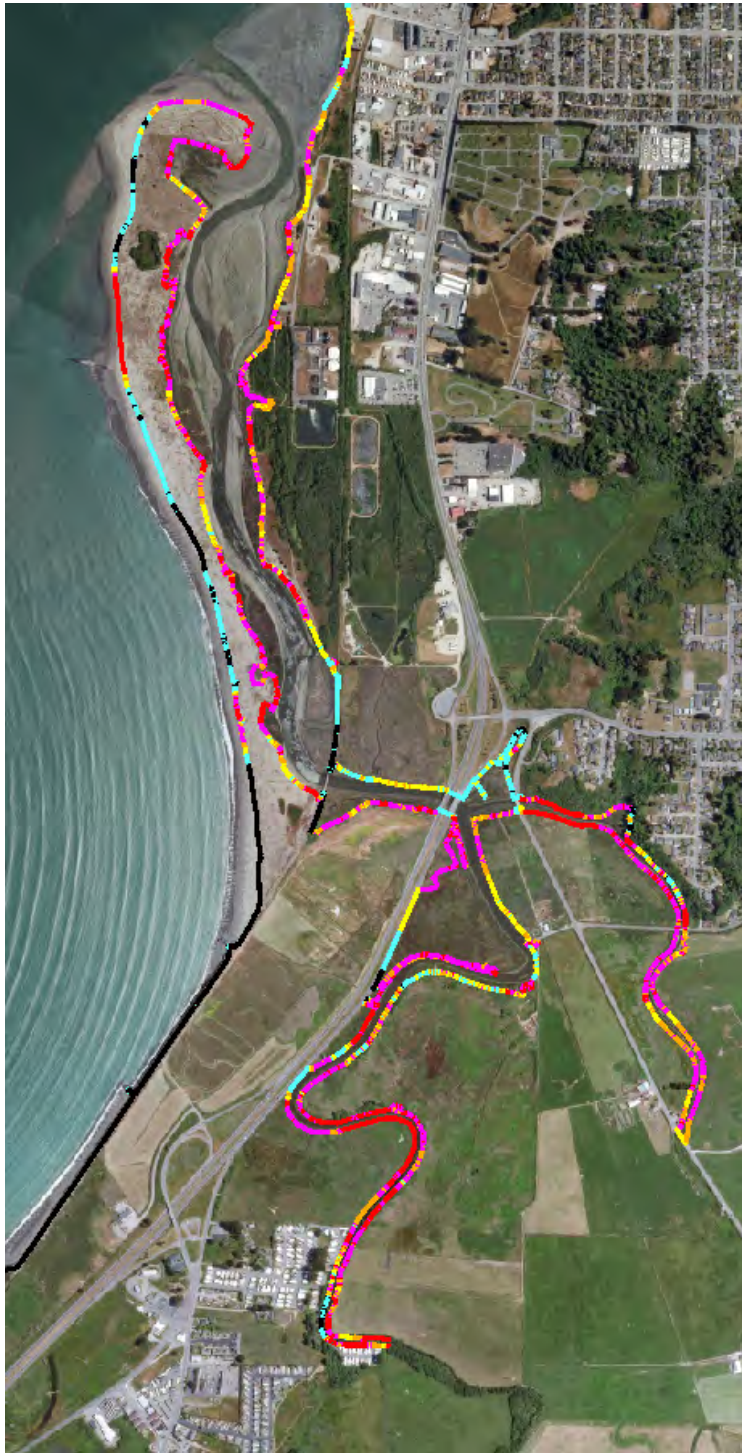
Figure 62. Distribution of shoreline elevations on Elk River Slough: 7.74 feet (red), 8.74 feet (magenta), 9.74 feet (brown), 10.74 feet (yellow), 13.74 feet (turquoise), and greater than 13.74 feet (black).

The shoreline of Elk River Slough is 9.7 miles long; 5.4 miles (55%), of the shoreline is natural and 4.2 miles, (45%) of the shoreline is composed of artificial structures. The three dominant shoreline structures are natural (3.0 miles, 31%), earthen dikes (2.9 miles, 30%), and foredunes (1.7 miles, 18%) (Table 27). Other types of shorelines are roadway (0.6 miles, 7%), and railroad (0.3 miles, 3%). A significant portion, 4,500 feet, of the upper tidal reach of Elk River Slough, has natural channel banks, 31% at an elevation 7.74 feet, and 37.2% at 8.74 feet. 51.3% of the earthen dikes are also at an elevation less than or equal to 8.74 feet.

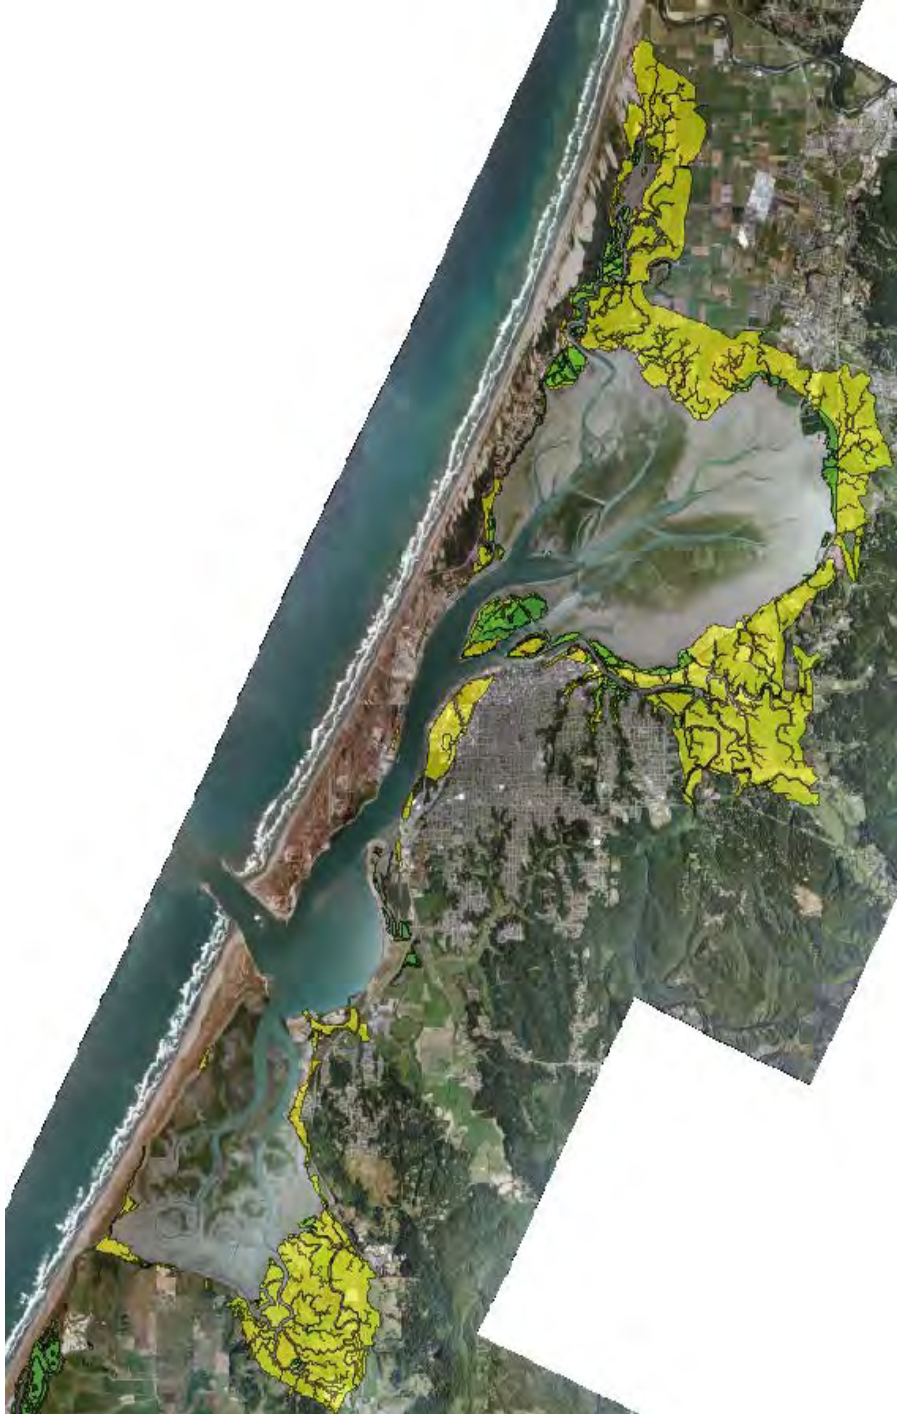
Figure 63. Humboldt Bay, salt marsh distribution and extent; 1870 (yellow) versus 2009 (green).

The salt marsh habitat present today is less than 900 acres (Pickart 2001), significantly less than the nearly 9,000 acres mapped in 1870 (USCGS) (Figure 63); large areas of salt marsh dissected by tidal tributary channels which were once common around the Bay and in the Sloughs, are now rare.

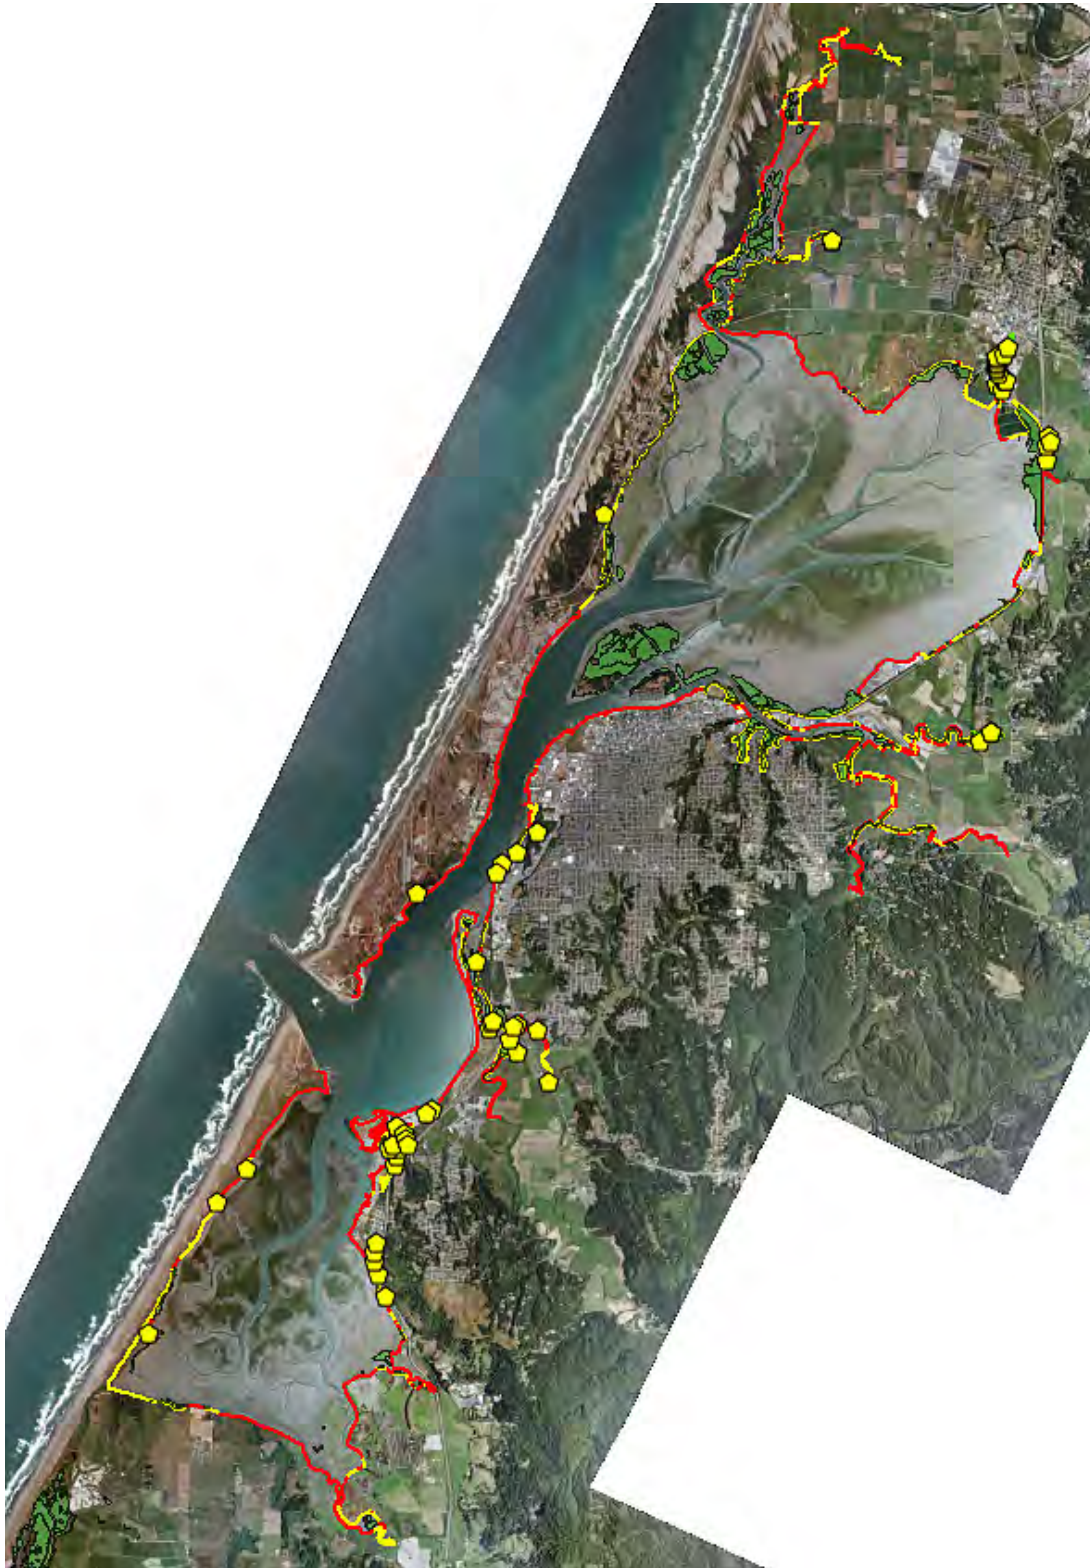
Figure 64. Distribution of shoreline with salt marsh (yellow), without salt marsh (red) and the location of previously un-mapped salt marsh (yellow shield).

During inventory and mapping, 57 areas were located where salt marsh habitat exists which was not delineated on the 2009 NOAA benthic habitat mapping (Figure 64). These salt marsh areas were found either within the Bay or slough channels or hydrologically connected with the Bay via large diameter culverts or breached dikes. However, the extent of these salt marsh habitats has not been delineated by this project.

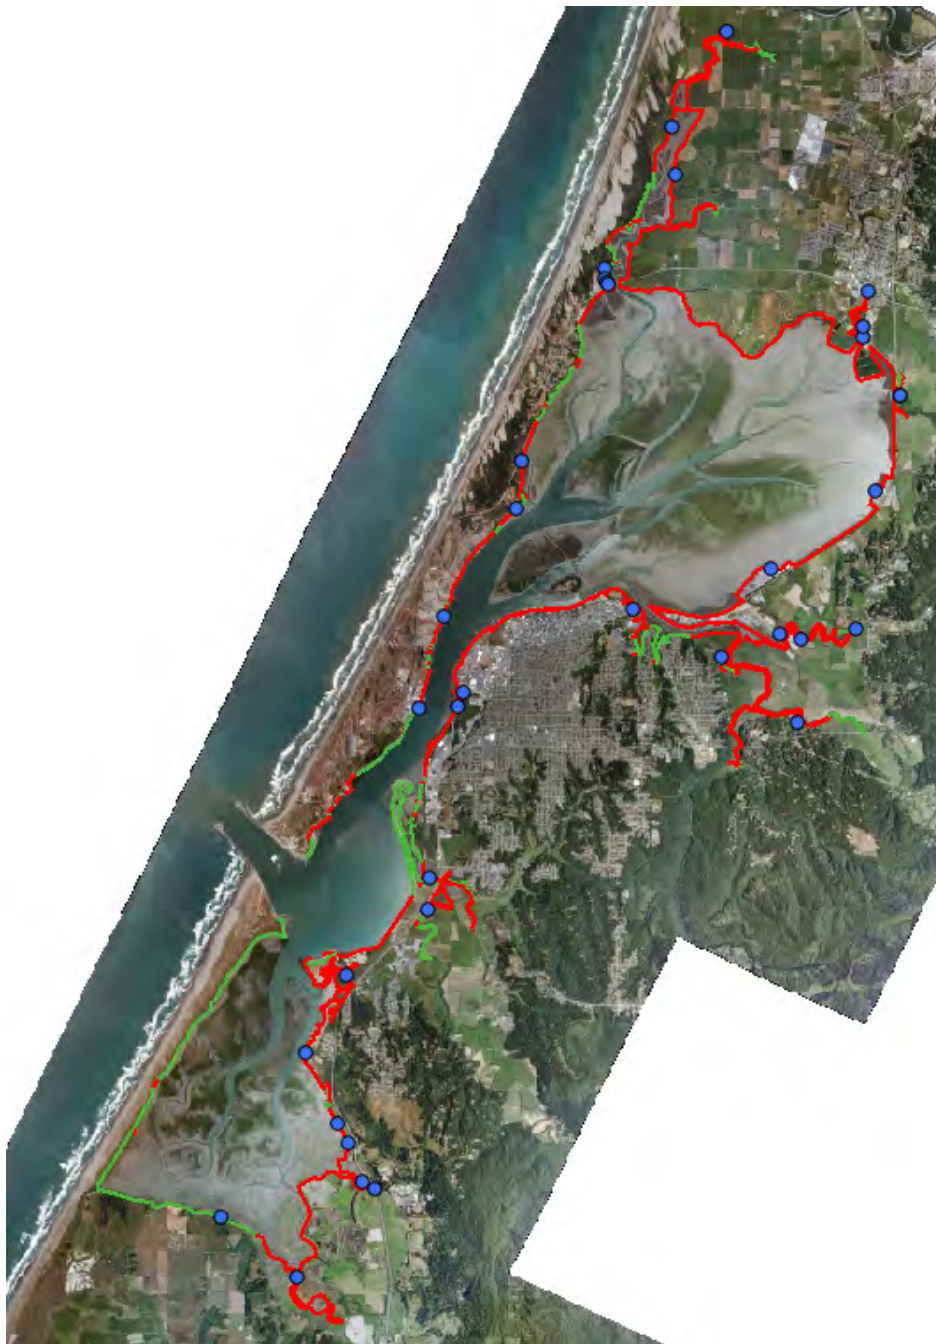
Figure 65. Humboldt Bay, 36 additional water control structures (blue) have been added to USFWS's 2007 database.

A total of 36 water control structures have been added to USFWS' 2007 water control structures database. The location and type of water control structures have been verified in the field; 18 culverts and 18 tidegates were found at 28 locations (Figure 65).

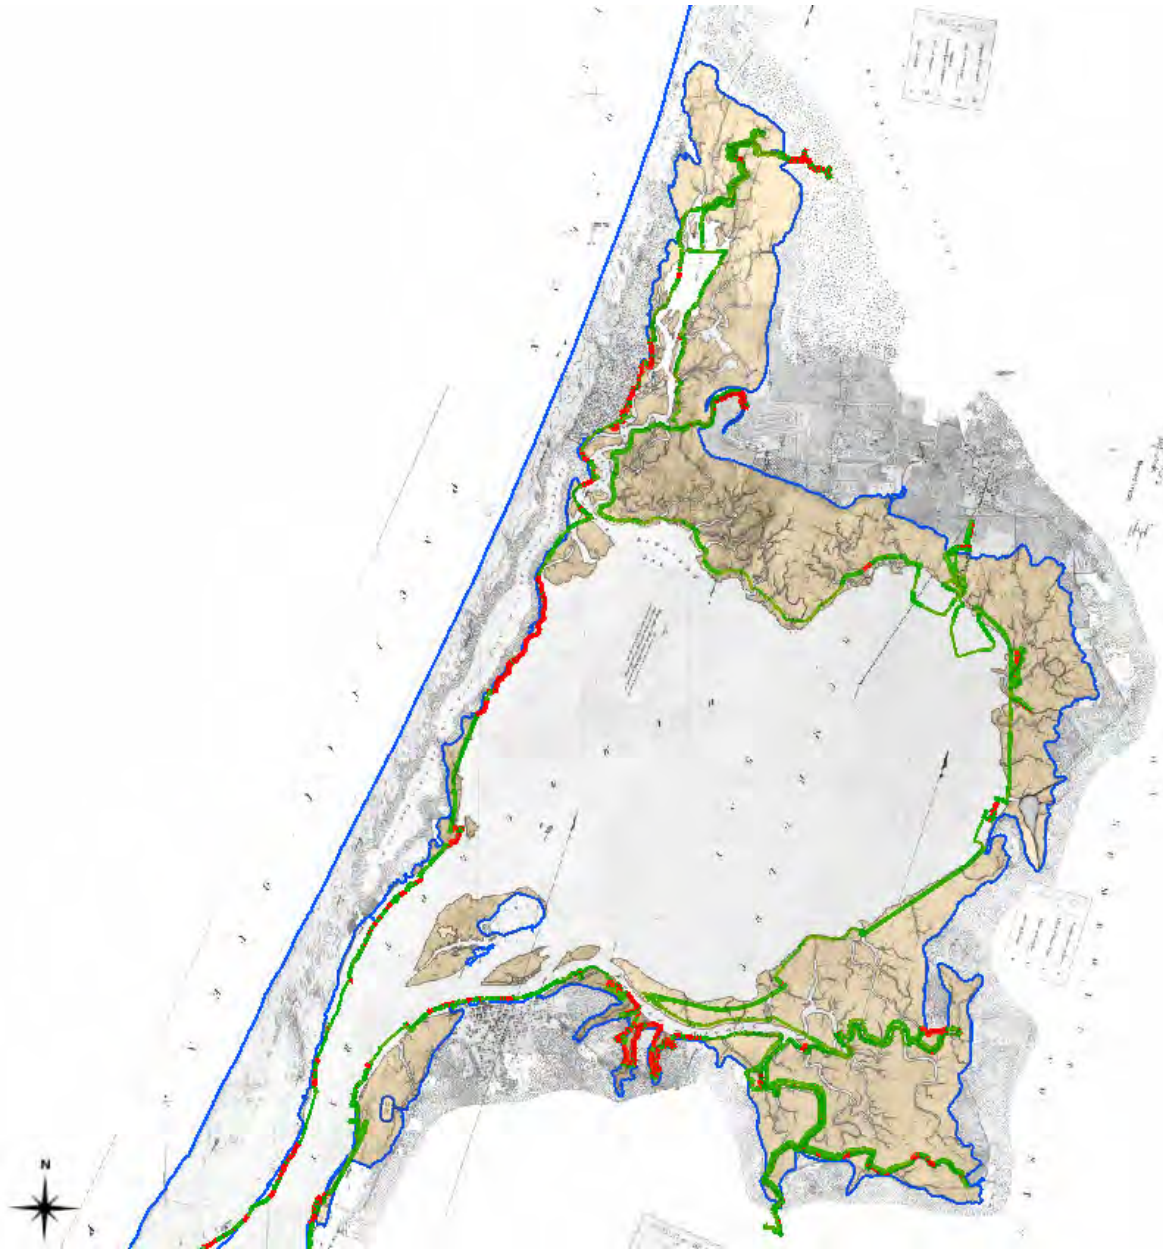
Figure 67. Arcata Bay, Mad River Slough, and Eureka Slough, 2009 shoreline elevations for EHT (red) and shorelines higher in elevation (green) with the 1870 tidal inundation footprint and tidal-upland shoreline (blue) (Laird 2007) on the 1870 USCGS map.

lowering these lands' surfaces. Within the historic tidal footprint, reside land uses, infrastructure, and resources that are important to the Humboldt Bay region. Without a sea level rise inundation model specific to Humboldt Bay, the historic tidal-upland boundary, as surveyed in 1870 by the USCGS, is being used as a minimum or conservative inundation footprint for this shoreline vulnerability assessment (Figures 67 and 68).

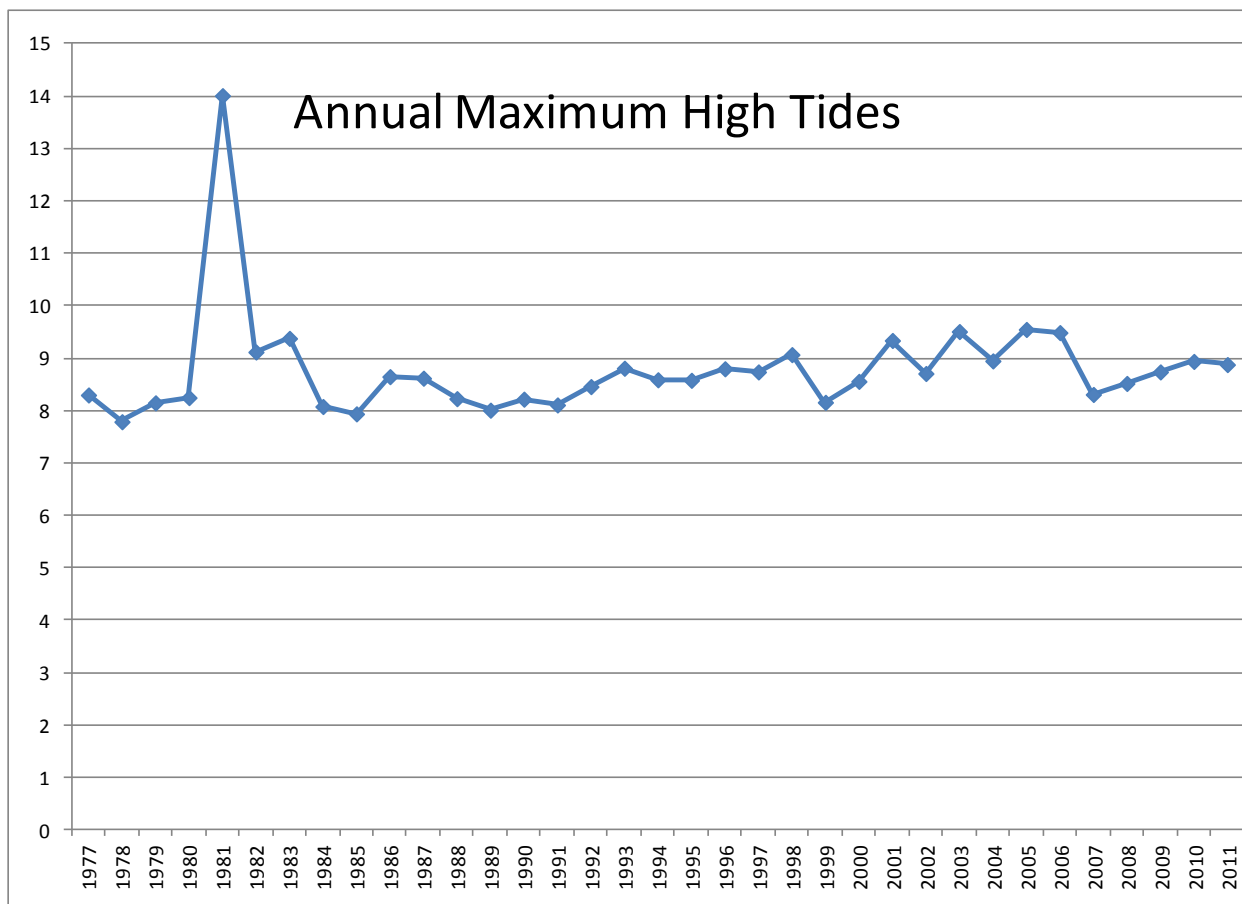
Chart 6. Annual maximum high tide, 1977 through 2011, average annual maximum high tide is 8.79 feet at the north spit tidal datum.

Since 1977, twelve of the annual EHT have exceeded the average annual maximum high tide of 8.79 feet, and since 2000, seven have been greater (Chart 6). El Nino events can also cause elevated tide elevations of 12 inches or more for several months (Griggs 2012). The most recent El Nino events occurred during 1982/1983 and 1997/1998. A combination of King Tides and El Nino event could raise sea levels several feet, even more with storm surges.

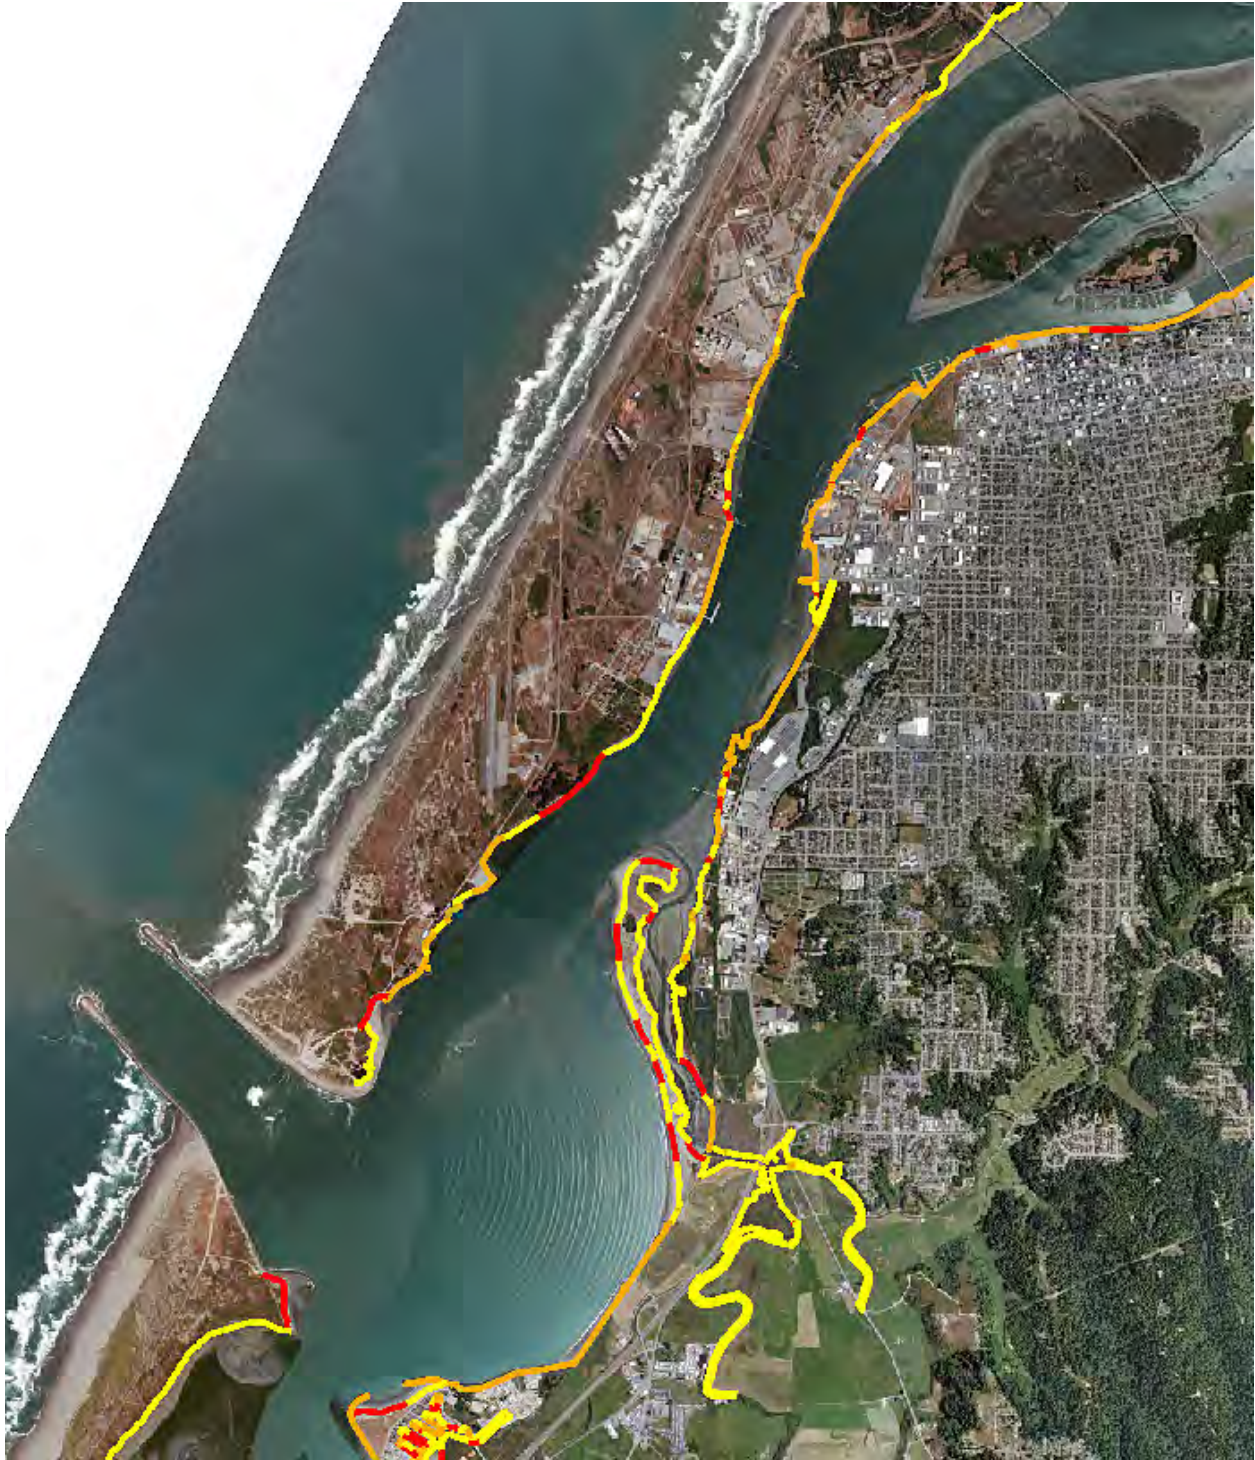
Figure 76. Eureka Bay shoreline cover: fortified (brown), vegetated (yellow), and exposed (red).

The shoreline of Eureka Bay is 15.9 miles long and 71% of the shoreline is composed of artificial structures, but only 6% of the artificial shoreline is exposed (3,587 feet) (Figure 76). The two dominant artificial shoreline structures are fortified shoreline segments (49%, 29,657 feet) and the NCRA's railroad grade (15%, 8,794 feet). Other types of artificial shorelines are fill (10%), bulwarks (6%), and roadways (6%). The railroad grade is mostly fortified (66%), 2,980 feet are vegetated, and none is exposed. There are 2,015 feet of exposed fill and 963 feet of exposed road way. The 963 feet of exposed County road is on the North Spit facing the Bay south of the Coast Guard station. The bulk of the 2,015 feet of exposed shoreline fill areas are along the eastern shore of the Bay mostly in abandoned waterfront areas. There are 2,600 feet of exposed natural shoreline on the Bayside of the Elk River Spit and 1,200 feet of exposed fore-dune between the Jetties at King Salmon. Existing artificial shoreline conditions of structure and cover in Eureka Bay are not exhibiting any substantial vulnerability.

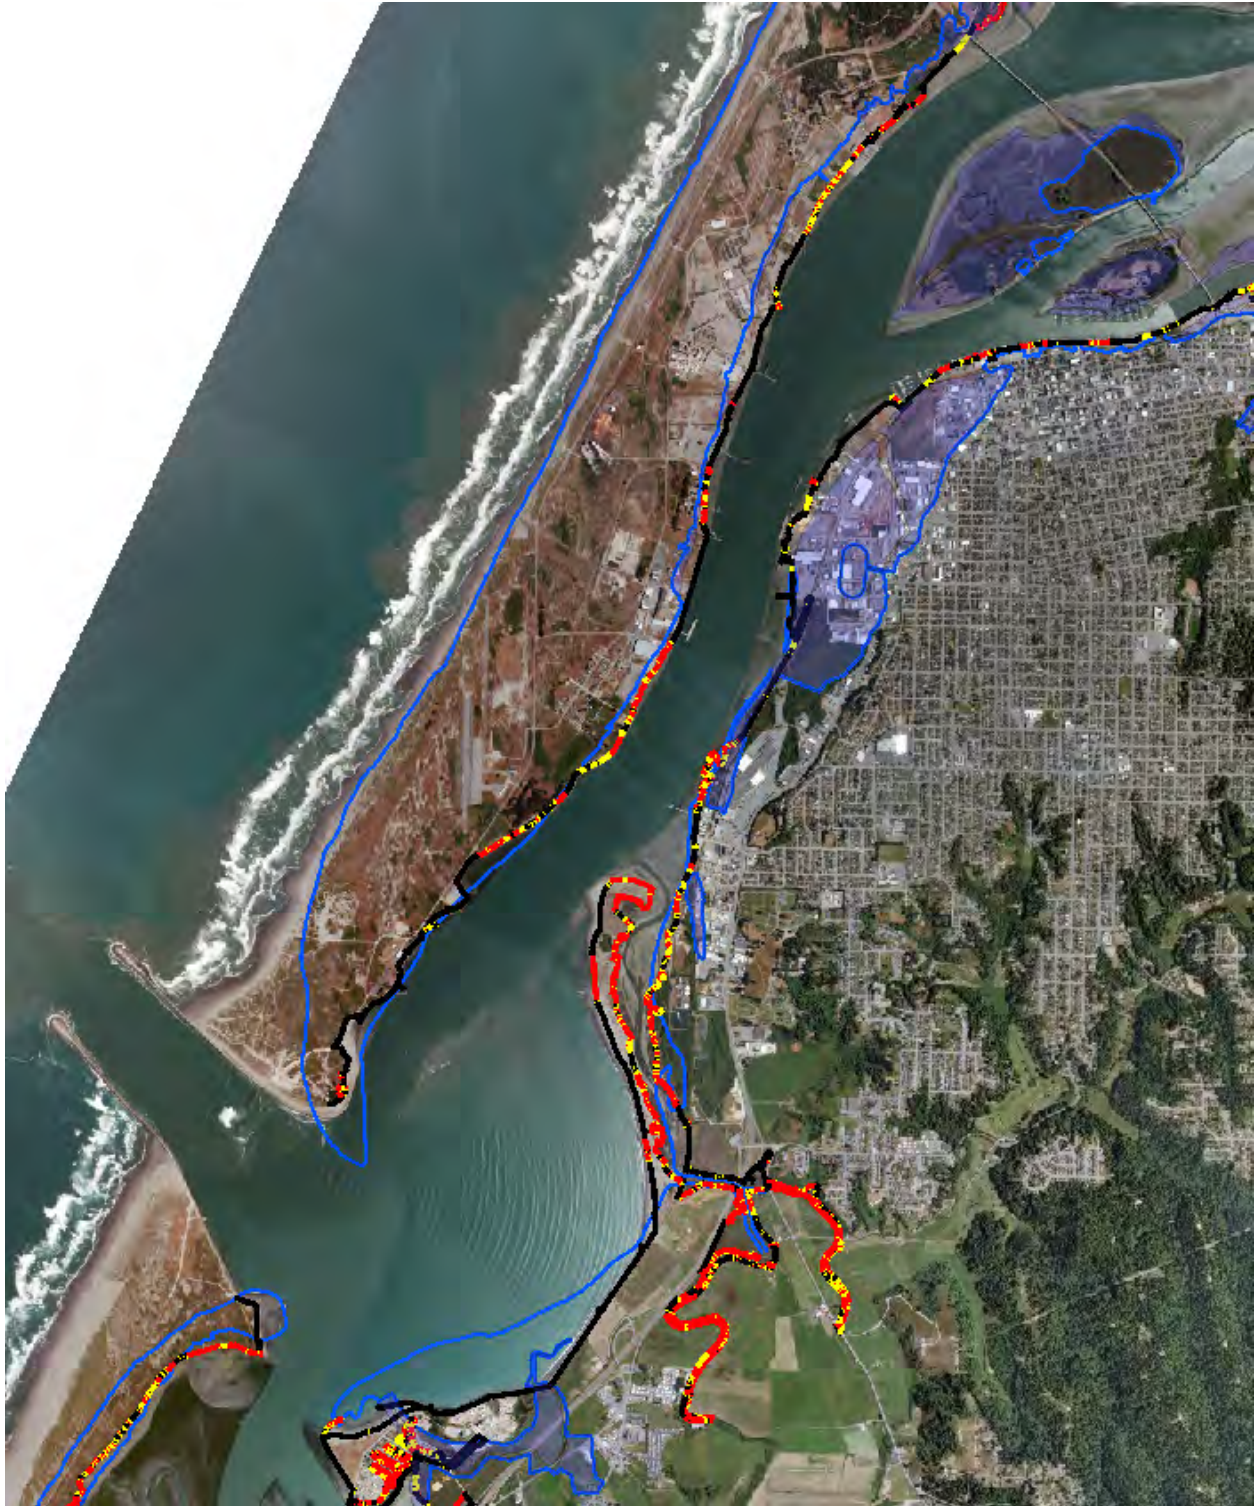
Figure 77. Eureka Bay, shoreline areas overlapped by 1 foot of sea level rise (red), and 2 feet (yellow), and the 1870 tidal inundation footprint (blue).

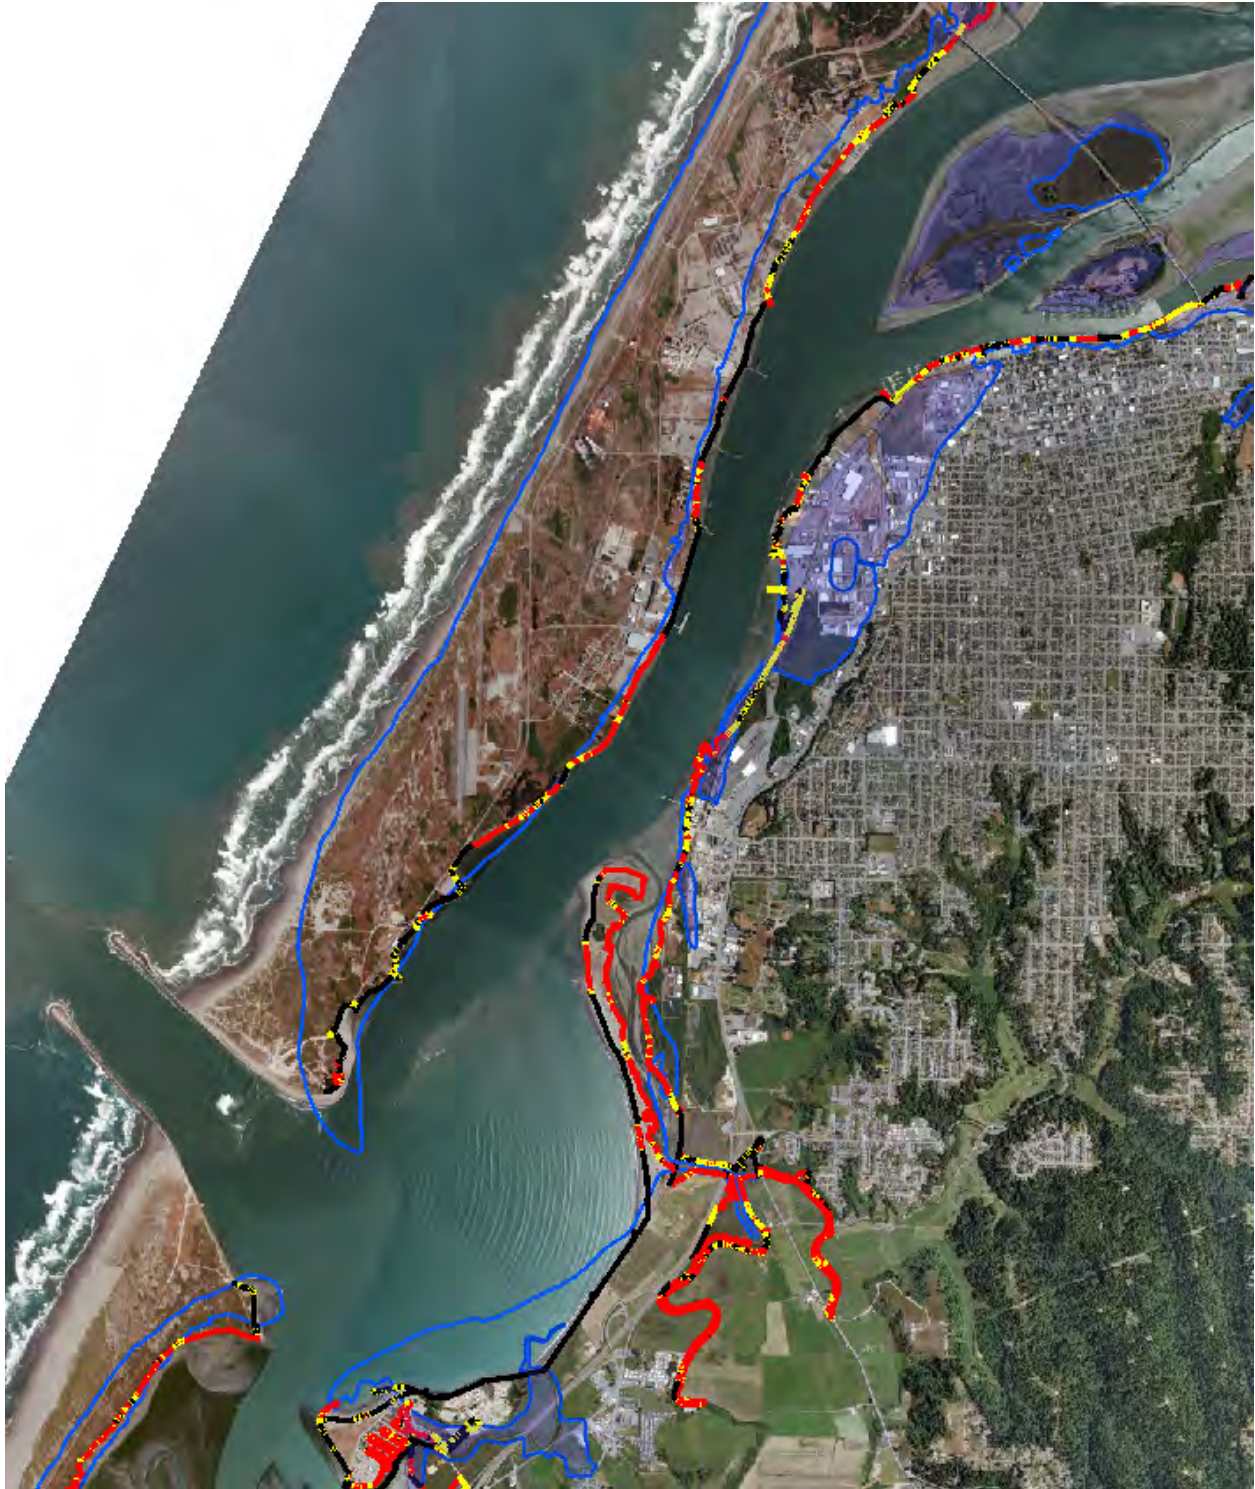
Figure 78. Eureka Bay, shoreline areas overtopped by 2 foot of sea level rise (red), and 3 feet (yellow), and the 1870 tidal inundation footprint (blue).

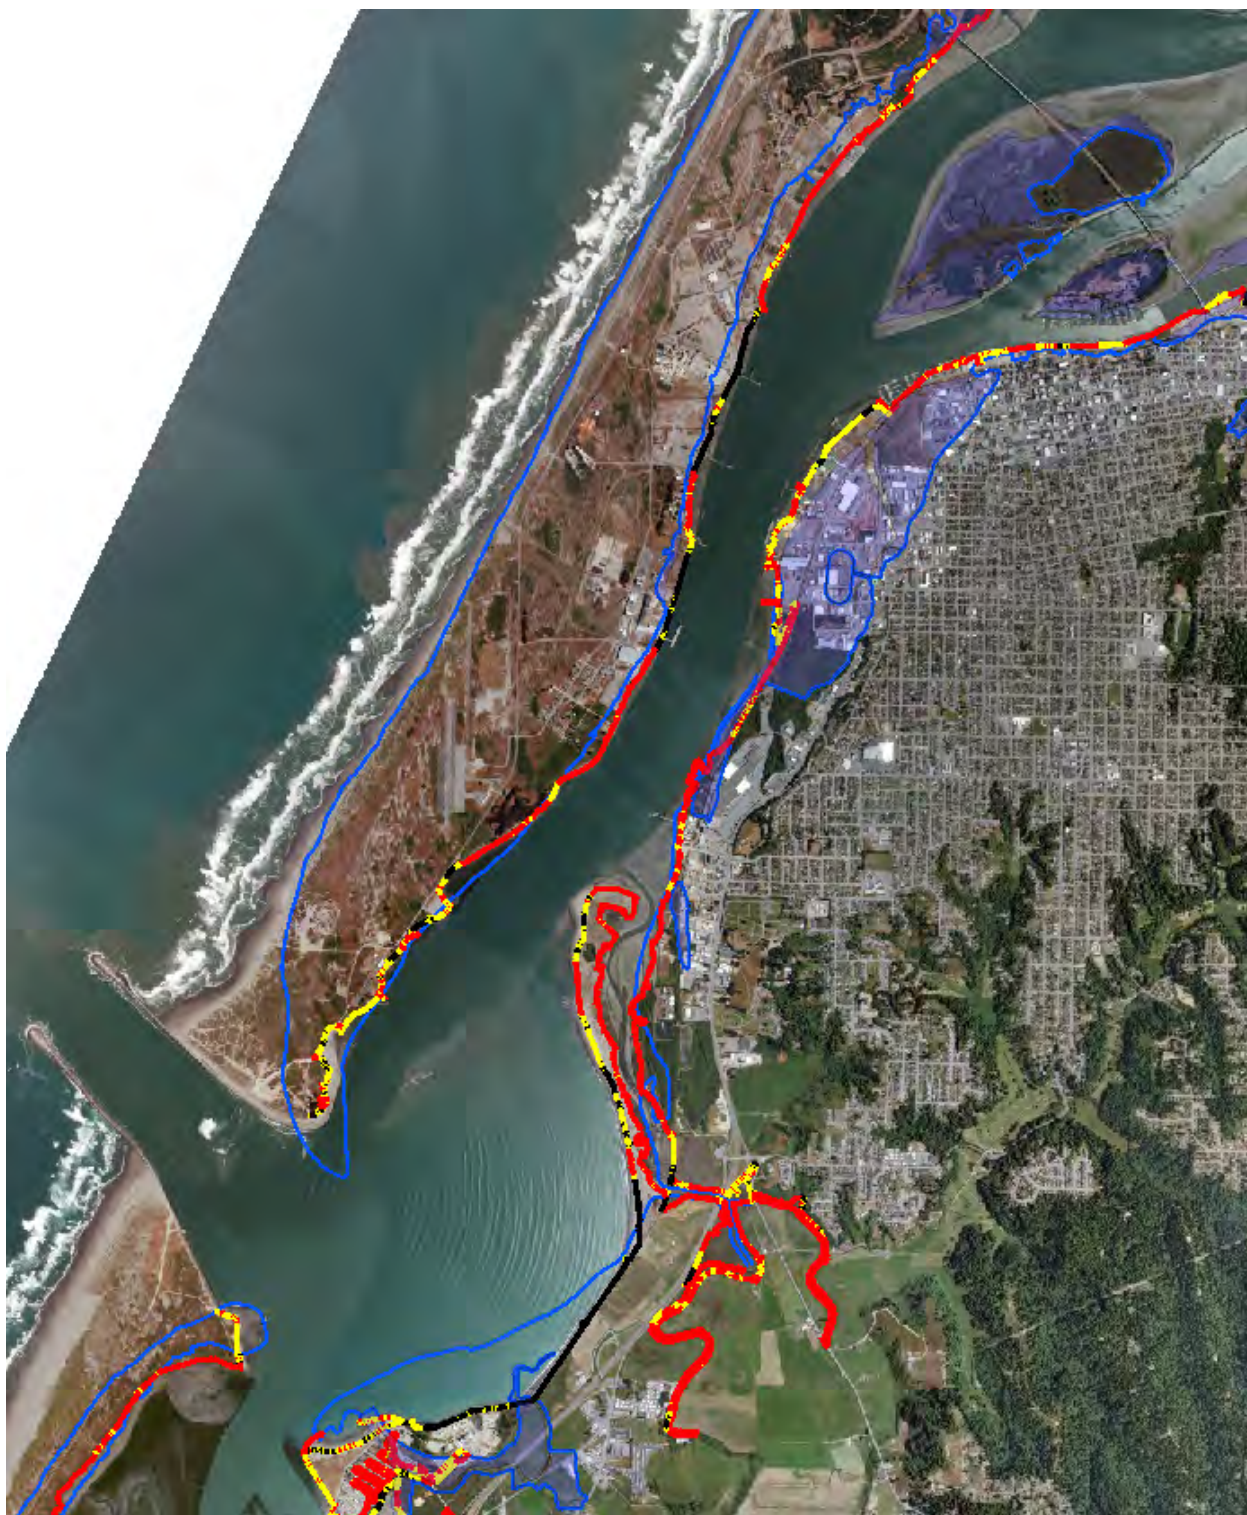
Figure 79. Eureka Bay, shoreline areas overtopped by 3 feet of sea level rise (red), and 6 feet (yellow), and the 1870 tidal inundation footprint (blue).

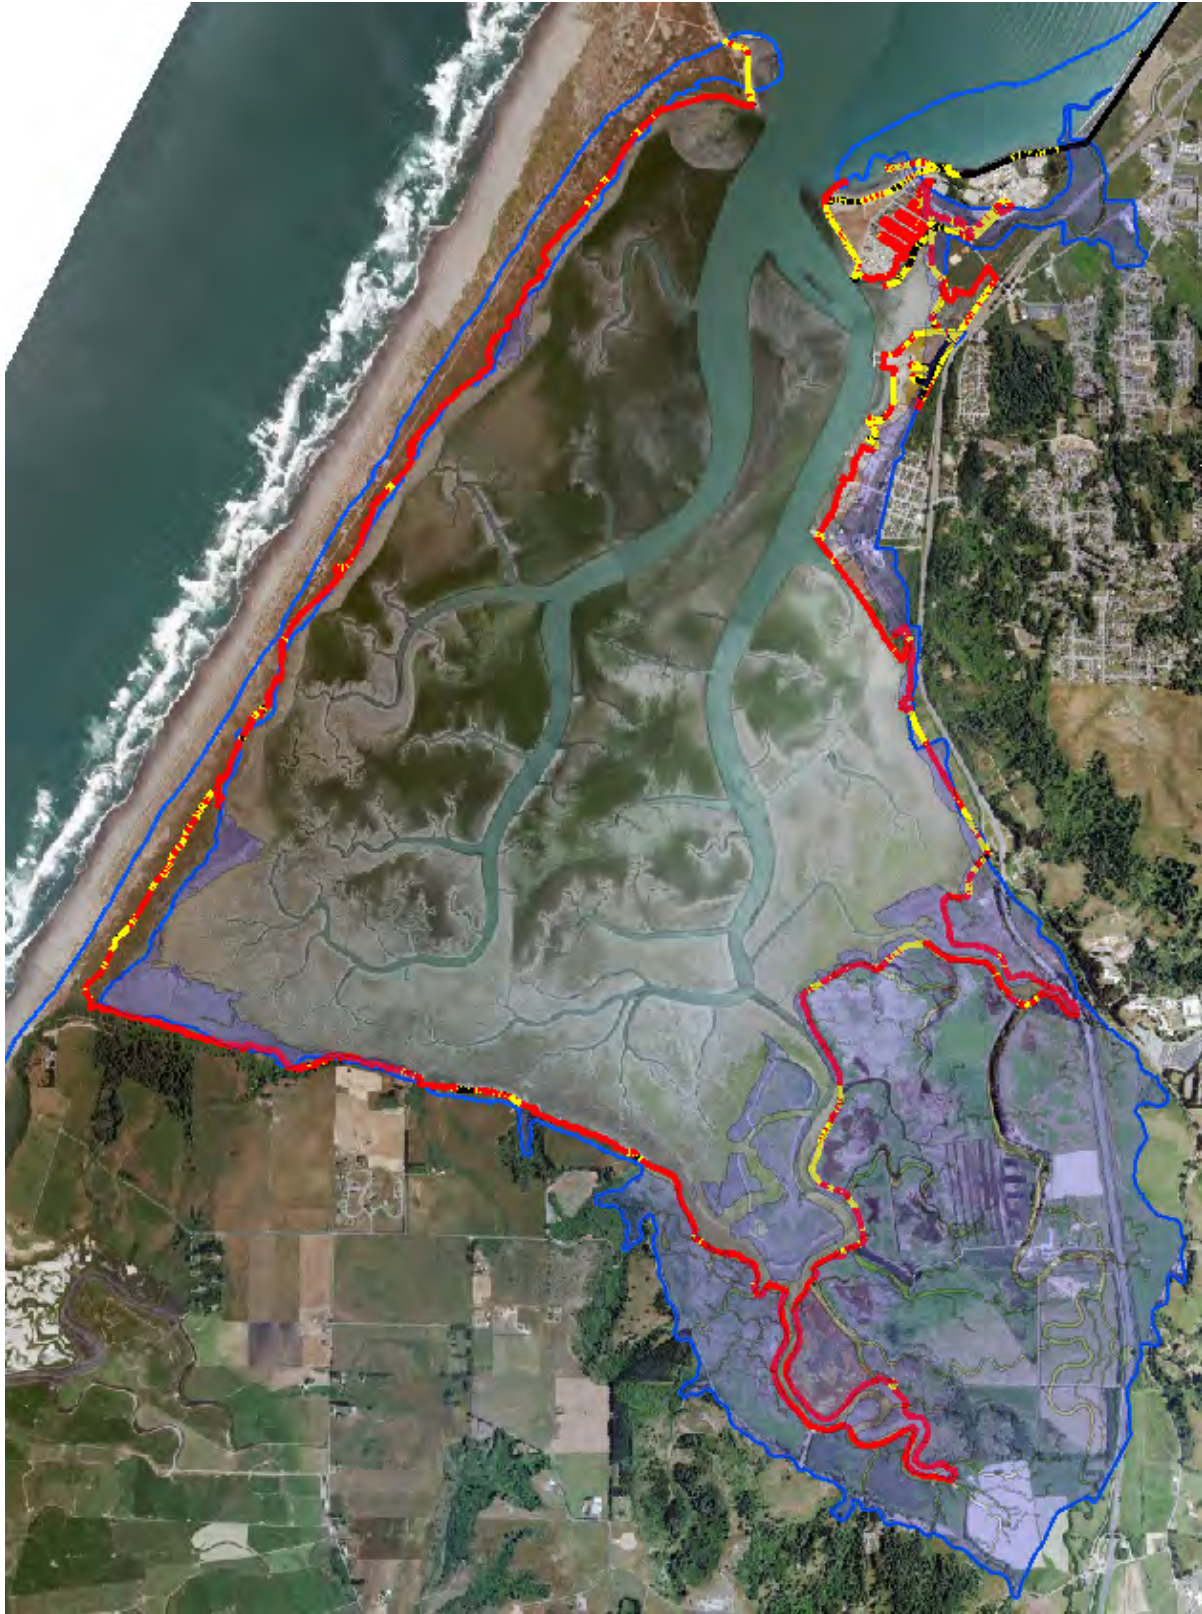
Figure 83. South Bay, shoreline areas overtopped by 3 feet of sea level rise (red), and 6 feet (yellow), and the 1870 tidal inundation footprint (blue).

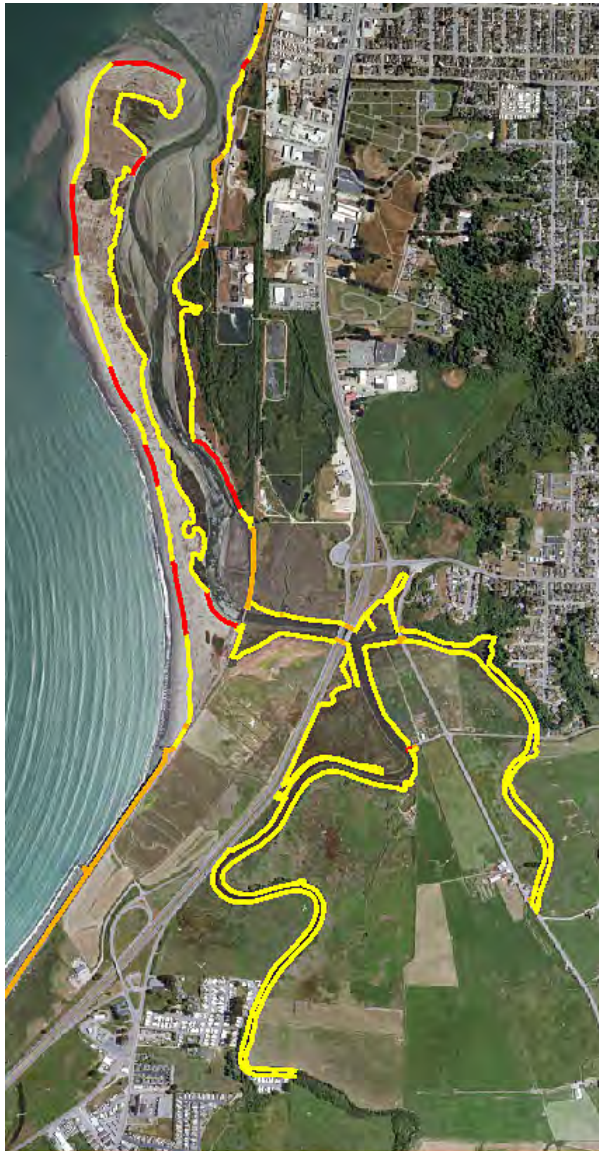
Figure 92. Elk River Slough shoreline cover: fortified (brown), vegetated (yellow), and exposed (red).

The shoreline of Elk River Slough is 9.7 miles long. 45% (35,306 feet) of the shoreline is composed of artificial structures, and only 100 feet of the artificial shoreline are exposed (Figure 92). The dominant artificial shoreline structures are dikes (43.4%, 15,334 feet) and roadway (9.7%, 3,443 feet). The diked shoreline is 57.4% (20,273 feet) vegetated, and only 74 feet are exposed. The majority of the shoreline on Elk River Slough, 55%, is made of natural channel banks. The upper 4,850 feet of the tidal reach of Elk River Slough is a natural channel that traverses the floodplain.

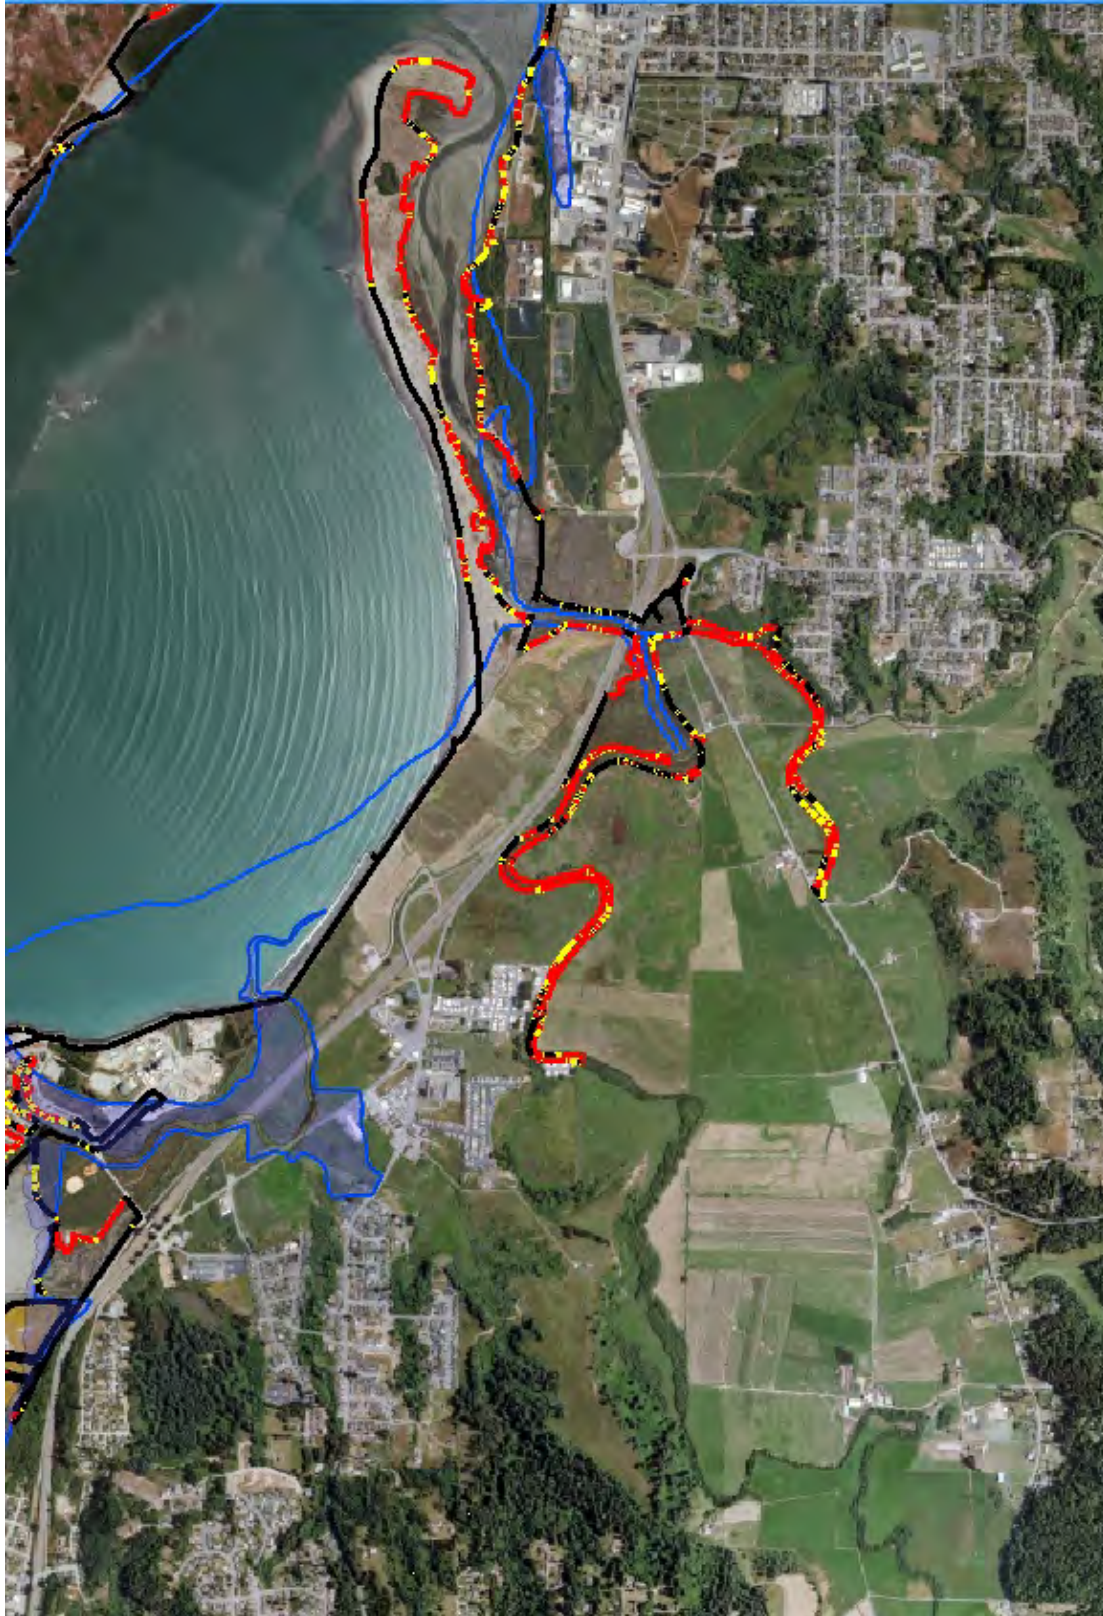
Figure 93. Elk River Slough shoreline areas overtopped by 1 foot of sea level rise (red), and 2 feet (yellow).
