Humboldt Bay Shoreline Inventory, Mapping, and Sea Level Rise Vulnerability Assessment

Prepared for
State Coastal Conservancy
1330 Broadway, 13th Floor
Oakland, CA 94612-2530

January 2013

Humboldt Bay Sea Level Rise Adaptation Planning Project:
Phase 1
Shoreline Inventory, Mapping, and Vulnerability Assessment

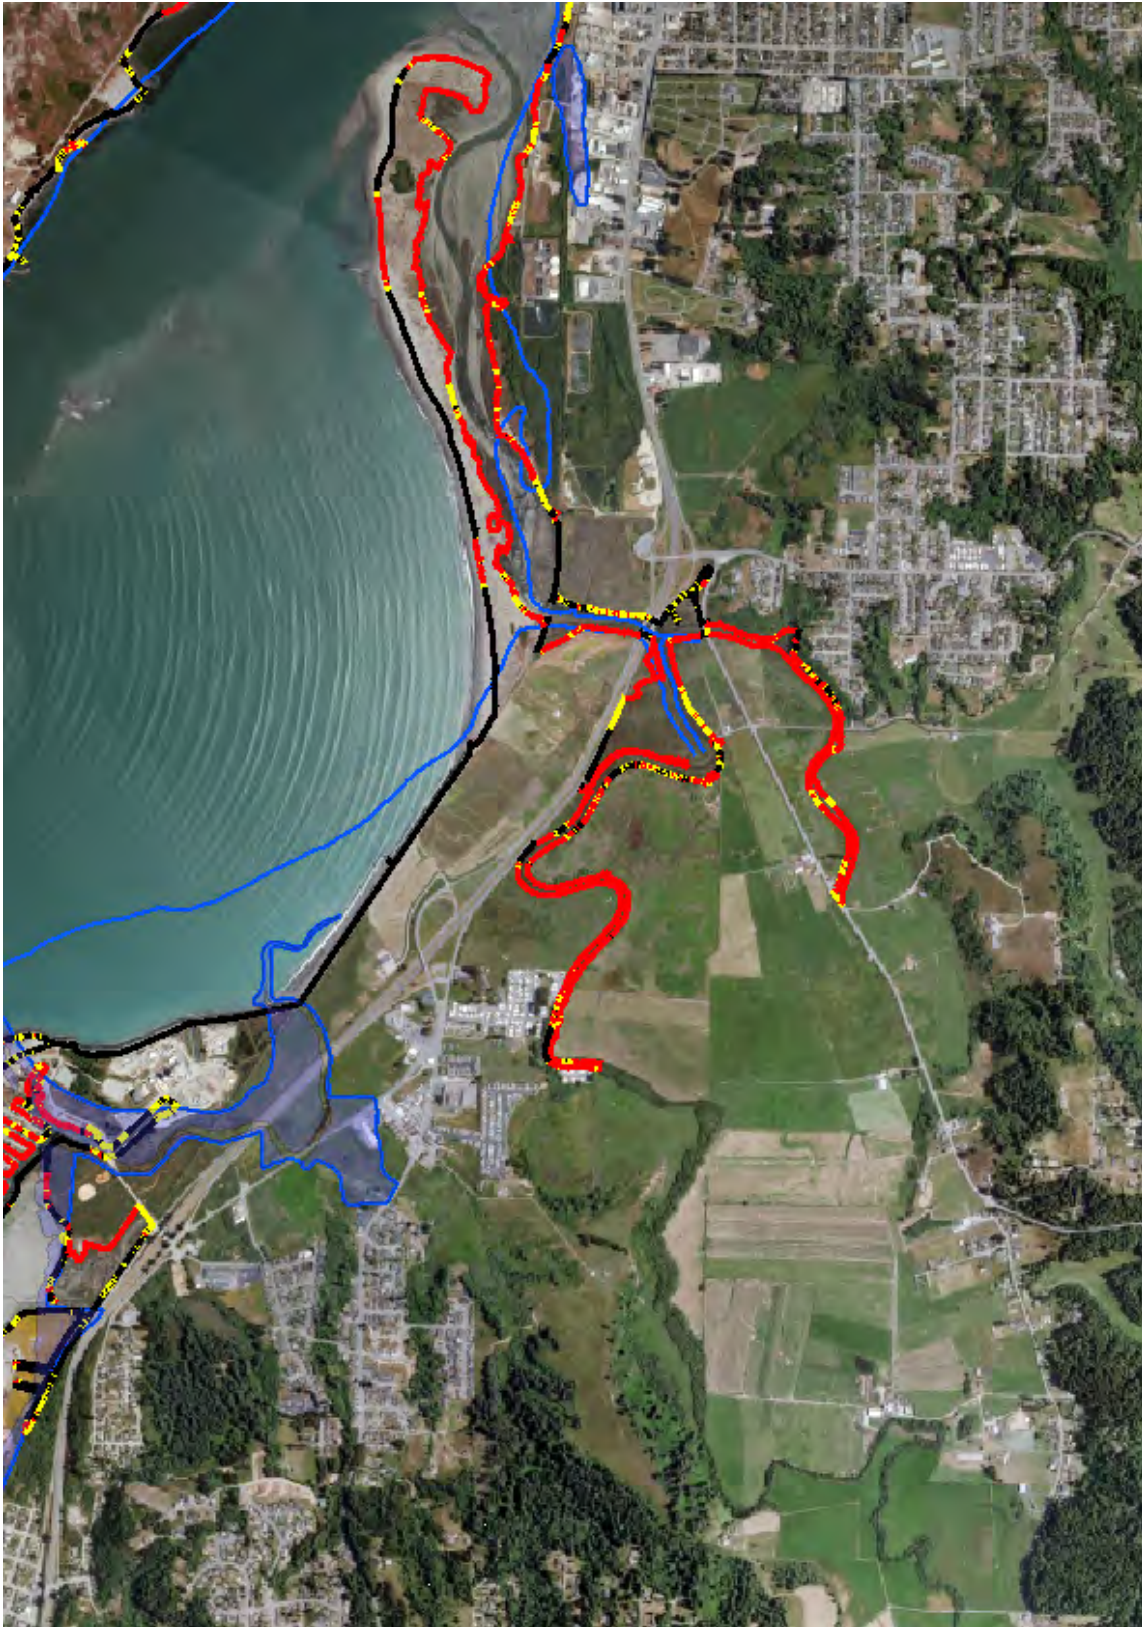
Figure 94. Eureka Slough shoreline areas overtopped by 2 foot of sea level rise (red), and 3 feet (yellow).

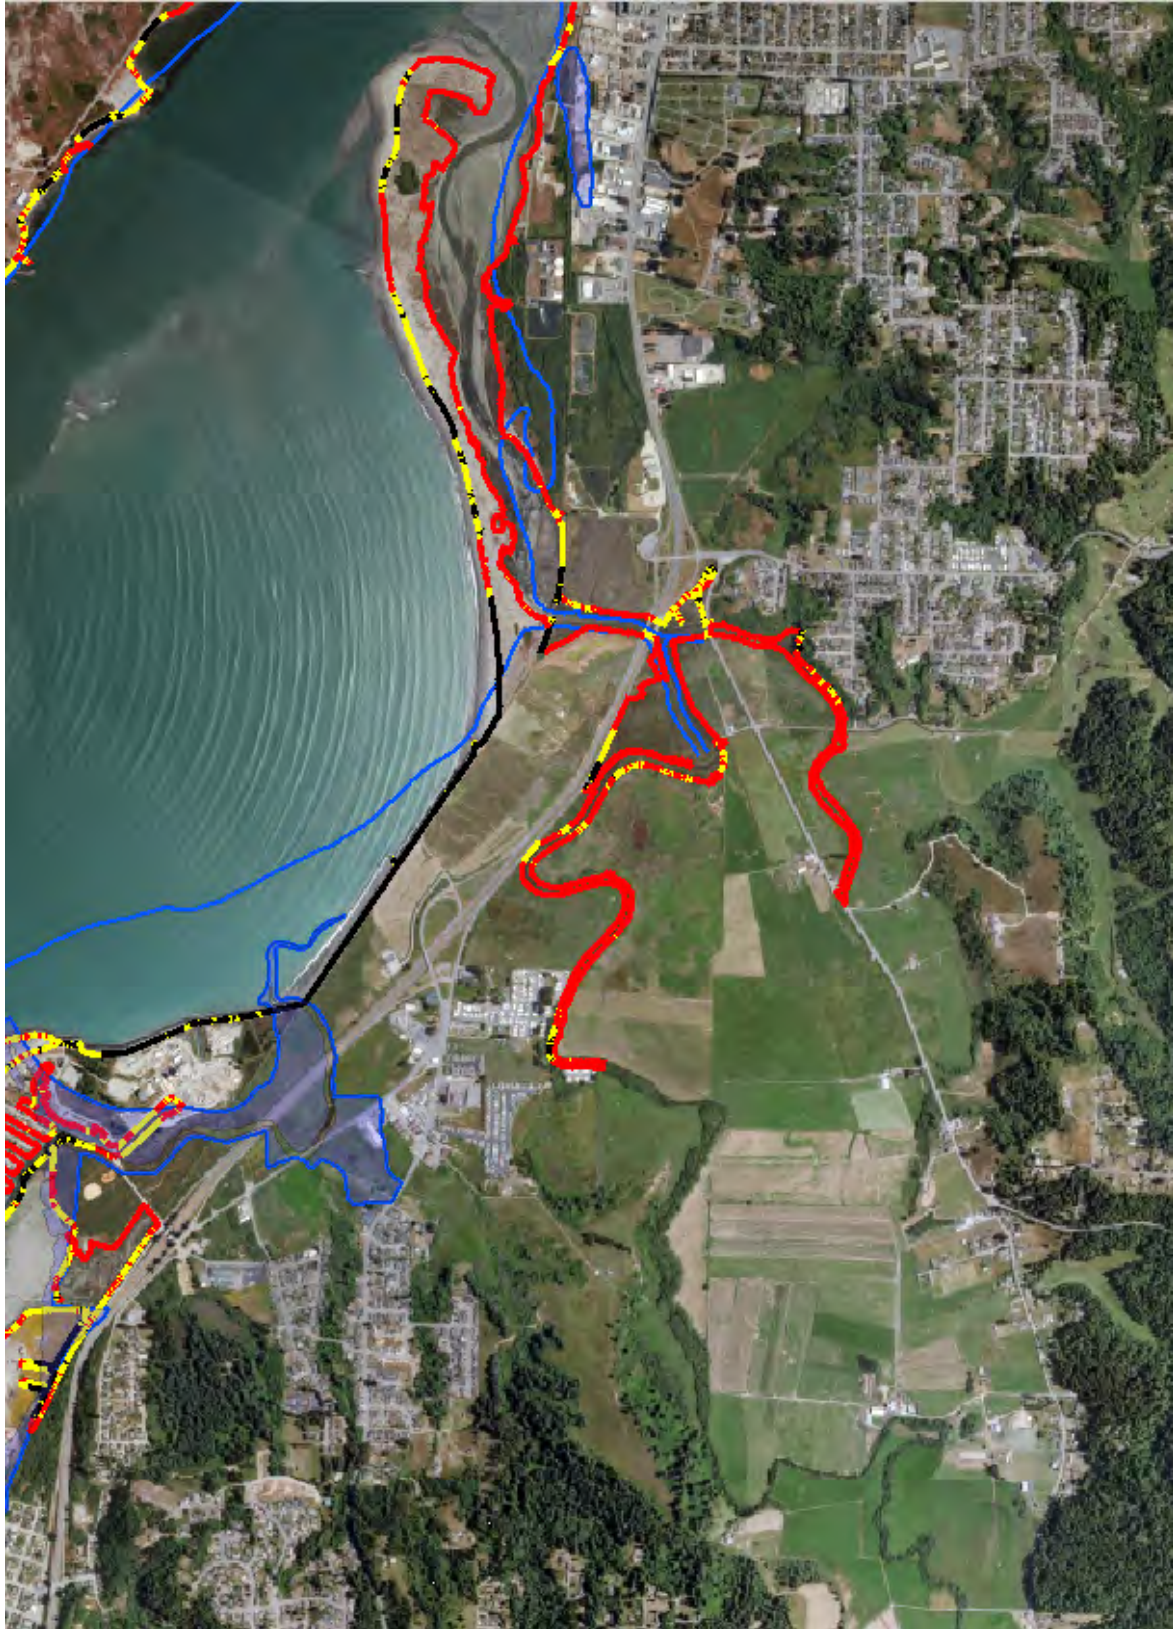
Figure 95. Eureka Slough shoreline areas overtopped by 3 feet of sea level rise (red), and 6 feet (yellow).

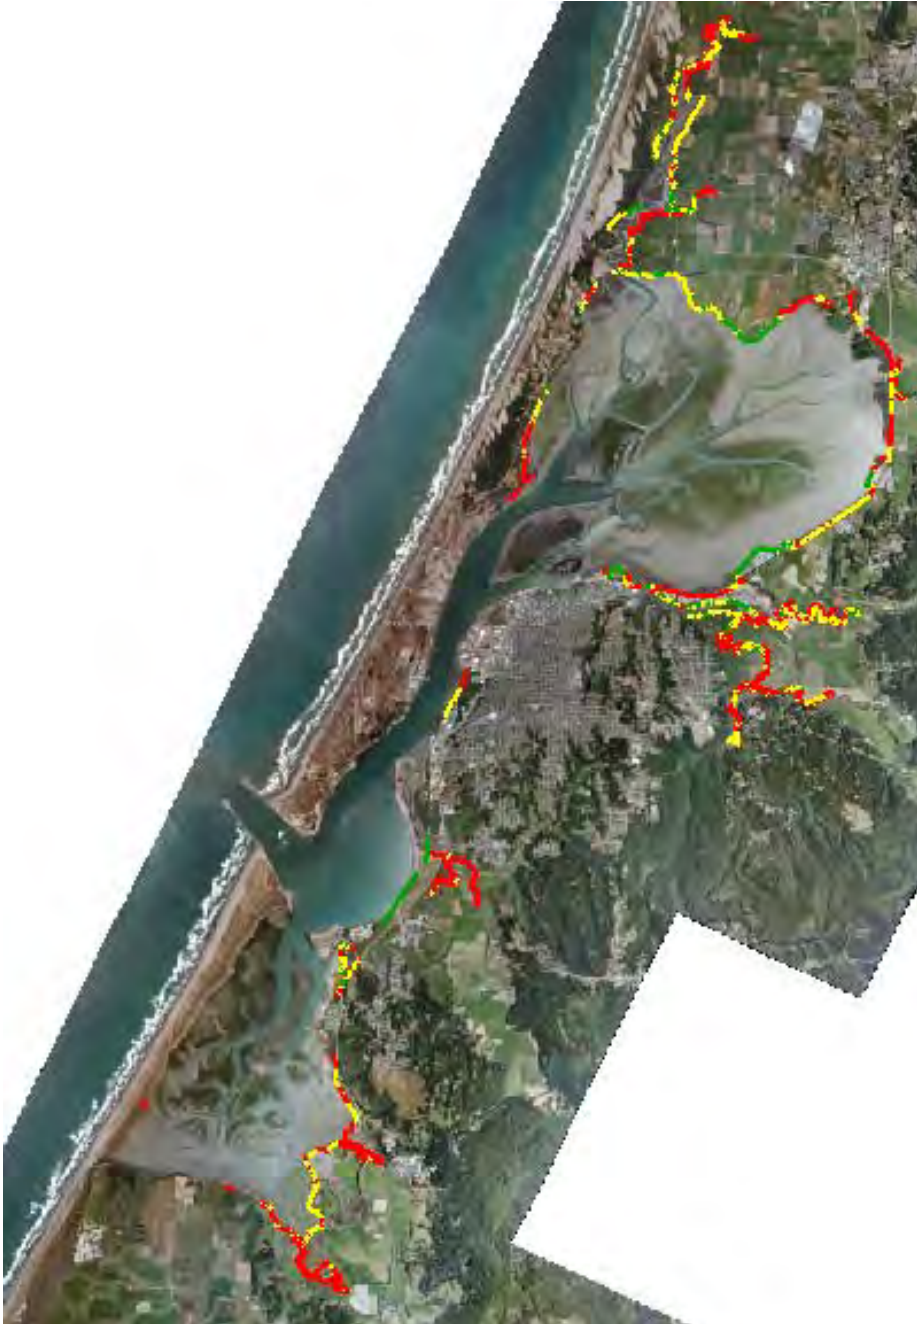
Figure 1. Diked and railroad shoreline vulnerability rating for Humboldt Bay; red-high, yellow-moderate, and green-low.

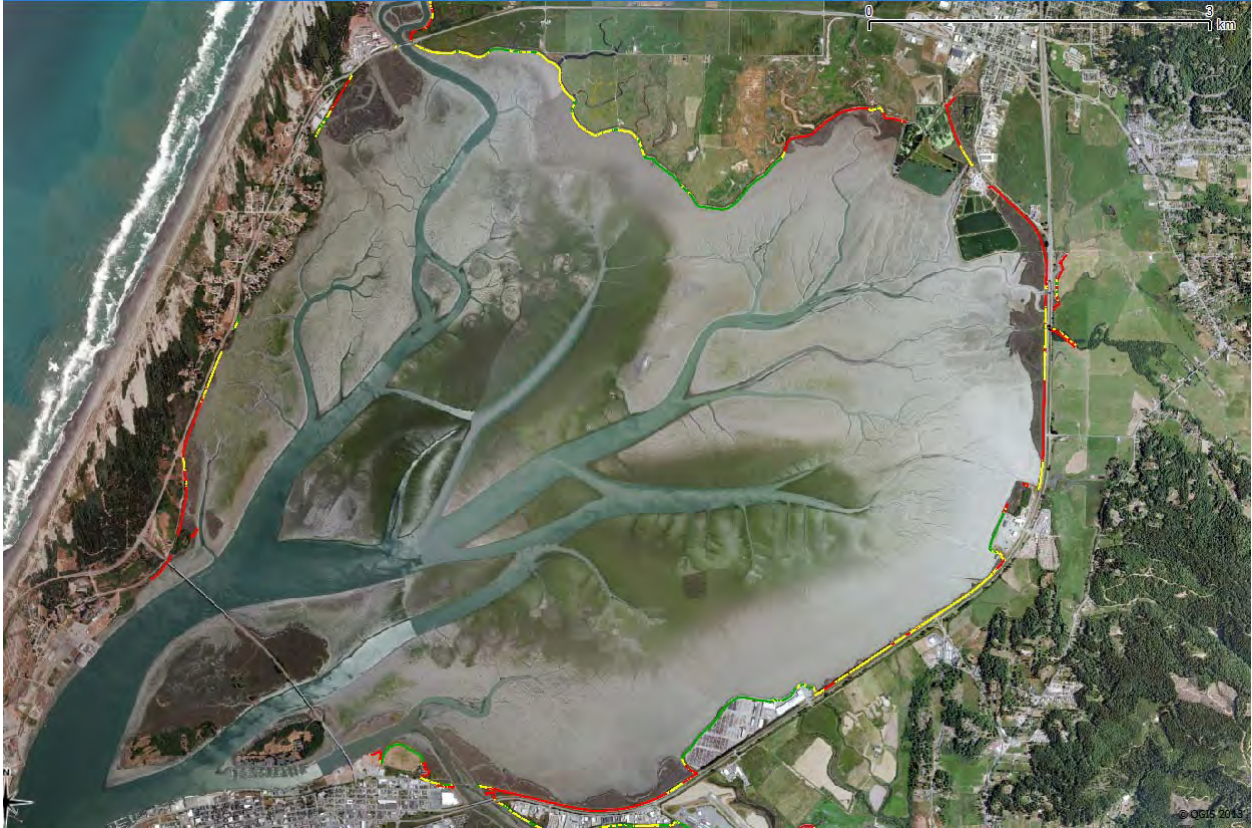
Figure 4. Diked and railroad shoreline vulnerability rating for Arcata Bay; red high, yellow moderate, and green low.

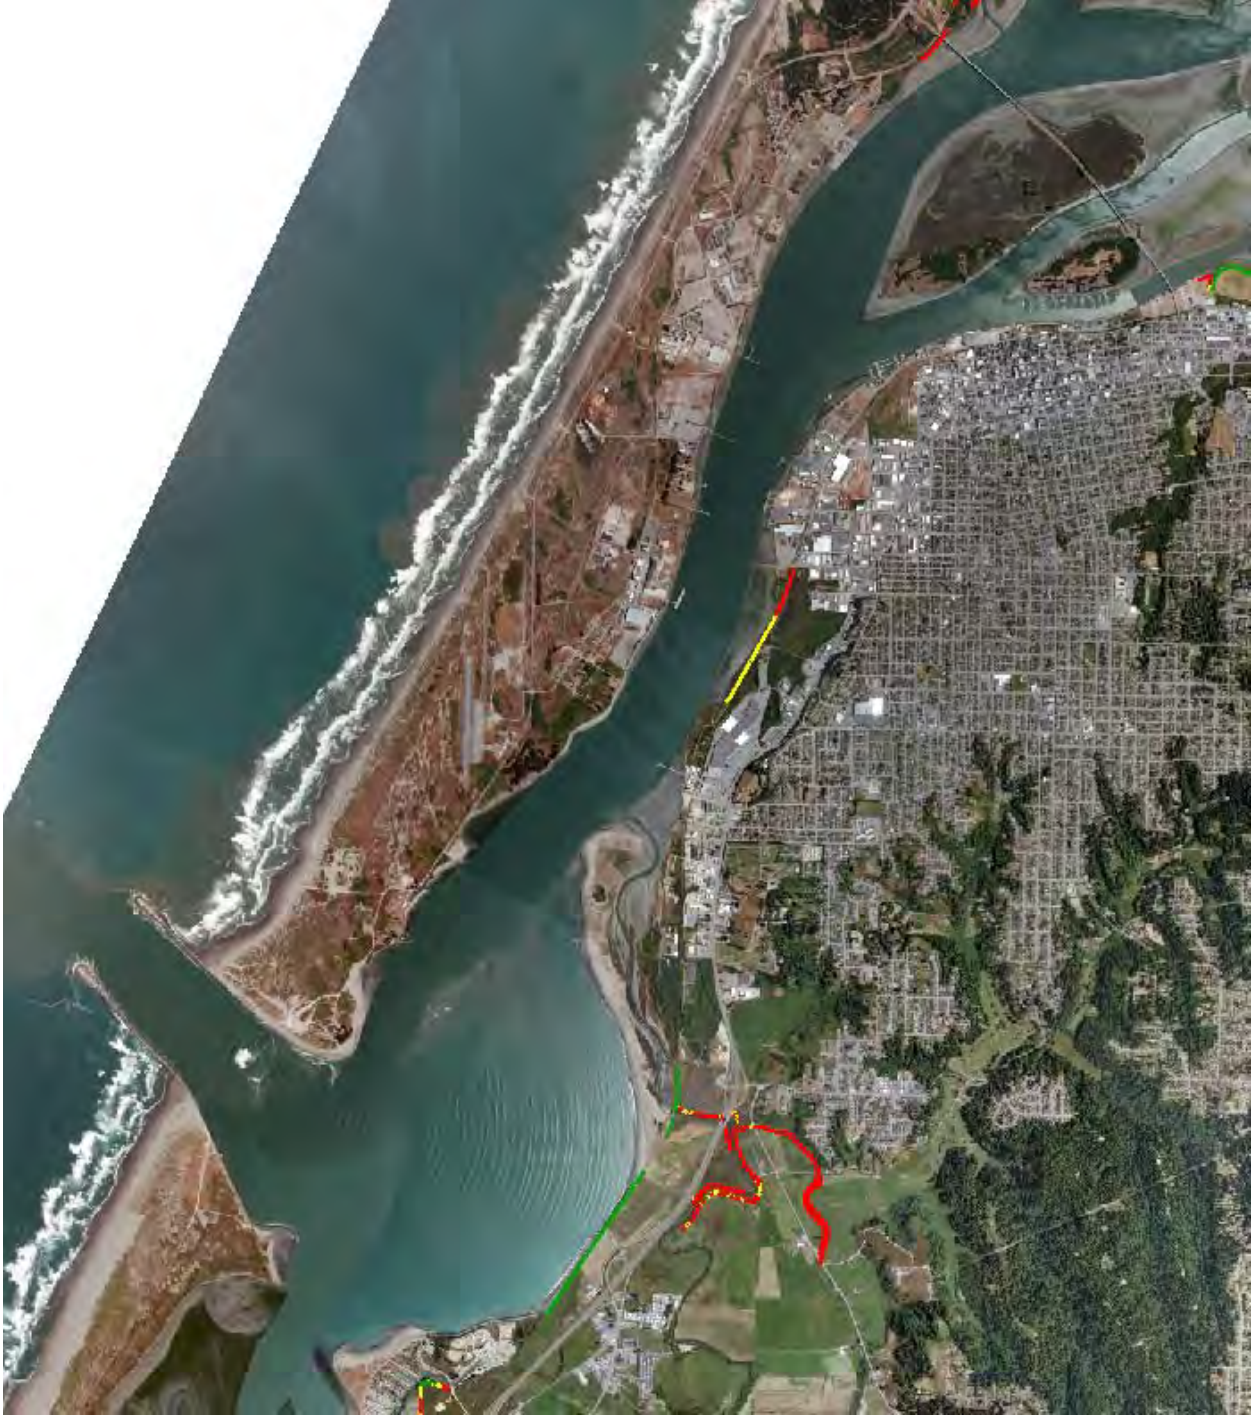
Figure 5. Diked and railroad shoreline vulnerability rating for Eureka Bay; red high, yellow moderate, and green low.

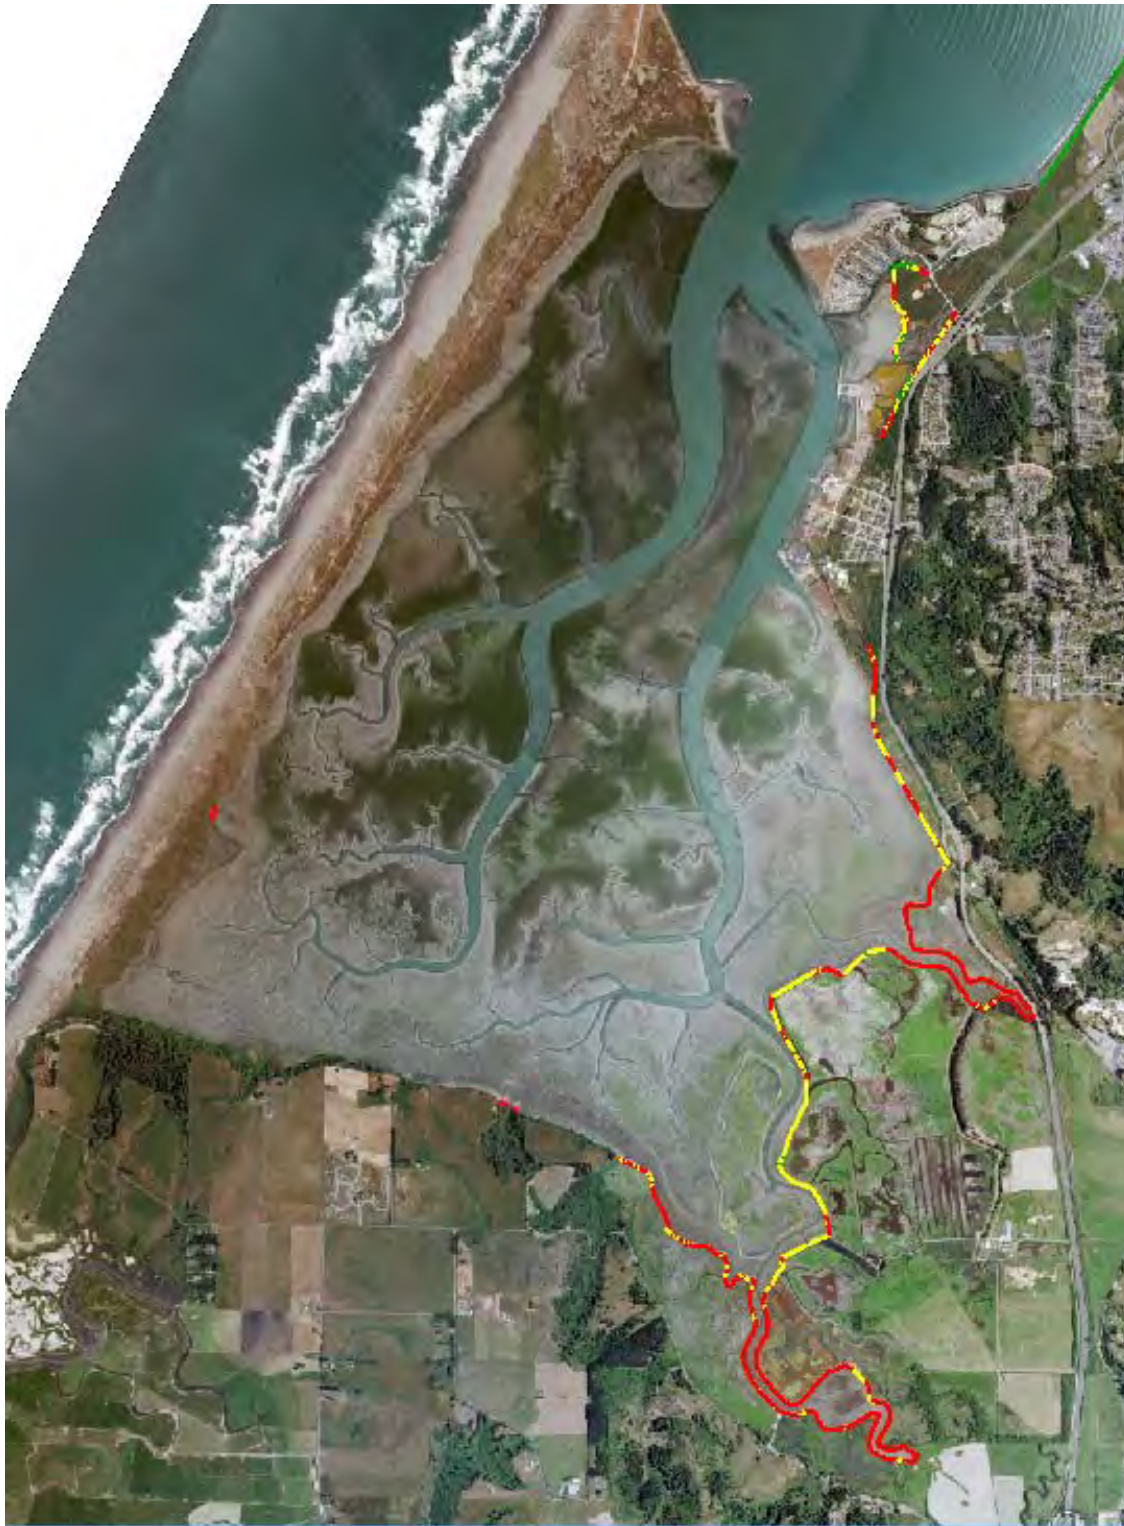
Figure 6. Diked and railroad shoreline vulnerability rating for South Bay; red high, yellow moderate, and green low.

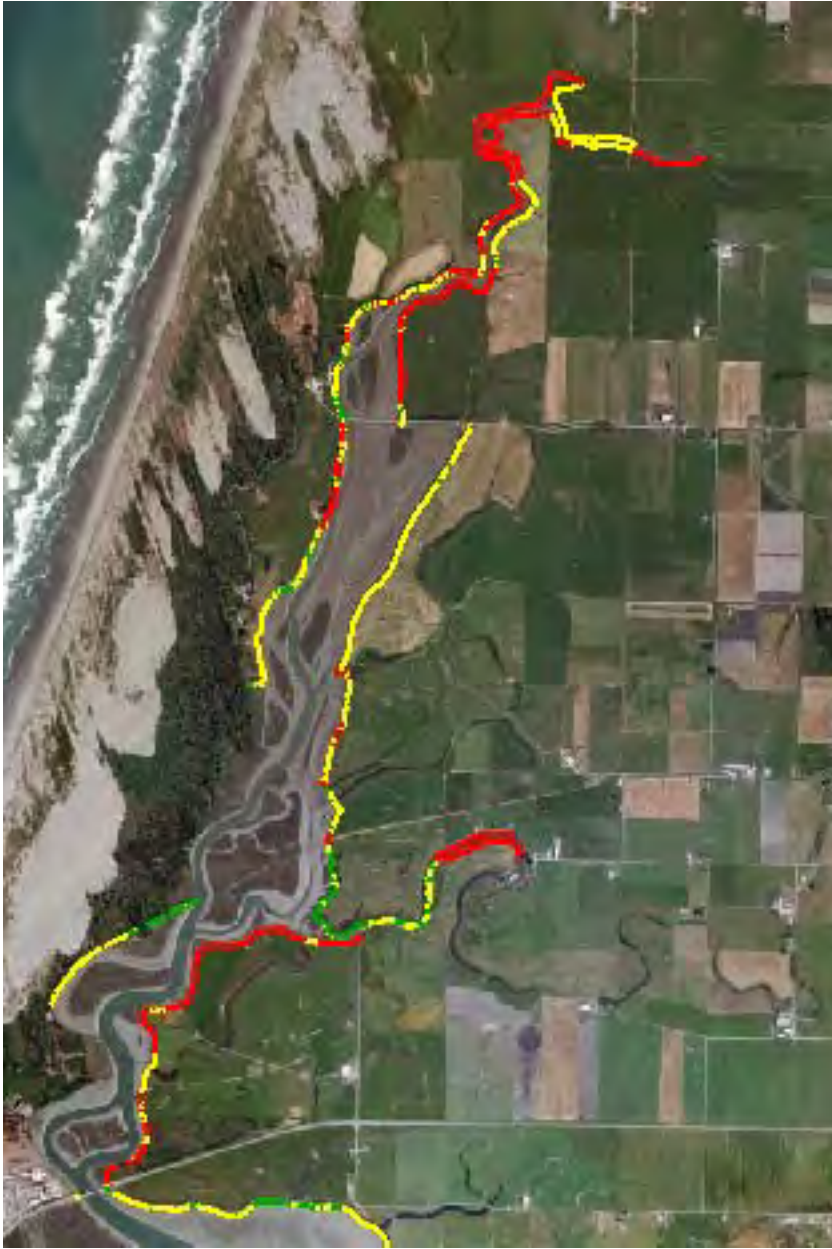
Figure 7. Diked and railroad shoreline vulnerability rating for Mad River Slough; red high, yellow moderate, and green low.

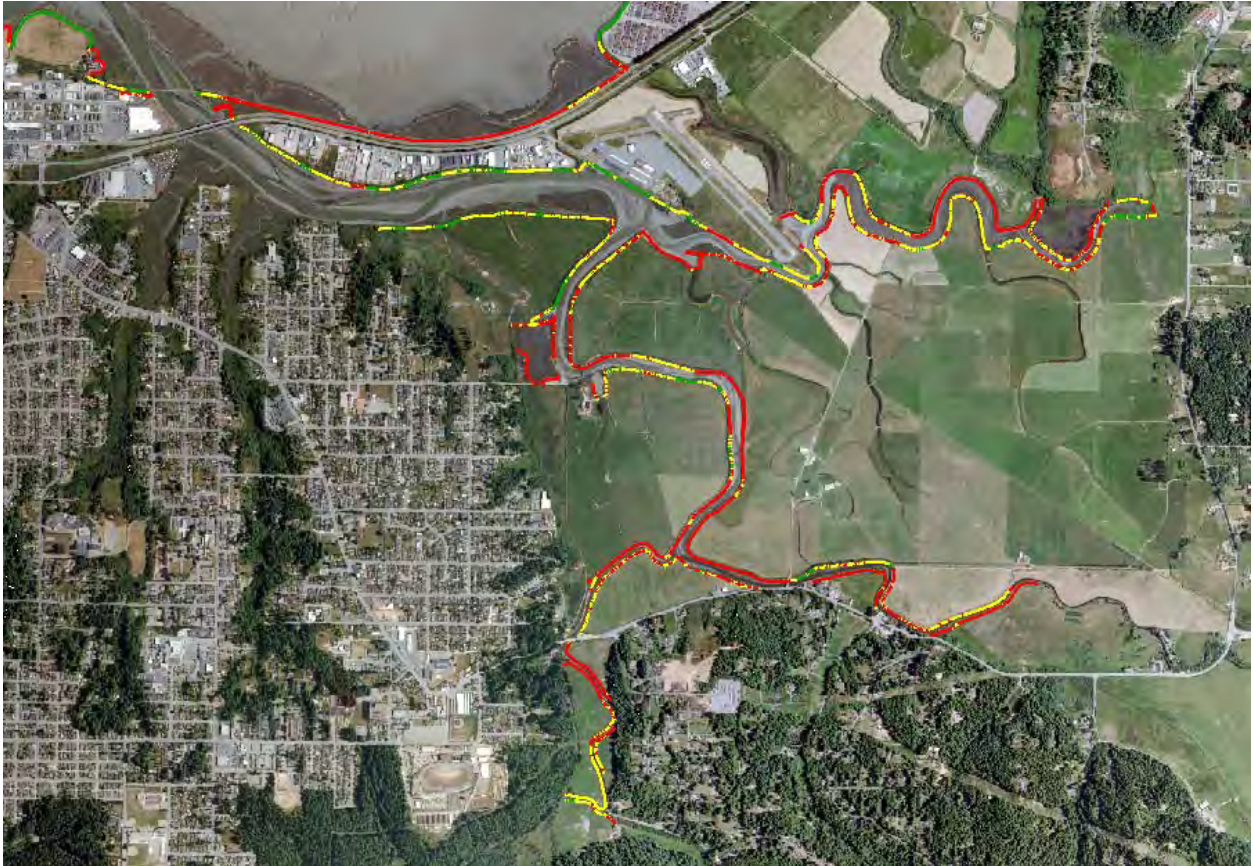
Figure 8. Diked and railroad shoreline vulnerability rating for Eureka Slough; red high, yellow moderate, and green low.

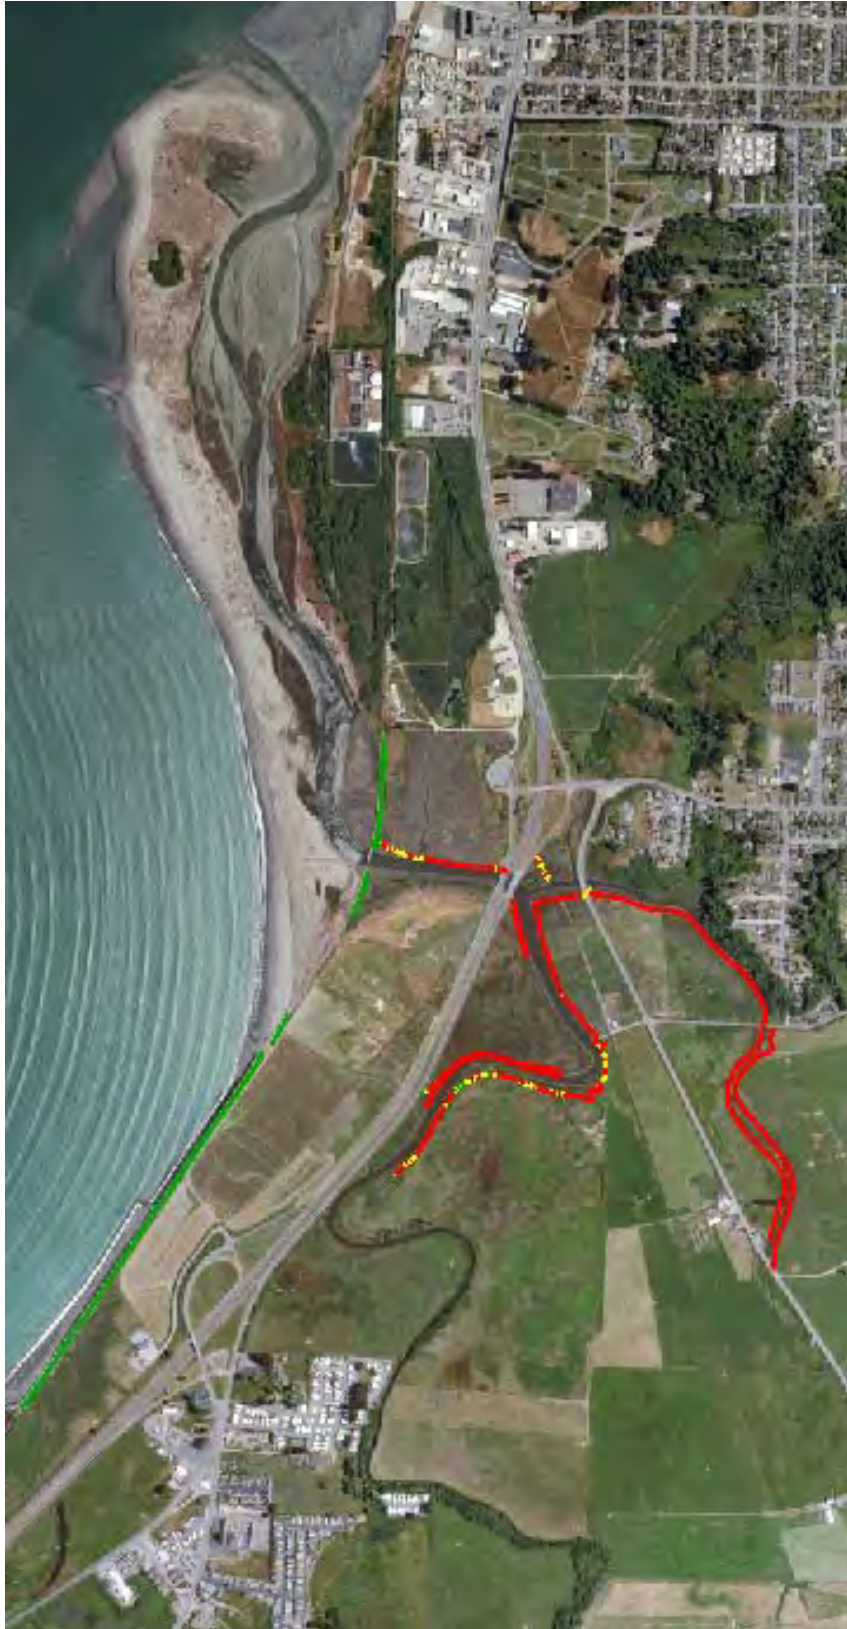
Figure 9. Diked and railroad shoreline vulnerability rating for Elk River Slough; red high, yellow moderate, and green low.
