# **Water Quality Assessment Report**

## **UNT North Branch Little Aughwick Creek**

### **Huntingdon County, Pennsylvania**

**April 2021**

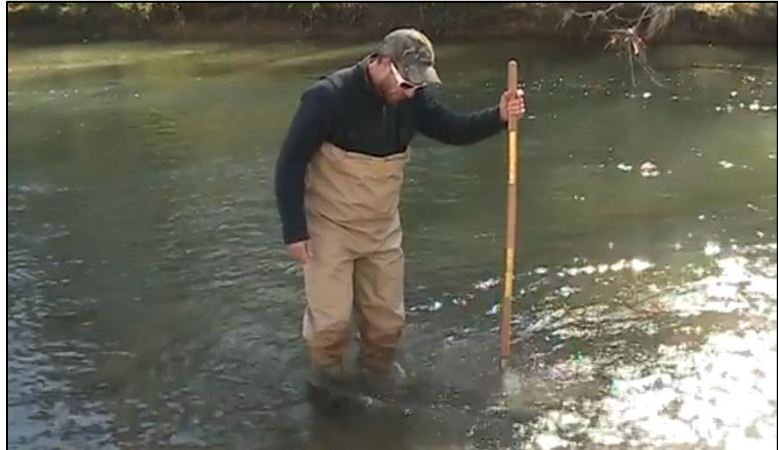
Benthic macroinvertebrate samples were collected at each sample site following PADEP methodology for wadeable, freestone, riffle-run streams (Shull and Lookenbill 2018). Collection begins by delineating a 100-meter reach along the stream of interest. A six-kick composite sample is collected from the reach using a 12-inch wide x 10-inch high D-frame net with 500-micron mesh. For each kick, the collector places the net against the stream bottom and disturbs a one square meter area immediately upstream of the net for approximately one minute. The collector attempts to distribute the kicks among a variety of riffle habitats (e.g., slow-flowing, shallow riffles and fast-flowing, deeper riffles). Kicks were also conducted throughout the width of the stream to include the left, middle, and right areas. This is done to ensure the composited

Photo 1. HCCD Watershed Specialist collecting a benthic macroinvertebrate sample.

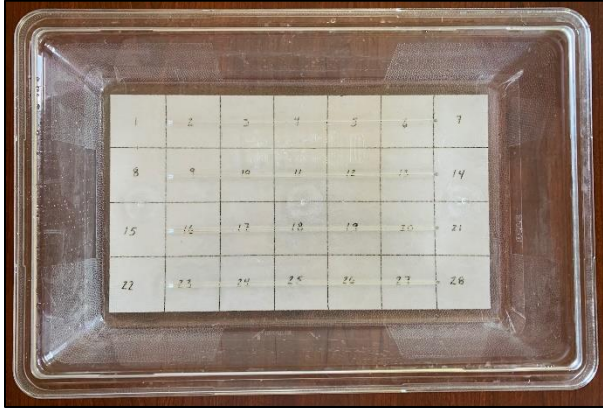
In the laboratory, benthic macroinvertebrate samples were sorted and processed following PADEP methodology for macroinvertebrate samples collected from freestone streams (Shull and Lookenbill 2018). Prior to subsampling, the composited sample is removed from the collection container and placed in a 500-micron sieve. The sample is gently rinsed under running water to remove ethanol and minimize damage to the macroinvertebrates. The sample is then placed in an 18-inch x 12-inch x 3½-inch pan, marked off into (28) 2-inch x 2-inch grids. Water is added to the pan before sample placement to ensure the macroinvertebrates are evenly distributed throughout the pan, and to prevent the contents of the sample from drying out during the subsampling process. Once the contents of the sample are placed in the pan, four 2-inch x 2-inch grids are randomly selected.

Photo 2. Example of gridded subsampling pan.

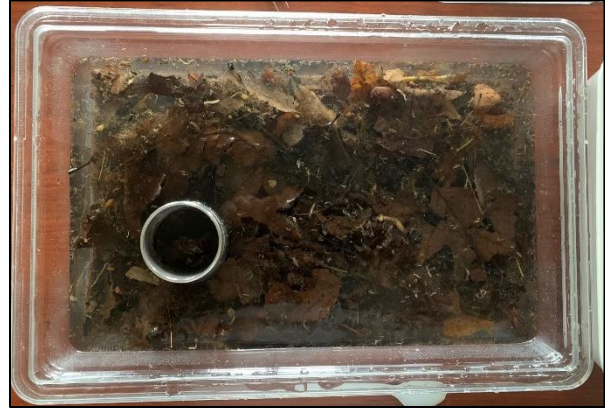
The materials and organisms from the selected grids are removed from within four-square inch circular “cookie cutters” placed in the randomly selected grids and removed using spoons, turkey basters, tweezers, and other implements as needed. The extracted contents are then placed into a second pan with water. Identifiable organisms are then picked and counted from the second pan.

Photo 3. Subsampling pan with sample contents and one “cookie cutter” grid selected.

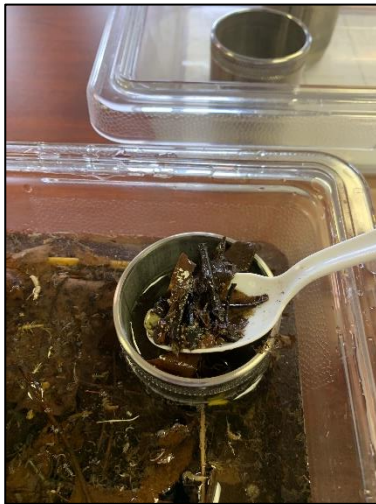
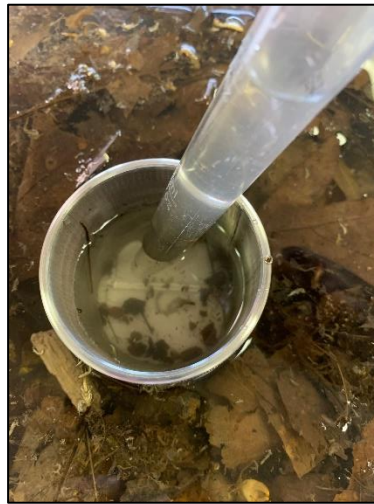
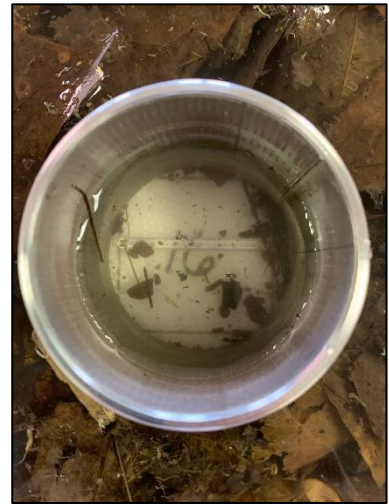
Photos 4-6. Contents of the subsampling grid are removed using spoons, turkey basters, etc.

Each grid selected during the subsampling process is picked in its entirety. The total number of grids selected from each pan and the count of organisms picked from each grid is recorded. Once the subsampling is complete and the target number of organisms is achieved, all organisms are placed in a clean, 125mL container with 70% - 80% ethanol. The container is labelled both inside and outside with date, time, collector, and location. The container is then stored for later identification.
