The Walled Garden Borthwickshiels, Hawick

Historic Buildings Report

AOC 21382 16th July 2009

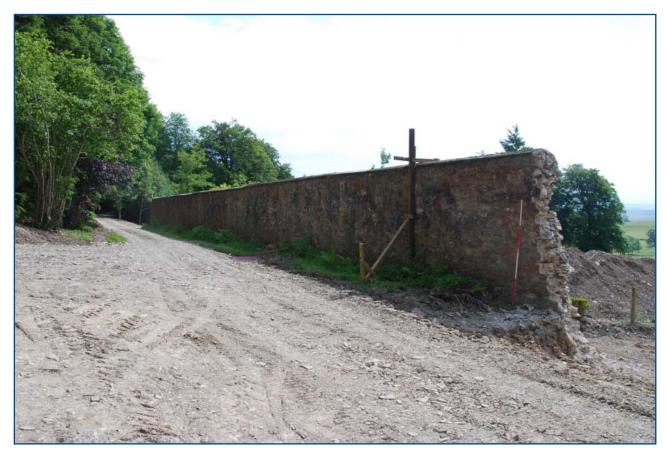
Plate 1: General view of the north wall from the north-west

4.2.1 The walled garden is relatively well-preserved. The north part of the wall is constructed of stone rubble held together with a lime mortar and with a curved concrete coping (a modern addition to protect the wallheads) (Plates 1 – 3). The east wall, however, is drystone construction, reducing in height to the south end of the wall adjacent to the hedge (Plates 4 & 5). There are two entrances in this wall. The southernmost of these has a 1950s upturned baluster which was created to appear like decorative finials to the gate piers (Plates 6 & 7). The west wall is a roughly coursed lime-mortared wall with a small slate pitch and zinc flashings coping, effectively creating a boundary wall to the adjacent gardener's cottage (Plates 8 & 9). A small square-headed entrance leads through to the bottom of the gardener's cottage. The doorway has a replacement concrete lintel and a wrought iron gate which were inserted during the 1950s according to the present owner (Plate 10).
