N of Kirkton Farm, Colpy, AB52 6XD to Blackhall Road (adjacent to Westburn Gardens), Inverurie, AB51 5SN Data Structure Report (DSR)

Alison Cameron and Robert Lenfert, Cameron Archaeology 4 October 2016

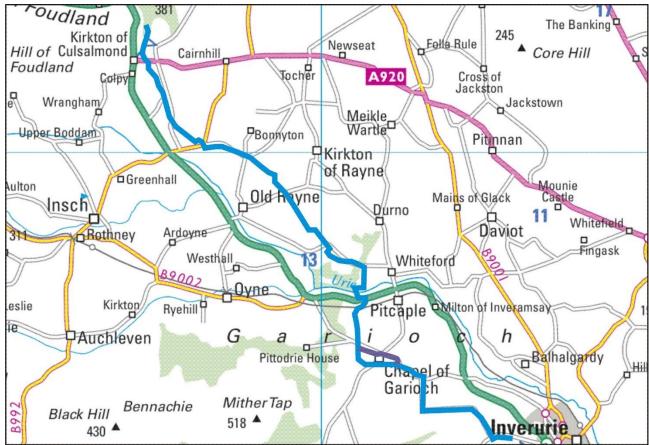
Illus 1 Location plan showing cable route in blue (Contains Ordnance Survey data © Crown copyright and database right 2016)

- 1.1 The proposed underground cable (Illus 1) runs from N of Kirkton Farm, Colpy, AB52 6XD to Blackhall Road (adjacent to Westburn Gardens), Inverurie, AB51 5SN. The National Grid Reference of the NW end is NJ64961 33749 and the SE end is NJ75620 21721. The proposed cable is in Culsalmond Parish (NW end) and Inverurie (SE end). The height is 245-250m OD (NW end) and 95-100m (SE end).
- 1.2 The work was commissioned by Gordon McConachie, CKD Galbraith LLP for SSE. Requirements for watching brief areas are detailed in Section 5 (see below).
- 1.3 All the archaeological work will be carried out in the context of Scottish Planning Policy (SPP) Planning Advice Note (PAN 2/2011) and Scottish Historic Environment Scotland's Policy Statement (HESPS), which state that archaeological remains should be regarded as part of the environment to be protected and managed.

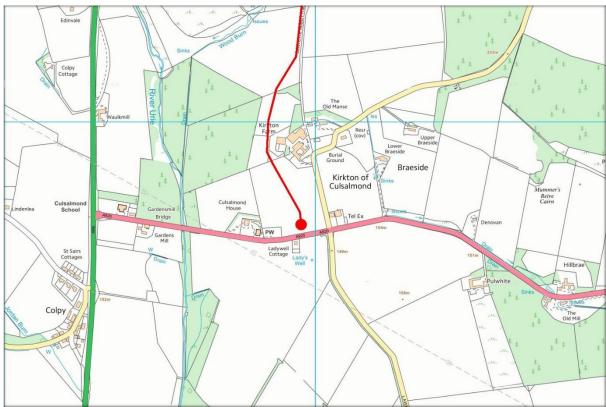
Illus 3 Watching brief trench showing location of ring ditch 101 (Contains Ordnance Survey data © Crown copyright and database right 2016)

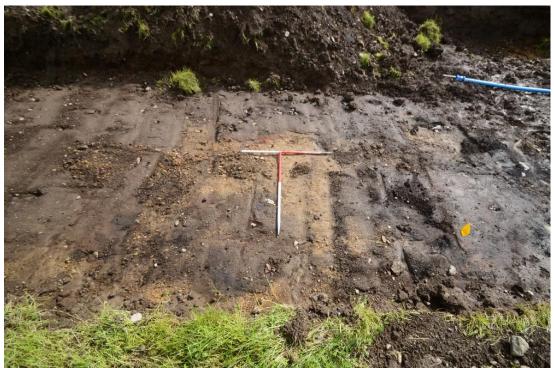
Illus 5 Central area of F101-F103; facing NE

Features F101-103 and the associated small finds of poorly-preserved course prehistoric pottery indicate the presence of a prehistoric structure south of Kirkton Farm (Illus 3). The nature of the pottery (Illus 6) is typified by course fabric with rough gritty inclusions and thick (c.13-14mm) sections suggests that these vessels were most likely used for cooking purposes in a domestic setting, i.e. a house. Indeed, feature 101 (Illus 4, 5) appears as a probable fill (possible deposit) of an interior area. Due to plough truncation and limited exposure during corridor trenching, it is uncertain whether the structure is a circular ring-ditch or hut circle of likely Bronze or Iron Age date, or if it is indeed rectilinear, Neolithic in origin as discussed above, it suggests a Neolithic origin. The current backfilled state of the site should afford future archaeologists a clear opportunity to carry out excavations to more clearly characterise the deposits if the opportunity arises in the future.

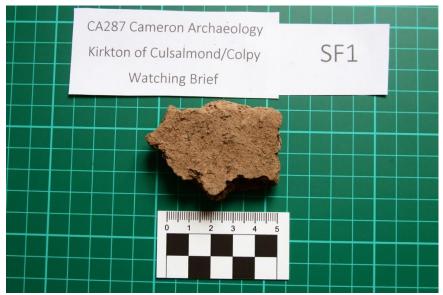
Illus 6 Course prehistoric pottery located within F101.

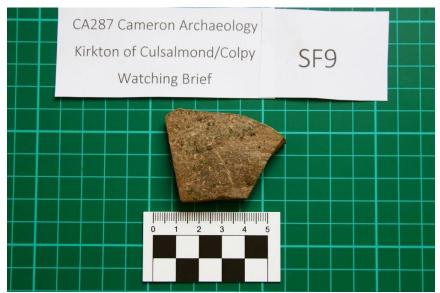
Illus 7 Possible medieval or post-medieval pottery SF9 located 40m north of prehistoric features in corridor trench.

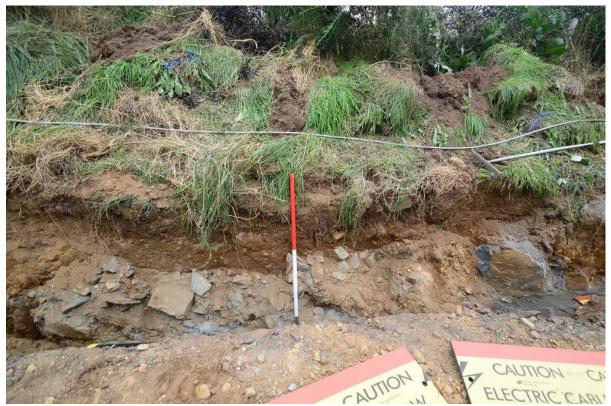
The watching brief continued intermittently between September 1st and 8th, 2016 during excavation of approximately 215m of cable trench some 0.6m wide and1.2m in depth along the same road. The watching brief began as trenching reached approximately 100m SE from the track leading to Easterton Steading at NJ 70374 26999 (Illus 12). At NJ 70314 27040, some 16m from the steading track, a possible but not entirely convincing, concave ditch cut (43; Illus 13, 14) was noted which cuts into the bedrock. The fill (42) was identified as a midbrown sandy-silty clay with gritty inclusions which typified the soils along the length of the trench, though this possible cut appears to have held a higher degree of moisture thus enhancing the appearance. It is of course entirely possible that this is a natural feature and a reflection of the uneven bedrock surface (44), yet the variation was sufficient enough to

warrant noting. A five litre soil sample (Sample 1, 42) was taken, though no finds or associated features were noted within the possible ditch. The trench was subsequently backfilled after photographing and recording. No other archaeological finds or feature were noted along the trench en route to tie into the sump.

Illus 13 Section of possible ditch, 43; facing NE.

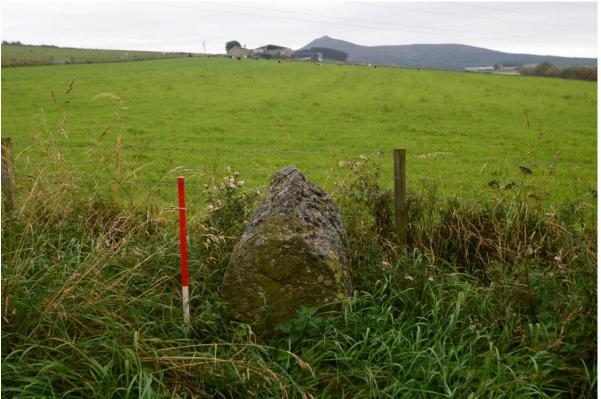
The Scheduled Monument of East Blairbowie Standing Stone (Illus 15) located at NJ7300 2288 (HES 2016a; Illustrations 1-3) is a relatively inconspicuous 1.2m tall standing stone situated immediately on the eastern edge of the north to south section of the minor road which connects Burnside of Balquhain and Balquhain Mains, approximately 3.5km NE of Inverurie, Aberdeenshire.

Illus 15 View of Blairbowie Standing Stone with the nearby Bennachie Range and prominent summit of Mither Tap in the background; facing W

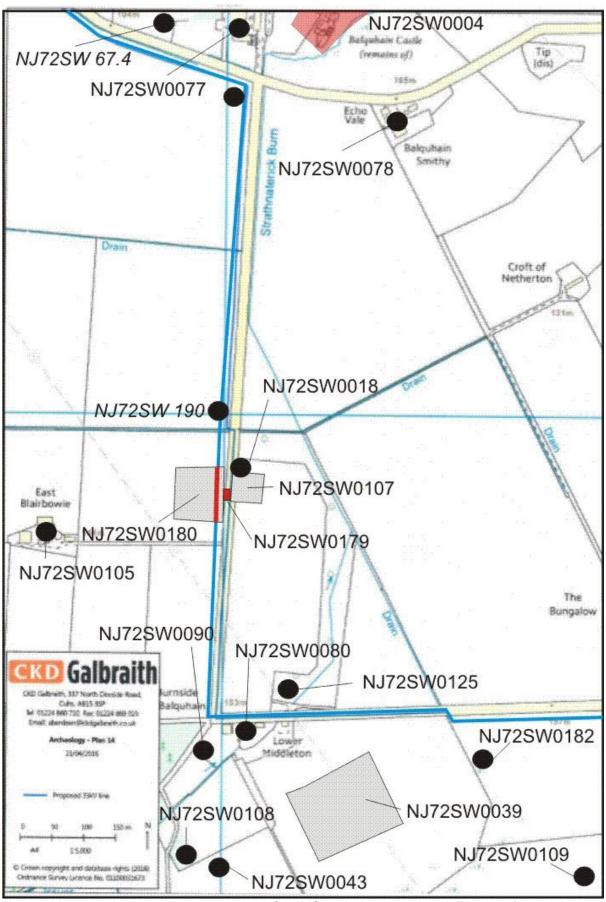
Illus 31 Map showing proposed route with RCAHMS and Aberdeenshire HER sites (copyright CKD Galbraith)
