ACID SULFATE SOILS GUIDEBOOK FOR VA/MD MAPSS/VAPSS TOUR, NOV. 4, 2011, IN GENERAL VICINITY OF FREDRICKSBURG, VA

Edited by Del Fanning, DelvinDel@aol.com or dsf@umd.edu

TABLE OF CONTENTS

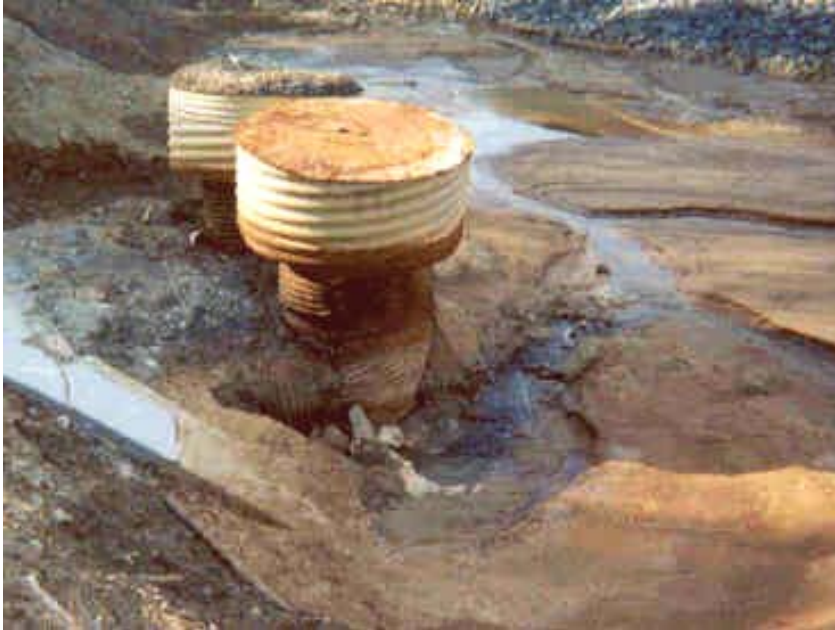
pictures to show some of the metal and concrete corrosion at SRAP. The first picture shows drain pipes from a sediment control pond on the south side of the airport where the pipes have been eaten thru by the acidic waters. This picture was taken by Dr. Daniels of Virginia Tech. The picture at the bottom of the page, also from Dr. Daniels, shows

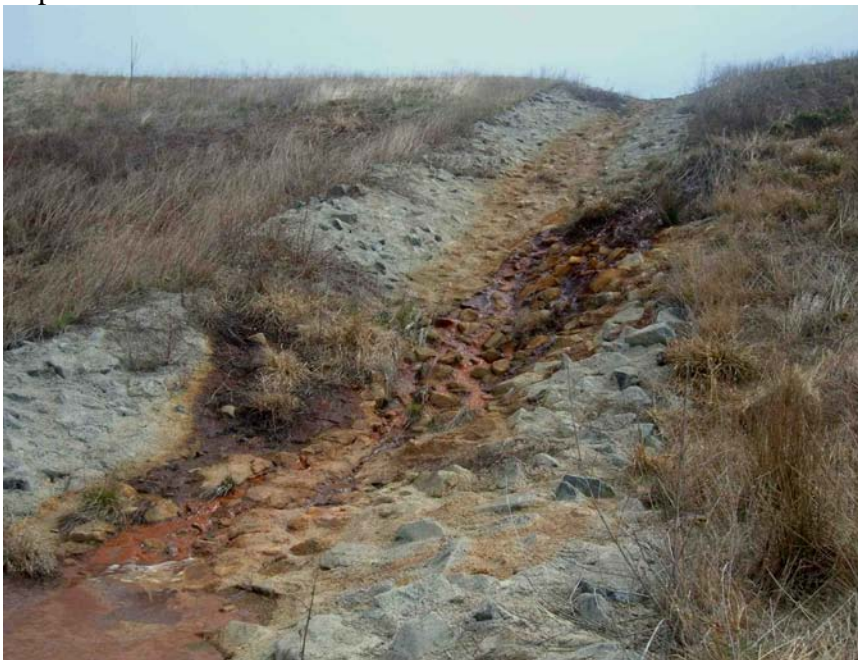
concrete corrosion and iron staining in a “protected” channel on the north side of the airport.

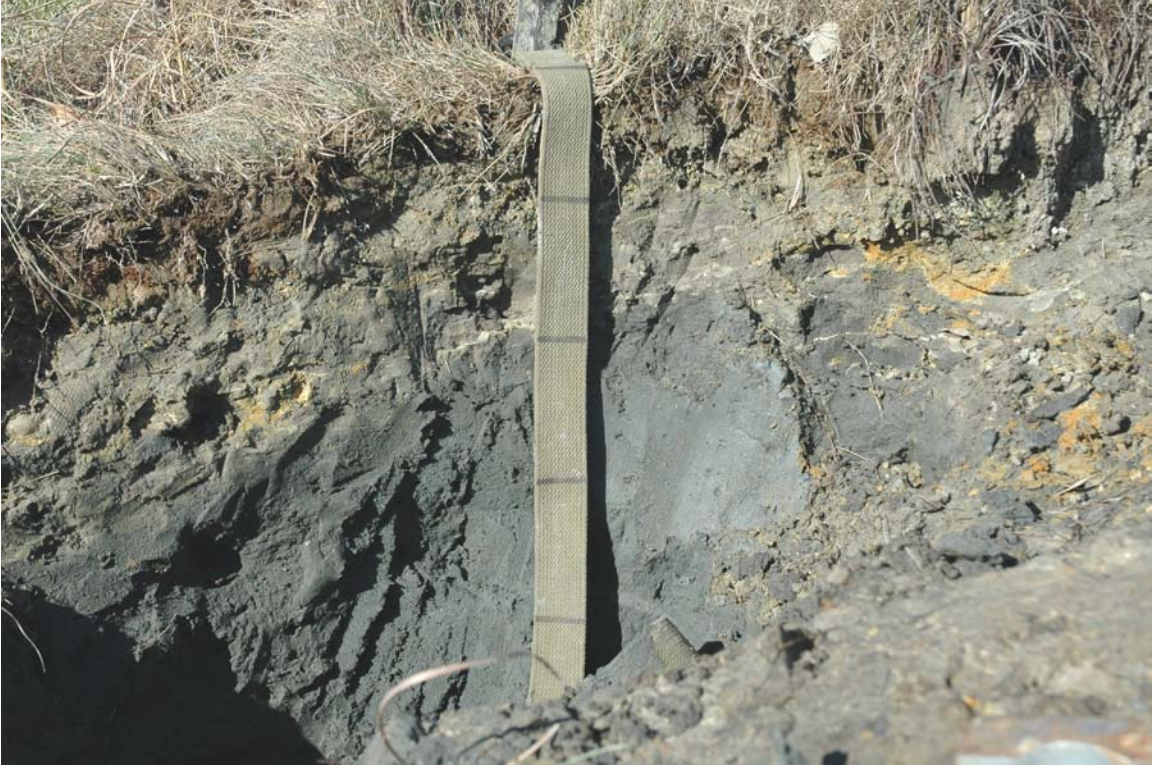
The depth increments on the tape over profile are 10cm (about 4 inches) apart.

Description of Soil on Scalped Land Surface at Stafford Co., VA, Regional Airport Developed in Sandy Sulfidic Tertiary Geologic Sediments

Additional Notes: The faces of the platy structure in the BA and Bwj horizons are mostly covered with jarosite. The plate faces are roughly parallel to the soil surface. This demonstrates that the platy structure formed on the new, human-constructed, land surface and that the jarosite formed after the land surface was constructed. There are some fine, sand-size lignite grains/chips in the Cg horizons that appear to constitute about 5% of the sand of these horizons. Pictures of profile and landscapes follow.

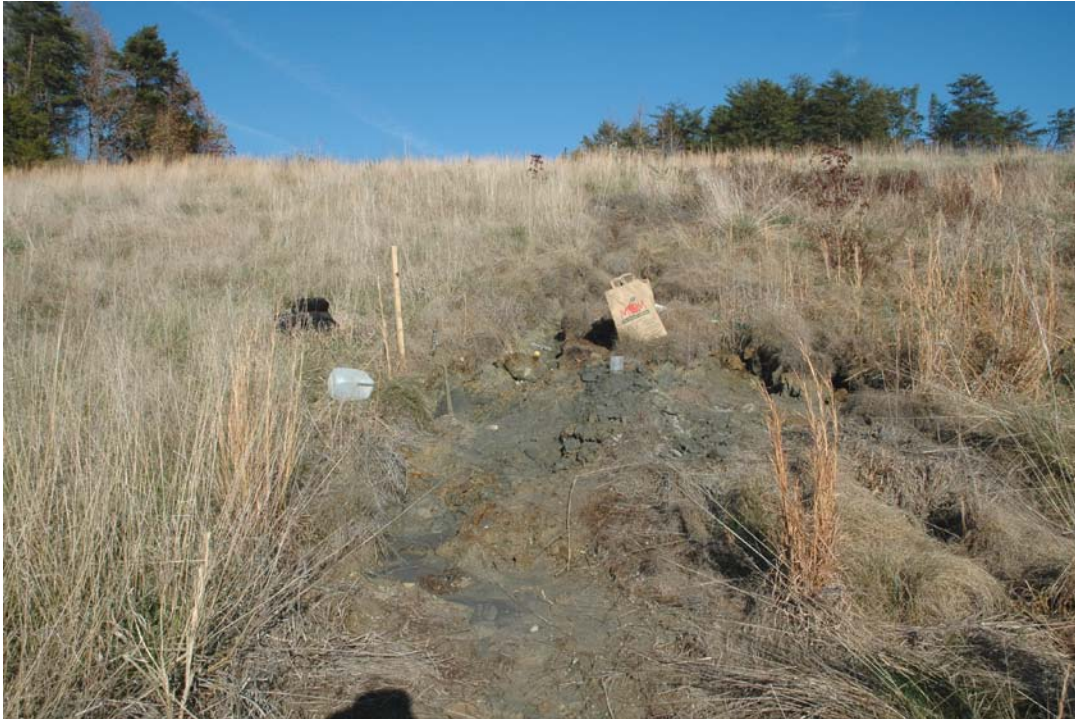
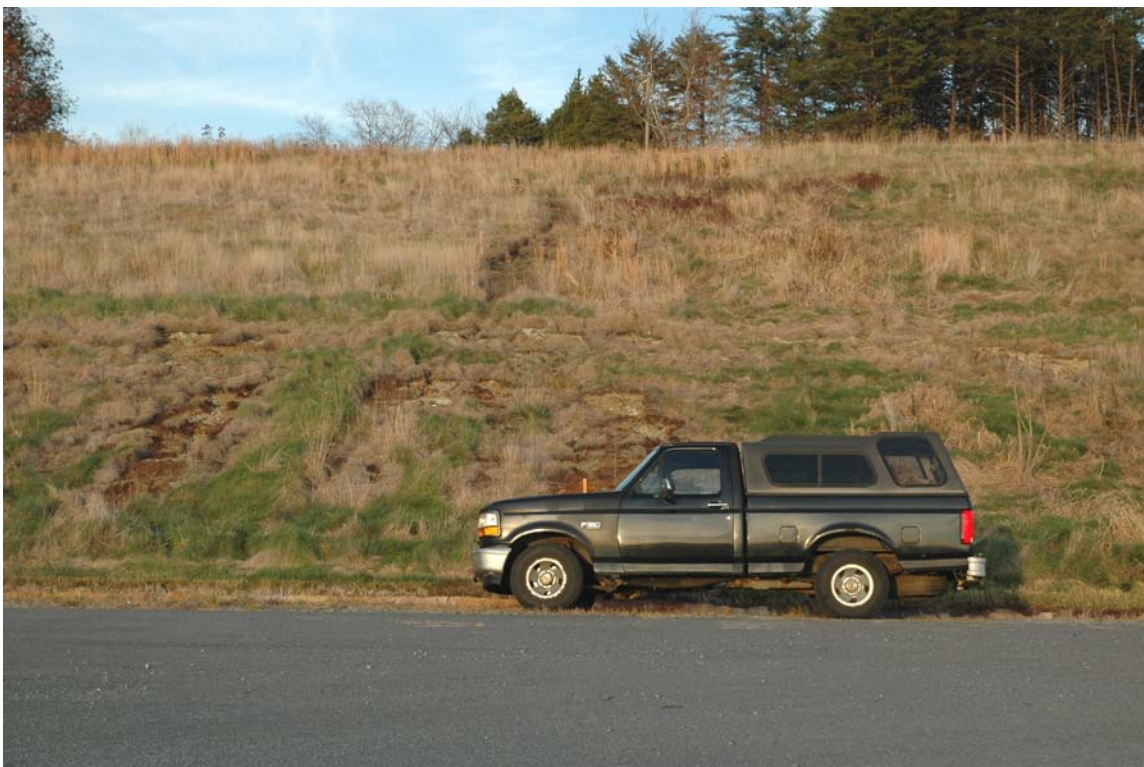
These pictures taken in November, 2005, may be compared to the pictures of this slope when it was covered with salts etc. and not vegetated in 2001, shortly after airport construction as given in the paper by Fanning et al. (2004). For some lab data for the profile, see the next page. The top picture is a close up of the profile sampling site, the bottom is the full slope.

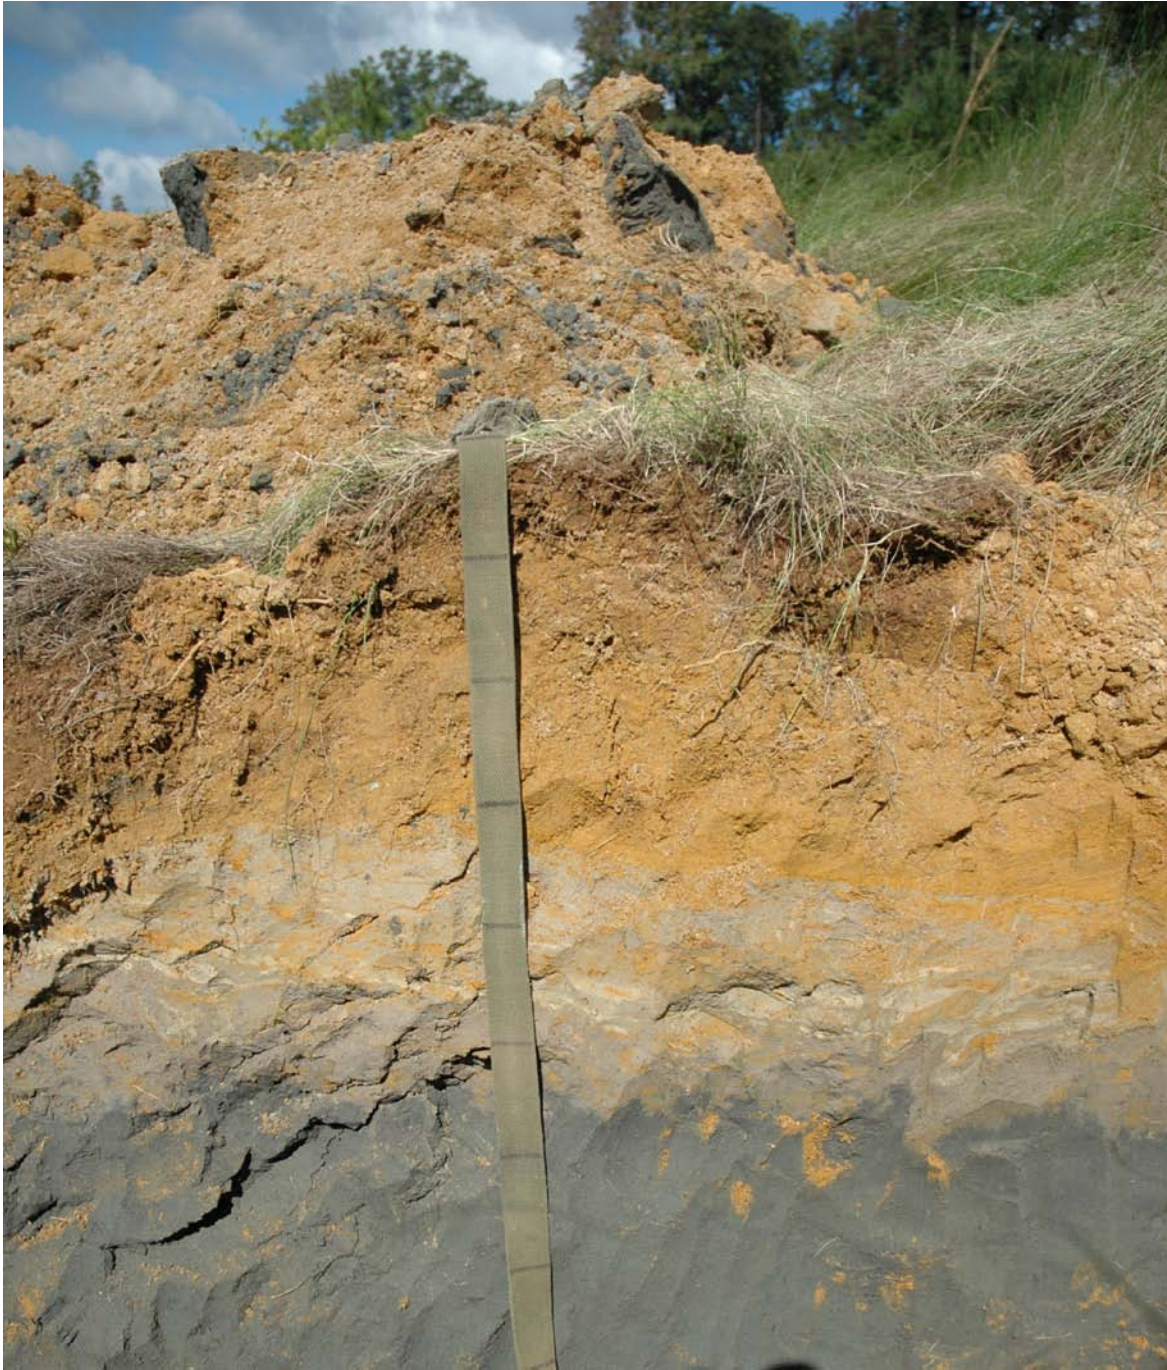
A picture of the soil profile described on the previous two pages. Note that the thickness of the strong brown Bw horizon increases upslope to the right and decreases downslope to the left. The textures of the various horizons was similar, indicating that the upper horizons developed from material like the *sulfidic materials* of the Cgse horizon at the bottom of the profile. The brown spots at the top of the Cgse horizon are contamination of materials fallen from above – the profile should have been cleaned better prior to photography. Picture taken by D. S. Fanning, Oct. 4, 2011.

Description of soil profile on scalped land surface at Stafford Co., VA, Regional Airport. This profile is developed in very fine sand sulfidic Tertiary Geologic Sediments. It was described in a new backhoe pit, opened Oct. 3. 2011 by Ed Wallis, for VAPSS/MAPSS acid sulfate soils workshop tour Nov. 4, 2011. The profile was described on the land surface about 2 meters upslope from the boundary between the oxidized zone and the unoxidized zone on the scalped land surface.

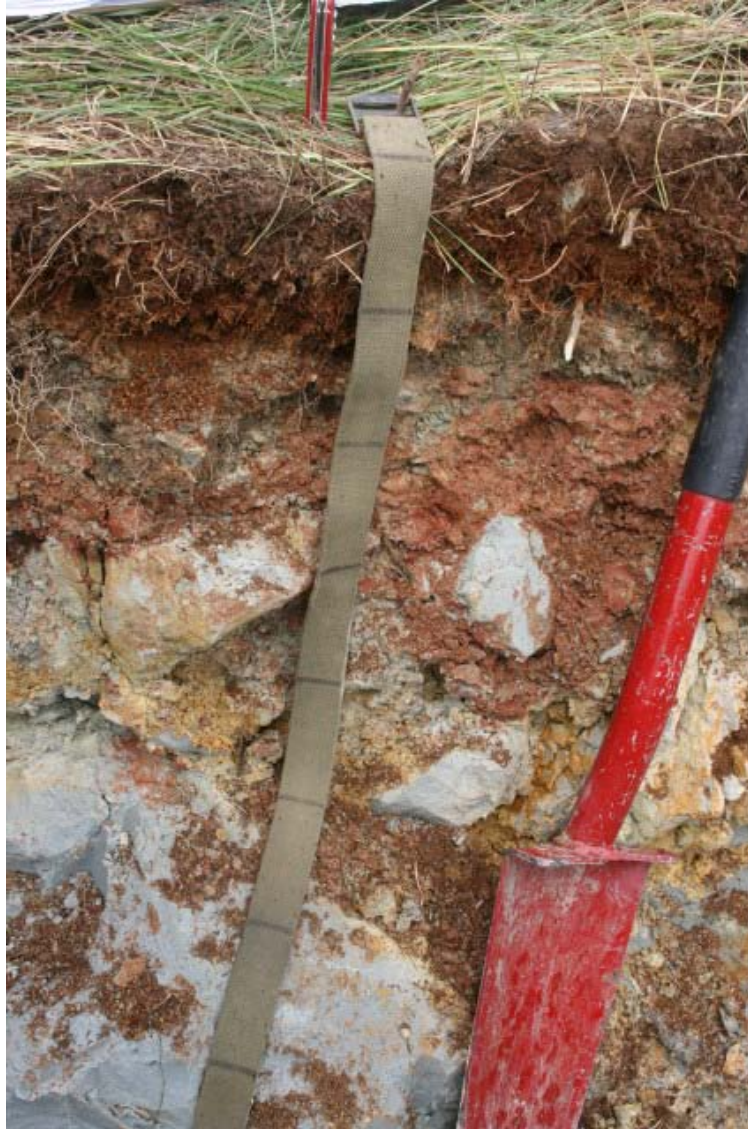
Picture of profile described, taken by Matt Salos, Oct. 3, 2011, the same day the pit was opened with backhoe by Ed Wallis, SRAP Manager of Pit 2 at the airport for the Nov. 4, 2011 VAPSS/MAPSS tour. The light gray clayey soil materials were rock-like (Ed's term was non-durable stone) and when broken up and tested with 30% hydrogen peroxide gave a violent heat-generating reaction, however, it took about 15 minutes for the reaction to "take off", probably because of low surface area available for the reaction. Fracture surfaces in this rock-like material were decorated with iron oxide and jarosite concentrations.

Description of soil profile (SRAP pit 2 for Nov. 4, 2011 field trip) on lower slope of scalped land surface at Stafford Co., VA, Regional Airport. This profile is developed in clayey Tertiary or Upper Cretaceous Geologic Sediments, which have essentially hardened (possibly in part after exposure by landscape scalping) to a rock-like (shale?) material. It was described in new a new backhoe pit opened Oct. 3, 2011, by Ed Wallis, SRAP Manager for VAPSS/MAPSS acid sulfate soils workshop tour Nov. 4, 2011.

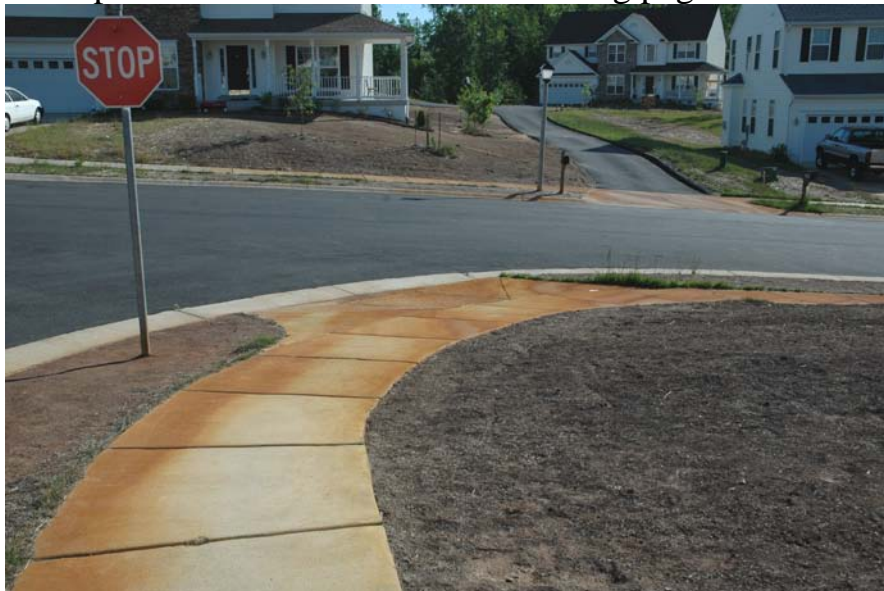
Yard above had dead turf at corner of Great Oaks Lane – the street going across the picture -- and Hickory Court that leads out to the STOP sign.

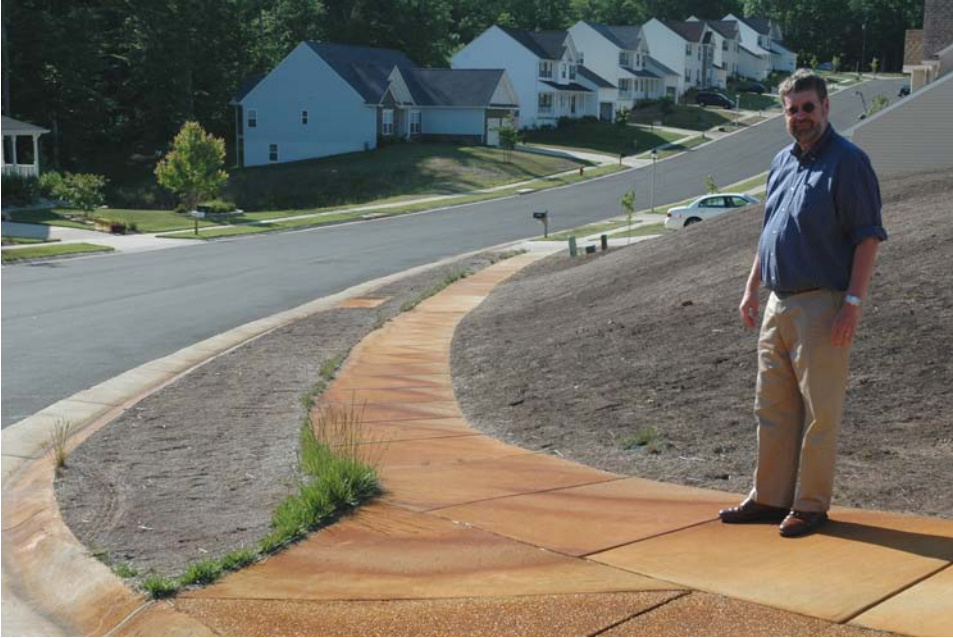
Lee Daniels, soil scientist and reclamation expert from Virginia Tech is shown standing on discolored side walk around house at the corner of Great Oaks Lane and Hickory Court. Grass is growing along the edge of the concrete probably because of the liming effect of the concrete.

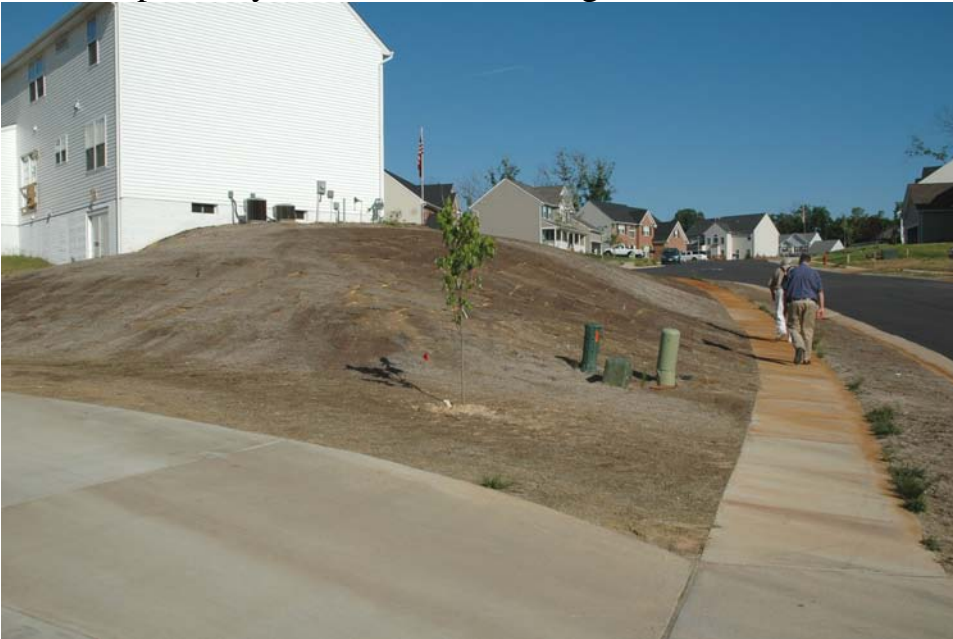
Dead turf on hill side coming down from house in spite of being sodded with healthy turf two times. Lee and Zenah Orndorff have worked with some home owners who had lawns looking like this one to enable the establishment of planted turf grasses as shown in two pictures from the yard of Les Hazen on the next page. About 30 tons of lime per acre and 4 inches of a compost/topsoil mix were mixed into the top 6 inches of the acid sulfate

soil to achieve the excellent turf shown (pictures taken May 23, 2006). The adjoining yard below was also treated with the same measures.

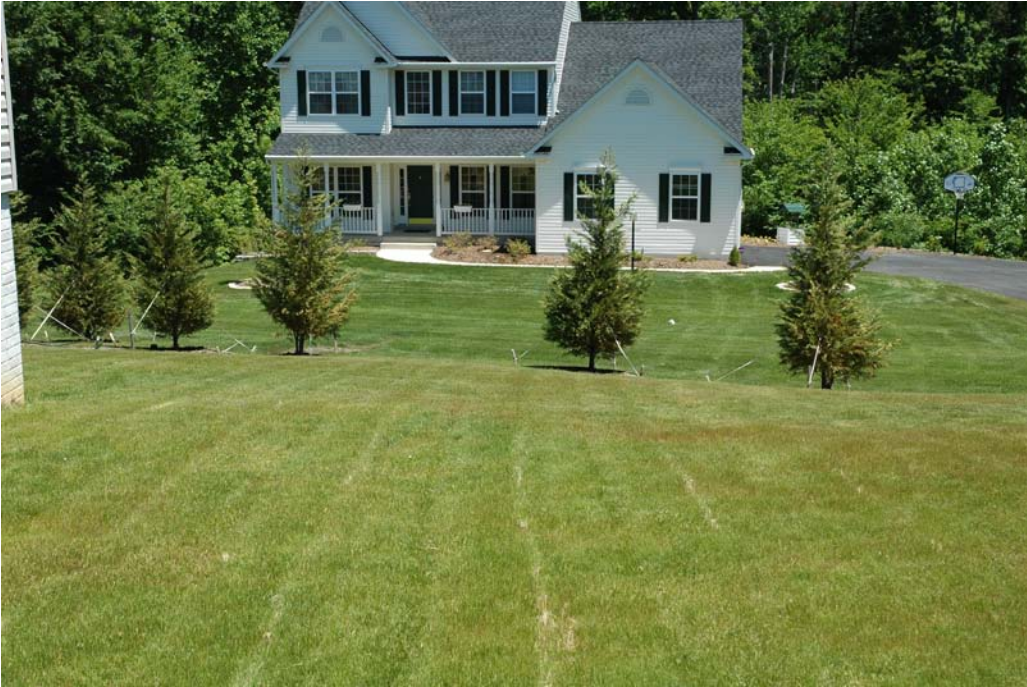
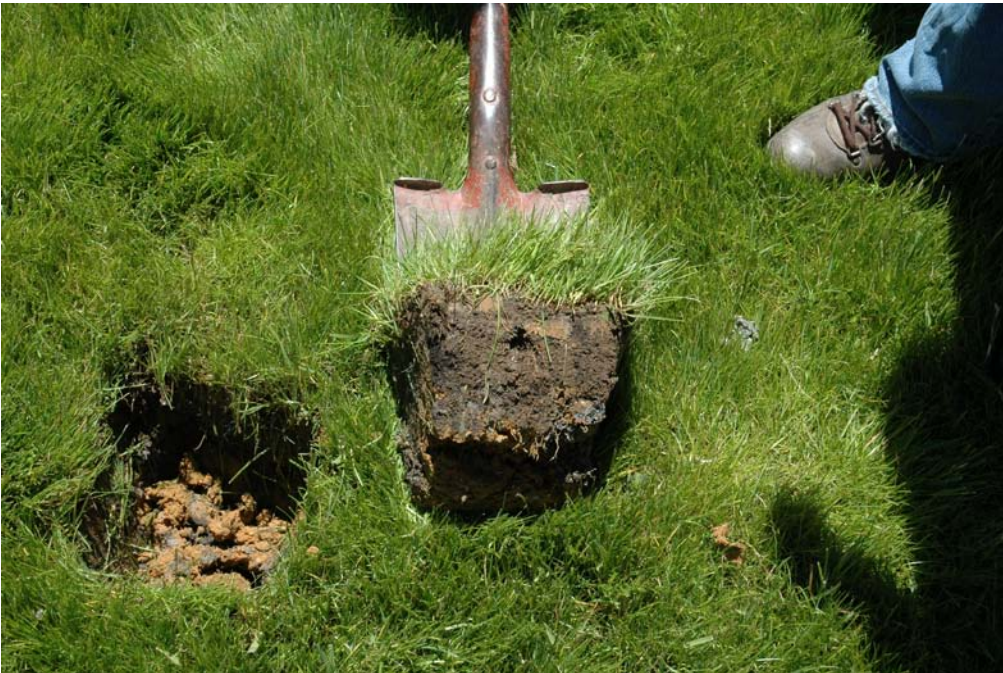
The lower picture shows a peek into the soil beneath turf in Mr. Hazen's front yard. Mr. Hazen claims that prior to the soil reclamation treatment his yard looked like the un-reclaimed ones shown in the pictures on the previous pages. The geologic materials here are considered to be Tertiary Coastal Plain sediments like those at SRAP to be seen at Stop 5.

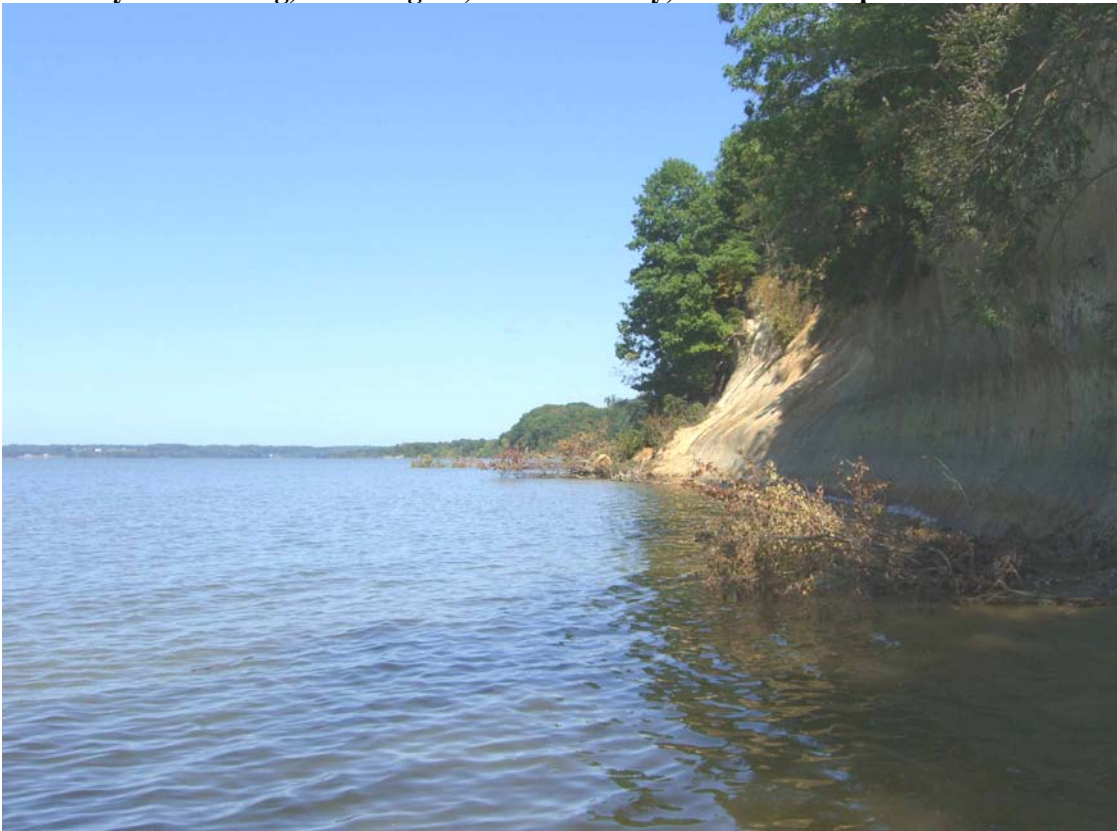
ABOVE: Photo by Darrin Lowery looking to the north, of cliff face which the trail from the Retreat House leads to, which is off the right side of the photo, where the thickest part of the kitchen midden, shown in other photos for this stop, also lies. The slope of the hill of the land, on top of the cliff, leads down to close to the water of the river off the right side of the photo. A main reason for visiting this site, from an acid sulfate soils perspective, is to see the boundary between the brown soil materials of the oxidized zone at the top of the cliff and the dark gray color of the unoxidized zone at the base of the cliff. Lateral oxidation into the unoxidized zone on the face tends to obliterate the gray colors of the unoxidized zone on the face, but the boundary is visible to trained eyes, even without scraping away the thin surficial zone, which in many places contains bitter-tasting salts, produced by the acid sulfate weathering of pyrite of the unoxidized zone. The salts undoubtedly are iron and aluminum sulfate minerals such as rozenite, copiapite, and halotrychite. In the soil materials along the boundary at the top of the unoxidized zone, pale yellow jarosite is visible in many places, and a thin *sulfuric horizon* as defined by *Soil Taxonomy* may be present, overlain by post-active acid sulfate soil materials. Most of the iron of the brown iron oxides of the oxidized zone was very likely released from pyrite of those soil materials prior to oxidation -- as documented for other sites, such as the Burrough's site data of Wagner (1982) shown on subsequent pages. The Burrough's site where the deep weathering column was studied by Wagner is about a mile north up the river.

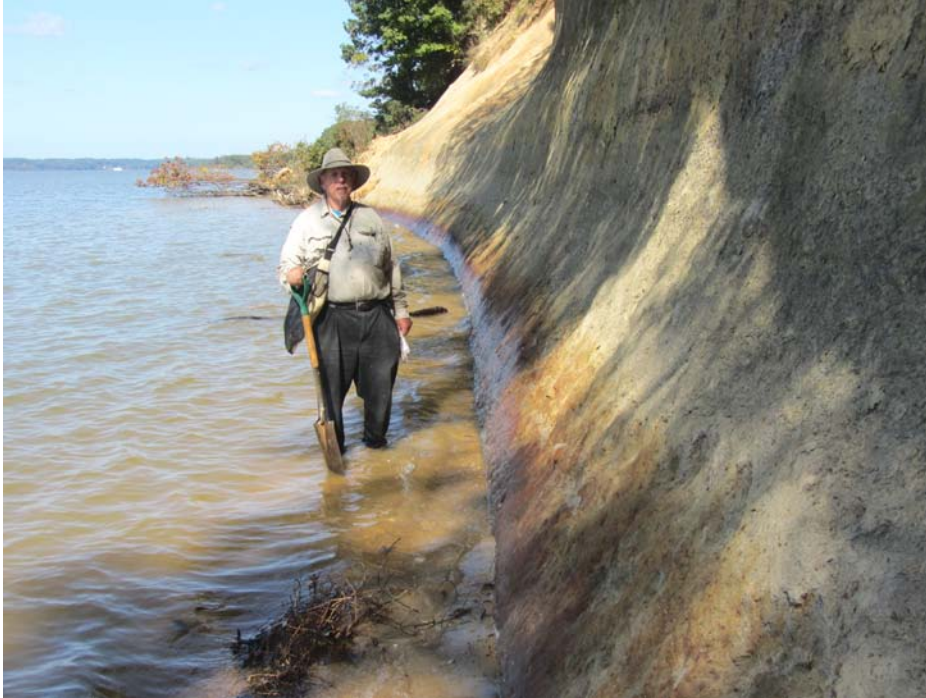
A picture of Del Fanning standing beside unoxidized zone (surficially weathered after exposure by shore erosion) of the soil-geologic column. This picture was taken by Dan Wagner. Dan entitled the photo “splash zone” to call attention to the orange iron oxides at the

base of the cliff, which we are convinced have formed by splashing of the high pH river sea water up onto the base of the cliff, which triggers the oxidation of the iron containing salts and the precipitation of lepidocrocite and/or goethite.

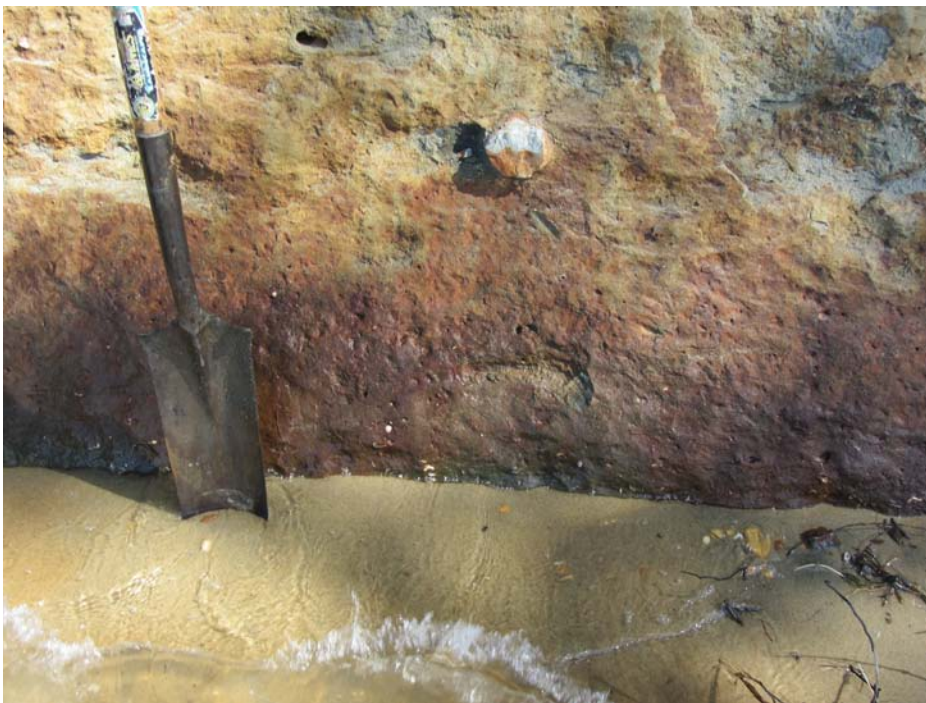
A close-up of the “splash zone”. The iron oxides occur only on the face. The round object that protrudes from the cliff face in the lateral middle of the photo, but close to the top vertically, is silica cemented. Sandy soil material of the beach lies against the bottom of the

cliff.

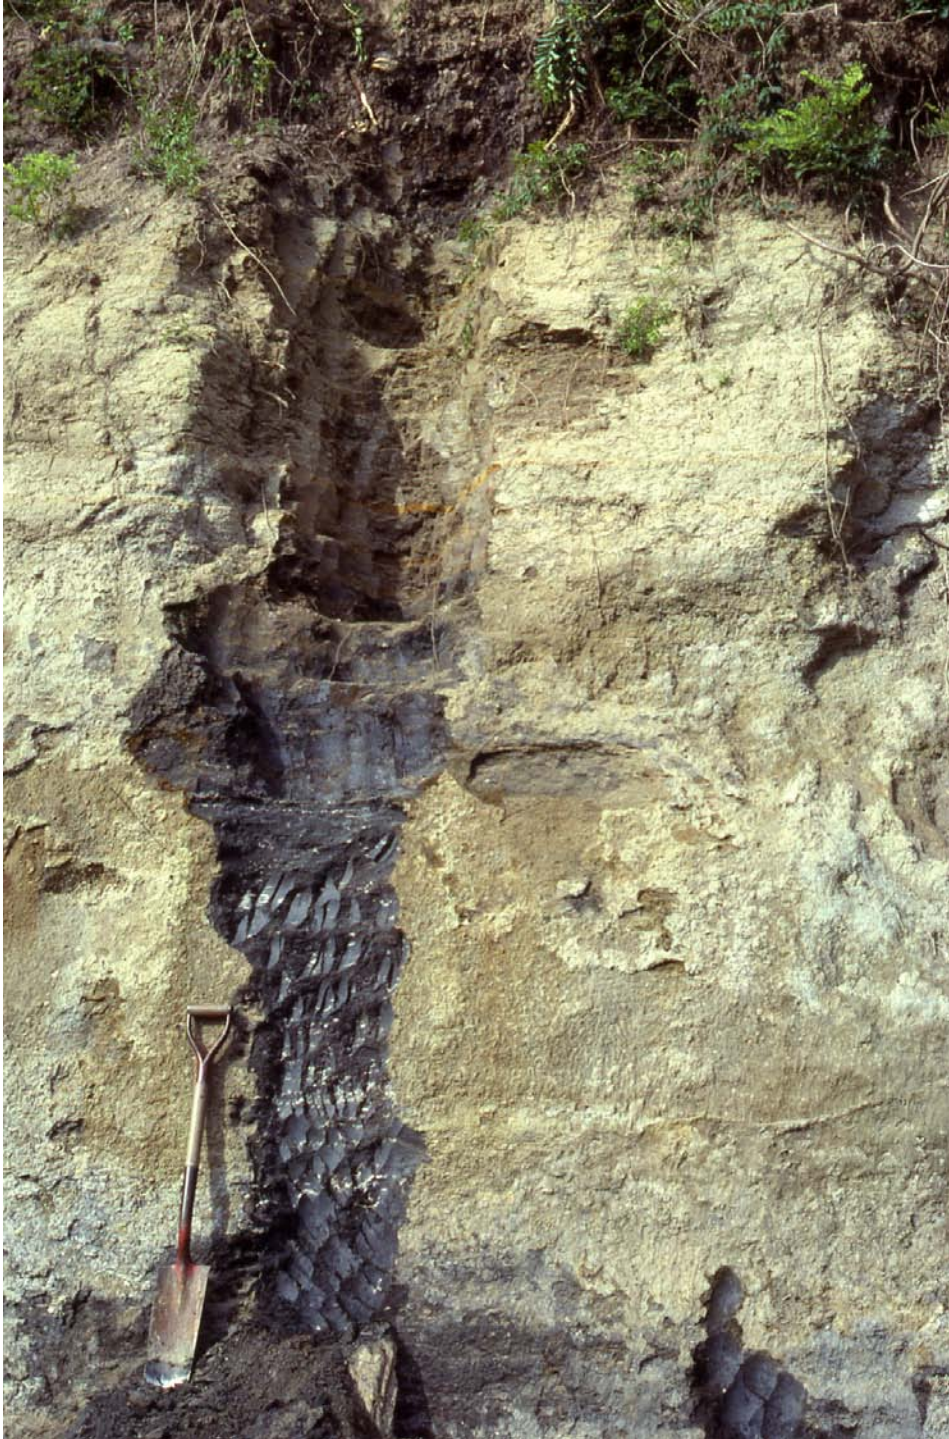
A 6 meter profile in sulfidic, glauconitic Tertiary sediments on Potomac River cliff face studied by Wagner (1982). Oxidized zone is nearly 3 meters deep with a *sulfuric horizon* with gypsum crystals at top of un-oxidized zone. White shells occur in black *sulfidic materials* in un-oxidized zone. Surficial materials from lateral weathering were removed to show the profile. The info here and in the next two pages are from a Power Point presentation

by Fanning et al. which fed into a paper, Fanning et al. (2010), published in *Geoderma*.

The soil profile pictured below with S and Fe data on subsequent pages was studied by Dan Wagner as part of his Ph.D. dissertation studies at the Burrough's site, about 1 mile up the Potomac River from the Loyola Retreat House location. Here the entire cliff, except for some thin, presumed wind-deposited silts at the top, were in a cut terrace of the glauconitic Tertiary Nanjemoy formation.

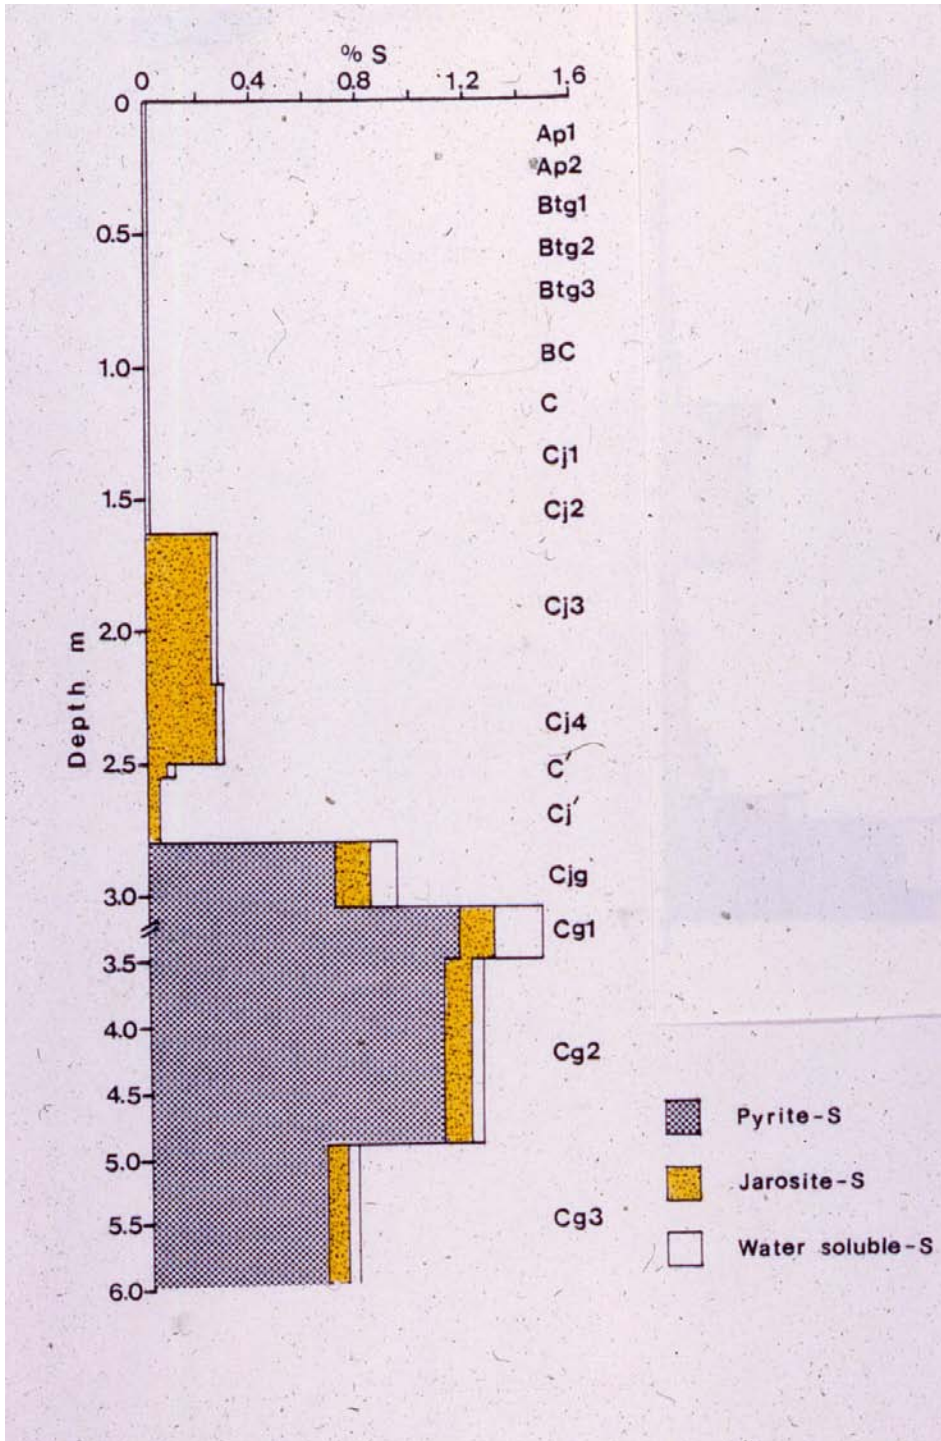
Sulfur forms with depth for profile shown on previous page, after Wagner, Ph.D. dissertation, 1982. Pyrite is present only in un-oxidized zone. Jarosite is retained in post-active zone in lower part of 3m soil. J and soluble sulfate are present in un-oxidized zone because of post-sampling oxidation. Note change in depth scale below the 3.0 meter depth.

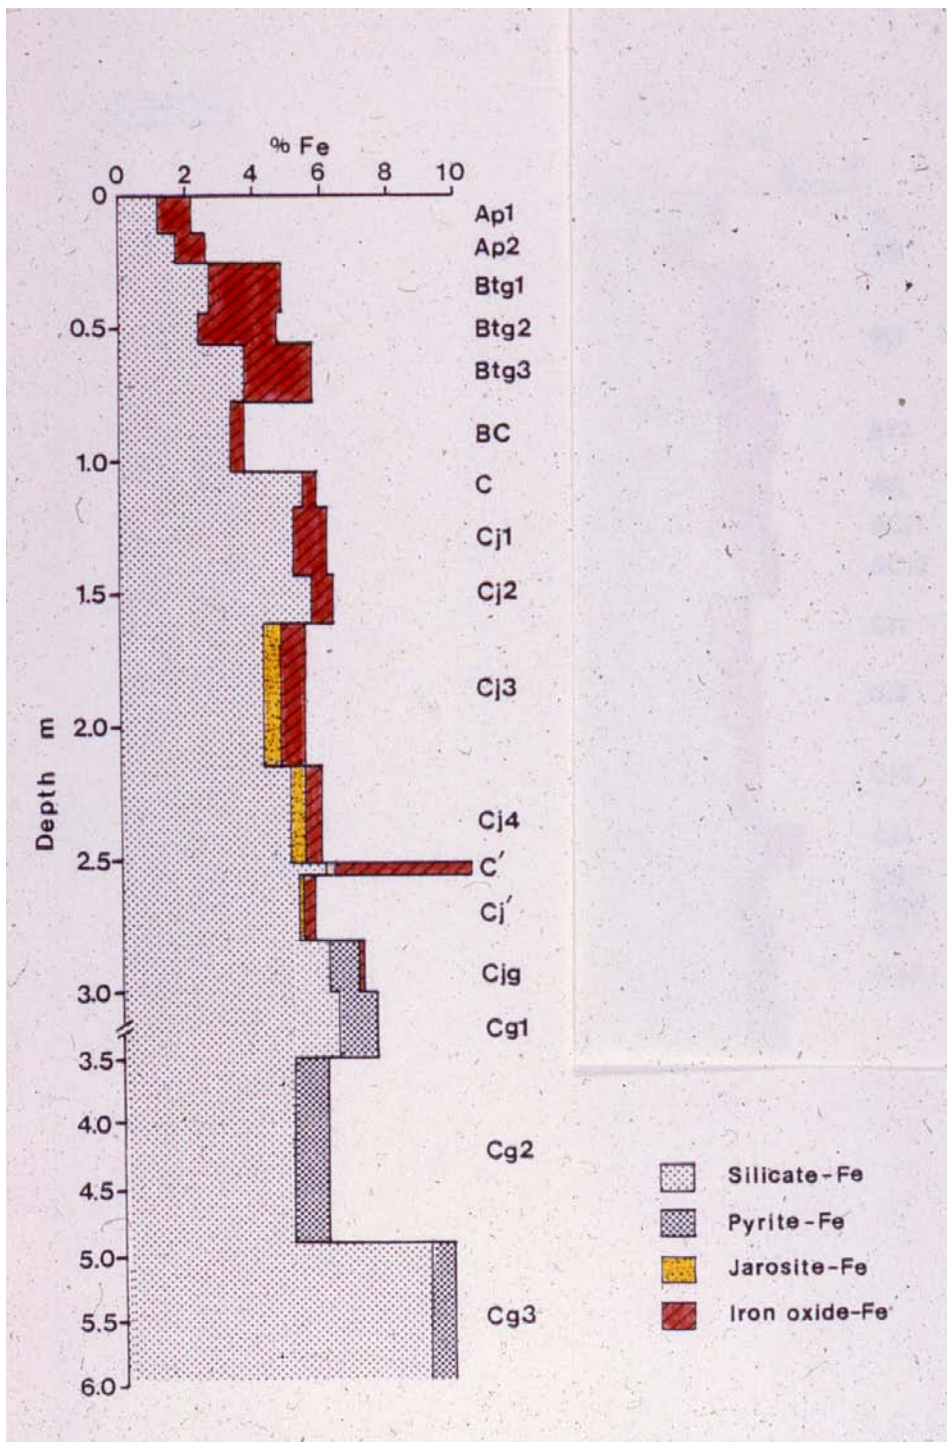
Fe forms with depth in same profile, previous pages, after Wagner, 1982. Silicate Fe, mainly in glauconite, accounts for the biggest share of Fe at all depths. The implication is that the bulk of the Fe of the Fe oxides and jarosite in the oxidized zone came from Fe sulfides in the parent material of these horizons. Note change in depth scale below 3.0 meter depth.

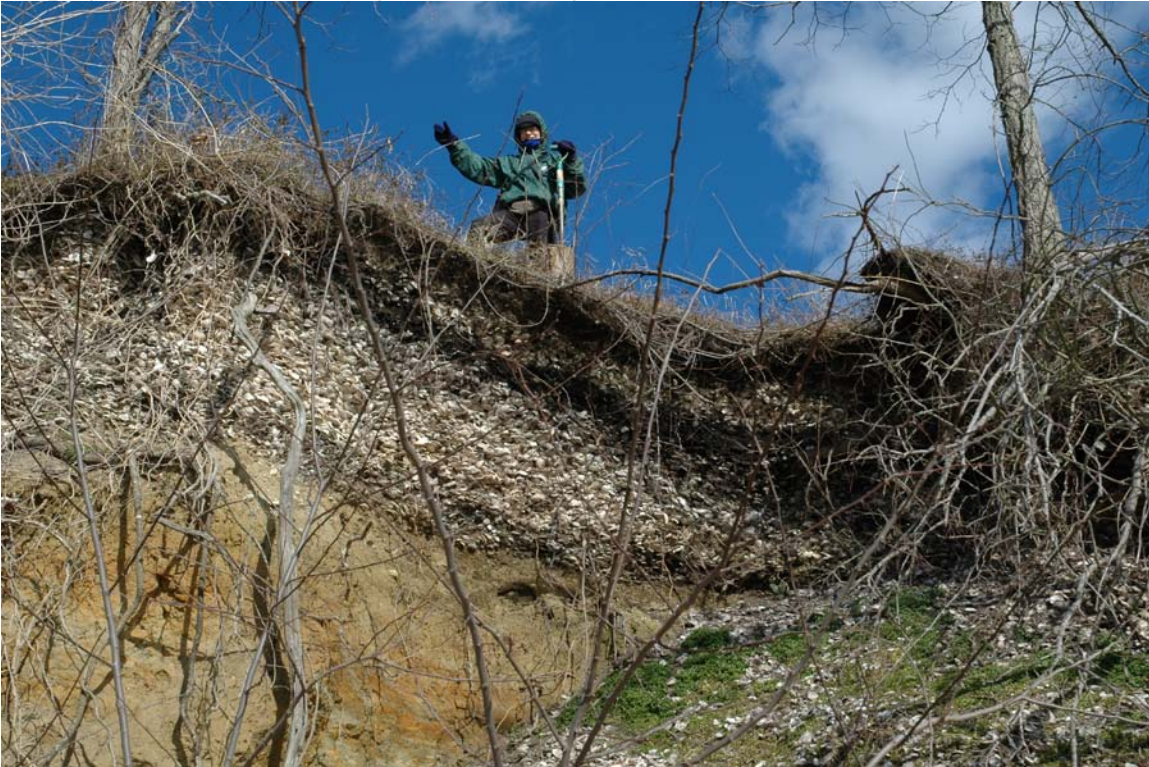
Picture X1. Carol Gordon, (now, 2011, Carol Loopstra) who is a short person, holding a tiling spade (sharp shooter) standing on top of Native American oyster shell kitchen midden exposed on low cliff above tidal Potomac River just a short distance (50 meters) upriver from where the trail from the Loyola Retreat House reaches the river thru a creek valley to the right of where Carol is standing.

One of the points of interest here is a thick Native American oyster shell kitchen midden that can be viewed from below, from the beach, up to where it is exposed at the top of the cliff – see picture X1 on the next page. There are such middens at many places along the tidal Potomac River, but this is one of the thickest that we have seen. It appears to have a buried soil surface with a thick A horizon (probably a buried *anthropic epipedon*) within it – that apparently was followed by another period of shell deposition. A few miles farther down the river, the small present-day village of Morgantown is built on an extensive midden on flat land just a little above sea level. The soils of that midden site have been studied as part of Master's thesis research by former students Jim Luzader (1983) and Ian Kaufmann. Pictures of a soil

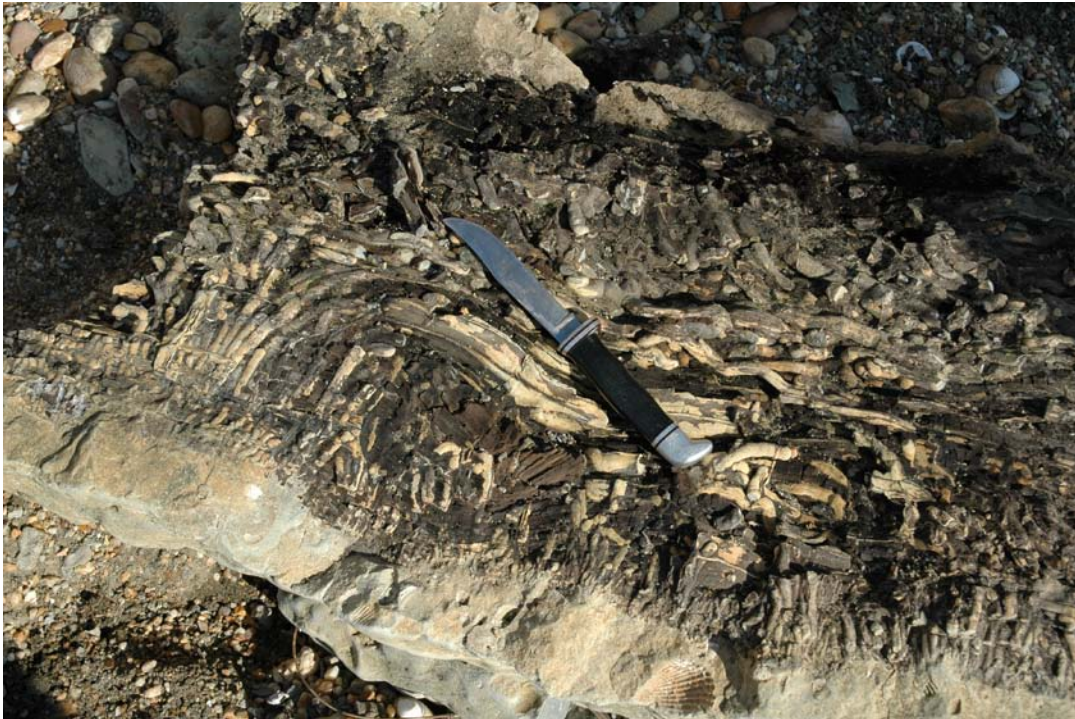
Picture X2. What is interpreted to represent a worm burrowed log, where the burrows have been silicified, from the sediments near the base of the cliff on the Potomac River at the Loyola Retreat House. The surrounding sediments, which contain shells and shell casts are also apparently silicified.

This site will also afford an opportunity to view other parts of the cliff face to see the oxidized vs. un-oxidized parts of the soil-geologic column that are in marine sediments of Miocene (probably Calvert formation) and/or Eocene (probably Nanjemoy formation) age. We are hoping to get out to this site for a further look before we bring the tour group here. One of the interesting features that occurs in the cliff face are what we think are petrified (silicified) tree logs that have petrified worm burrows within them – see the picture, X2, on the following page.

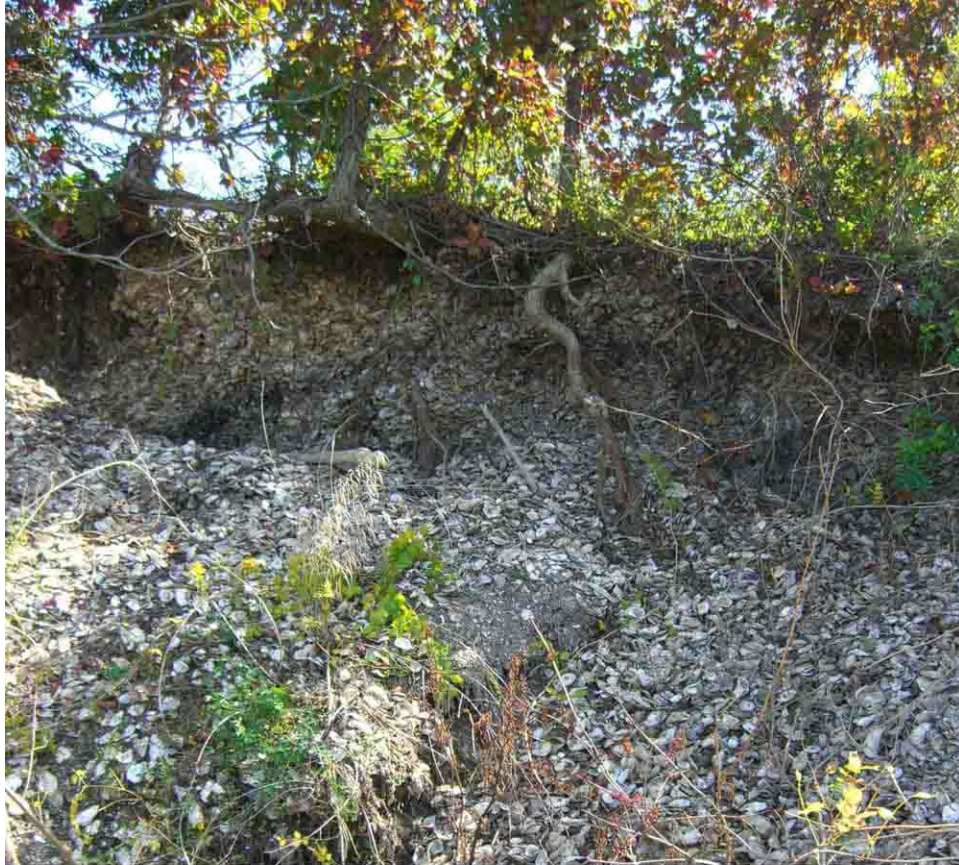
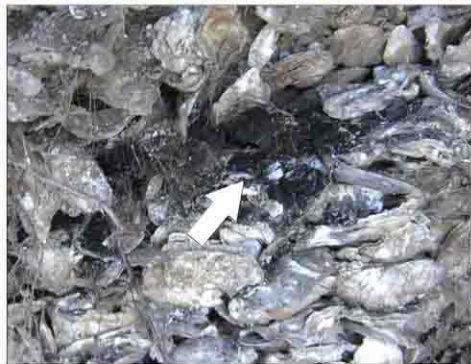
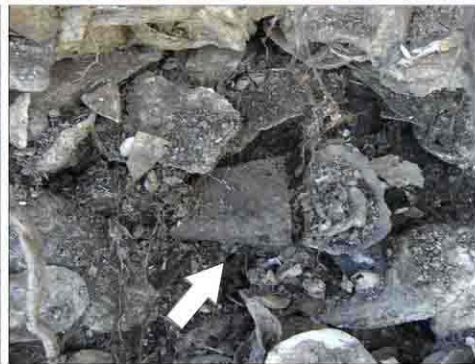
Figure 1. Eroded Shell Midden with Prehistoric Refuse.

A). Charcoal Feature

B). *In Situ* Prehistoric Vessel Fragment

The Popes Creek area has a rich archaeological record. The archaeological record is indicated by the vast quantities of shell that are deposited across the landscape (see Figure 1). These shell deposits represent the refuse from thousands of prehistoric Native American meals that were discarded across the landscape over many millennia. The earliest shell midden debris along this stretch of the Potomac River dates to around 4,000 to 4,500 years ago. As expected, carbonized wood from ancient hearths (see Figure 1A), prehistoric ceramic fragments (see Figure 1B), stone tool chipping debris, damaged projectile points, and other materials have been found within the Popes Creek middens. The impressions on the ceramics (see Figure 2) provide evidence of other perishable materials (i.e., cordage, nets, and other fabrics) that have long since decayed and disappeared from the archaeological record. Some decorations observed on the ceramics show strong humanistic ties. A uniform gouged surface along the rims of some ceramic shards (see Figure 3) may have been created by scratching the surface of the wet clay with a finger nail and finger prints in the clay have also been noted on a few specimens.
