ACID SULFATE SOILS GUIDEBOOK FOR VA/MD MAPSS/VAPSS TOUR, NOV. 4, 2011, IN GENERAL VICINITY OF FREDRICKSBURG, VA

Edited by Del Fanning, DelvinDel@aol.com or dsf@umd.edu

TABLE OF CONTENTS

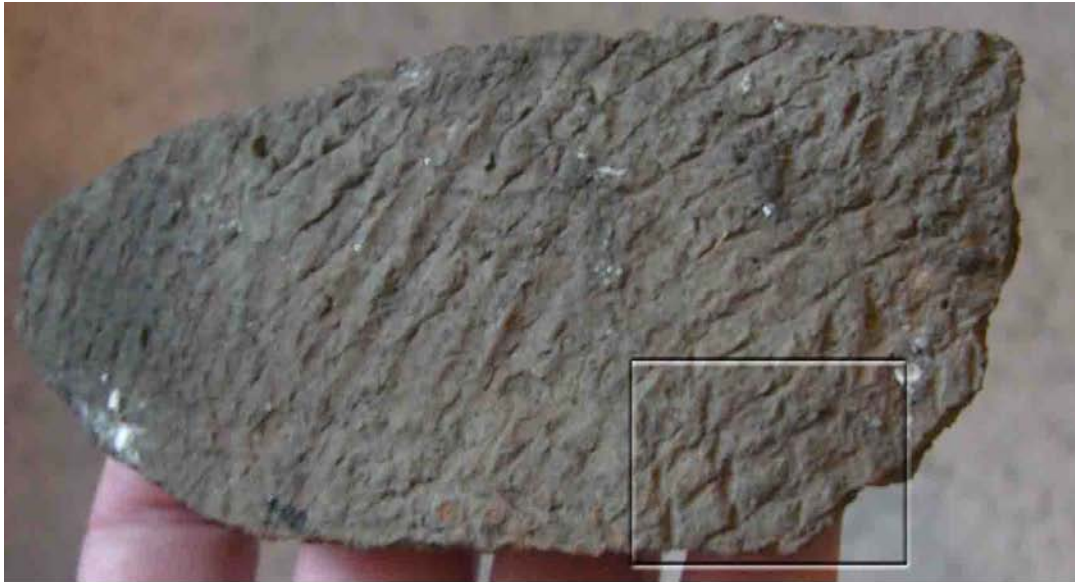
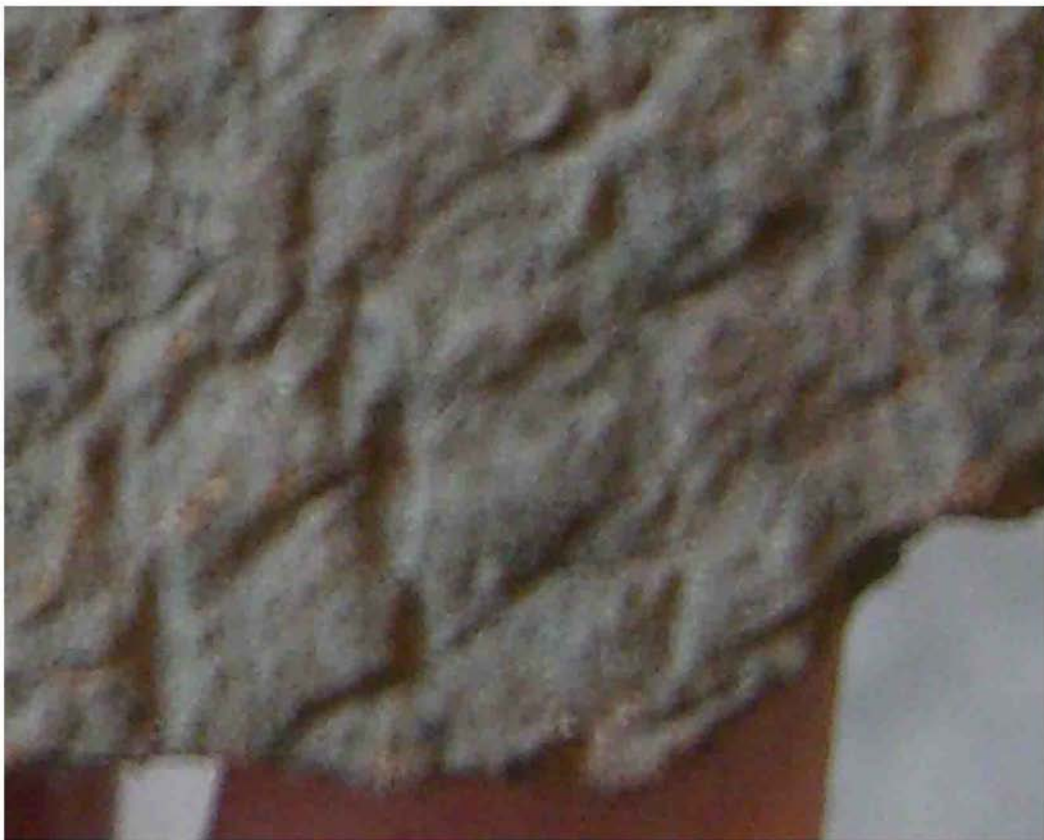
Figure 2. Prehistoric Mockley Type Vessel Fragment with a Net Impression.

Net Impressed Ceramics

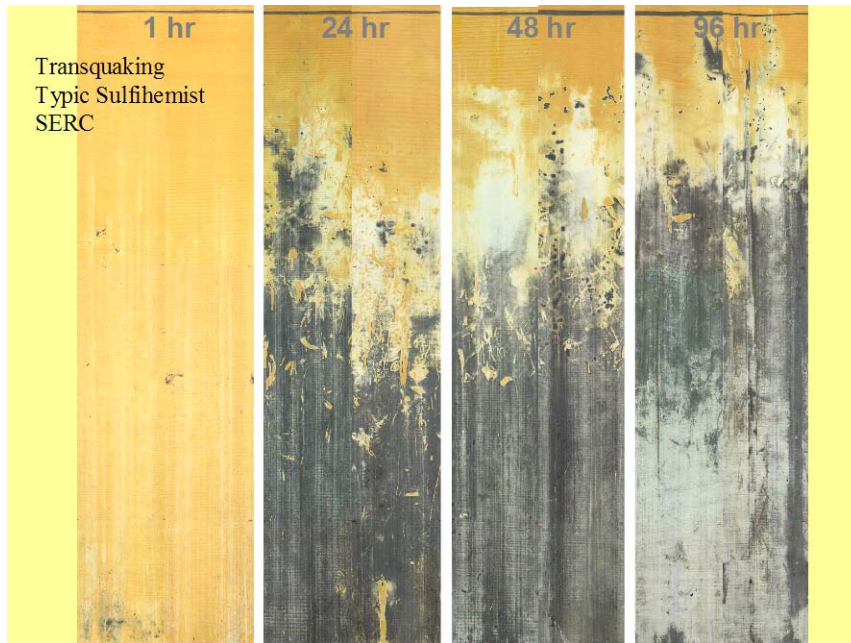
and painted on the tubes are transformed to iron sulfides thru the chemical reduction of the iron, which then reacts with the sulfide to form iron sulfides. We have not been able to find a tidal marsh close enough to the tour route, which is accessible to do this at the time these words are being written, but a place may yet be found. Dr. Rabenhorst, who has been pioneering

Edgewater, MD (Anne Arundel Co.) where the tubes in photo above were inserted for the times indicated to produce the black and white (indicating that that colored materials peeled off the tubes after all the iron oxides had been transformed to iron sulfides. Note that the PVC tubes were about 1 inch in diameter. The soil was a *Typic Sulfihemist*. The vegetation was *Spartina* in the foreground, where the

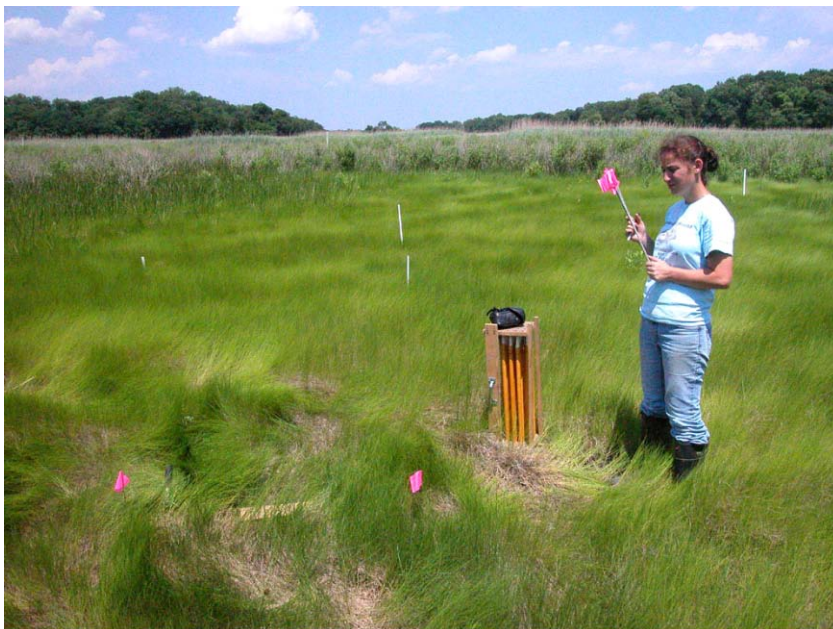
this technology will be available for explanations. The second picture on this page shows the tidal marsh site at SERC, the Smithsonian Environmental Research Center near

tubes were inserted and Phragmites in the background and forest on the hills surrounding the marsh. A reference to work by Rabenhorst and others pertaining to the measurement of sulfide concentrations in pore waters appears below.
