**PRELIMINARY REPORT ON ARCHAEOLOGICAL EXCAVATION AND MONITORING
OF GROUNDWORKS
FOR CONSERVATION WORKS
AT
KILMANMAN CHURCH, CLONASLEE, CO. LAOIS.**

Author: Colm Flynn, Archaeological Consultant, Kilmainham, Mountmellick, Co. Laois

Client: Laois Co Co

Archaeological Licence: 19E0490

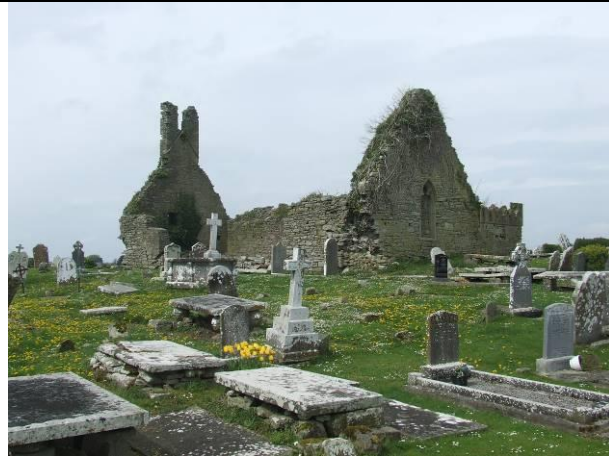
The conservation works for the masonry walls of Kilmanman Church, were proposed to reverse the effects of weathering, erosion, and neglect at the site (see Plate 1). Laois Co Co commissioned David Kelly Partnership CE (DKP) conservation specialists to oversee the works. Sheen Stoneworks (SHE) were appointed to carry out the conservation works.

Plate 1 Showing Kilmanman Church prior to works taking place, facing NW.

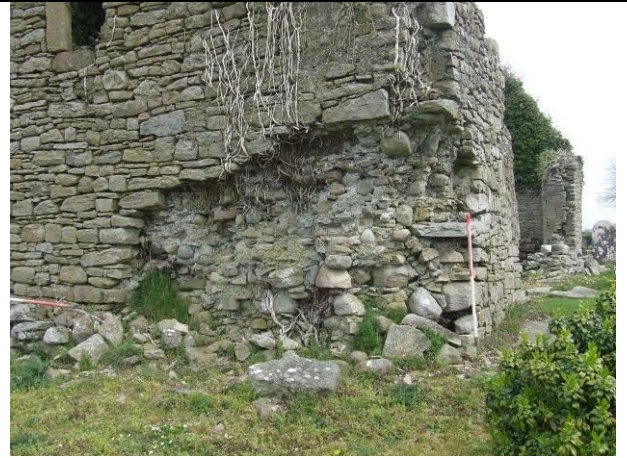
A large section of the west facing elevation of the southern end of gable C02 had previously collapsed (see Plate 2). This collapse undermined the structural integrity of the west gable C02. SHE masons commenced removing the loose stones, mortar and vegetation from the works area at the southern end of the west gable (C02). These stones were rough limestone blocks, cobbles and angular stones. The west gable wall (C02) comprised west and east facing elevations of these stones with a central rubble and lime-mortar core. A decorated stone fragment (19E0490:02:01) was retrieved from the rubble core of the junction between the west gable wall (C02) and the southern long wall (C03). Once the loose material and damaged courses had been removed, the author carried out a small localised excavation (see below for details) through the topsoil (C01) at the southern end of the external side of the west gable wall (C02). This excavation was required to provide an area for a foundation pad for the masonry repairs (see Plate 3). When the excavation was completed the SHE masons laid a foundation pad and commenced rebuilding the west elevation of the wall using the original stones. Some helical ties and steel rods were used to stitch masonry sections together (see Plate 4). No other artefacts were recovered during the masonry repair works to the west gable.

Plate 2 Showing west gable (southern end) prior to repair works, facing east.

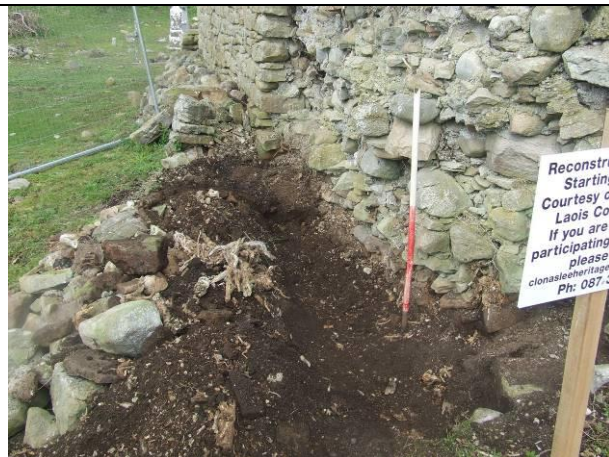
A localised archaeological excavation was carried out at the external side of the southern end of the west gable wall (see Fig 5 and Plate 3). This excavation measured 2m N x S, 0.6m E-W and was 0.1m deep (max). The author marked out the location of this excavation and cleaned back the area. The author carefully excavated topsoil (C05) from the excavation area using hand tools, to a depth of 0.1m. This allowed the masons to construct a foundation pad for the repair and rebuilding of the west gable (C02). No features and no grave cuts were identified within the excavation area in this location. Approximately 40 fragments of disarticulated human bone were recovered from the topsoil (C05) in this

Plate 3 Excavation area at west elevation of west gable, facing north.

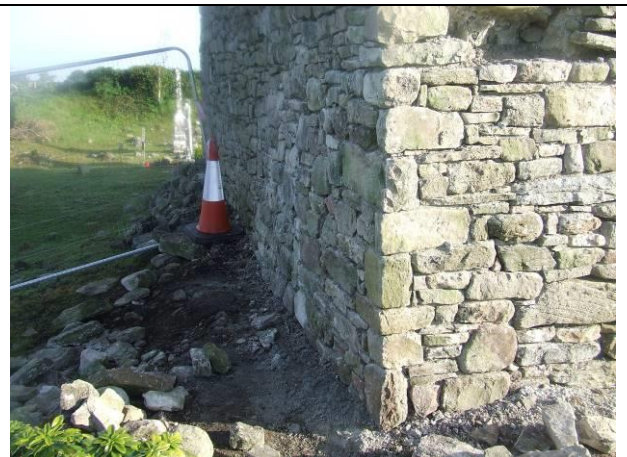
Plate 4 Repaired west gable wall, facing north.

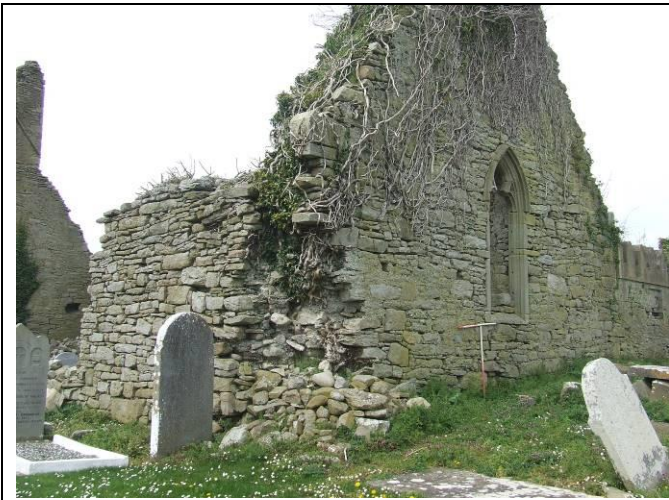
Work on the east gable (C04) then took place. This work focused on the southern end of the east gable where a collapse of this wall had previously taken place (see Plate 5). Several of the quoins from the southern end of the east gable wall had been removed from the collapsed material. SHE masons commenced removing the loose stones, mortar and vegetation from the works area at the southern end of the east gable (C04). These stones were rough limestone blocks, cobbles and angular stones. The east gable wall (C04) comprised west and east facing elevations of these stones with a central rubble and lime-mortar core. A decorated stone fragment (19E0490:04:01) was retrieved from the collapsed material from the southern end of the east gable wall (C04). Once the loose material was removed, SHE masons commenced a rebuilt of the east gable using the loose stones. The rebuild was bonded with lime-mortar mix (see Plate 6). No other artefacts were recovered during the masonry repair works to the east gable.

Plate 5 East gable wall (southern end) prior to repair works.

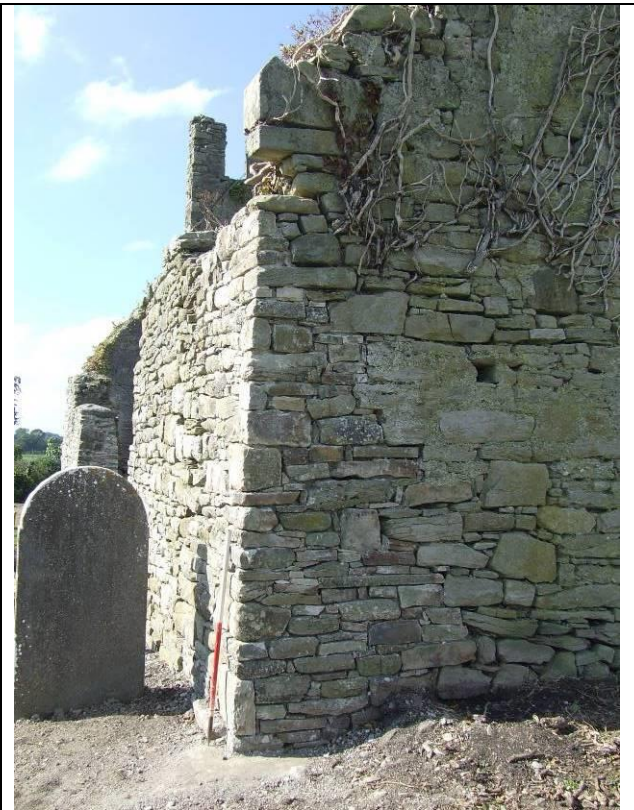
Plate 6 Repaired east gable wall, facing west.

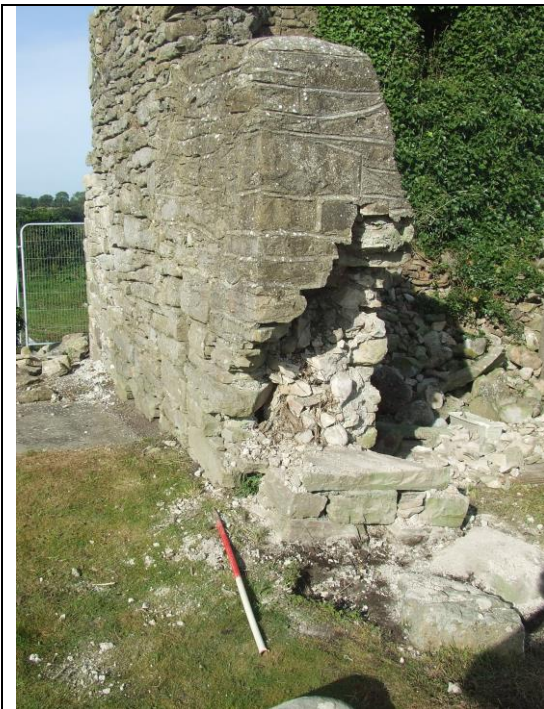
Works for the repair of the bulkhead in the southern wall (C03) commenced with the SHE masons carefully removing the existing bulkhead. This part of the southern wall (C03) had been repaired in 1966 by local workmen. Unfortunately, this work had used concrete mortar to repoint this part of the southern wall, which can damage masonry fabric. A substantial crack had developed to the west of the bulkhead since this repair. The SHE masons removed the loose stones, and concrete mortar from the works area around the bulkhead (C03). Angle grinders were used to 'chase out' the concrete mortar from the bulkhead. Once the loose stones had been removed from the area of the bulkhead, a small localised excavation was carried out by the author (see details below). This excavation was required to provide an area for a foundation pad for the masonry repair works. When the excavation was complete, the SHE masons laid the foundation pad, and reconstructed the bulkhead with the original stones, using natural lime products. Some helical ties and steel rods were used to stitch masonry sections together. The SHE masons then repointed and flanchued the bulkhead with natural lime mortar (see Plate 9).

Plate 7 Bulkhead in southern wall prior to repair.

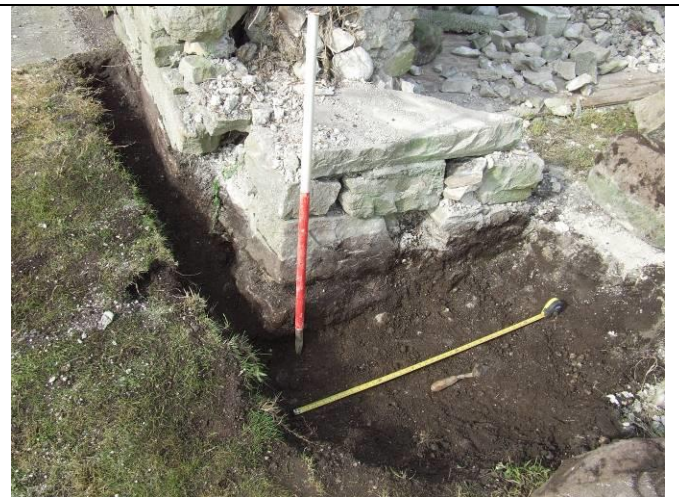
A second localised archaeological excavation was carried out beside the bulkhead part of the southern long wall (C03) (see Fig 5 and Plate 8). This excavation area measured 1.6m N x S, and 2.8m E x W, and was excavated to a maximum depth of 0.3m. The author marked out the area, and used hand tools to excavate the topsoil (C05) within the area. No features or grave-cuts were identified in this excavation area. Approximately 150 fragments of disarticulated human bone were recovered from the topsoil (C05) within this excavation area. The assemblage includes adult cranium, long-bones, and pelvis fragments, as well as finger and toe bones. A clay pipe stem was also recovered from the topsoil (C05) in this excavation.

Plate 8 Excavation area at bulkhead in southern long wall.

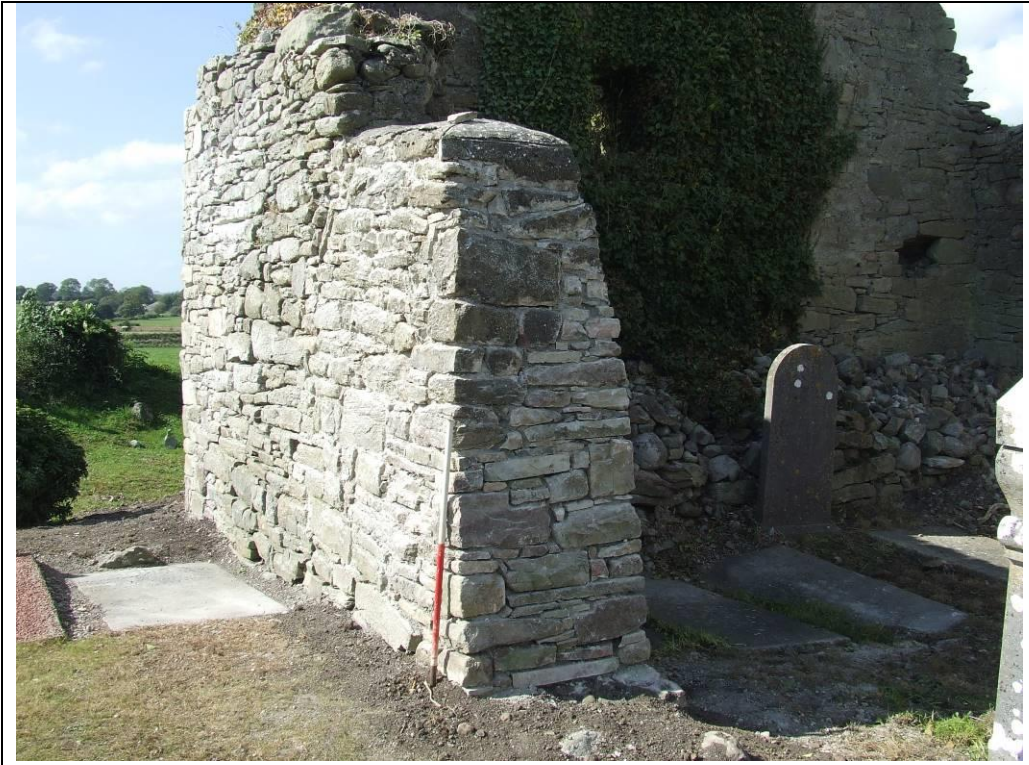
Plate 9 Repaired Bulkhead in southern wall, facing northwest.

Once the excavation was completed the SHE masons constructed the foundation pad and rebuilt and repaired the bulkhead (see Plate 9).
