Department of
Environment and Conservation

Biodiversity values of basic raw material sites within Cape Range National Park

Prepared by
Rachel A. Meissner
DEC Science Division
rachel.meissner@dec.wa.gov.au

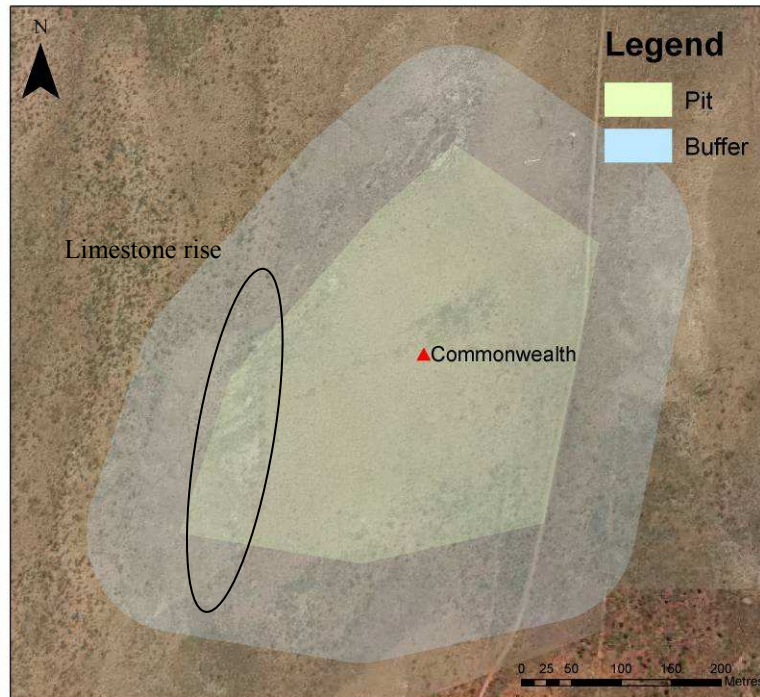
The Commonwealth Pit is located on the northern point of Cape Range (Figure 1) within the northern extent of the Pleistocene red sandplains. The entrance is located approximately 3.7 km west of the intersection of Yardie Creek Road with Murat Road. The site is dominated by sparse shrubland of *Acacia bivenosa*, *Senna glutinosa* subsp. *pruinosa* over mid dense hummock grassland of *Triodia epactia* and *Triodia basedowii* on deep red sands. Towards the western side of the survey area was a small limestone rise covered in a sparse shrubland of *Acacia bivenosa* over dense hummock grassland and shrubland of *Triodia epactia* and *Acacia gregorii*. As the limestone rise progresses south, the vegetation grades into shrubland and hummock grassland of *Acanthocarpus humilis*, *Melaleuca cardiophylla* and *Acacia gregorii*. Towards the southern border of the survey area, the dominant shrubs of *Acacia bivenosa* are replaced with *Acacia tetragonophylla* and *Stylobasium spathulatum*.

Two priority taxa were recorded from this area. A small scattered population of *Eremophila forrestii* subsp. *capensis* (< 10 plants) was located on the low limestone rise (Figure 2). One priority taxa, *Corchorus congener* was also recorded within the survey area.

Figure 2. The proposed excavation site and buffer of the Commonwealth Pit. The low limestone rise is located on the western side of the survey area and is where the priority species, *Eremophila forrestii* subsp. *capensis*, was found.

The site is located adjacent to a large limestone quarry on Defense (Commonwealth) land. This is the site of a proposed large quarry that would be a major source of BRM for Yardie Creek Road maintenance and would minimize the number of borrow pits required within CRNP. This site is suitable and recommended for gravel extraction, however a targeted survey of *Corchorus congener* is recommended to determine the population size and possible impacts prior to any expansion of the pit on or in the vicinity of the limestone rise.

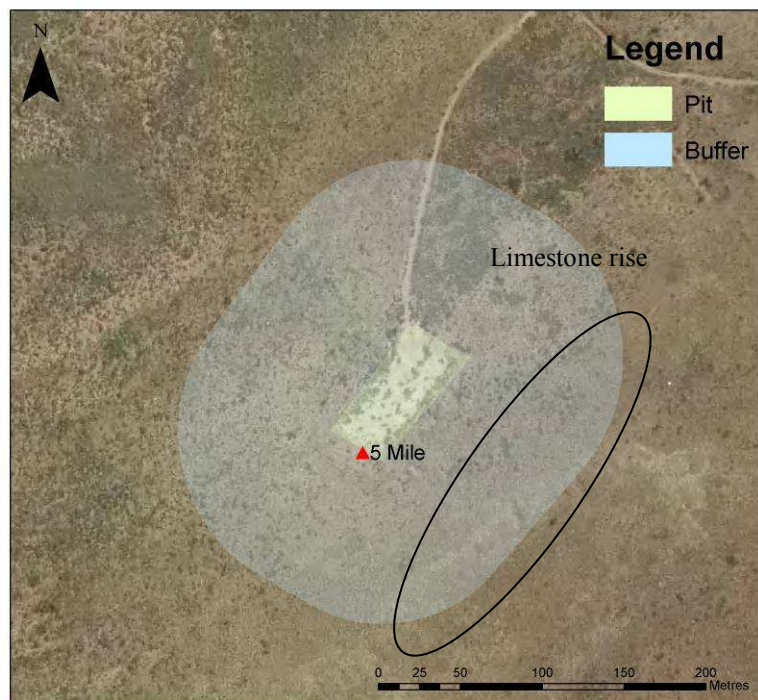
One priority taxa, *Corchorus congener*, was recorded from the low limestone hill.

Figure 3. The existing pit and buffer of Five Mile pit, located outside the national park on UCL.

This location is within UCL and not visible from the road therefore any proposed excavation would be hidden from view. This pit is suitable for gravel extraction for the annual maintenance of Yardie Creek Road. An additional survey is recommended to determine the abundance of *Corchorus congener* and possible impacts on this species should the pit be further developed on or in the vicinity of the limestone rise, otherwise there is no impediment to the expansion of the site.

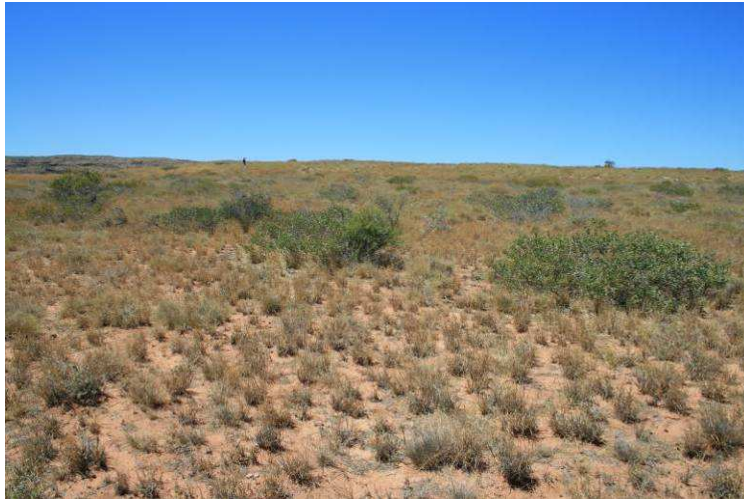
The limestone hill is characterised by an isolated shrubland of *Acacia bivenosa* over mid dense shrubland and hummock grassland of *Indigofera monophylla* and *Triodia wiseana*, while the low coastal plain is described as low very sparse shrublands of *Acacia bivenosa* and *Acacia tetragonophylla* over mid dense hummock and tussock grassland of *Triodia epactia* and *Cenchrus ciliaris* (Figure 4).

Figure 4. Typical vegetation on the plain at Five Mile Pit, low very sparse shrublands of *Acacia bivenosa* and *Acacia tetragonophylla* over mid dense hummock and tussock grassland of *Triodia epactia* and *Cenchrus ciliaris*.

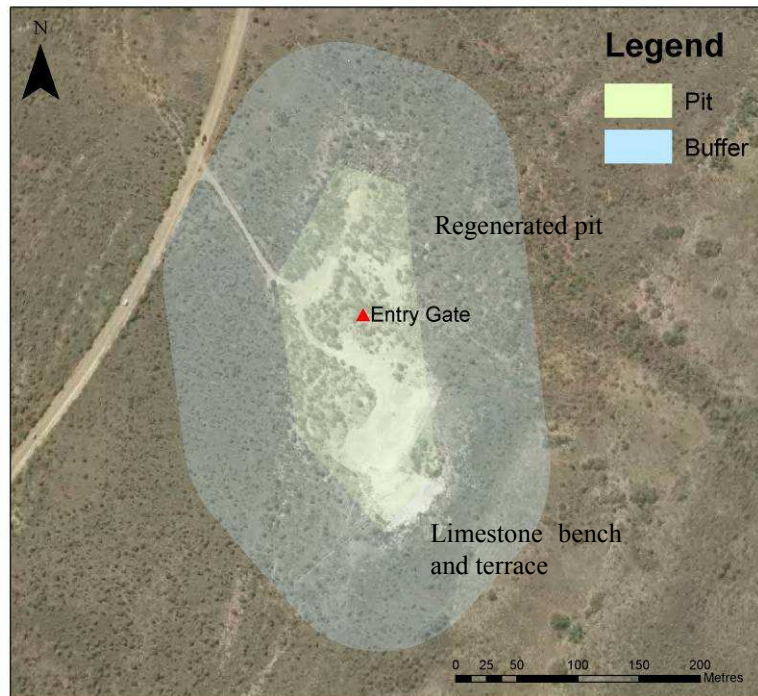
A single priority taxon, *Brachychiton obtusilobus*, was recorded within the buffer area.

Figure 5. The existing pit and buffer of the Entrance Pit. The regeneration area is located northeast of the existing pit. The Yardie Creek Road is visible on the north western edge of the buffer.

Due to the close proximity of the pit to a massive limestone bench, potential karst features could be adversely affected by any further expansion of this pit. In addition, this site is located close to Yardie Creek Road and excavations would be visible to visitors to the national park. The expansion of this pit of a scale required for annual and ongoing maintenance of Yardie Creek Road is not recommended, however small

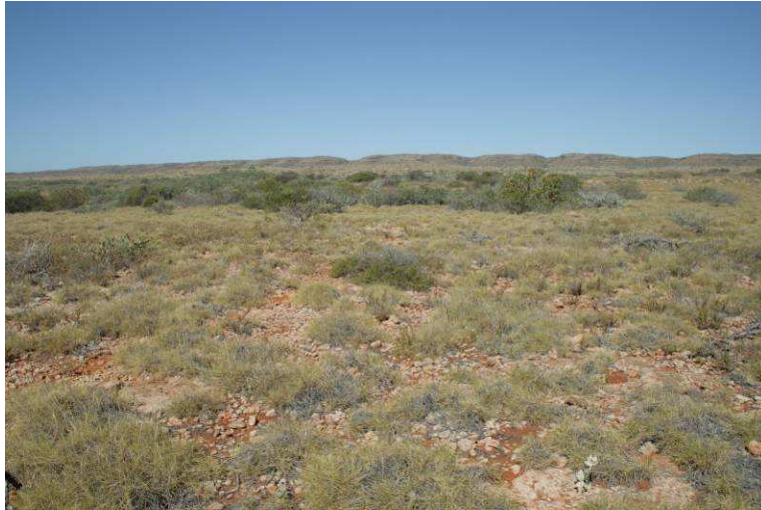
Figure 6. Typical vegetation on the limestone bench at the Entrance Pit.

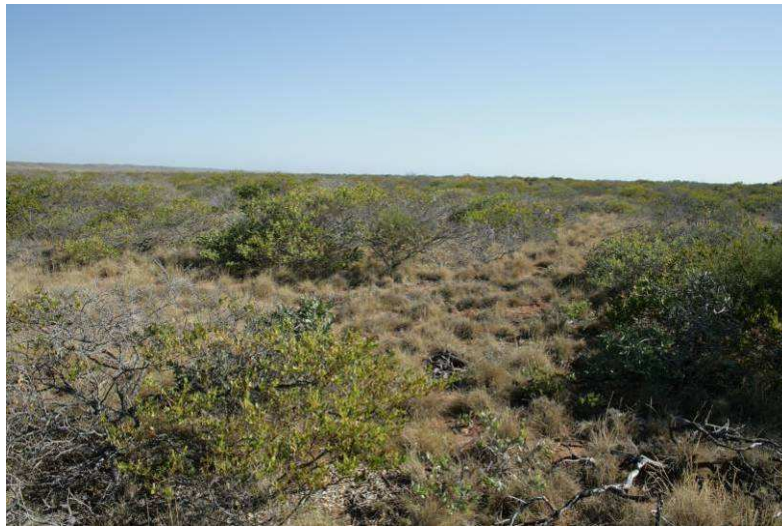
The west of the extant pit is a mixed shrubland of *Acacia bivenosa*, *Alectryon oleifolius* subsp. *oleifolius* over *Triodia basedowii* and occasional shrubs of *Melaleuca cardiophylla* on soft brown sand (Figure 7).

Figure 7. Typical vegetation at the western edge of the Entrance Pit, mixed shrubland of *Acacia bivenosa*, *Alectryon oleifolius* subsp. *oleifolius* over *Triodia basedowii* and occasional shrubs of *Melaleuca cardiophylla*.

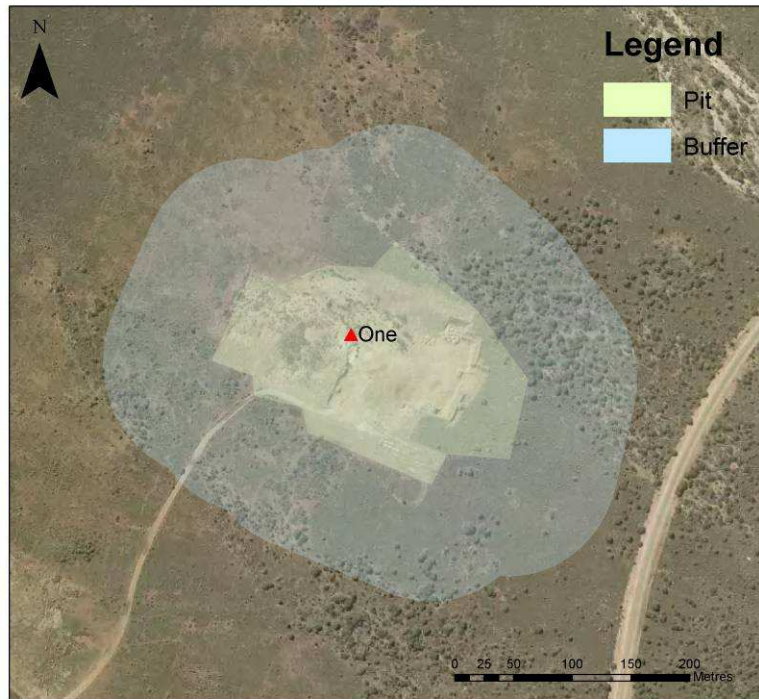
The pit is located approximately 3.8 km south from the park entrance. This site is located close to Yardie Creek Road (Figure 8) on deep sandy loam of the coastal plain. This pit corresponds to Pit One in Keighery (1996). It is a large open pit with the south western and western side dominated by Buffel grass and *Atriplex* spp. The vegetation of the remaining buffer area is characterised as open shrubland of *Acacia bivenosa* and *Acacia tetragonophylla* over a hummock grassland of *Triodia epactia* and a tussock grassland of Buffel (Figure 9). The cover of shrubs is greater towards the eastern side of the pit. *Brachychiton obtusilobus*, a priority four taxon, was recorded on the northern eastern side of the pit within the dense shrublands of *Acacia bivenosa*.

Figure 8. The extant pit and buffer of Pit One. The Yardie Creek Road is visible to the east of the pit.

Currently, this pit is being used for the storage of road base and other material for use within the national park. Ongoing extraction and future expansion of a scale required for the annual maintenance of Yardie Creek Road is not recommended as works within the pit would impact on the view shed from Yardie Creek Road and be highly visible to visitors of the national park. However, small scale taking of gravel for park management purposes would be suitable as long as there is no further clearing and no additional visual impact.

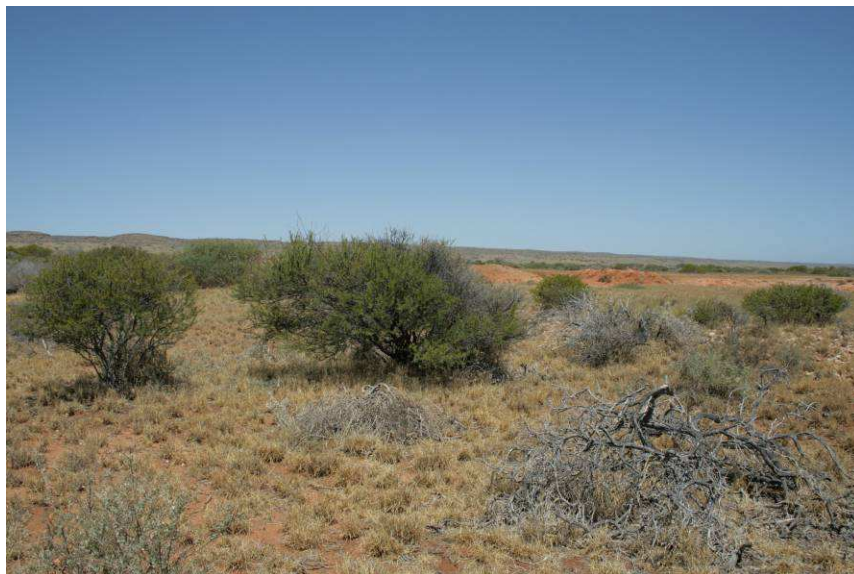
Figure 9. Vegetation on the northern side of Pit One, with *Acacia tetragonophylla* in the foreground over tussocks of Buffel. In the background, the existing wall of the pit is visible.

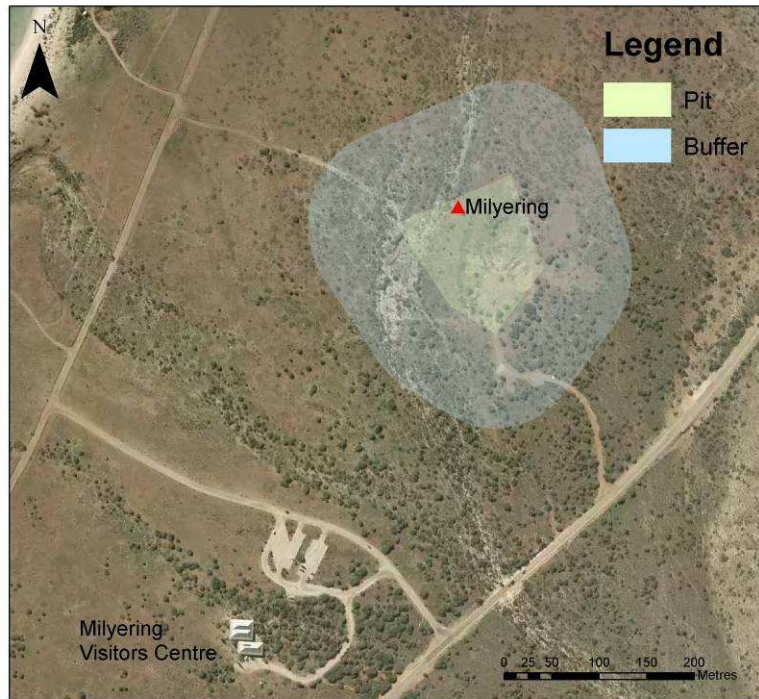
This pit is located 250 m northeast of the Milyering Visitors Centre and is currently used as a storage, equipment lay down and waste management site by DEC (Figure 10). The extant pit is situated on the coastal plain, and is surrounded by shrublands of *Acacia bivenosa* and *Acacia tetragonophylla* over an open hummock grassland of *Triodia epactia* and tussock grassland of Buffel (Figure 11). The northern side of the pit has extensive degraded areas of dead *Acacia bivenosa* and abundant Buffel. A creek line dominated by *Triodia angusta*, a hummock grass commonly found within drainage channels occurs on the western side.

Figure 10. The extant pit and the buffer of the Milyering Pit. The Milyering Visitors Centre is located south west of the pit and any extraction would be highly visible to visitors of the national park.

required for the annual maintenance of Yardie Creek Road is not recommended. However small scale taking of gravel for park management purposes would be suitable as long as there is no further clearing and no additional visual impact

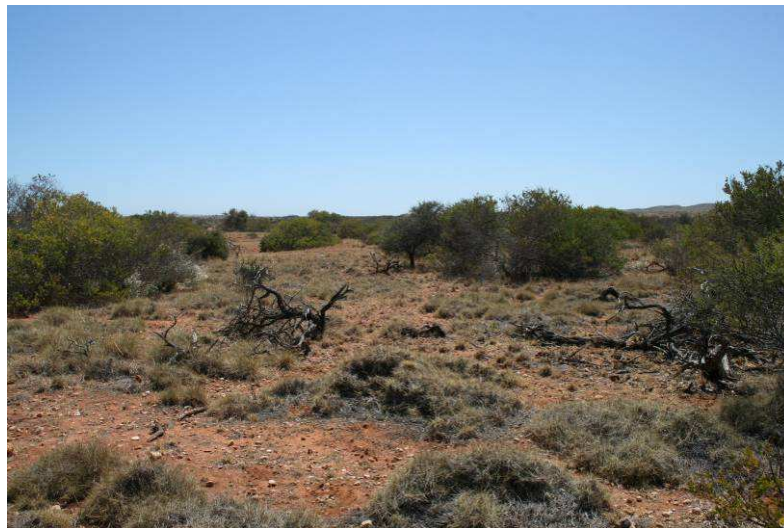
Figure 11. Typical vegetation surrounding the existing Milyering pit.

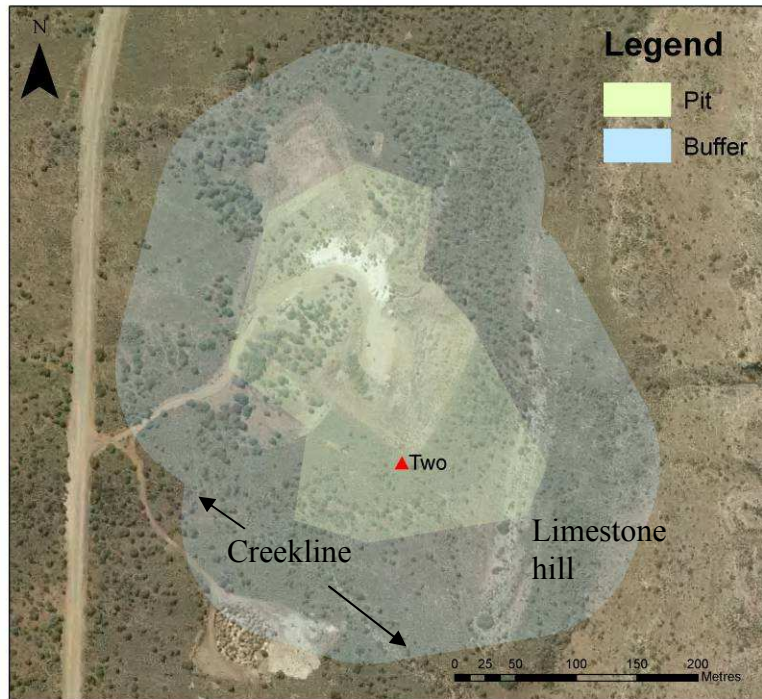
A scattered population of *Eremophila forrestii* subsp. *capensis* was present within the survey area, mainly located along the drainage channel to the south of the main pit and on the limestone hill.

Figure 12. The extant pit and buffer of Pit Two. The survey was extended towards the creekline as part of the proposed expansion of the pit. Yardie Creek Road is visible to the west of the pit.

Gravel extraction close to the massive limestone terrace to the east of the borrow pit could affect potentially karst features and contaminate the groundwater system. In addition, this site is highly visible from the road and any extraction and further development of a scale required for the annual maintenance of Yardie Creek Road would be visible to the public, and is therefore not recommended. However small scale taking of gravel for park management purposes would be suitable as long as there is no further clearing and no additional visual impact.

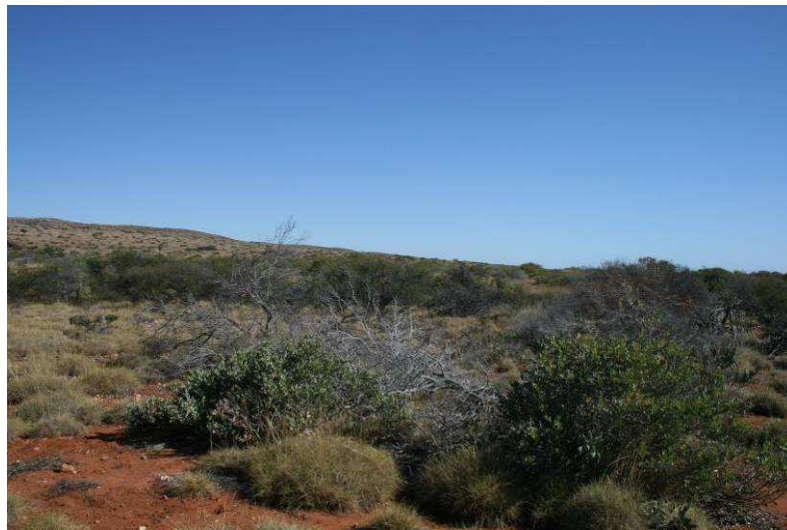
The low limestone hill surveyed to the south was characterised by sparse shrubland of *Acacia bivenosa*, *Acacia tetragonophylla* and *Alectryon oleifolius* subsp. *oleifolius* over shrubland of *Diplopeltis eriocarpa* and *Acacia arida* over hummock grassland of *Triodia wiseana*.

Figure 13. Main vegetation at Pit Two, shrubland of *Acacia bivenosa* over hummock grassland of *Triodia wiseana*.

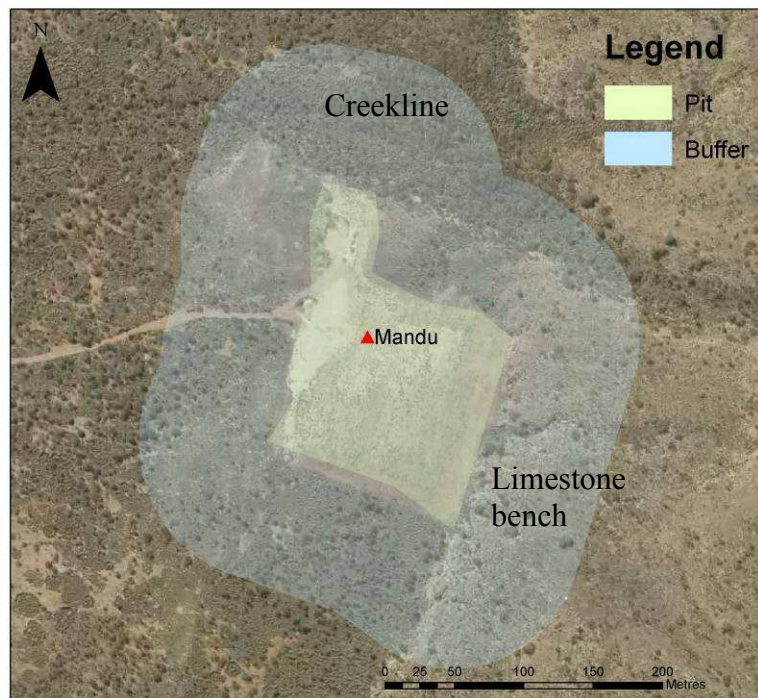
Four priority taxa, *Brachychiton obtusilobus*, *Grevillea calcicola*, *Tinospora esiangkara* and *Eremophila forrestii* subsp. *capensis*, were collected from the creek line. The vegetation is in good condition with only a small area supporting Buffel.

Figure 14. The extant pit and buffer of Mandu pit . The creek line, where several priority taxa were located, is north of the pit and the limestone bench on the eastern side.

The proximity of the pit to limestone terraces and possible encroachment into karst features and the high biodiversity values of the site may present an unacceptable risk to ongoing and future use of this BRM source. It is recommended that the Mandu site not be used for any BRM extraction, either of a large scale extraction for the annual

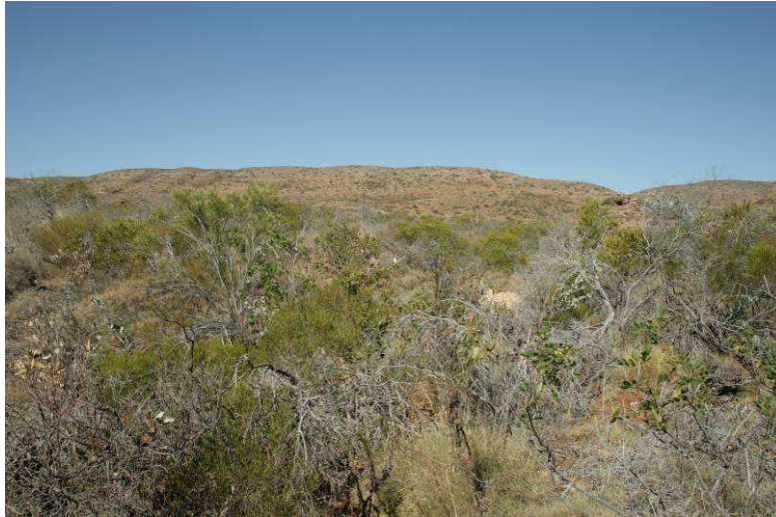
Figure 15. Dense vegetation in the creekline within the buffer zone adjacent to the Mandu Pit.

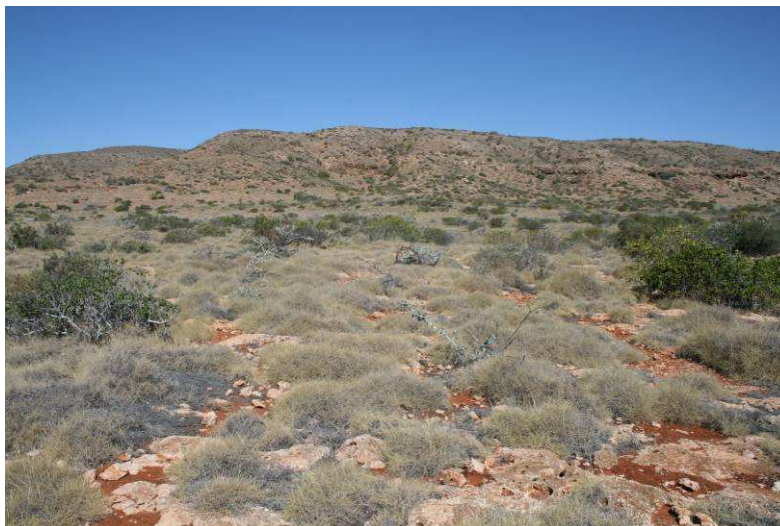
The limestone terrace has elements represented of the massive tertiary limestones of Cape Range (Keighery & Gibson 1993). The terrace is charactered by a shrubland of *Ficus brachypoda*, *Acacia pyrifolia*, *Grevillea variifolia* subsp. *variifolia* and *Ipomoea costata* over hummock grassland of *Triodia wiseana* (Figure 16).

Figure 16. Vegetation on the limestone terrace adjacent to the Mandu Pit. The main range can be seen in the background.

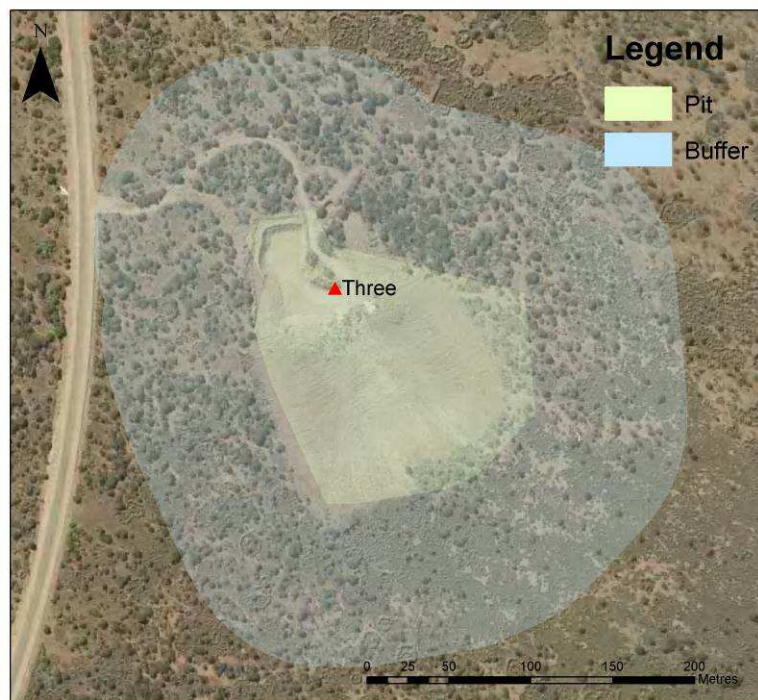
Figure 17. The extant pit and buffer of Pit Three. Yardie Creek Road is visible on the western side of the buffer.

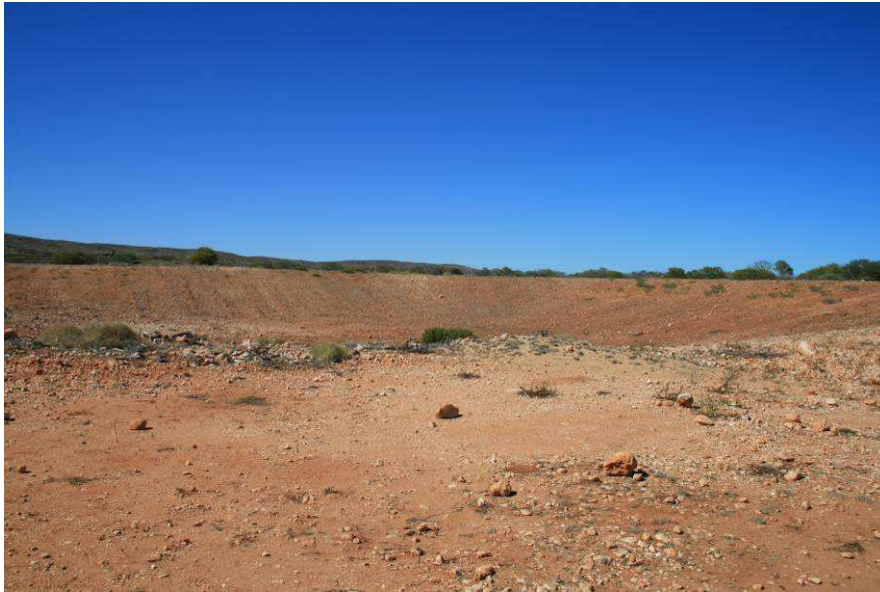
This pit is located approximately 17.5 km south of the Milyering Visitors Centre. The appearance of Pit 3 is similar to that of an amphitheatre, with previous BRM extraction extending quite deep (Figures 17 & 18). The pit is located on the coastal plain and is characterised by open shrubland of *Acacia bivenosa* and *Acacia tetragonophylla* over hummock grassland of *Triodia epactia* and tussock grassland of Buffel (Figure 19). The vegetation is in reasonable condition. Four to five trees of *Brachychiton obtusilobus* are within the immediate vicinity of the old pit but all were in poor condition.

Figure 18. The appearance of Pit 3 at the time of the survey, resembling an amphitheatre.

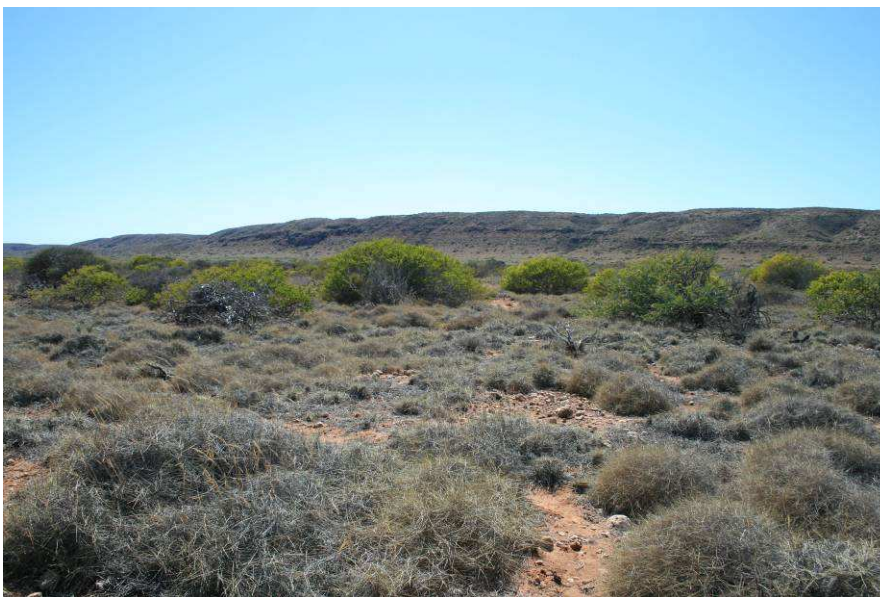
Figure 19. The dominant vegetation surrounding Pit 3.

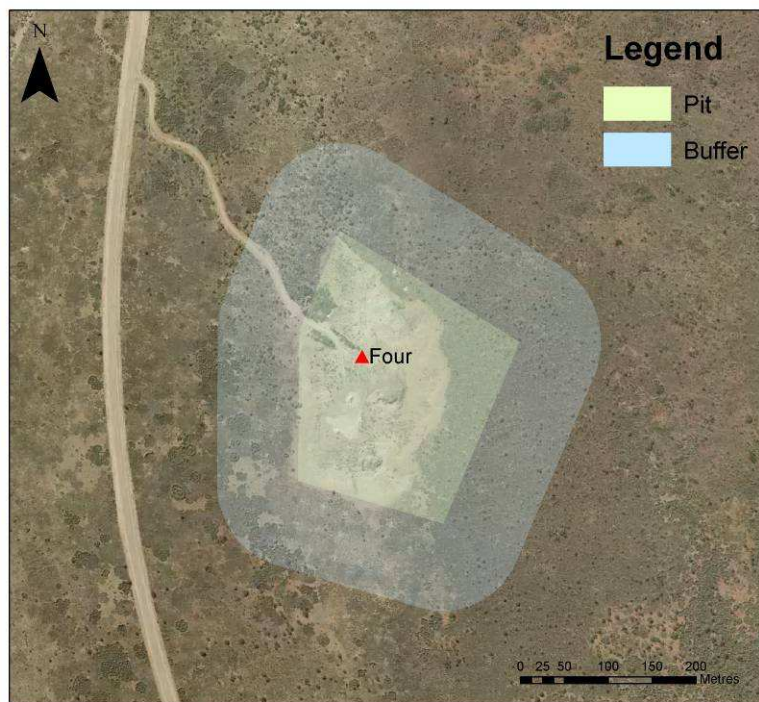
This pit is located approximately 27 km south of the Milyering Visitors Centre. The pit corresponds to Pit Six of Keighery (1994) and the vegetation is consistent with that report. The pit is located on the coastal plain and characterised by a sparse shrubland of *Acacia bivenosa* over *Olearia dampiera* subsp. *dampiera* ms over open hummock grassland of *Triodia epactia* (Figures 20 & 21).

Figure 20. The extant pit and buffer of Pit Four. Yardie Creek Road is visible on the western side of the buffer.

No Priority flora were found within the 100 m buffer zone. This pit is located close to the road and further excavations will possibly be visible to the public. If possible, future excavation could be conducted behind the low rises on the coastal plain which would block the activity from the view shed of the road. This pit is suitable for extraction of a scale required for the annual maintenance of Yardie Creek Road as well as for park management purposes.

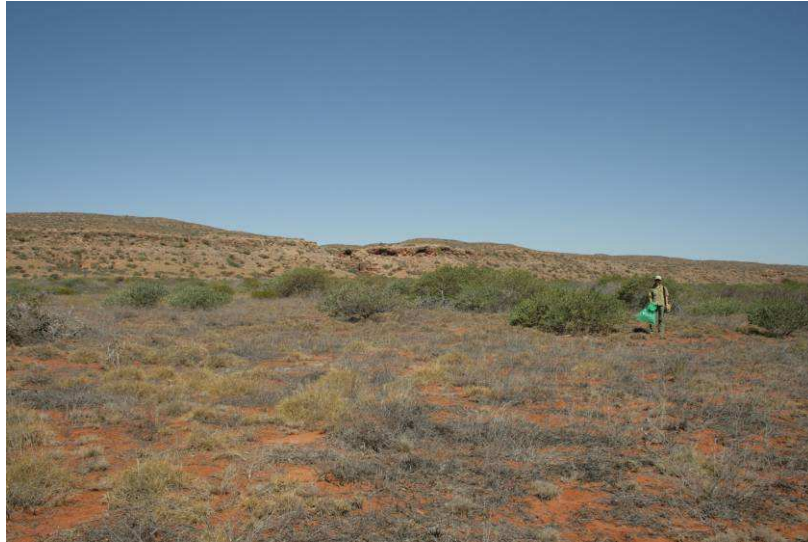
Figure 21. The dominant vegetation surrounding Pit 4 is characterised as sparse shrubland of *Acacia bivenosa* over *Olearia dampiera* subsp. *dampiera* ms over open hummock grassland of *Triodia epactia*.

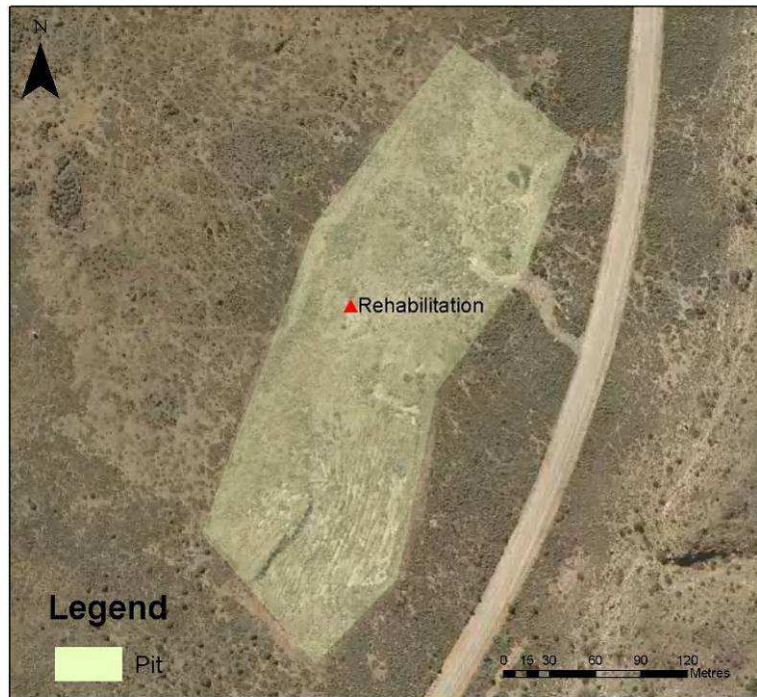
This is a disused BRM site located close to the Yardie Creek Road (Figure 22), approximately 3.5 km northeast of Yardie Creek camp site. This site corresponds to Pit 7 Seven in the Keighery (1996) report (Table 1). The vegetation in the buffer is characterised as hummock grassland of *Triodia epactia* and a tussock grassland of Buffel under scattered shrubs of *Acacia arida* and *Indigofera monophylla*.

Figure 22. The Rehabilitation Pit adjacent to Yardie Creek Road.

Since this site has been rehabilitated and due to its proximity to the road, further expansion or extraction is not recommended .
