A Desktop Assessment and Field Survey of the  
Vegetation and Conservation-listed Flora within Proposed  
Gravel Pit Expansions in Karijini National Park.

Adrienne Markey<sup>1</sup> and Steven Dillon<sup>2</sup>

1: Ecosystem Science Program, Biodiversity and Conservation Science,  
Keiran McNamara Conservation Science Centre

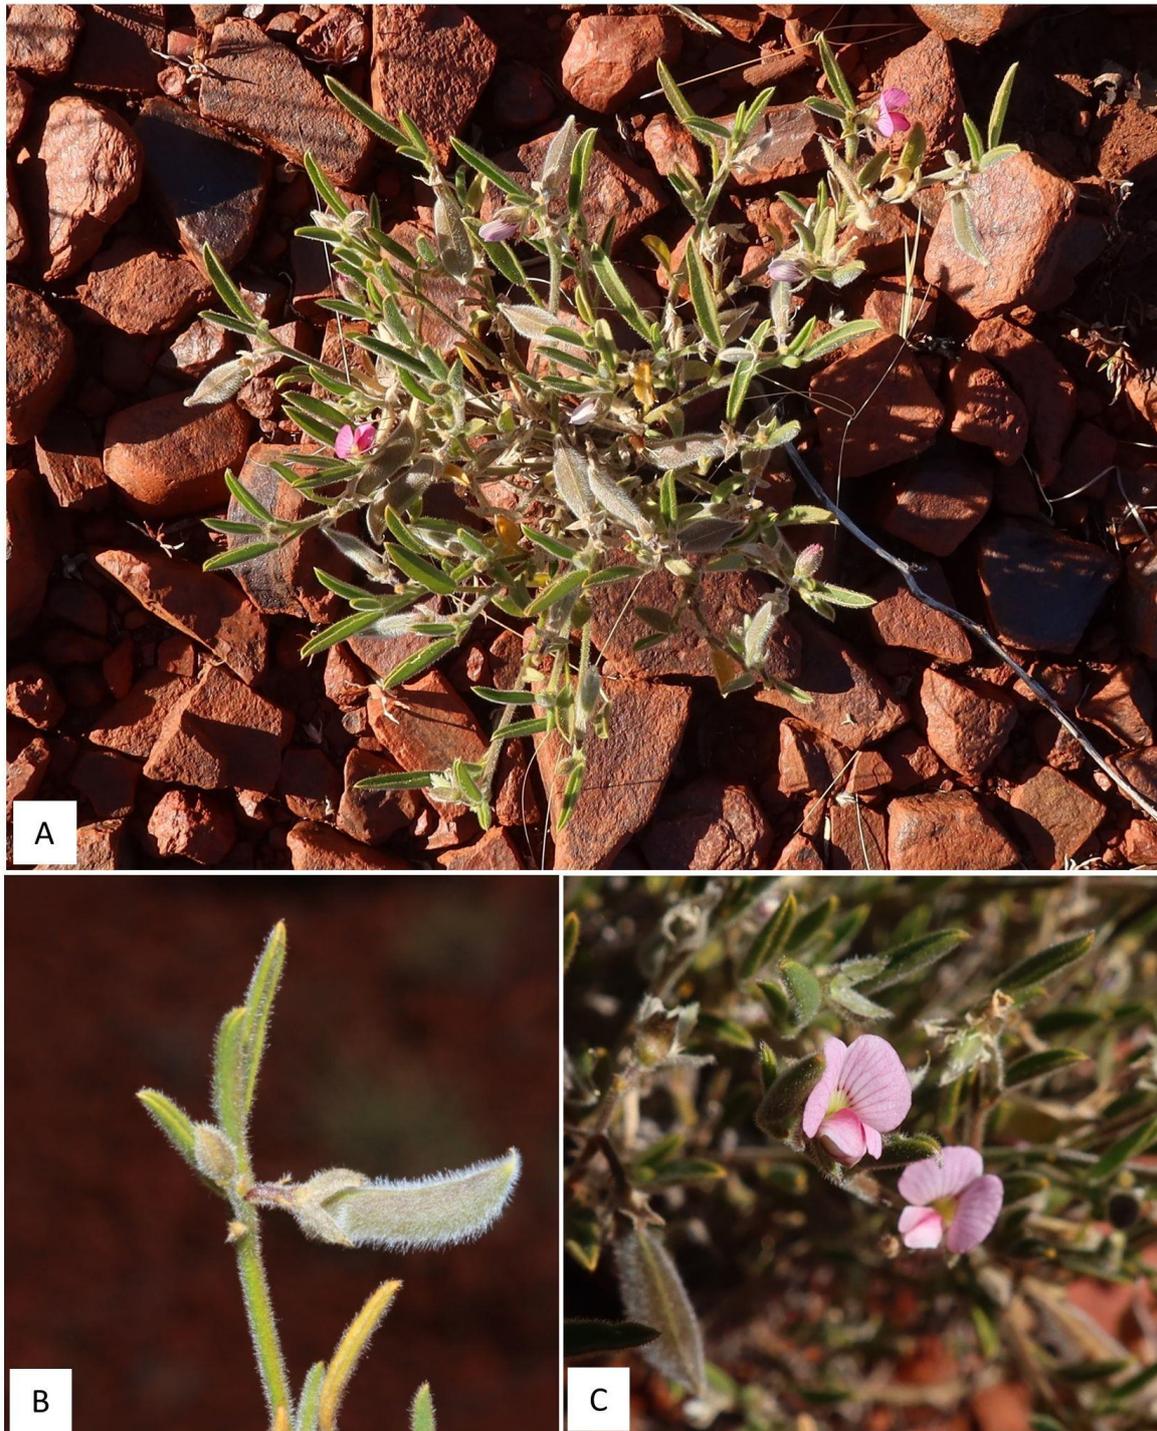
Figure 2.1.1. *Isotropis parviflora*, showing A: subshrub habit B: mature pod and C: flowers.

*Isotropis parviflora* (Fabaceae) is a short-lived (annual or perennial), compact subshrub 10–30 cm tall with pink flowers, unifoliate leaves, an indumentum of ascending to spreading hairs, and pods with characteristically laterally-compressed bases (S. Dillon per. obs) (Figure 2.1.1) (Bailey 1899). *Isotropis parviflora* was the most frequently encountered conservation-listed taxon in the overall survey, with a total of 268 plants counted over 6 survey polygons (Table 3.1). Four proposed pit expansion areas had only a few plants, but pits SLK8A and 8B had high counts of

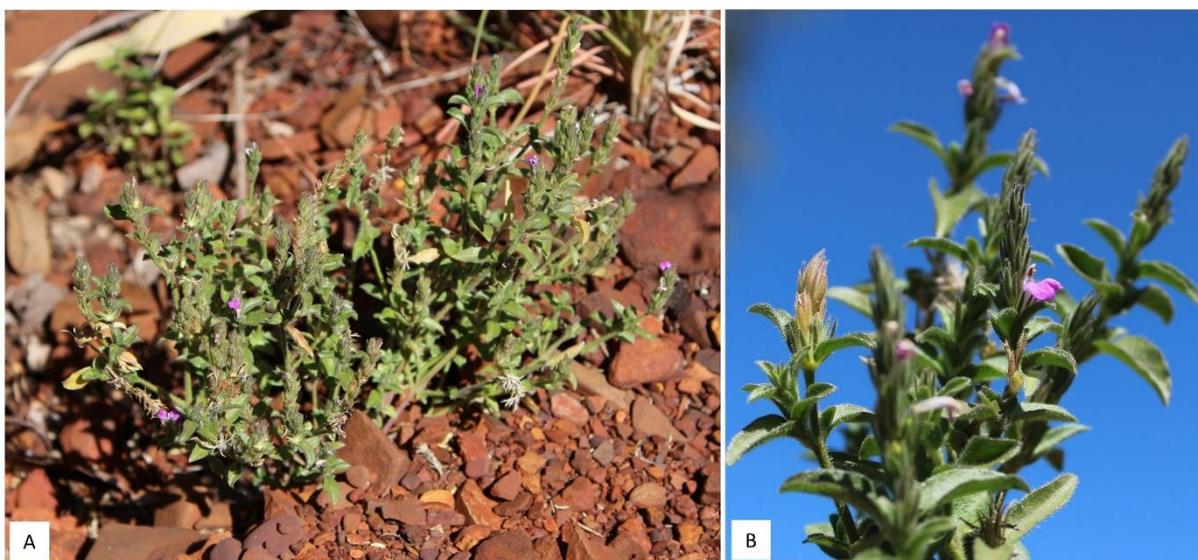
Figure 2.1.2: *Rostellularia adscendens* var. *latifolia* A: Habit and B: detail of inflorescences.

*Rostellularia adscendens* var. *latifolia* (Acanthaceae) is a small decumbent to erect shrub with pink flowers (Barker 1986). It is distinguished from *Rostellularia adscendens* var. *clementii* by having a moderately dense indumentum of long, spreading hairs on the stems (as opposed to a very sparse indumentum of short hairs), and by the shape of the floral bracts and the occurrence of eglandular hairs on the central portion of the bracts (S. Dillon pers. obs). A total of 8 plants of *Rostellularia adscendens* var. *latifolia* were located from the one creekline immediately adjacent to gravel pit expansion site SLK51 (see Section 3.4). Plants were found growing in gravelly, bare creekbed channels which had been scoured from previously flows. Plants ranged in height from 10–15 cm, and were found in fruit and flower (Figure 2.1.2).

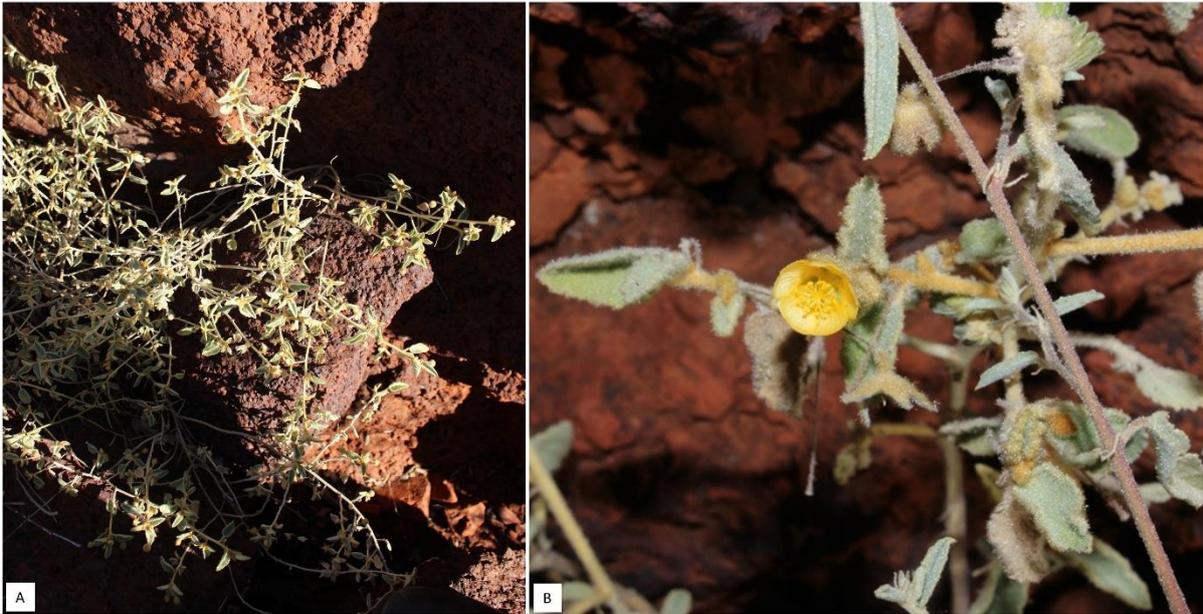
Figure 2.1.3: *Sida* sp. Barlee Range (*S. van Leeuwen* 1642). A: Habit and B: detail of flower and foliage.

One individual of *Sida* sp. Barlee Range (S. Van Leeuwen 1642) (Malvaceae) is a subshrub to 1 m, intricately branched, with a densely woolly-velvety hairy indumentum, ovate leaves with crenate margins, yellow flowers and fruits with 6-8 mericarps. It is characterised by a combination of characters including glabrous mericarps and a mericarp number exceeding 5 (from Barker 2007). This taxon was located in a rocky gully of weathered laterised ironstone adjacent to gravel pit expansion area SLK17 (see Section 3.5). This individual wasn't located growing on gravel pit substrates and associated habitat, but on skeletal loam soils on exposed bedrock in a rocky gully adjacent to the site (Figure 2.1.3) (see Section 5.5). The size of this population in the gully is unknown but unlikely to be more than a few scattered individuals. Although outside of the proposed pit expansion area, plants could be affected by excavation activities if these affect the gully or if Buffel Grass spreads from the pit area.

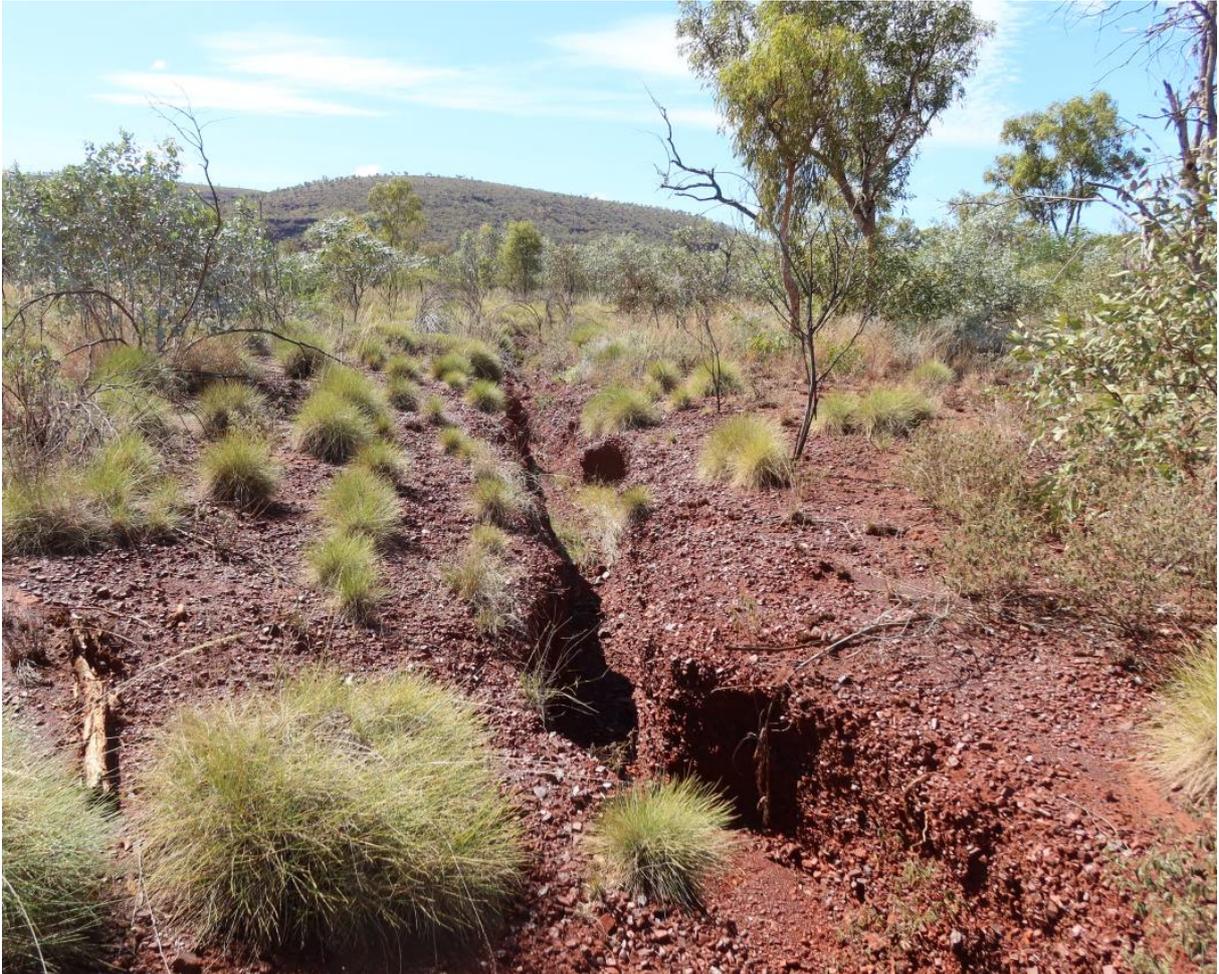
*Figure 5.1.8: A narrow channel on the northern margin of SLK2 and which has been eroded into a deep, narrow gully by runoff.*

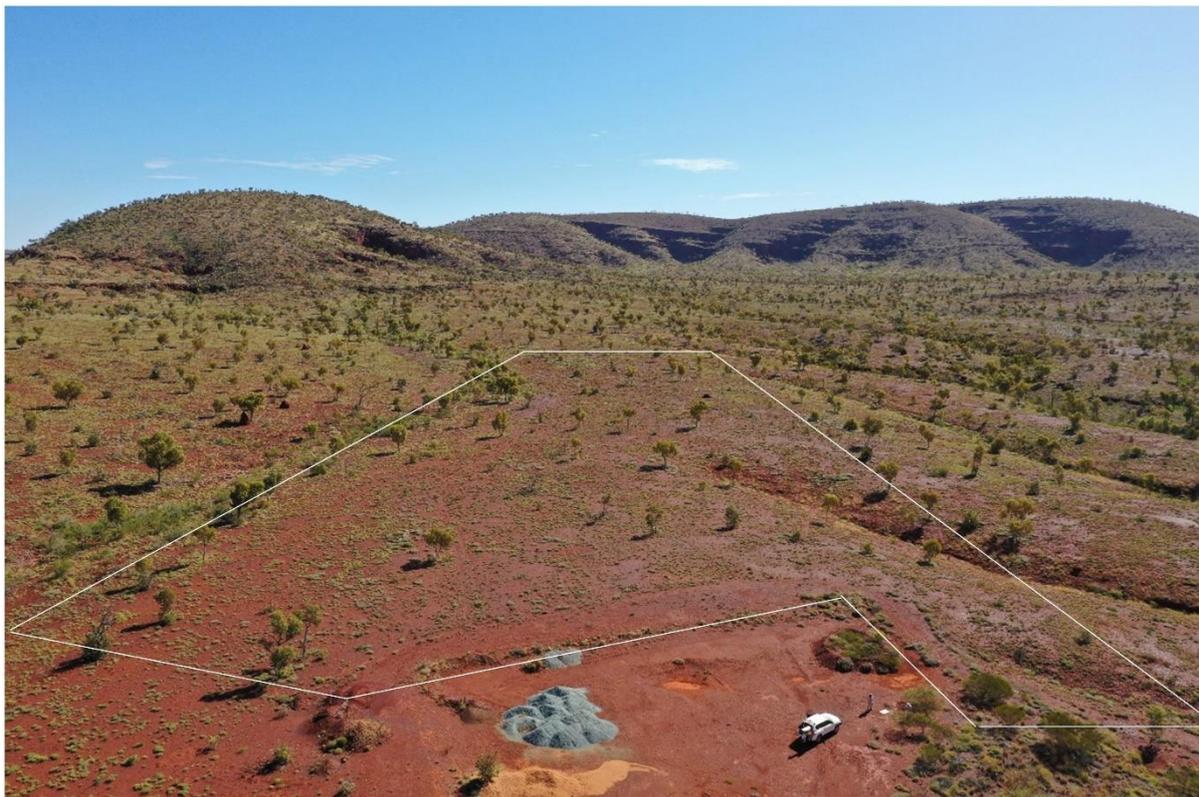
Figure 5.2.2. Oblique aerial view of the SLK7 gravel pit expansion area facing west. The survey polygon is outlined in white.

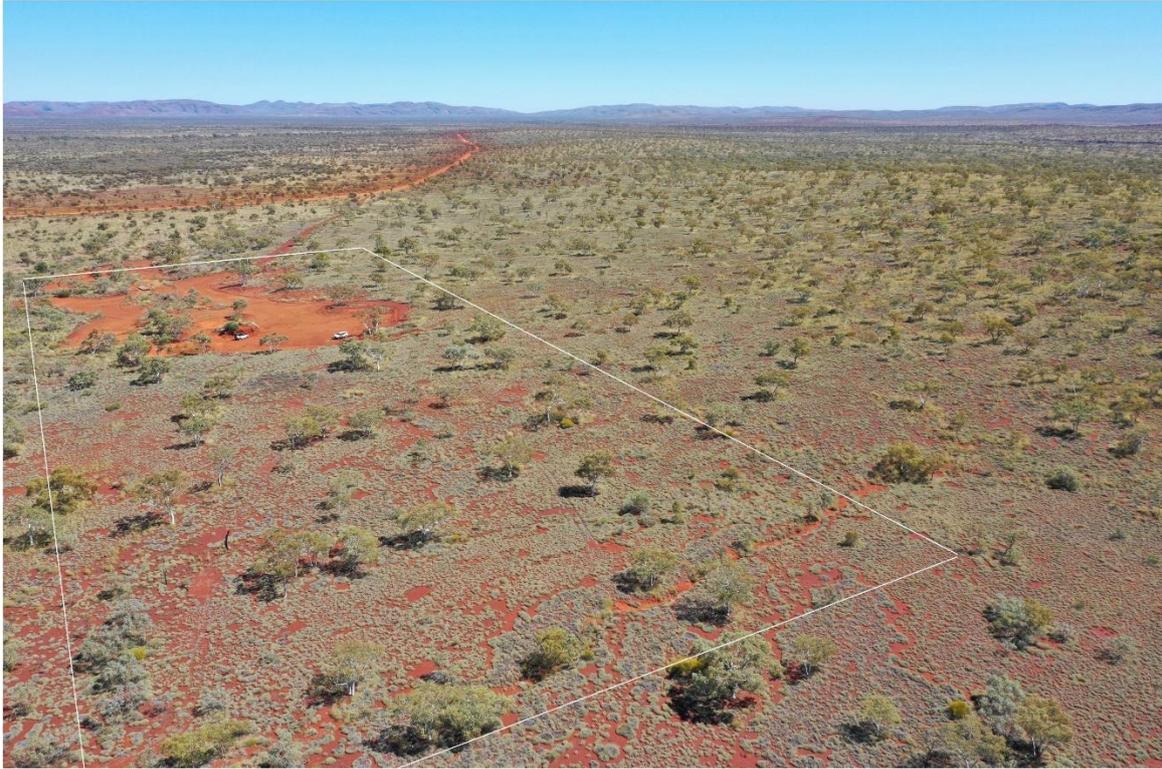
Figure 5.3.2. Oblique aerial view of the SLK31 gravel pit expansion area facing east. The survey polygon is outlined in white.

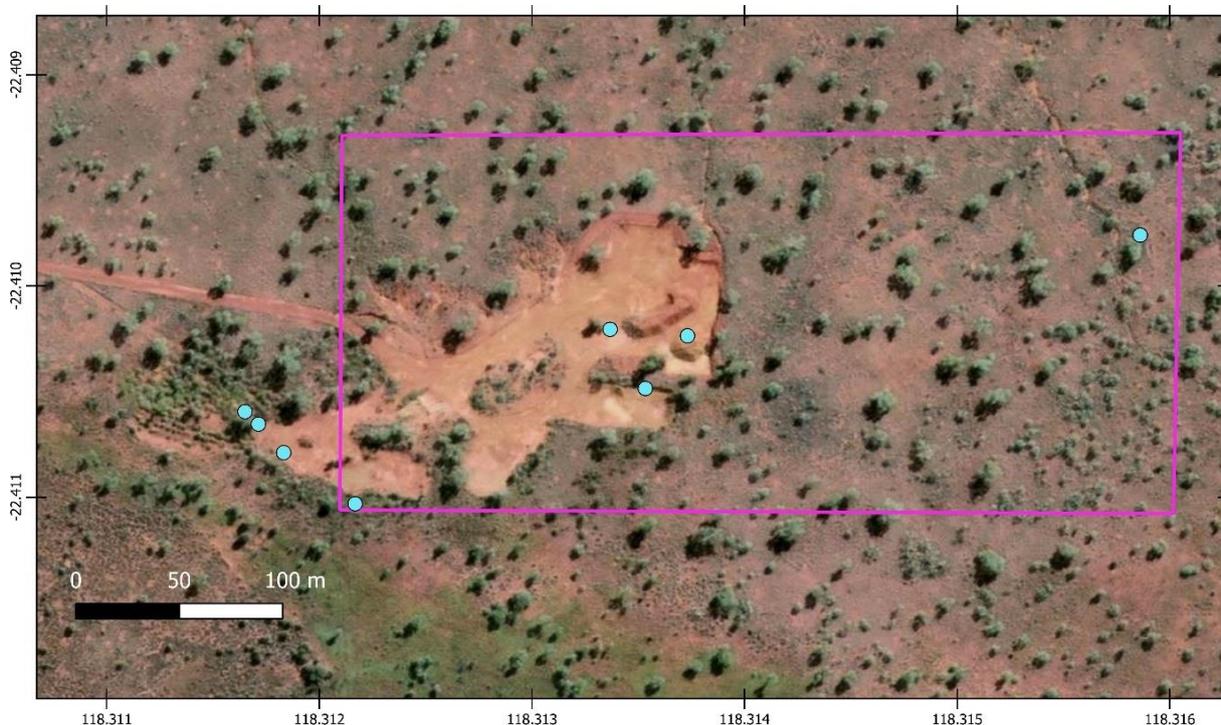
Figure 5.3.5: Locations of *Isotropis parviflora* within SLK31 survey polygon, *Isotropis parviflora* (●). Basemap of aerial imagery from Microsoft© Bing™.

Eleven individuals of *Isotropis parviflora* were located across the survey polygon (Figure 5.3.5), with only one plant located in undisturbed open woodland. Most plants were found on previously disturbed sites, either on isolated gravel heaps in the middle of the bare gravel pit, or on the south-western margin among gravel heaps that had since become revegetated after excavation (Figure 5.3.4D).

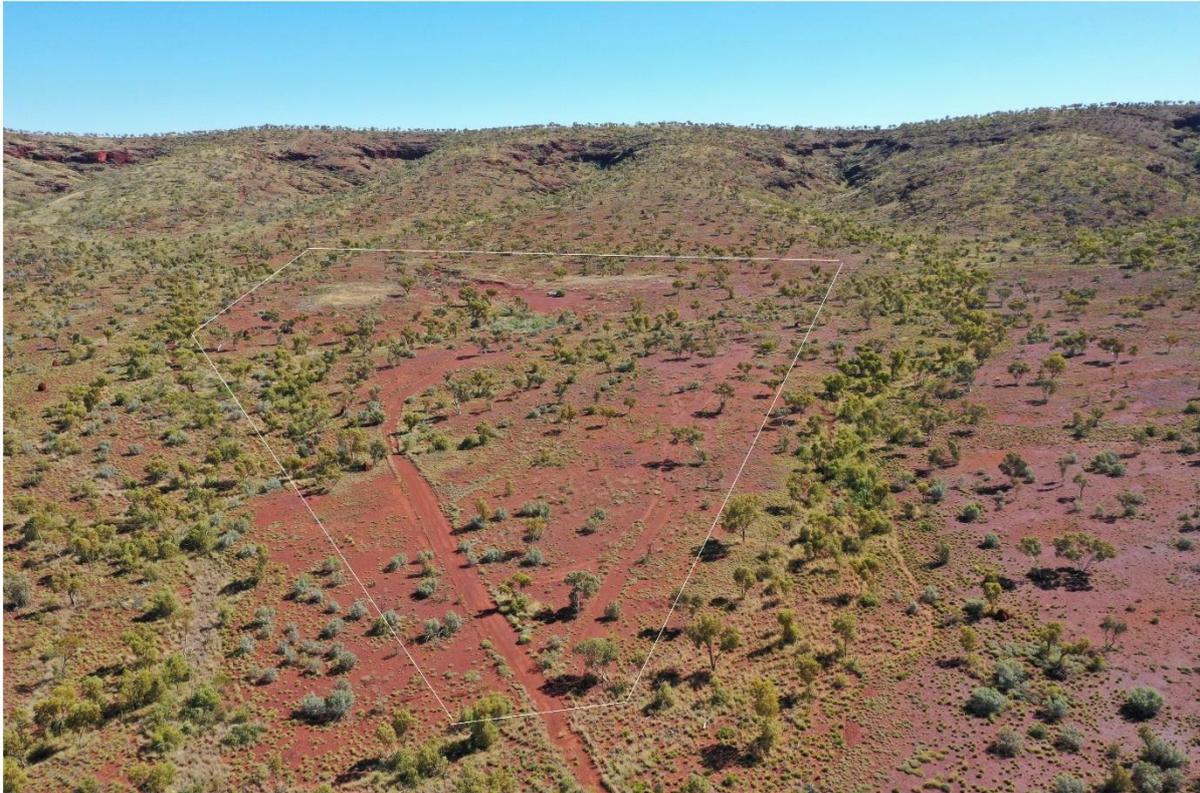
Figure 5.4.2. Oblique aerial view of the SLK51 gravel pit expansion area facing north. The survey polygon is outlined in white.

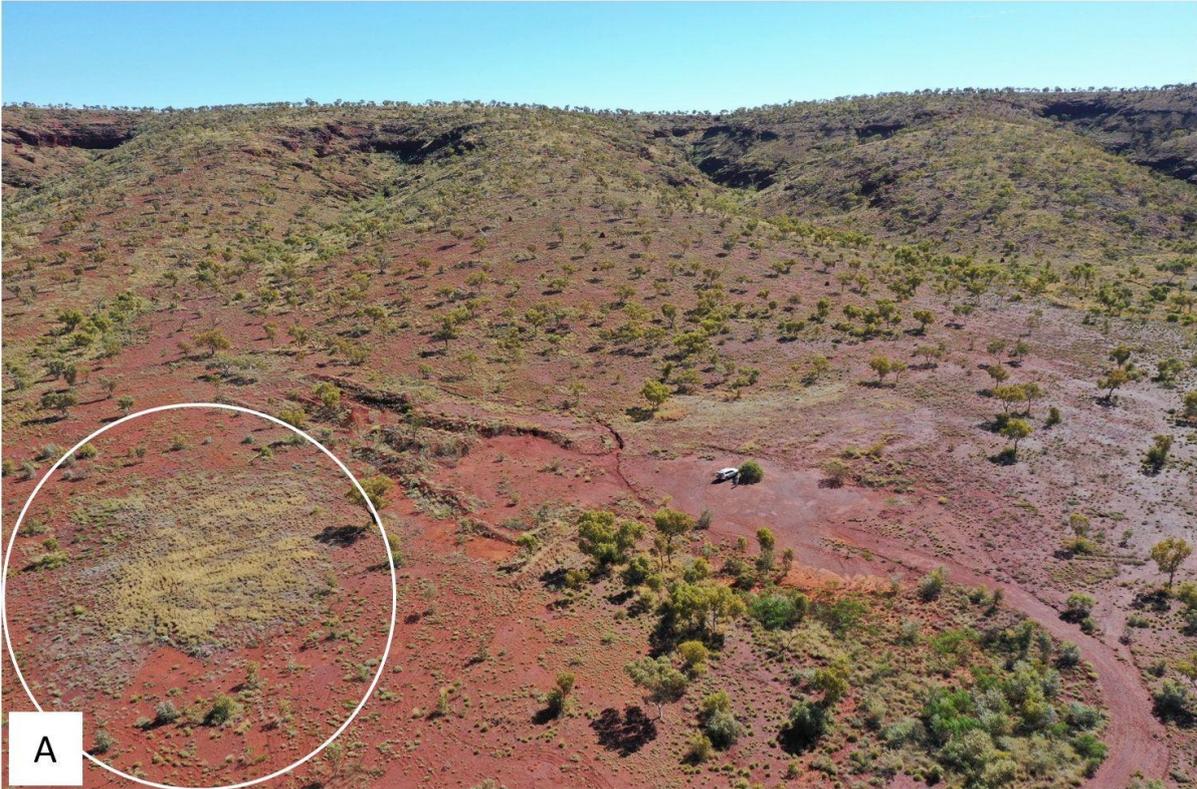
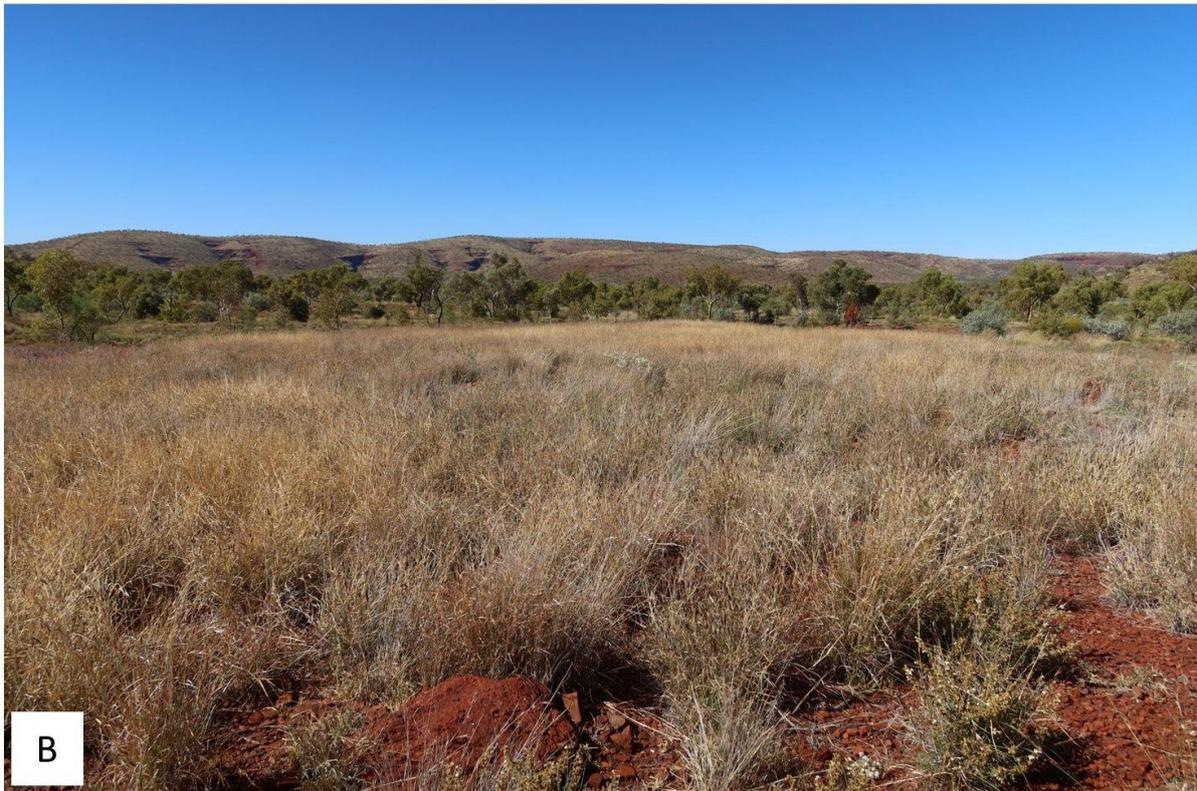
A large, dense, rectangular stand of buffel 55 × 30 m was found on the western edge of the current pit, on a gentle slope of 1° and with history of soil excavation, stockpiling and grading (Figure 5.4.6). This was the only area of Buffel Grass located in the pit area, while other similarly disturbed areas in the polygon supported dense stands of native grasses (*Enneapogon polyphyllus*, *Eriachne mucronata* and *Themeda triandra*) and/or shrubs. Buffel Grass currently appears to be restricted to this disturbed area and wasn't observed in the adjacent creeklines nor observed along the track.

*Figure 5.4.6: A: Aerial view of SLK51 facing north with the *Cenchrus ciliaris* patch circled, B: ground view of the same dense patch of *Cenchrus ciliaris*. Note that the other grassland area north of the parked vehicle is composed of native species.*

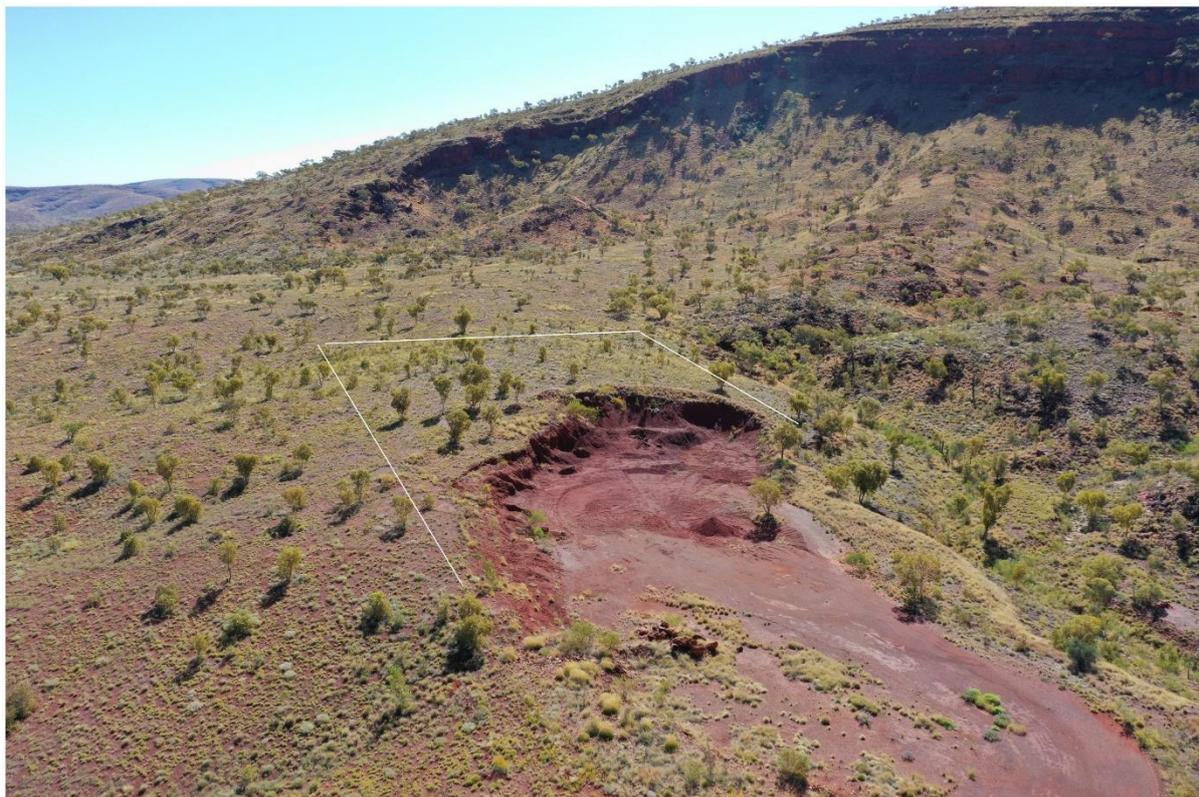
Figure 5.5.2. Oblique aerial view of the SLK17 gravel pit expansion polygon facing north-west. The survey polygon is outlined in white.

The current gravel pit at site SLK17 is on a ridge with sloping edges that direct runoff into either the steep gully north of the pit or down the slopes and minor gullies of the slopes on southern edge of the ridge (see Figures 5.5.1 and 5.5.2). Runoff from further uphill is already directed into the steep gully. Given the steep embankments along the current pit northern and western margins, the greatest erosion issues would be from those if not stabilised. Of concern would be if debris then entered the steep gully.

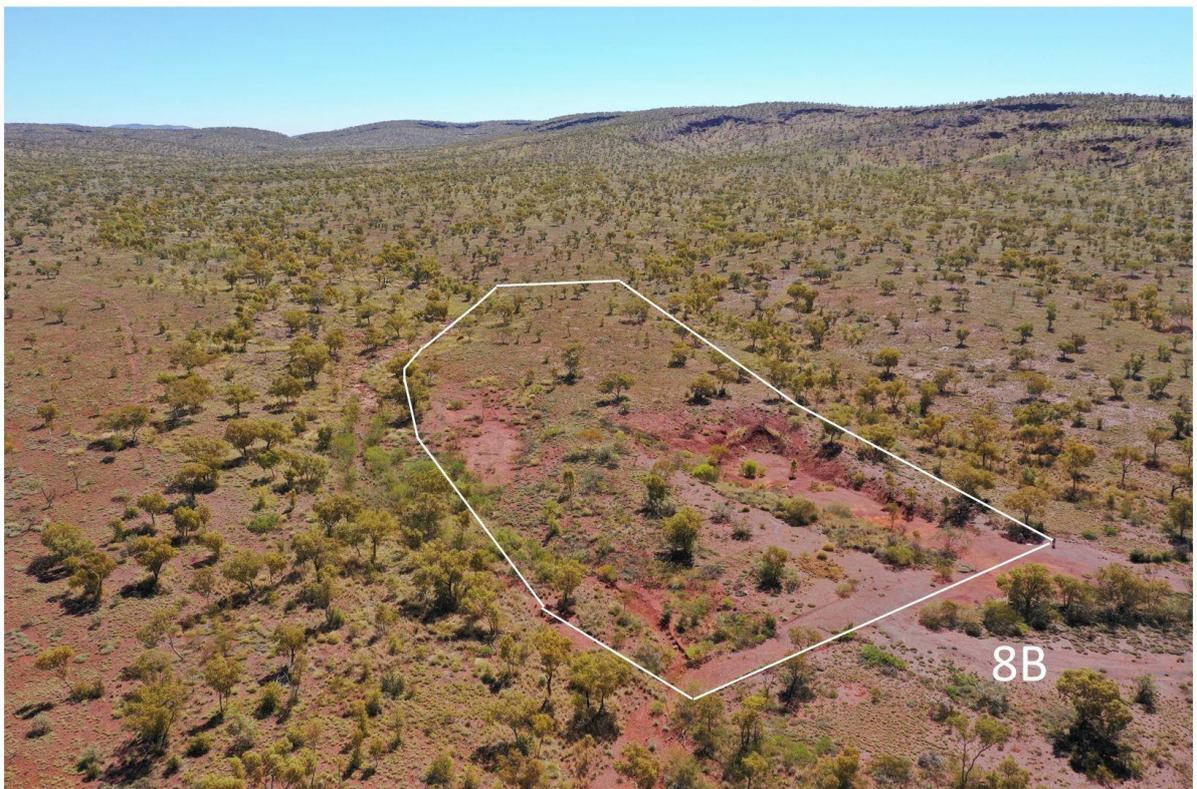
*Figure 5.6.2. Oblique aerial view of the SLK8A and SLK8B gravel pit expansion polygons facing north-west. The survey polygons are outlined in white.*

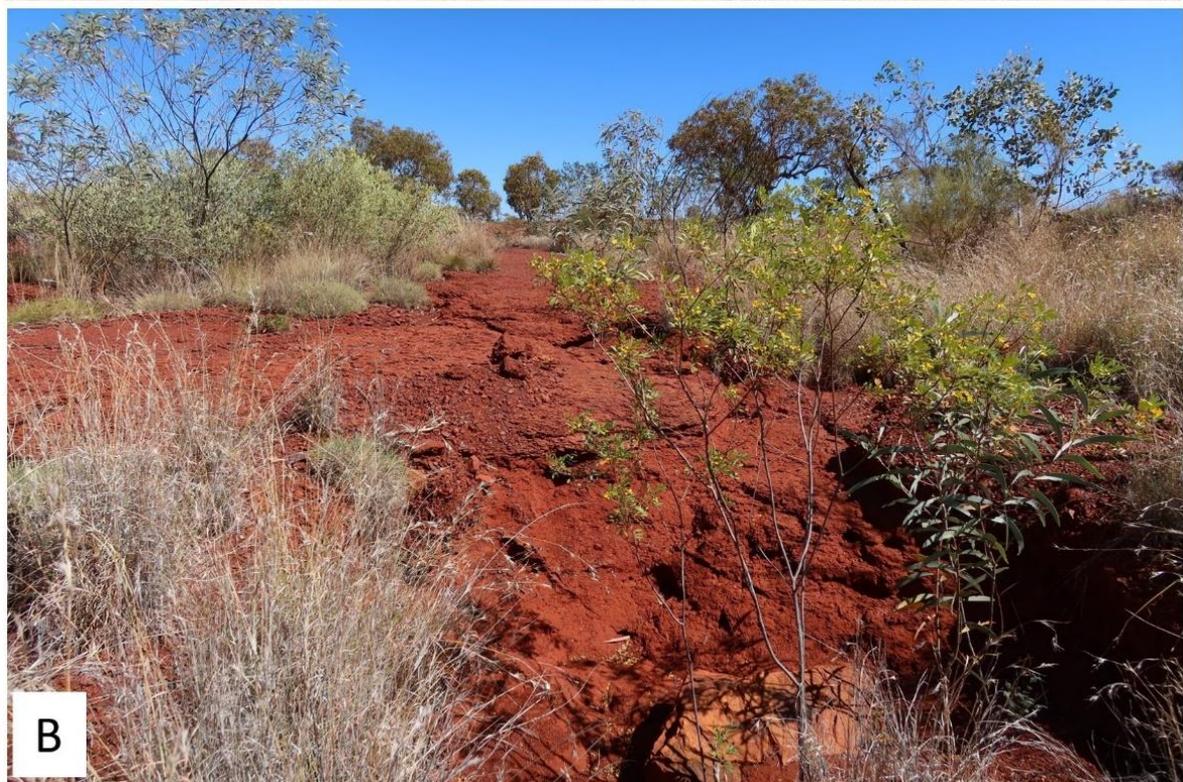
Figure 5.6.7: A: Aerial view of the entry track into SLK8B, where the creekline (a, b) splits and part of it deviates down the track. Gully erosion is arrowed (c). B: Pit wall in SLK8A (facing upslope) which has been eroded by runoff.
