**SEAFLOOR MAPPING OF LONG ISLAND SOUND -
FINAL REPORT: PHASE I PILOT PROJECT APPENDICES**

June 2015

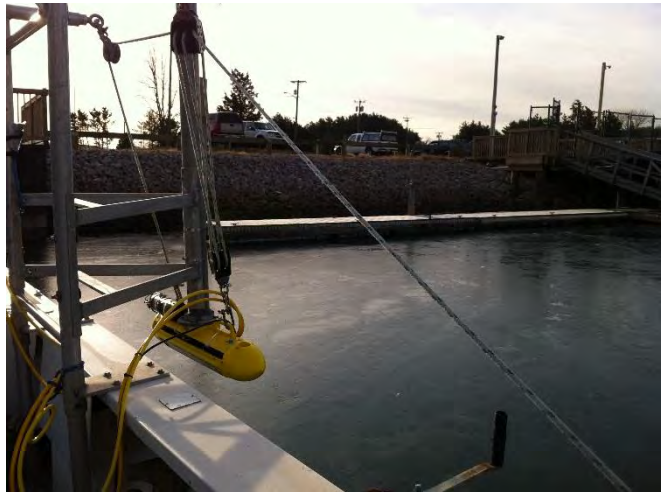
The Teledyne Benthos C3D interferometric sonar system operated at 200 kHz, with vessel speed varying from 1 to 4 knots. Horizontal and vertical positional data were provided by a differential GPS and inertial motion unit (Applanix POS-MV). A CTD was fixed to the C3D polemount to obtain real-time temperature and salinity data for on-the-fly correction of signal travel time (sound velocity). A vessel and sensor diagram¹ and offsets² are provided with these deliverables. Interferometric data were acquired with Ocean Imaging Consultants (OIC) GeoDAS software in proprietary .oic format³. Subbottom data were acquired with SonarWizMap⁴, using the GPS feed from the POS-MV, corrected with a layback value of 5 meters. A backup of the Hypack project file is available at the URI Environmental Mapping Laboratory⁵; the raw navigation file (.csv) for all survey transects is available as a part of these deliverables⁶.

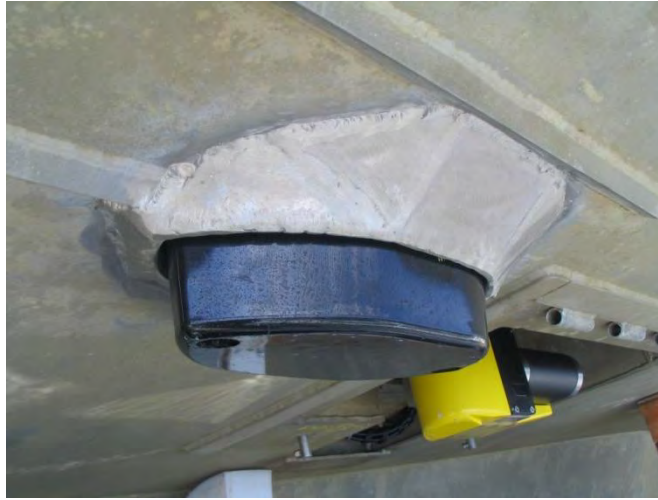
Figure A-3 - Odom Vertical Beam on 3101 / 3102.

On Launches 3101 and 3102, the transducer is mounted on the port side forward of the retractable arm that accommodates the RESON 7125-SV (Figure A-3). The installation of the Odom on Launch 3101, 3102 allows simultaneous acquisition of KLEIN 5000 side scan with general survey-grade bathymetry when the ODOM is operated in either low or high frequency mode.

For the purposes of calculating total propagated error (TPU), the ODOM Echotrac CV-200 is assumed to be a single-frequency multibeam transducer with one beam. The maximum across-track and along-track beam angles are assumed to be identical at a value of 7.5°. The sonar is assumed to have a pulse length of 0.1 ms at 100 kHz and a ping rate of 20 Hz.

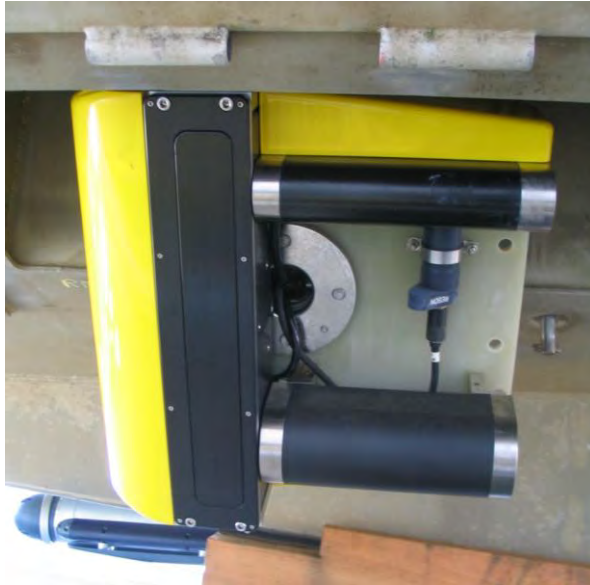
Figure A-5. 7125-SV Housing on Launch 3101/3102.

The RESON 7125-SV system aboard Launches 3101, 3102 are installed on a RESON Seabat 7125 mounting bracket deployed on a retractable arm from the hull. (Figure A-5).

The RESON 7125-SV forms 256 beams and can be set to interpolate to 512 beams in the receive array and can be set to acquire equi-distant or equi-angular beam spacing. Standard operating procedure on *Thomas Jefferson* is to acquire 512 equi-distant bathymetry. The 400 kHz frequency has a 0.54° across-track resolution and 1° along-track resolution. The 200 kHz frequency has a 1.1° across-track resolution and 2.2° along-track resolution. The RESON 7125-SV has a maximum ping rate of 50 pings/s and can maintain a full swath width in depths of 1-75 m for the 400 kHz, and 1-150 m for the 200 kHz systems.

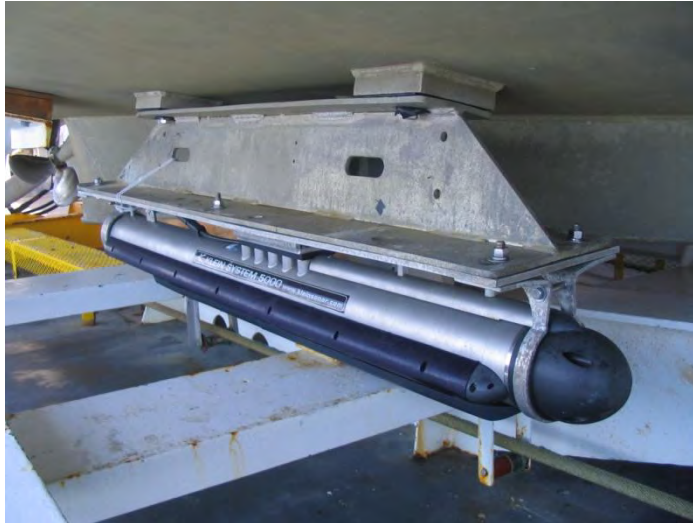
Figure A-7. Side Scan Hull Mounted on 3101 / 3102 (lightweight model shown).

Aboard both survey launches, the lightweight or heavyweight Klein 5500 towfish can be mounted to an aluminum sled using omega brackets (Figure A-7). Positioning of the hull mounted towfish is determined by entering the X,Y, Z position of the towfish as the tow point and a layback value of zero. Otherwise, the system is processed the same as the towed configuration.

The hull-mounted configuration is normally used in depths of twenty meters or less, per the HSSDM. Aboard Launch 3101 and 3102, sidescan may be collected concurrently with ODOM Echotrac CV-200 vertical beam bathymetry or RESON 7125 MBES.

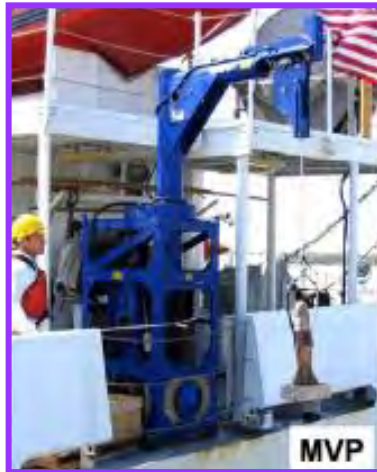
Figure A-8. MVP 100 on S-222

The Moving Vessel Profiler (MVP) (figure A-8) is a self-contained profiling system capable of sampling water column profiles to 100m depth. MVP-100 was mounted to the port quarter. The MVP consists of a computer-controlled high speed hydraulic winch, a

cable metering, over-boarding and docking system, a conductor cable and a streamlined free fall fish (FFF) housing an Applied Microsystems “time of flight” SV&P Smart Sensor (see SV&P below) . The system as configured aboard the *THOMAS JEFFERSON* collects vertical profiles of sound velocity data while the ship is underway at survey speed. The unit is located on the fantail and controlled remotely from the ship’s acquisition room. When using MVP casts in conjunction with the RESON 7125 MBES, sound velocity data is processed using Pydro Velocipy software, then applied in CARIS HIPS during post processing.

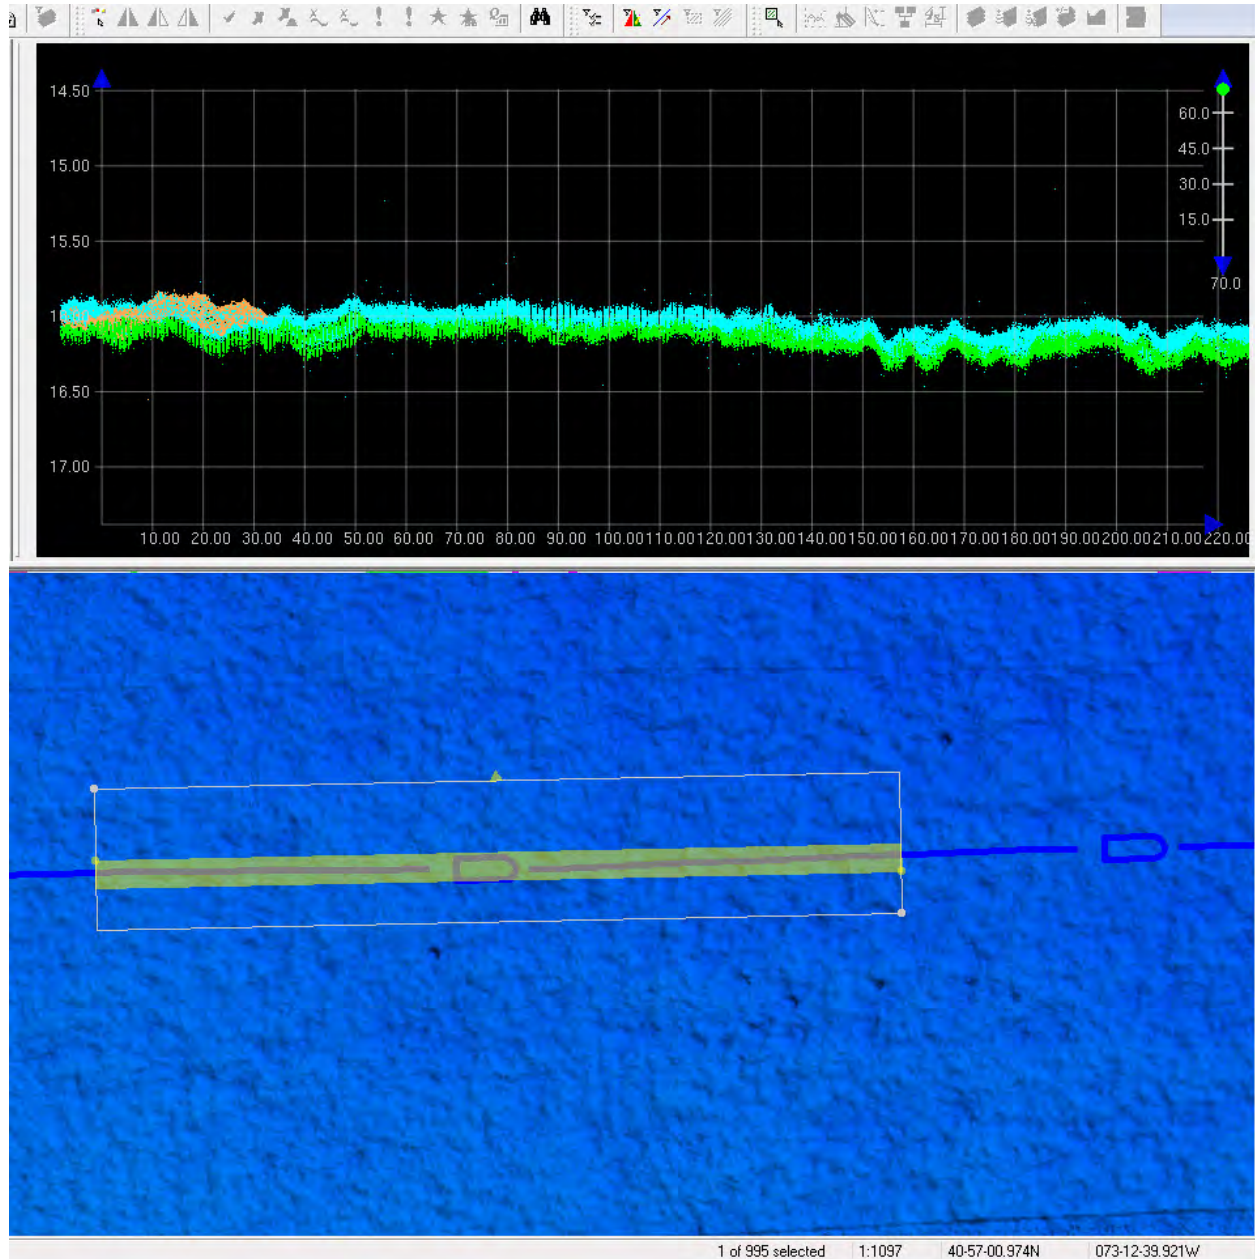
Figure 10: S222 DN181. Data Flagged by SSP tool in excess. Several lines are shown in addition to the line in error. All the lines have depths well within range.

Efforts to minimize sound velocity issues included frequent of casts based on time and location. While in acquisition, values in excess of 3 meters/sec while on line were monitored and decisions for casts determined on that basis.

In addition a Sound Speed Comparison Tool script developed by Matt Wilson was used on ship data. This tool will retroactively plot the real-time sound speed input to a multibeam echo sounder (SSP) versus the sound speed at the commensurate water level taken from the Moving Vessel Profiler (MVP). Out of 1007 MVP profiles for the ship, 13 comparisons failed the 2m/sec criteria on ship data. The 2m/sec criteria was chosen because the tool can better access the data then by monitoring it in acquisition. On inspection of the most excessive of the comparisons, data was either rejected completely or rejected to a reduced swath width(outside beams). Most excesses were within IHO specification for differences in depth caused by excess velocity error. The sample refers to a high reading from the results that occurred on S222 data DN181 at 2100. On inspection in subset editor the data was in fact within specification. The mean difference and standard deviation between surface and cast measurements was (m/s)=0.611, +/-0.927. See Fig. 11 and Separates H12488_Soundspeed_comarisons_All.txt for a list of times that were in excess.

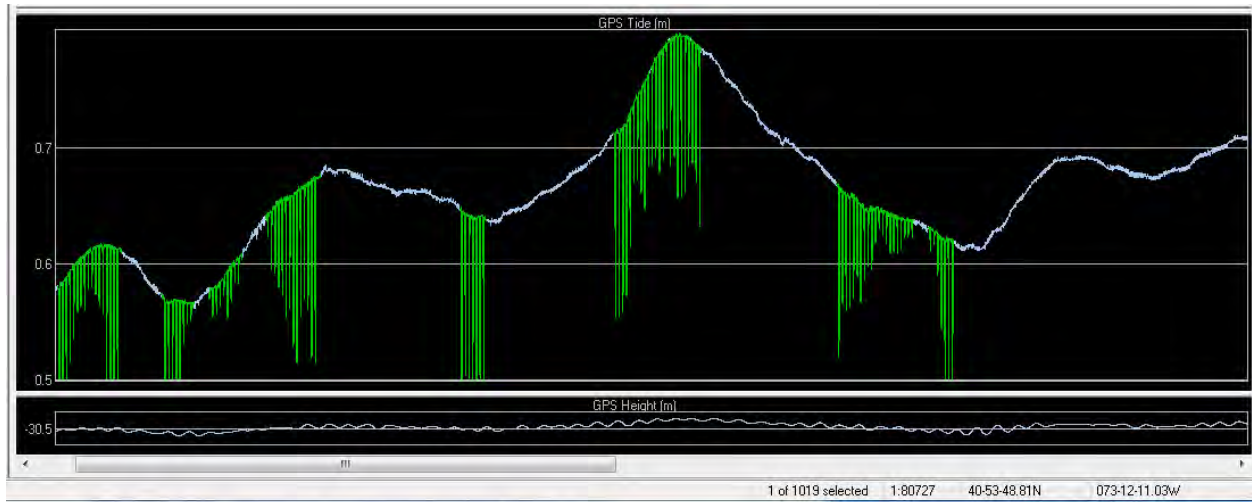
Figure 11: Altitude Anomaly as viewed in Attitude Editor (GPS Tide). The green is displaying unusual GPS Tide levels.

using TCARI. If a small section of GPS Tide/Altitude was observed, that area was smoothed in the attitude editor. Care must be taken during application of correctors so the smoothing is not over written. A list of lines using TCARI can be found in Separates, I_Acquisition_&_Processing_Logs, Processing_Logs, H12488_SBET_QC_Log.xlsx. Examples of the anomalies are listed below.

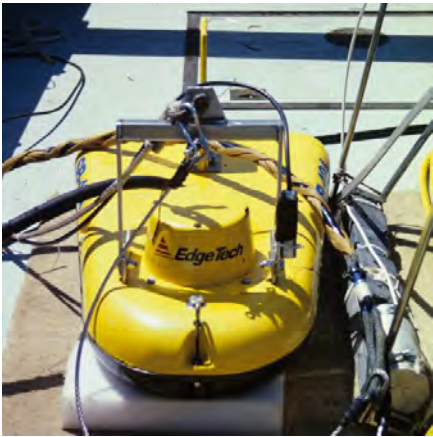
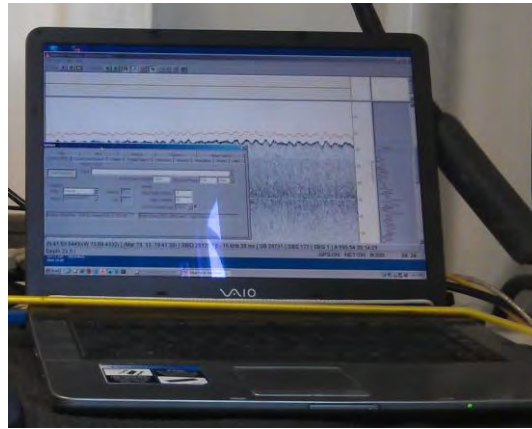
The subbottom surveys were conducted using a high-resolution Chirp subbottom profiler system consisting of an EdgeTech 424 tow fish and an EdgeTech P3200 acquisition unit with Discovery software (Fig. A4-1).

Lamont EdgeTech Chirp 424 subbottom profiler system (left) and EdgeTech Discovery software (right).

The system was operated using an acoustic sweep signal between 4-24 kHz that results in a nominal high vertical resolution of 0.1-0.2m. The horizontal resolution depends on the survey speed. The system transmits data at a rate of 4-5 pings/second. At survey speeds of 5-6 knots these transmission rates results in an along track spacing of traces between 0.5 and 1m. Data were recorded in EdgeTech's proprietary jsf format as well as in Standard SEG Y format.

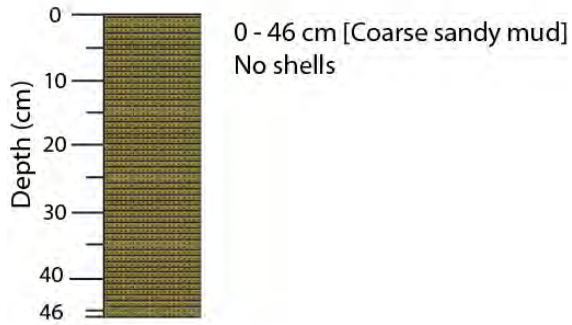
SEAWOLF 13-03-HDC23

Latitude: 41°1.349'
