SOCKBURN HALL, DARLINGTON AN ARCHAEOLOGICAL INVESTIGATION OF THE MEDIEVAL AND POST-MEDIEVAL MANORS AND THE SETTING OF THE PRE-CONQUEST CHURCH

Research Department Report 82/2007

**Sockburn Hall, Darlington:
an archaeological investigation of the medieval
and post-medieval manors and the setting of the
pre-Conquest church**

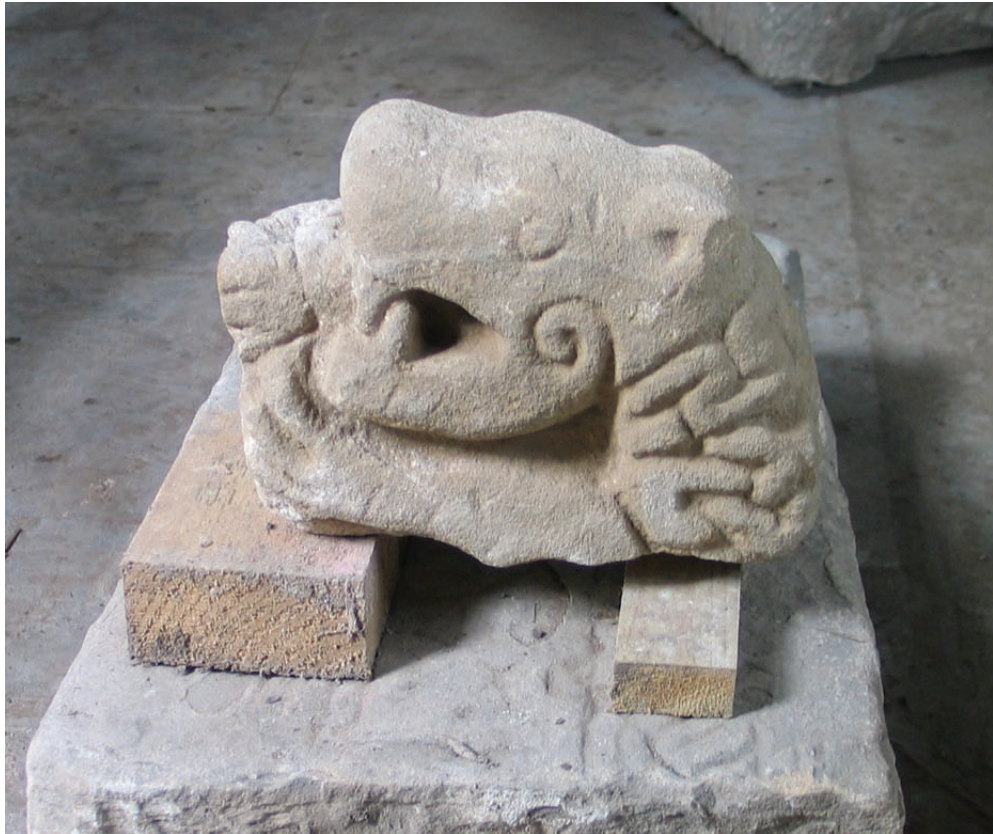
The end-beast from a hogback grave cover found during consolidation work at All Saints' Church, Sockburn, in 2005

Frontispiece: The end-beast from an Hiberno-Norse hogback stone, found during consolidation work in 2005.

No corpus No.	Unspecified, but probably later 10th century.	-	-	Bear's head from hogback. Not part of other hogbacks on site. Found during consolidation of the west face of the chancel arch in 2005 (Ryder 2005; and see frontispiece image in this report)
---------------	---	---	---	--

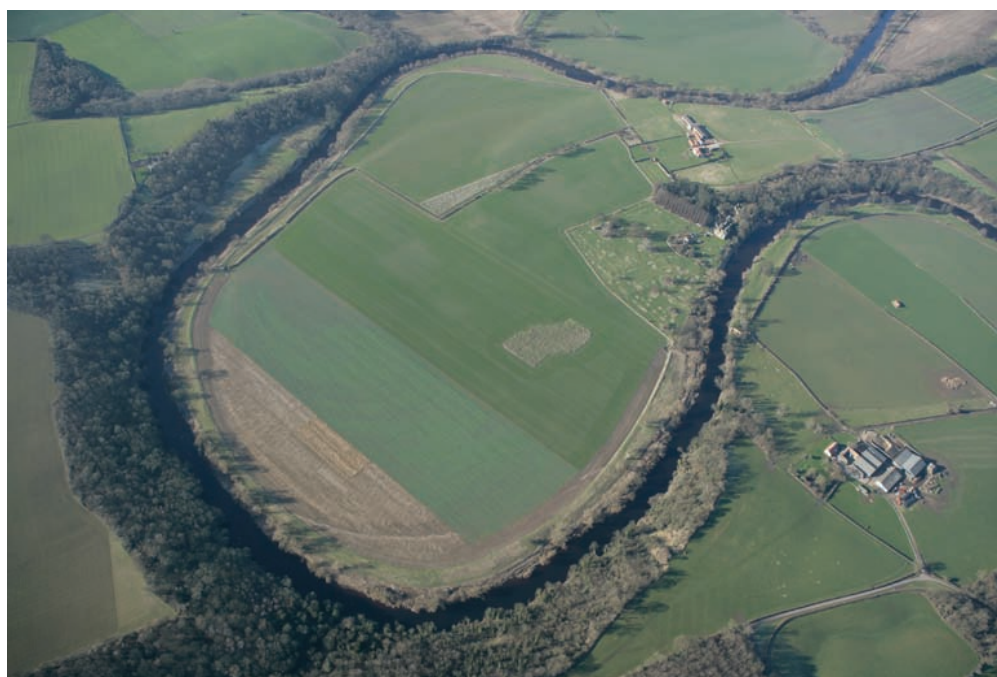
Figure 3. Sockburn Hall stands alongside the River Tees on the eastern (right hand) side of the loop, slightly to the north of the ruined church and the earthworks which form the subject of this survey (© English Heritage 2007 NMR 20629-051)

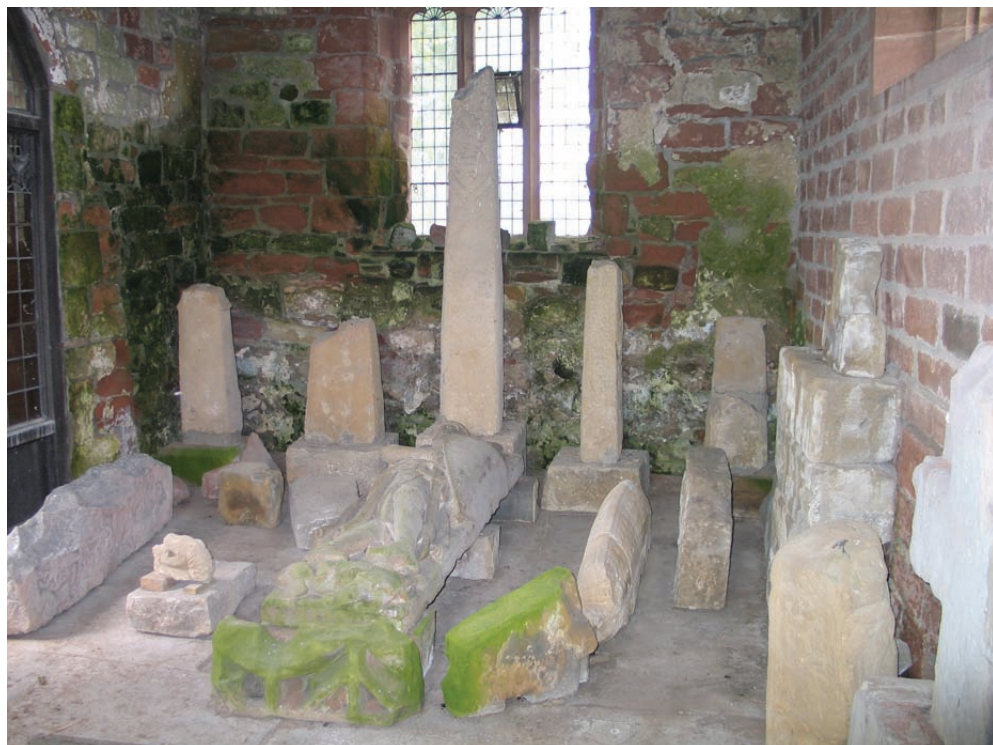
Figure 5. Part of the collection of Viking (and later) memorial stones assembled within the Conyers Chapel

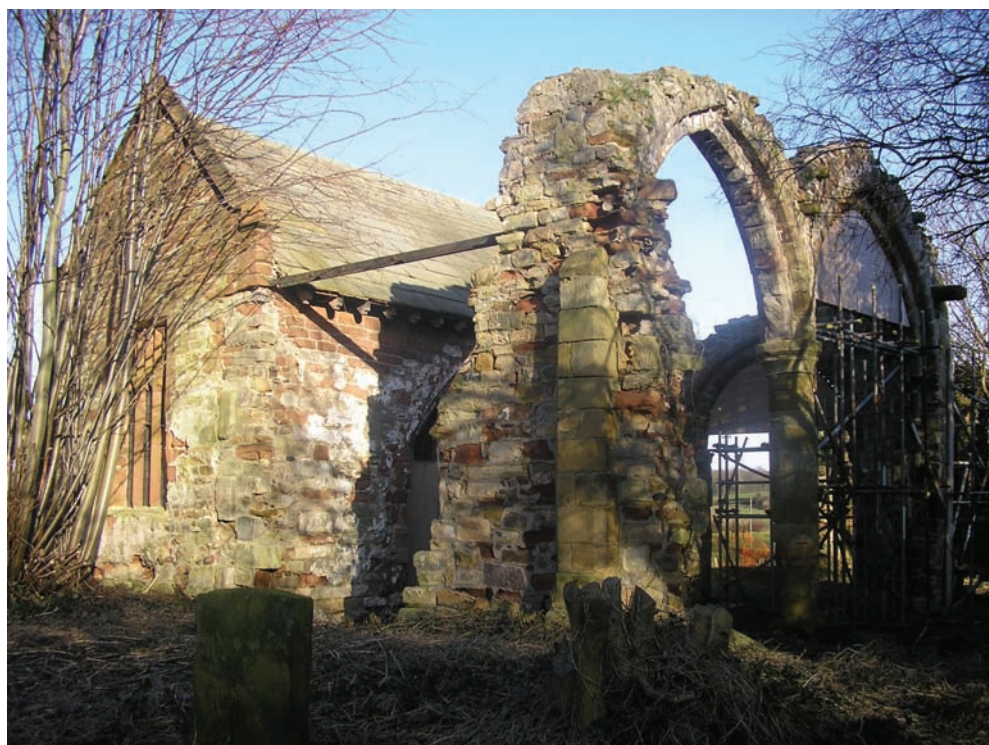
Figure 6. The ruined nave of All Saints' Church showing early stonework in the form of the massive alternative quoins at the north-west corner, bonded to the Conyers Chapel in the 14th century. The south wall is pierced by a 12th-century arcade to the former south aisle

The ruined nave of All Saints' church (Figure 6) with its narrow and lofty proportions (7.32m in length, 4.26m in width and over 7.5m high), thin walls (around 0.7m) and massive alternating quoins at the north-west and south angles, is characteristic of pre-Conquest construction. Exactly when this part of the church was built, however, remains a matter of some debate in the absence of any diagnostic door or window openings.

between the nave and a new south aisle (Figure 6). The chancel arch was replaced in similar fashion in the early 13th century, and the chancel itself was enlarged to exceed the width of the nave and extended eastwards. The east chancel wall, complete with a triplet of lancet windows, now stands in isolation from the rest of the structure (Figure 8). The chapel on the north side of the nave was added in the 14th century to provide a mortuary for the Conyers family and required a new doorway (a wide, shouldered arch) in the north nave wall. When the chapel was re-roofed in 1900 the original three-light perpendicular windows to east and west were comprehensively restored (VCH 1914, 454), the wooden doors added, and the north wall rebuilt with a new window in a complementary style.

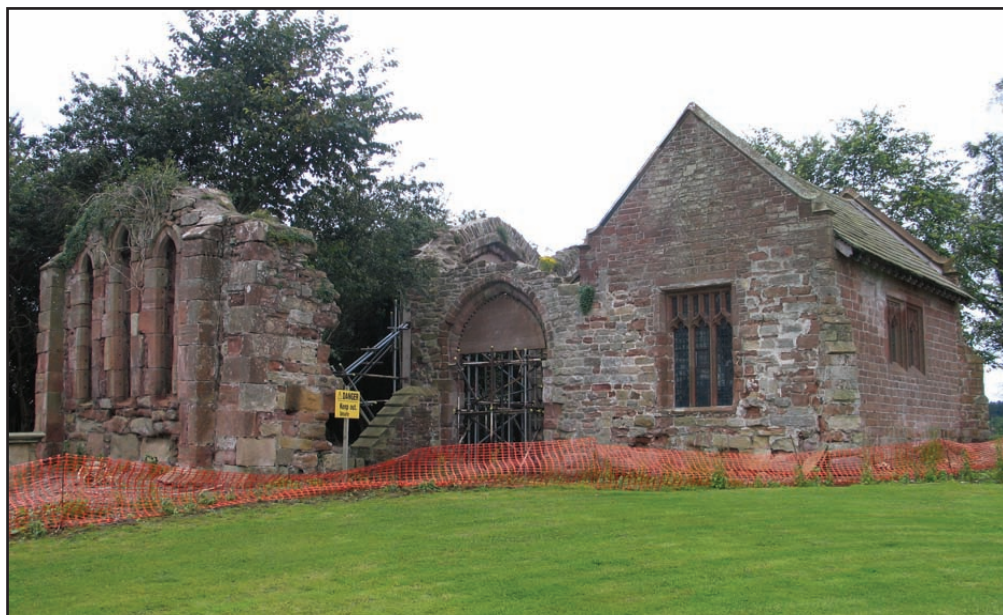
Figure 8. All Saints' Church viewed from the north east in 2007, showing the isolated west chancel wall, the preserved chancel arch and the restored Conyers Chapel

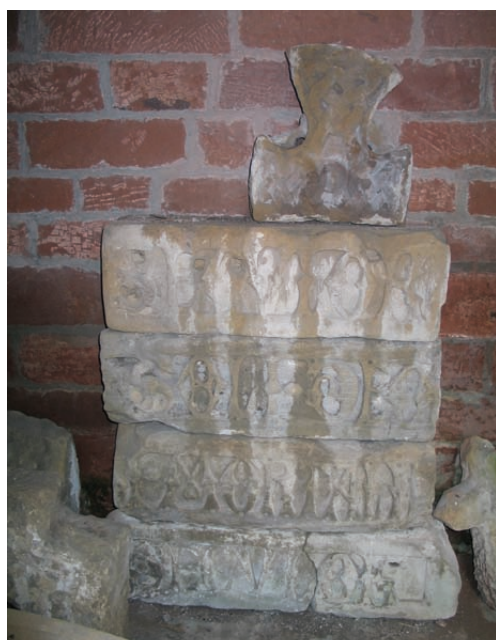
Figure 13. The carved stones bearing words from the Conyers’ motto

I.MORTALI and SECULOR) are carved in deep floriated script across four large rectangular stone blocks, now stored in the Conyers chapel (Figure 13). Knowles (1905, 110) states that these blocks were recovered from the river bank some distance from the church, although he does not record when this took place. They date from the late 15th or early 16th century, and were perhaps once set above a hearth or doorway.

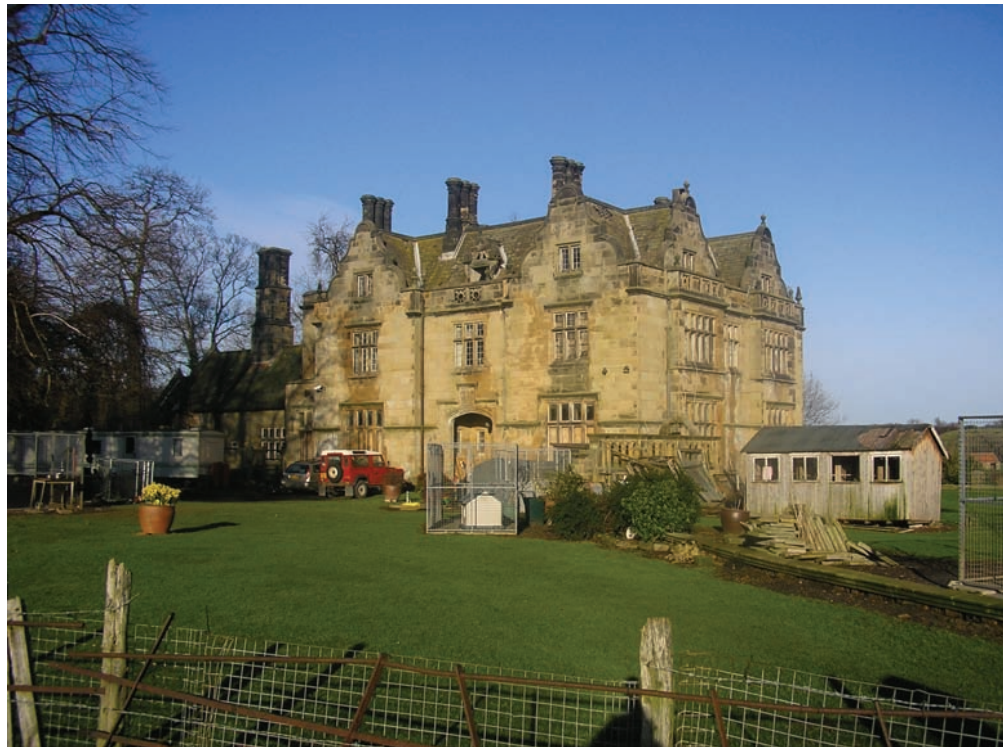
Figure 14. Sockburn Hall viewed from the south west

This new manor house, the present Sockburn Hall, stands overlooking the river on the eastern side of the peninsula, to the north of All Saint's Church (see Figures 2 and 14). It is built in an ornate neo-Jacobean style using local sandstone, set, at least in part, on brick foundations. The main building comprises a square block of two storeys

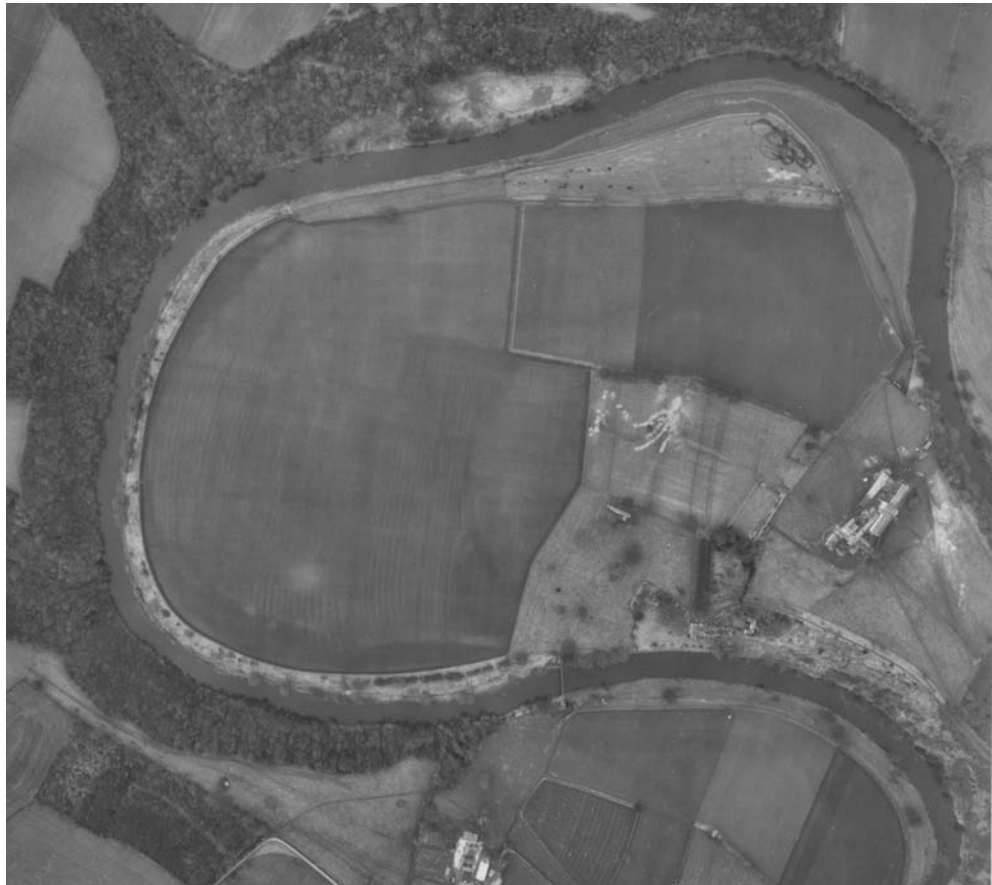
Figure 24. Aerial photograph taken in 1976 (MAL 1976) showing vestiges of ridge and furrow across the peninsula. The broad curving band across the ploughed fields just outside the park boundary is a natural feature, carved by the post-glacial river

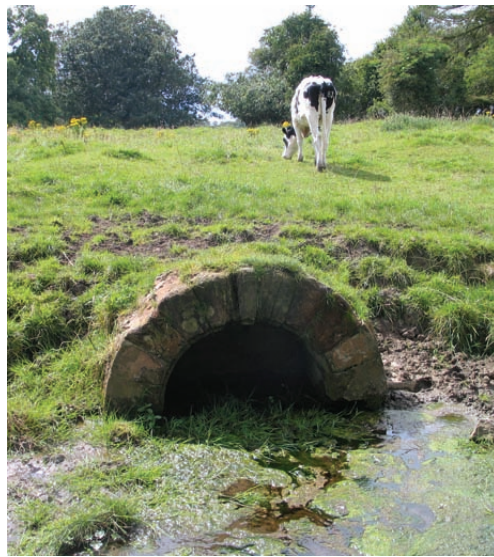
Figure 25. The spring-head vault (feature 27) located between the courtyard and the river

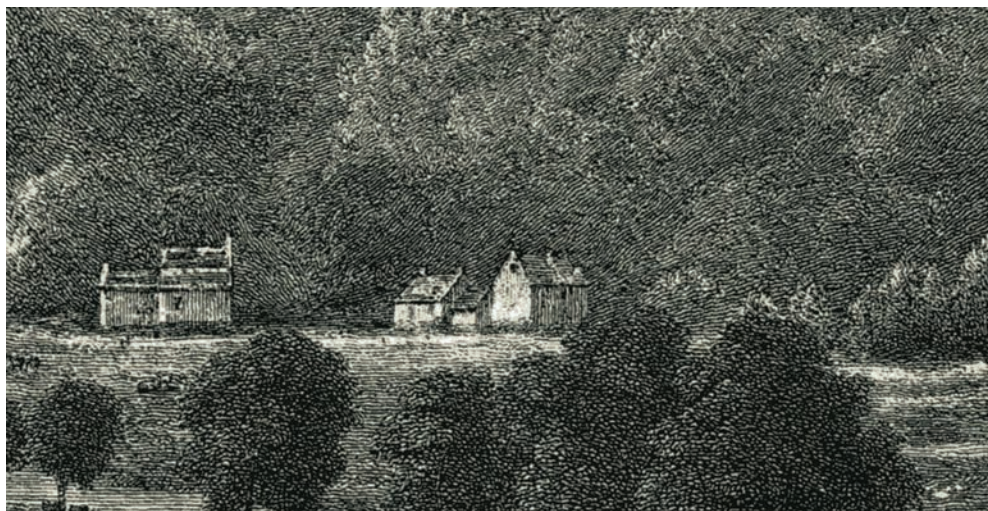
Figure 26: Detail of the buildings to the west of the church, taken from the 1830 engraving published in Surtees' county history (see also Figure 11)

The date and circumstances by which the manor house of the Conyers came to be demolished is unknown. It was certainly standing during Dugdale's visit in 1666, and presumably it still stood when the manor was purchased by Sir William Blckett in 1682. However, it was nothing more than a distant memory when Surtees wrote his county history in 1823. In its place Surtees (1823, 246) mentions, rather disparagingly, a 'modern brick house, better and worse than a farmhold' which was built as a residence of a younger son of the Blckett family. This appears to be illustrated as a small cluster of buildings somewhat to the west of the church in the accompanying engraving (see Figure 26).

In keeping with Surtees' description, the 'farmhold' does not appear to have been a particularly imposing arrangement. Two connected ranges set at a right angle are shown from this perspective - the northern range taller and with an uneven roofline implying more than one phase of construction. This impression accords with the earthwork evidence within the north west corner of the large enclosure (**A**), where there are clear indications of a range of buildings set around three sides of a narrow rectangular courtyard open to the south (**House 3**). It is possible that the remnants of stone walls noted within the adjacent banks (**7, 8** and Figure 22, '**K**') and considered potentially medieval in origin, could instead relate to these buildings. However, they appear to have been pierced and damaged by this later period of occupation, and the overall impression - that of a residence which was 'modern' in 1823 and almost certainly demolished around the time of the construction of the new hall in 1834 - is most unlikely to have accounted for the totality of time-worn ditches, banks and terraces within and around the wider enclosure in which it was located.

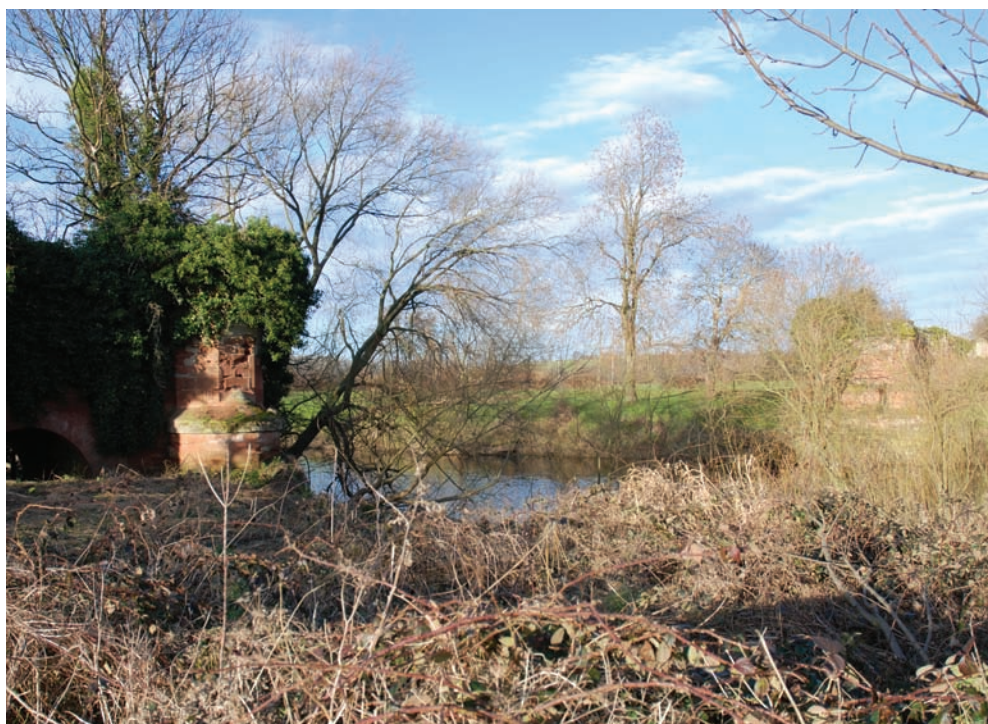
Figure 27. The western bridge abutment viewed from the south. (© C J Dunn)

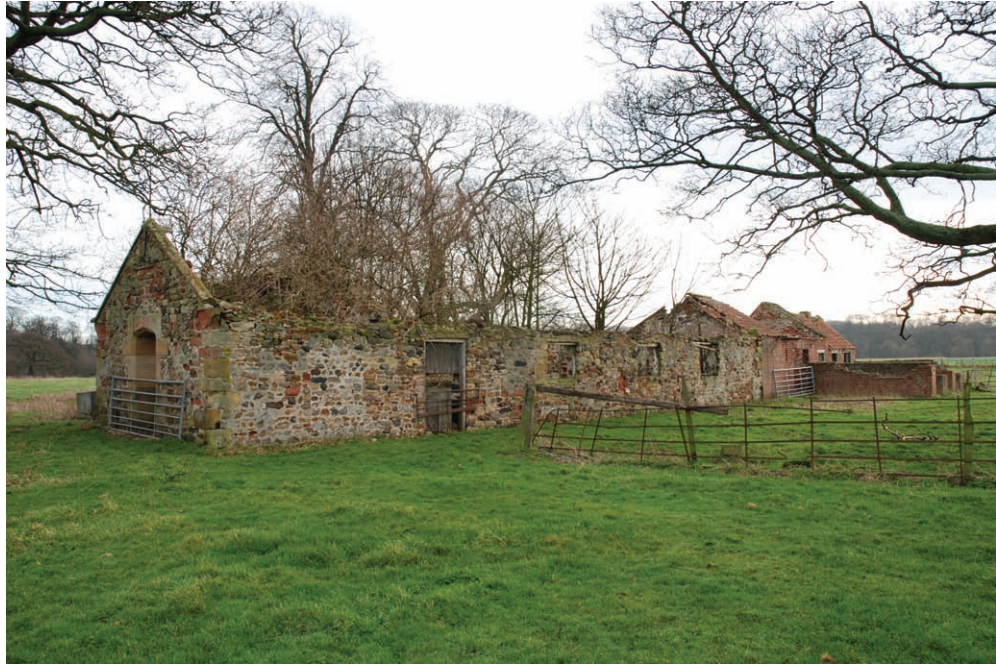
Figure 28. The agricultural buildings viewed from the north-west (© C J Dunn)

The row of farm buildings near the south-western corner of the park (Figures 21 and 28) exhibits many phases of extension and adaptation, and it is difficult to determine exactly when the earliest parts were built. The 1857 map provides the earliest

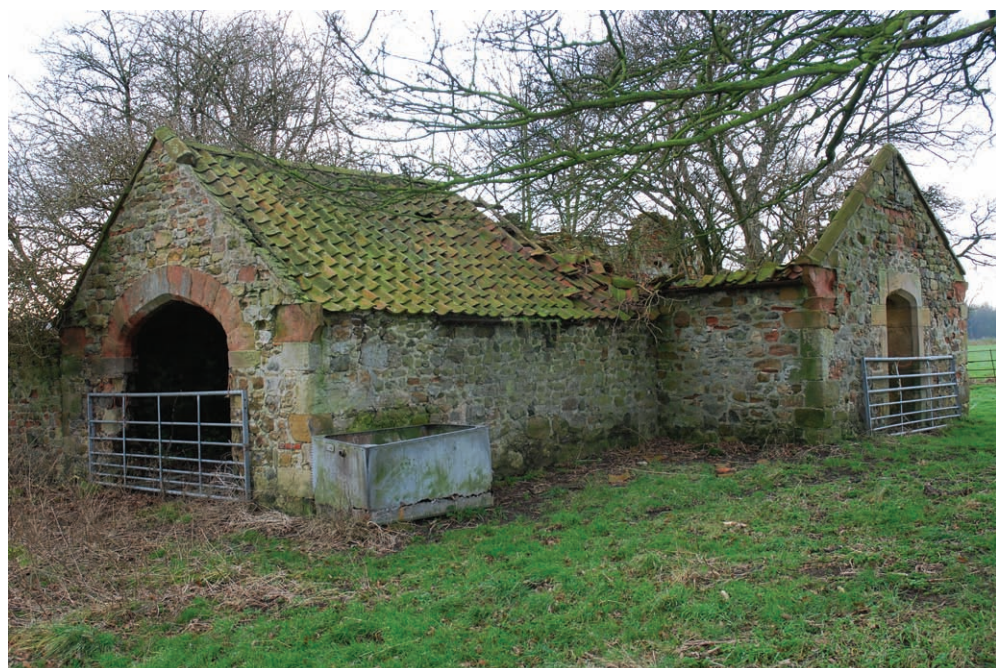
Figure 29. The agricultural buildings viewed from the north east showing the ornate doorways facing north (narrow) and east (wide). (© C J Dunn)

building stone, the arches show no signs of the damage that would result from such a process, and instead demonstrate a quality of construction, matched by the coping along the gables above, which is entirely in keeping with the stonework of the new hall. Incongruous though they may first appear, these doorways are perfectly acceptable examples of the neo-Jacobean architecture which the Blacketts used to such great effect for the hall itself - indeed the porch above the main doorway to the hall uses exactly the same form of arch. It seems probable, therefore, that the row was either constructed or significantly enhanced in the early 19th century in order to provide a balance of scenic and practical benefits – as an eye-catcher facing the hall and repeating its architectural motifs, and as a shelter for the grazing animals required to maintain the character and function of the park.

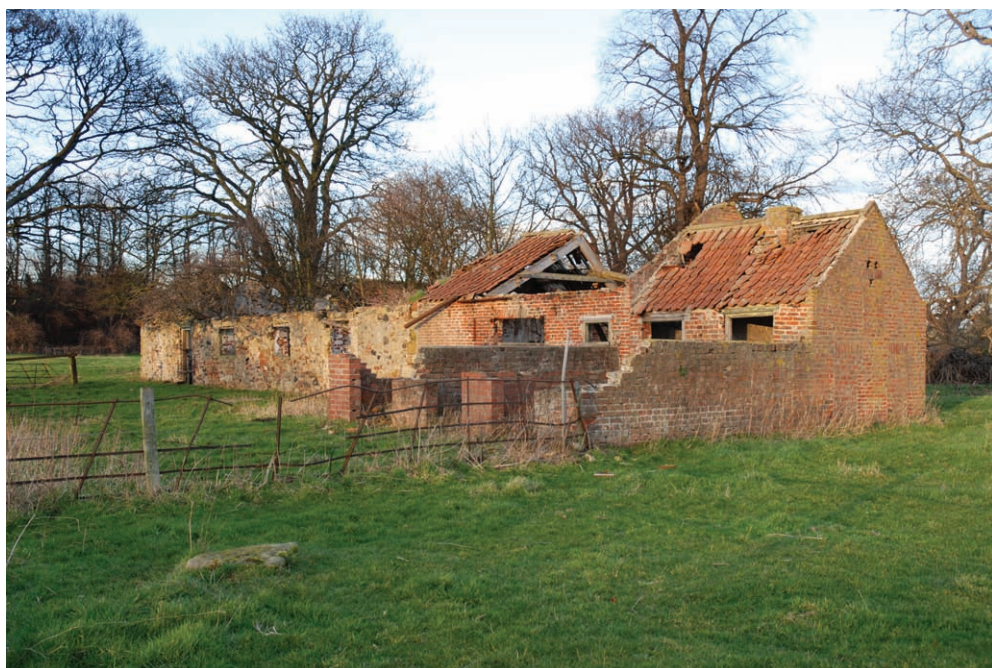
Figure 30. The brick-built extension, pigsties and 'poultiggery' at the southern end of the farm buildings © C J Dunn

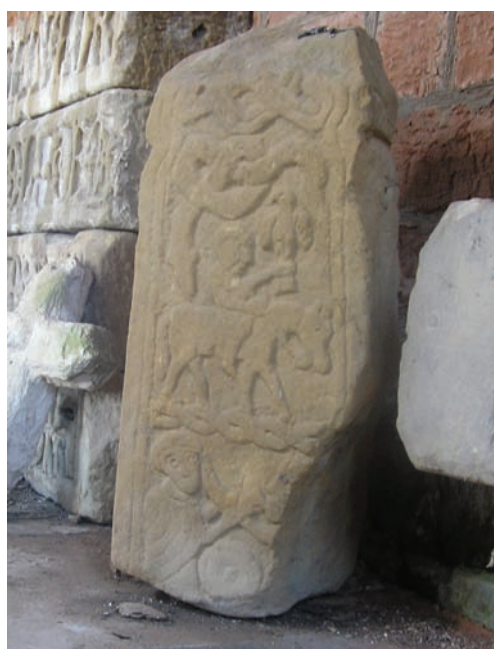
Figure 32. Cross-shaft fragment (Corpus No 3).

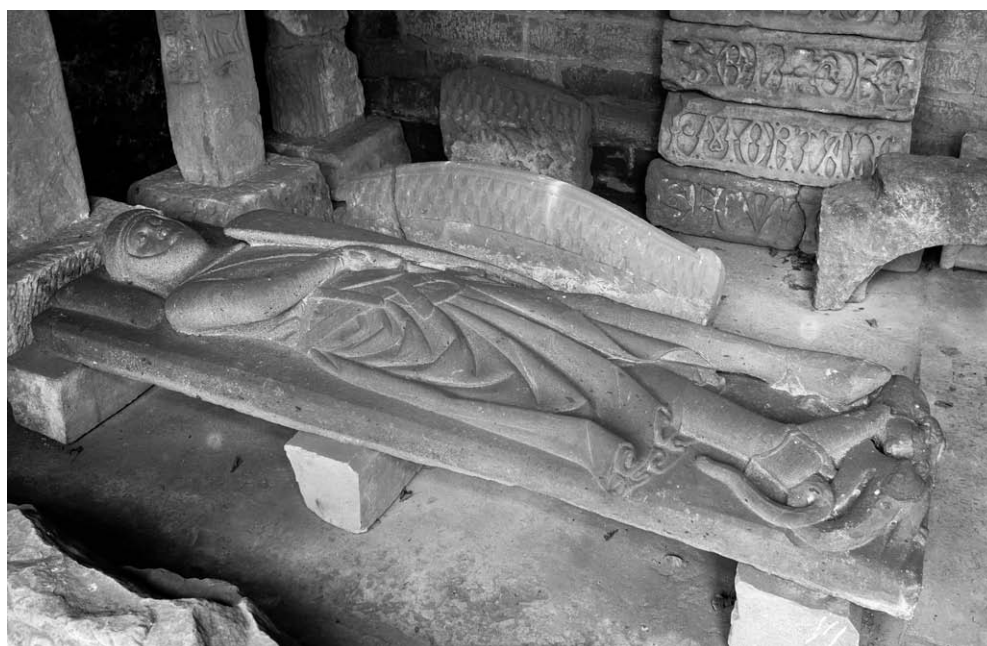
Figure 33. The knight's effigy in the Conyers Chapel, photographed before 1968 (NMR BB68-05289).

The most striking tomb cover at Sockburn is the sandstone knight's effigy currently resting on several blocks in the western side of the chapel (Figure 33). It is remarkably well preserved, having suffered none of the iconoclasm or vandalism associated with more accessible parish churches. The figure, dressed in mail and surcoat, lies cross-legged on a slab measuring c. 2.2 by 0.55m, a triangular shield covering the left arm and the right hand grasping the hilt of the sword which is also worn on the left side. The knight's mail-coifed head rests on a pillow and his spurred feet on a lion and wyvern in combat. Many authors have discussed this effigy. Leland thought it was the tomb of Sir John Conyers who died in 1395 (Toulmin Smith 1964, 69), but the style, as Surtees noted (1823, 249) is clearly older. Pevsner (1983, 411) puts the date at c. 1310-20. Knowles (1905, 107) draws parallels with still earlier examples from the 1220s and considers the effigy to date from the middle of the 13th century. More recent researches confirm that this style developed at about this time and lasted for approximately 100 years (Grinley 2001, 44-45). At the time of William Dugdale's visit to Sockburn in 1666 the effigy was located in the nave (Hunter Blair 1925, 56). Boyle (1892, 660) mentioned that the effigy was then preserved inside Sockburn Hall. It appears to have been returned to the church after the restoration of the chapel in 1900.

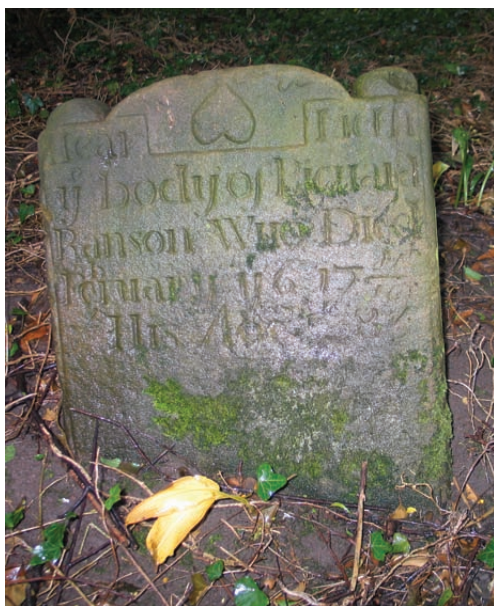
Figure 35. Richard Ranson's headstone (No 19), dated 17¹¹/₁₀

Earlier memorials, dating from first half of the 18th century may have been saved by similar considerations, although it is equally likely that they were retained because their archaic appearance suited the romantic role of the ruined church. One of these earlier gravestones merits a special mention. Richard Ranson's headstone (No 19) is inscribed with a split date 17¹¹/₁₀. This is fine example of the method used to mark a date in both the new calendar, when the year began on the 1 January, and the old calendar which counted each year from 25 March (Lady Day). Until the Gregorian calendar was

formally adopted under the Chesterfield Act of 1752 any date between 1 January and 24 March could be counted twice in this fashion. Ranson's death occurred on 6 January 1711 in the new style calendar, a day which was still in the year 1710 according to the old way of reckoning.

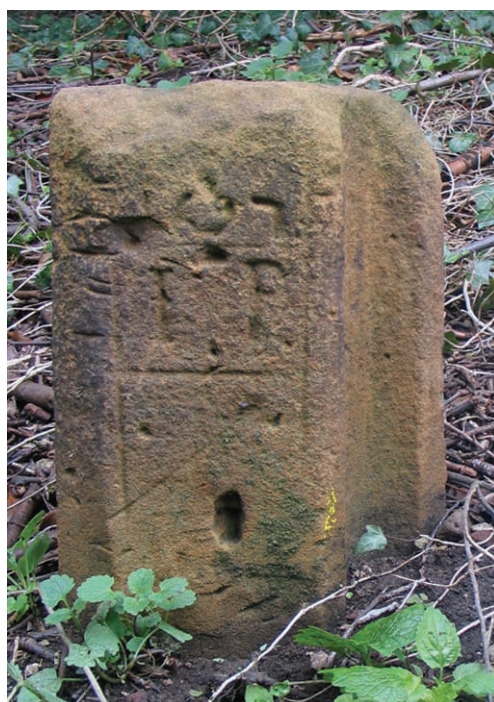
Figure 36. Re-used architectural fragment (No 13) bearing the graffiti 1697 IP

Another interesting stone is a small stump (No 13) located centrally to the south of the church ruins. This is an architectural fragment, possibly part of a door surround, poorly inscribed with the date '1697' and the initials 'IP'. This may have been set to one side during the demolition of the church on account of the 17th-century graffiti. Why it was placed in the graveyard, however, remains a mystery. Perhaps it was used to maintain the position of a grave whose temporary marker had all but disappeared in 1838. A similar stone, bearing the initials 'I (or V) R' and the date 1739 or 1709 was photographed resting at the foot of the new buttress on the south side of the chancel arch in 1944 (NMR AA45/02541). This stone can no longer
