Round Lake Beach: Wetland Management Plan

Submitted by Dezirae Gonzalez & Monika Jalowiecka
May 2019

This Management Plan outlines information which may be used to guide officials on how to identify, assess, enhance, and protect the wetlands in Round Lake Beach outlined in a year 5-, year 10-, and year 20- plan.

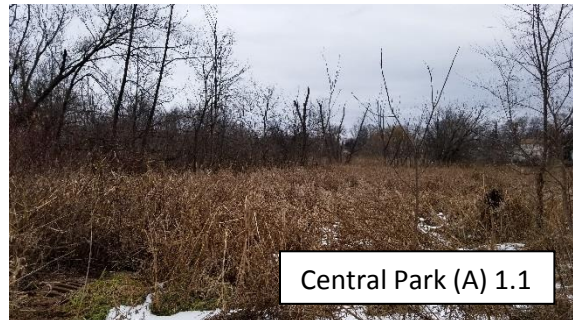
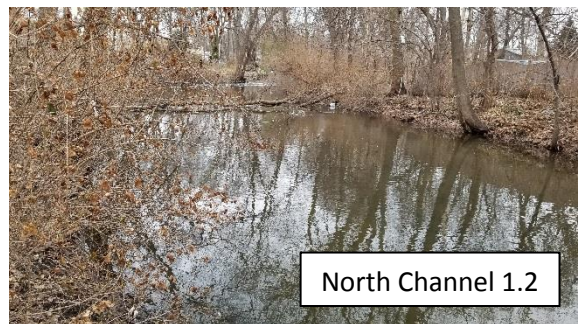
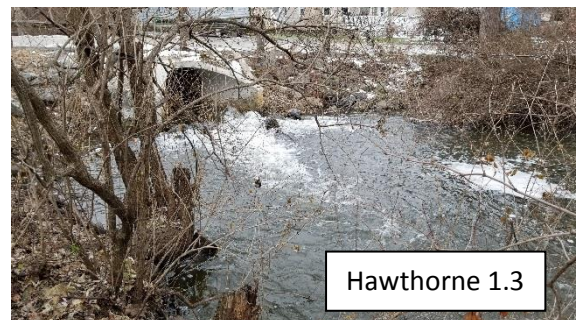
- a) Established invasive species
Invasive species make eradication difficult to control. Mature plants spread aggressively throughout a site, outcompeting native plants for resources. Figure 1.1
- b) High vegetation density
Very dense vegetation is difficult to treat. Many sites have a combination of high vegetation density and small sites with little room for movement making successful treatment a challenge. Sites are commonly located between homes and on active waterways. Figure 1.1
- c) Water proximity
Working near waterways poses the challenge of highly erodible soil and possibility of chemical drift when treating invasive species. Figure 1.2
- d) Hydrology
Hydrology is another challenge where too much water creates channels or causes extreme erosion and not enough water causes algae build up and hypoxia. Figure 1.3

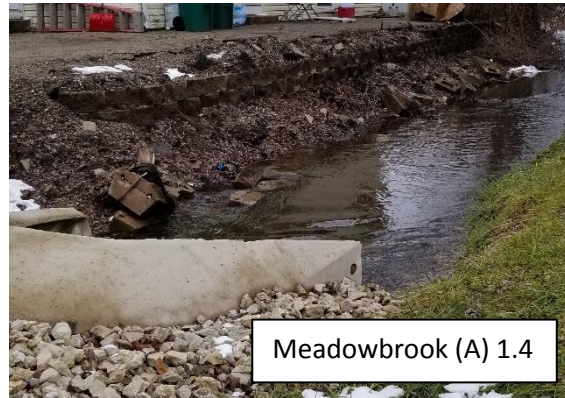
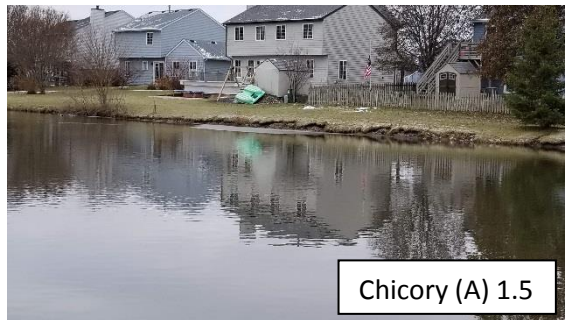
- e) Dumping
 Neighboring homeowners dumping into the waterways or onto wetland sites is a recurring issue with a few sites. This makes keeping the waterway clear and clean difficult. Additionally, wetlands located next to high traffic roads accumulate trash tossed along the edges. Figure 1.4
- f) Site disturbance or/alteration
 A few sites have been altered or disturbed. These disturbances include continuous mowing and development into a commercial building or parking lot. Figure 1.5
- g) Ownership
 Ownership is another challenge as a few sites have multiple owners such as the Park District, commercial, and private owners. Without all owners involved in restoration, the success of the site will be difficult.
