Test Report

Medigenic Keyboard & Mouse Water Ingress

Test Report Number:	9700-02201-00x	Rev: A
Keyboard Part #s:	K104E01-XX, K104C02-XX, K105E01-XXX, K105C02-XXX, K108E01-XX, K108C02-XX	
Scroll Mouse Part #s:	9200 Mouse, M03 Mouse	
Product Manager:	Harley McAllister	
Reliability Engineer:	Wayne Hash	
Test Conducted by:	Wayne Hash	
Date of Test:	September 23, 2020	
Location of Test:	Advanced Input Systems; Coeur d'Alene, ID

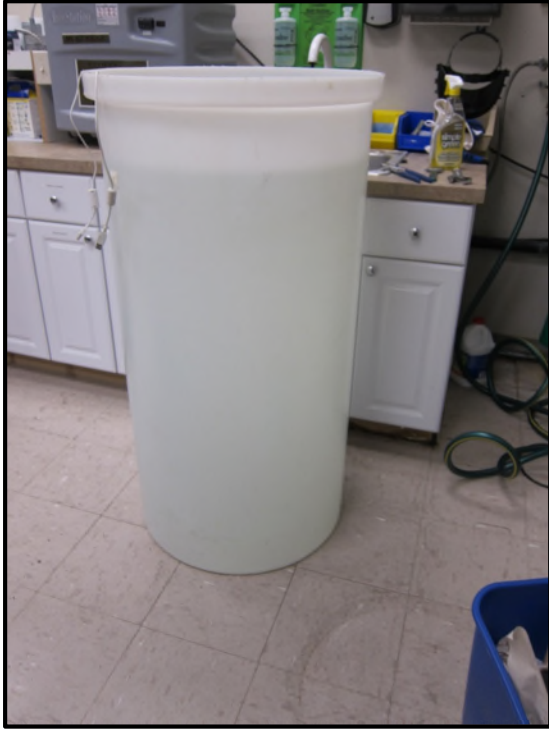
Figure 1: 1-meter deep dunk tank used for IPX7 testing.

To demonstrate compliance to IPX7, the only testing required was to submerge each EUT for 30 minutes to a depth of 1 meter. See Figure 1 and Figure 2.

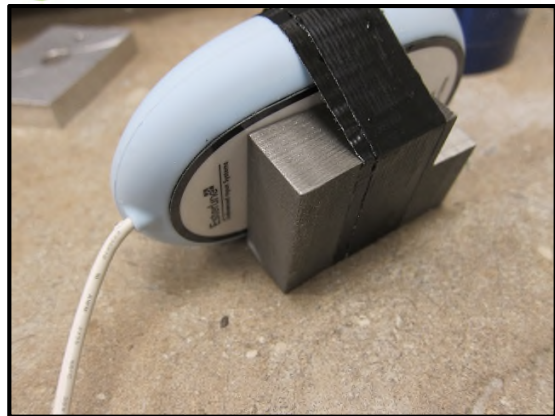
Figure 4: Metal sinker taped to mouse.

Because the EUTs are buoyant, a metal sinker was taped to the mouse and a PVC rod was used to keep the EUTs at the bottom of the tank. No other prep was done. The water temperature was approximately 68F (20C).

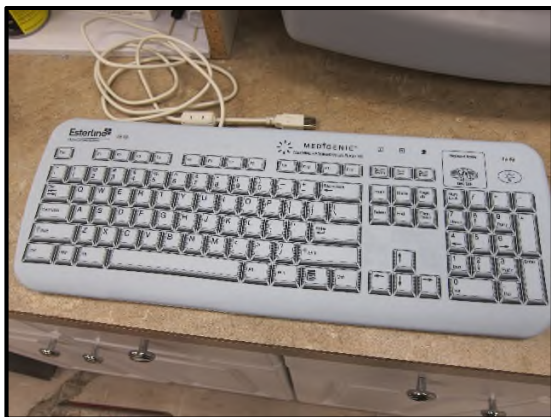
Figure 5: Keyboard sample prior to test.

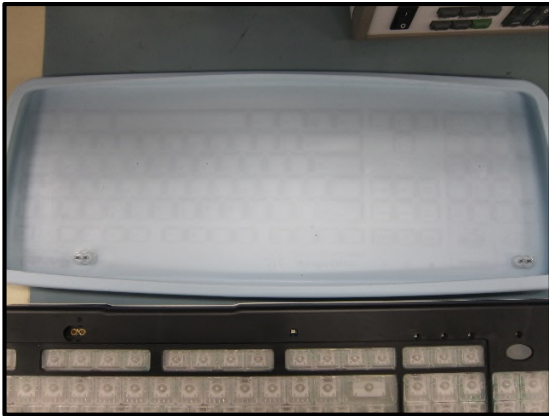
Figure 7: The underside of the elastomer overlay is dry.

The keyboard was disassembled by peeling away the elastomer then removing ten screws that hold the two housings together.

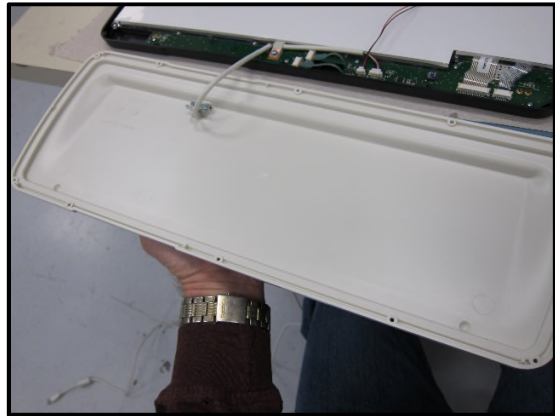
Figure 10: No evidence of ingress on the bottom housing

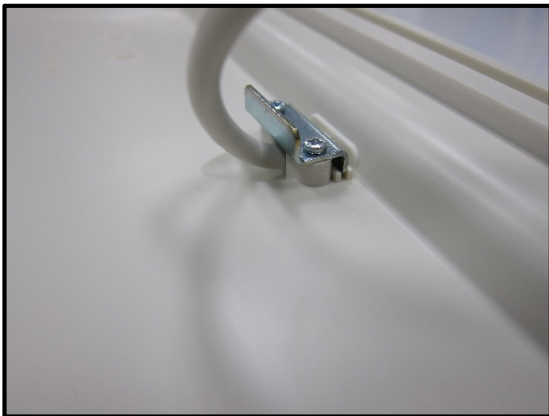
Figure 11: Cable exit was dry.

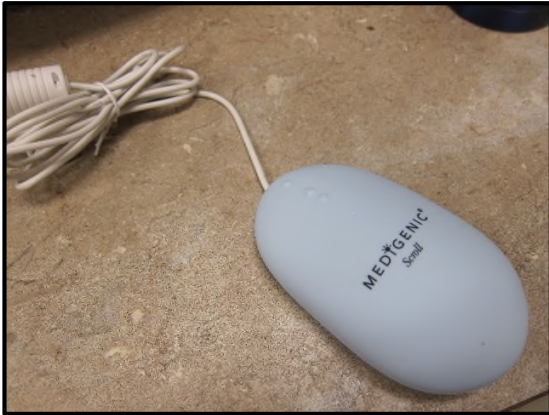
Figure 13: Mouse sample prior to test.

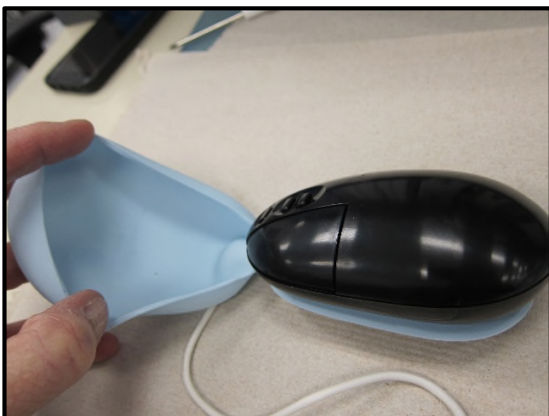
Figure 15: No water under elastomer

The mouse disassembly was destructive. The elastomer was cut off by scribing a line around the label adhered to the bottom. No water was found under the elastomer. An adhesive-backed label on the bottom surface was removed to expose screws to disassemble the rest of the unit.

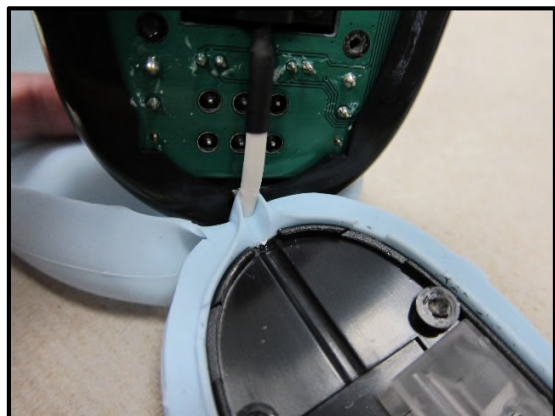
Figure 16: Cable penetration is dry

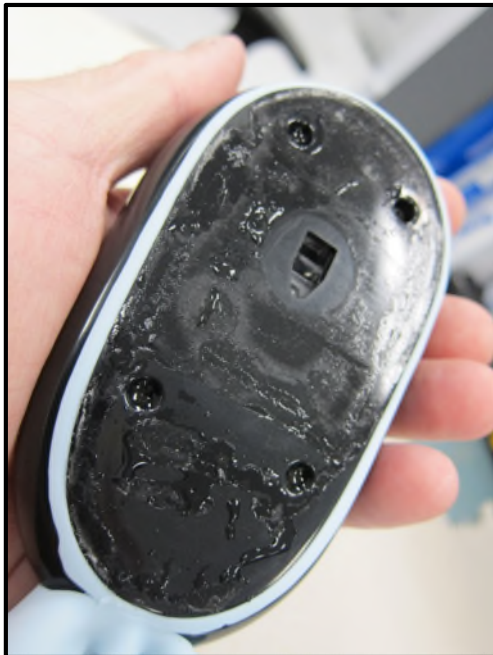
Figure 17: Water under adhesive label overlay

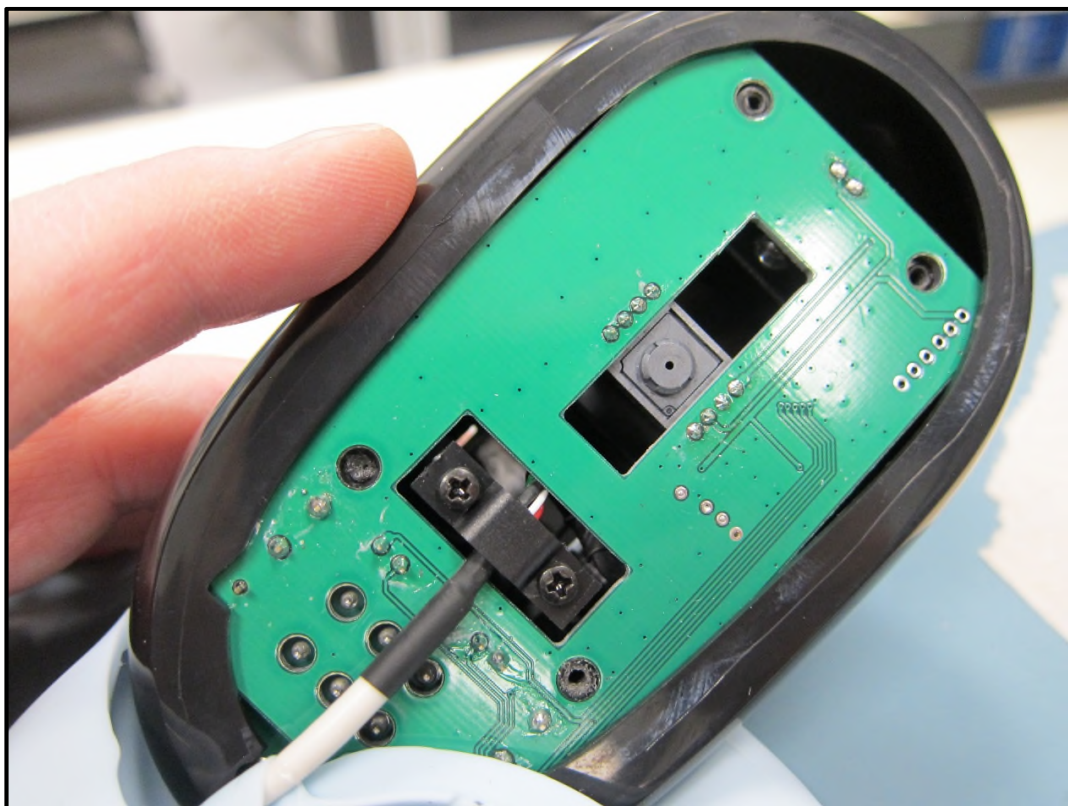
Figure 19: PCB and interior was dry
