Rare Plant Surveys for the Michigan Department of Transportation: US-23 in Ann Arbor. Project #200841, Washtenaw County, Michigan

December 23, 2021

MNFI Report No. 2021-24

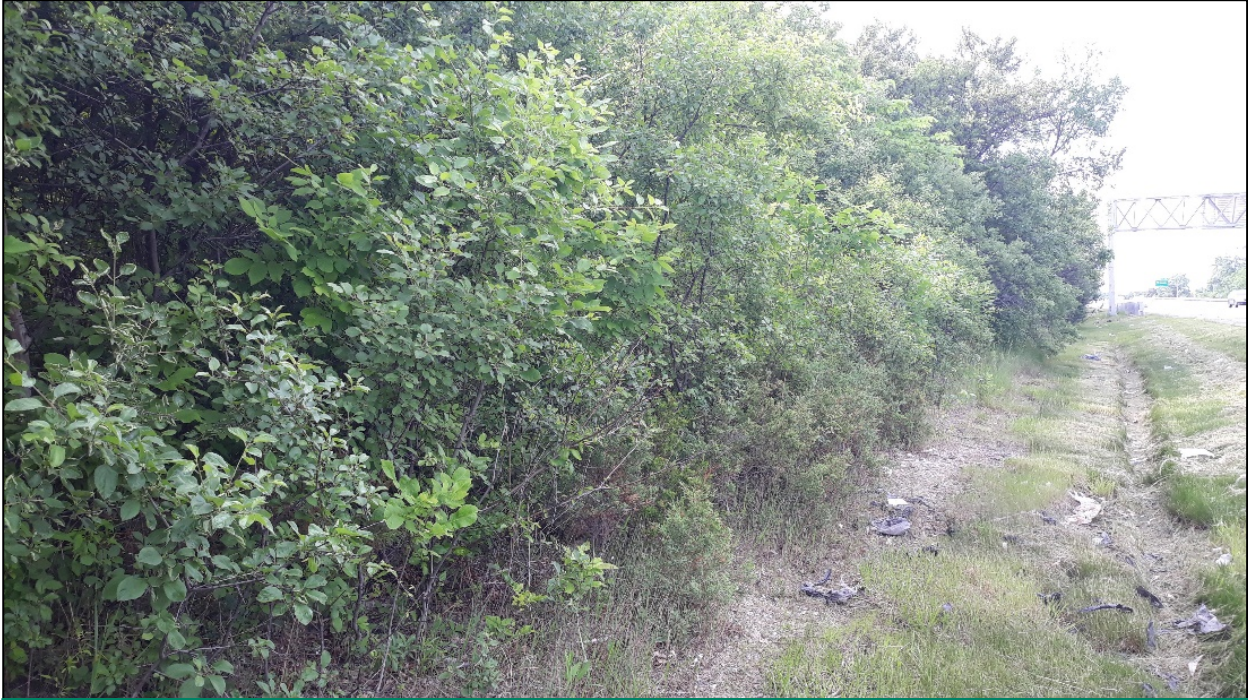
The general habitat along the right-of-way is comprised of disturbed woodlands with a dense shrub layer of mostly non-native invasive species (Fig. 2), at times opening to an herbaceous zone with a mixture of native and non-native forbs and grasses. A wet ditch zone dominated by invasive reed (*Phragmites australis* subsp. *australis*) and narrow-leaved cat-tail occur along much of the corridor, adjacent to the mowed areas along the freeway shoulder (Fig. 3). Invasive common buckthorn (*Rhamnus cathartica*), autumn olive (*Elaeagnus umbellata*), and Eurasian honeysuckles (*Lonicera* spp.) dominate the shrub layer and non-native species such as teasel (*Dipsacus fullonum*, *D. laciniatus*; Fig. 4), tall oat grass (*Arrhenatherum elatius*), smooth brome grass (*Bromus inermis*), red fescue (*Festuca rubra*), squirrel-tail grass (*Hordeum jubatum*), fescues (*Lolium arundinaceum*, *L. perenne*), reed canary grass (*Phalaris arundinacea*), and Kentucky bluegrass (*Poa pratensis*), dominate the herbaceous, open areas. There are also some urbanized areas that lack suitable habitat for the target species.

Figure 2. Dense, non-native shrub zones dominate throughout the corridor.

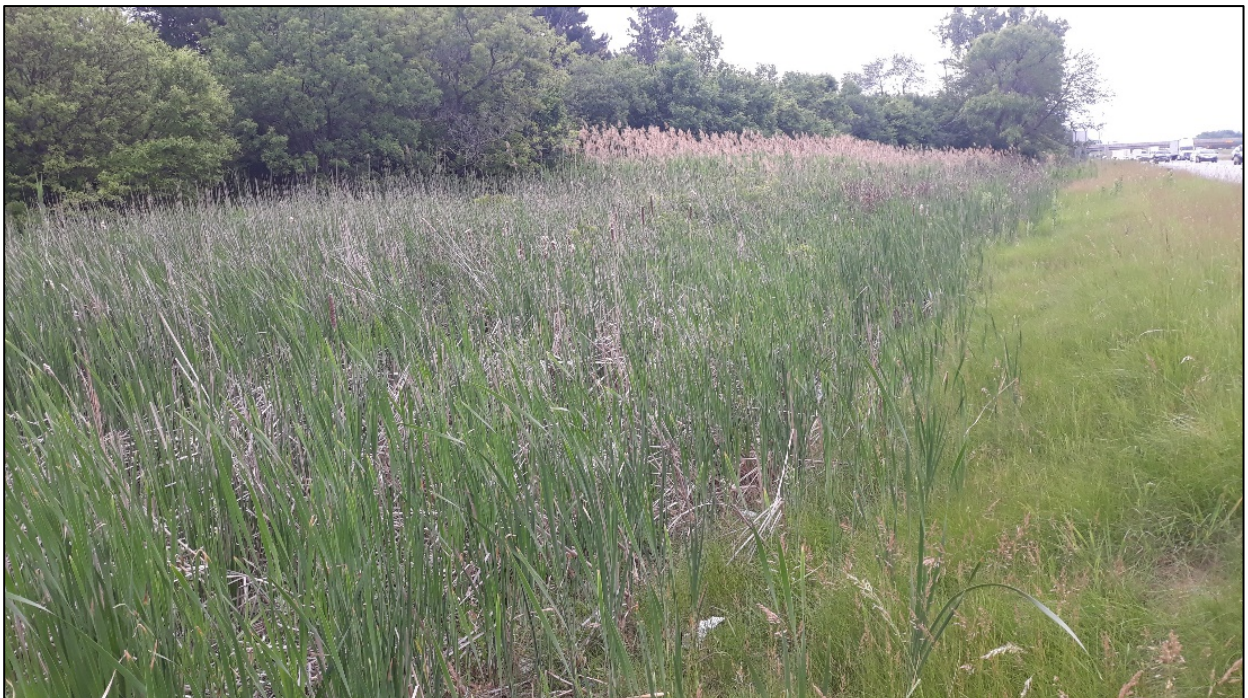
Figure 3. Wet ditch dominated by invasive phragmites and narrow-leaved cat-tail in Segment 2.

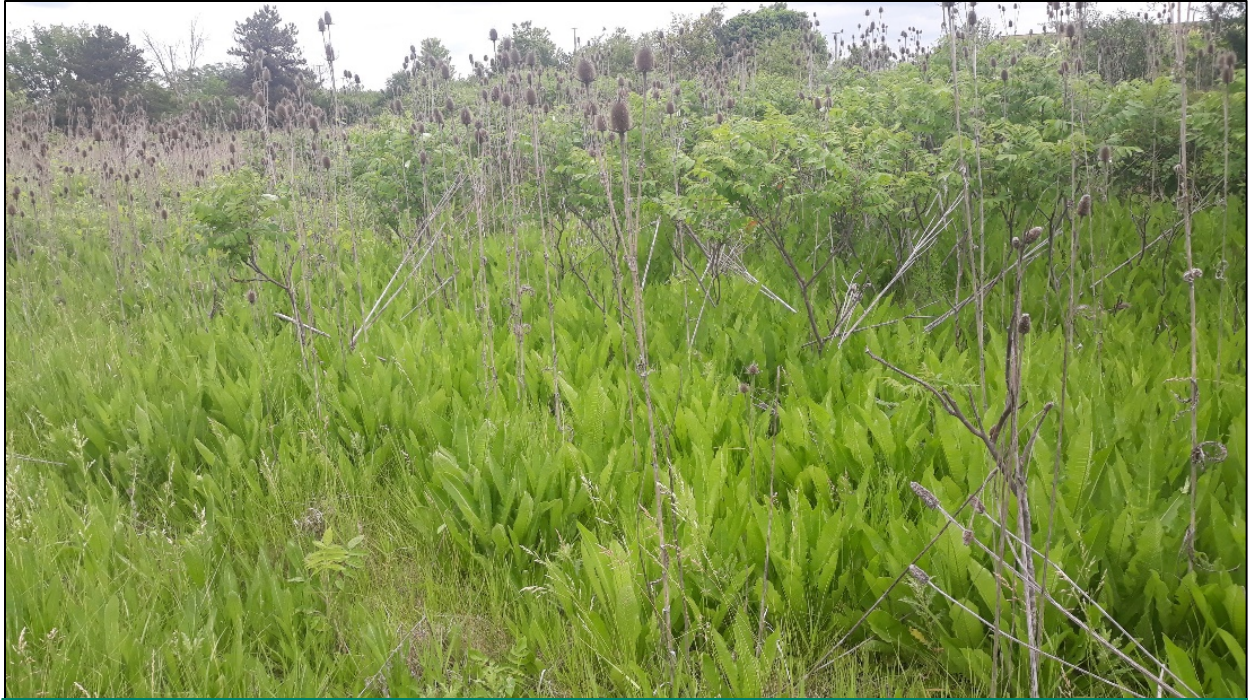
Figure 4. Dense teasel infestations are common in the project area.

The highest quality areas are the small, isolated old-field successional and prairie communities scattered throughout the project area, and in the median of the northern extent of the project area in Segment 6. Care should be taken to limit the disturbance throughout the corridor so that current habitat and native species components are maintained. Aside from these small openings, the ROW is highly infested with invasive species, especially shrubs and teasel. Emphasis should be placed on decontamination of vehicles when moving to uninfested sites.

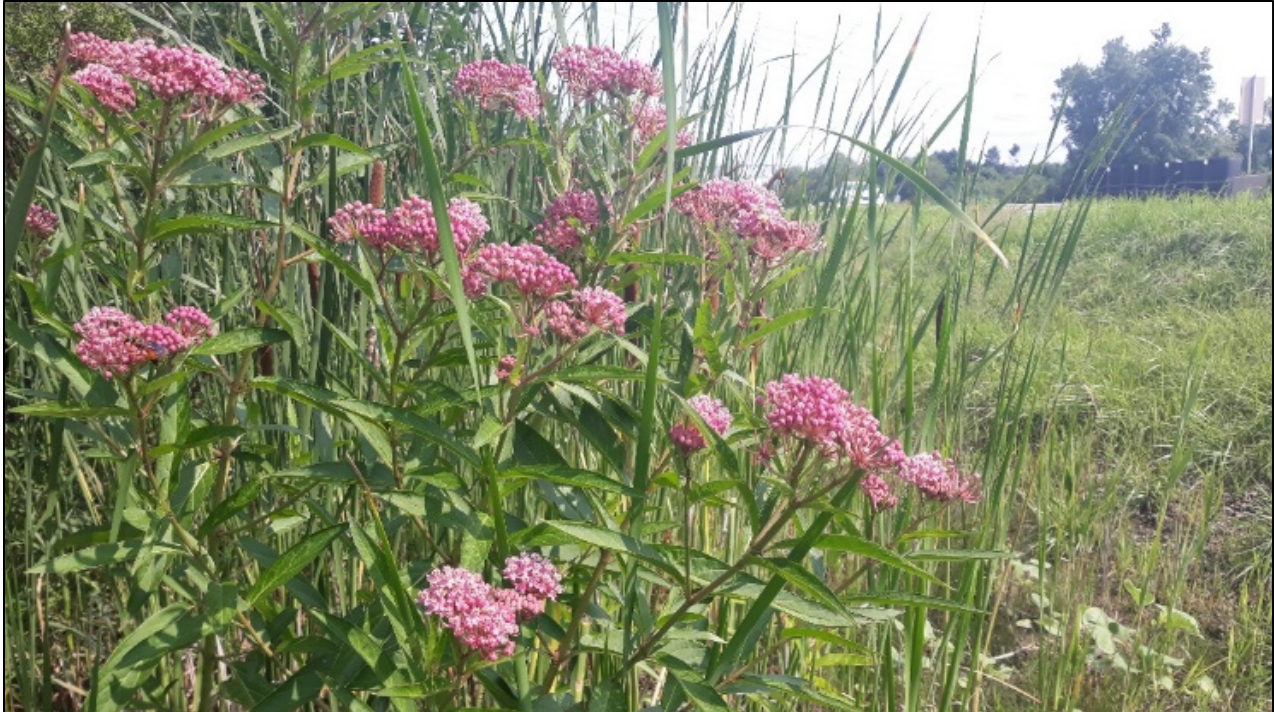
Figure 6. Native swamp milkweed mixed in with narrow-leaved cat-tail in a wet ditch in Segment 2.

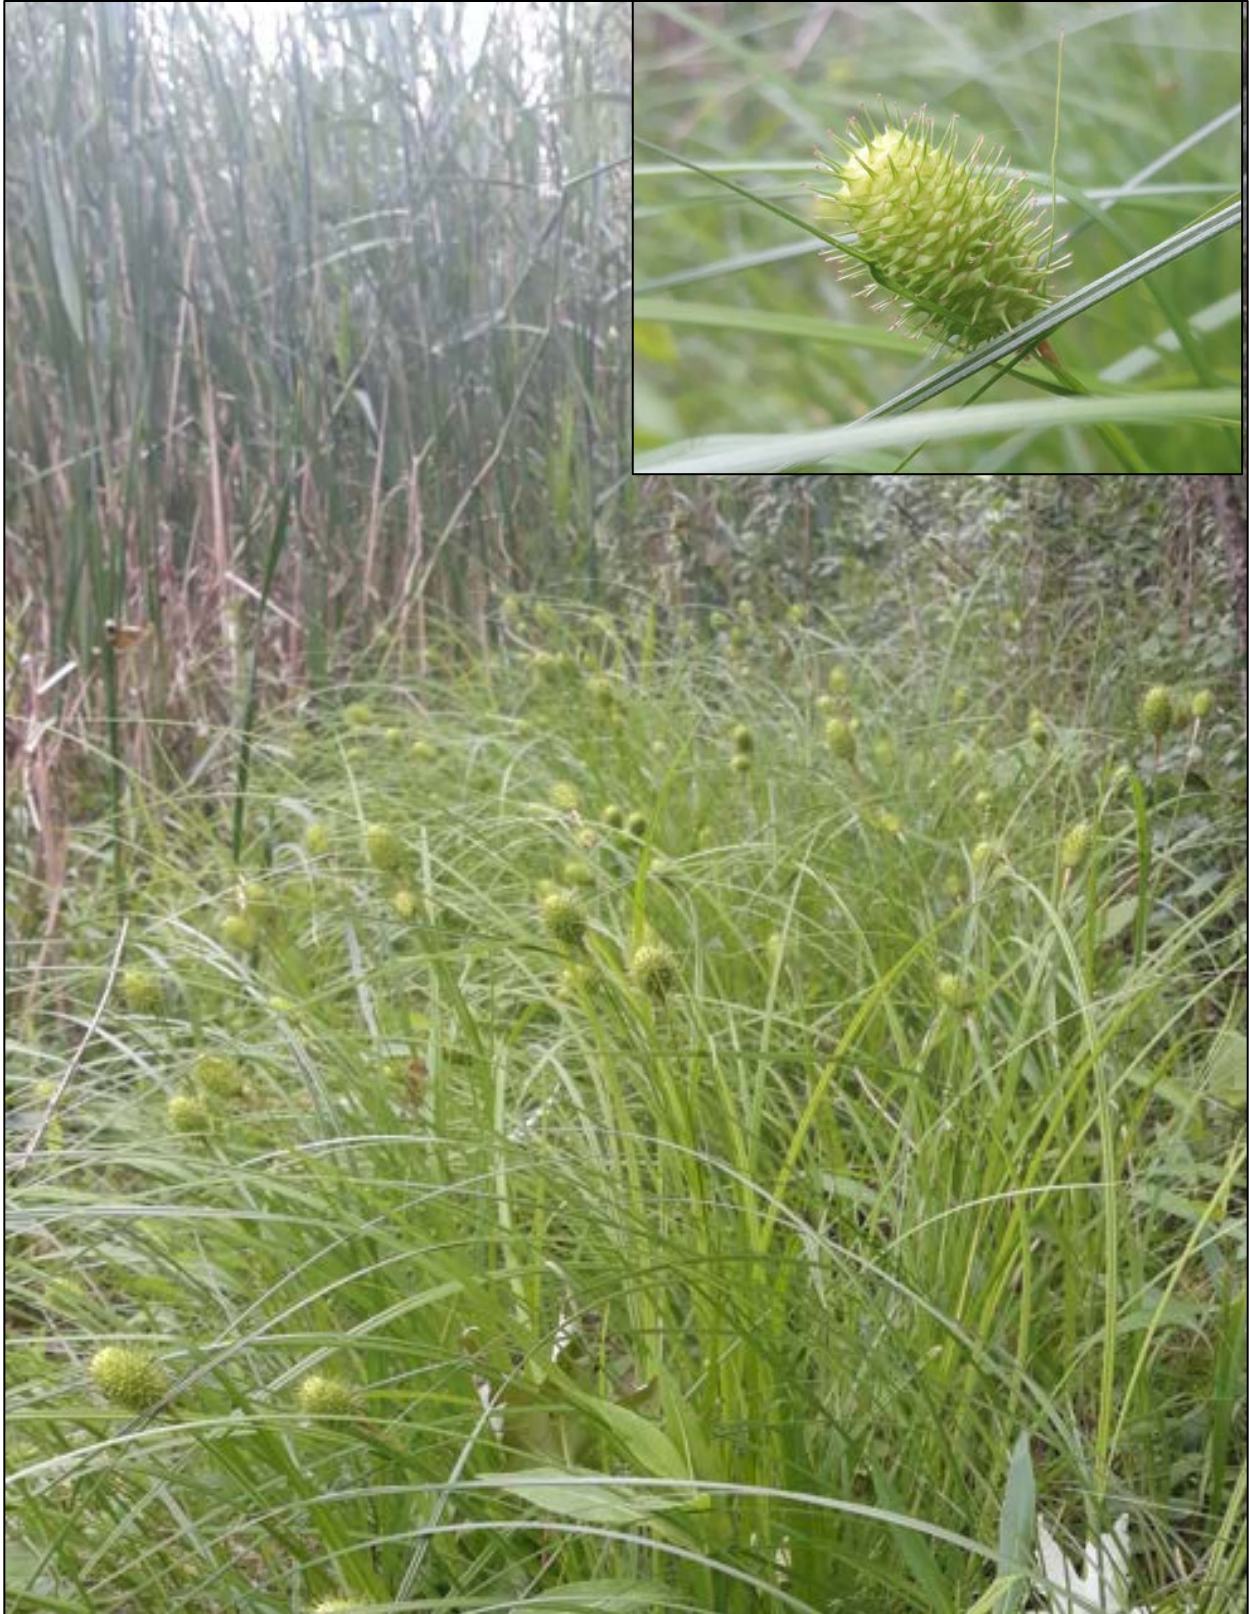
None of the target species were found, however, the nut-sedge *Carex squarrosa*, a species of Special Concern in the state, was observed in Segment 1, along the US-23 ROW just south of the I-94 interchange, behind a stand of narrow-leaved cat-tail (*Typha angustifolia*) (Figs. 5, 7).

This segment has a dense shrub layer at the ROW fence with wet ditches and open seeps in some areas. The shrub layer consists of native gray dogwood (*Cornus foemina*) and invasive autumn olive, glossy buckthorn (*Frangula alnus*), Amur's honeysuckle (*Lonicera maackii*), and common buckthorn. Some of the wet ditches are dominated by invasive phragmites and narrow-leaved cat-tail, while others are more diverse, including swamp milkweed (*Asclepias incarnata*), dogbane (*Apocynum cannabinum*), goldenrods (*Solidago canadensis*, *S. altissima*, *S. gigantea*), asters, including New England aster (*Symphotrichum* spp., *S. novae-angliae*), and rushes (*Juncus* spp.) (Fig. 7). Purple loosestrife (*Lythrum salicaria*) is present but not dominant. The ROW along the I-94 interchange is mowed and therefore unsuitable habitat for target species. State special concern *Carex squarrosa* was found in this segment however, it occurred in marginal habitat and is prone to population decline or mortality over time (Fig. 5, 7). Despite its status as a species of Special Concern, *Carex squarrosa* has been documented more frequently in the past 30 years thus becoming more common than previously thought³. The sedge was observed in a wet ditch microhabitat, sandwiched between a swath of narrow-leaved cat-tail and a common buckthorn thicket along the ROW fence. It is recommended to either transplant the occurrence to a suitable location or avoid disturbance to the immediate area.

Figure 7. State special concern *Carex squarrosa* in a wet ditch along the I-94 right-of-way.

The only rare species documented was state Special Concern *Carex squarrosa* where it is growing in a wet ditch. Transplantation to a suitable site elsewhere or ensuring that this location is not disturbed during road work is recommended.

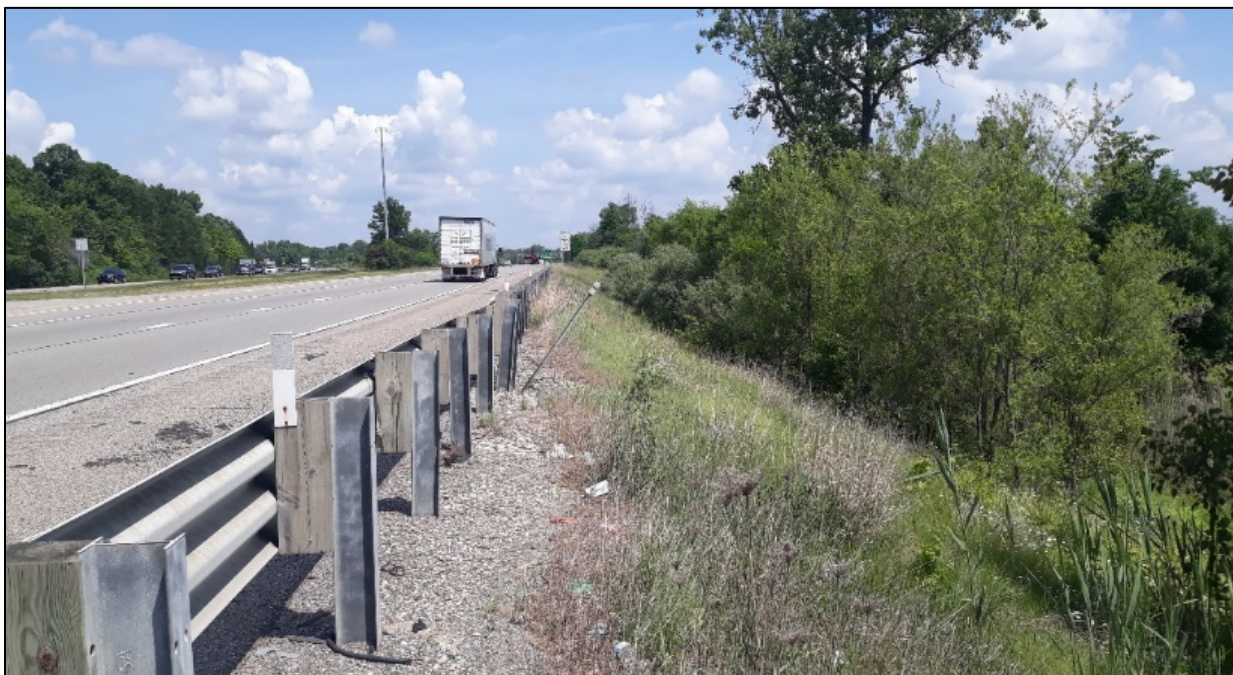
Although this segment is less urbanized, it displays much of the same disturbed woodlands and dense shrub and grass zones found in other segments (Fig. 8, 9). On the eastern side of the freeway there are a couple of very small openings with some nice prairie species including butterfly, whorled and green milkweed (*Asclepias tuberosa*, *A. verticillata*, *A. viridiflora*), low bindweed (*Calystegia spithamea*), and showy goldenrod (*Solidago speciosa*). Figs. 9, 10).

Figure 8. Grass and shrub zones in Segment 3.

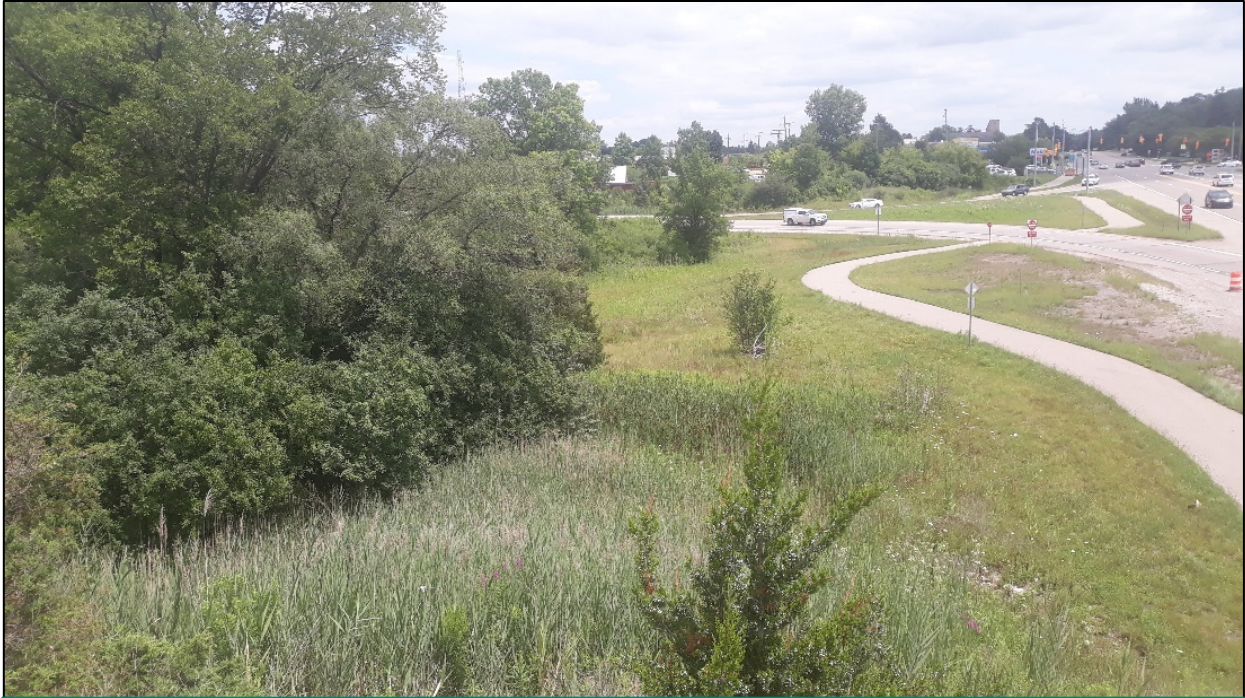
Figure 9. Common vegetation along the Washtenaw Ave. Interchange ramp in Segment 3.

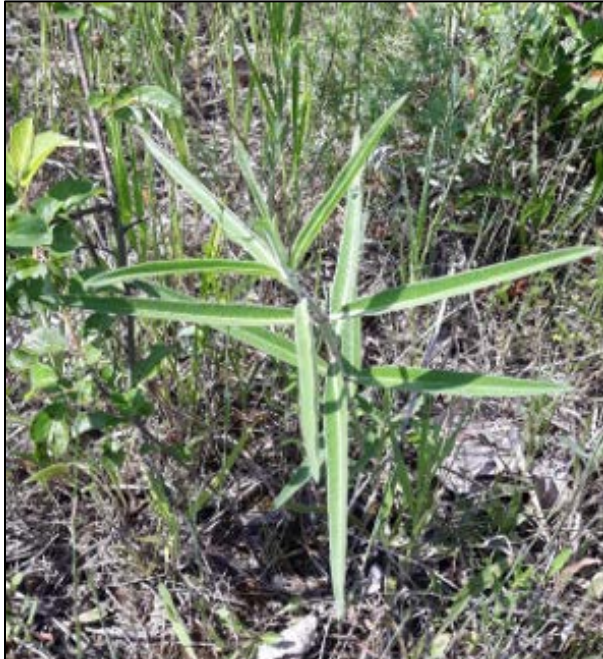
Figure 10. Green milkweed in openings in Segment 3.

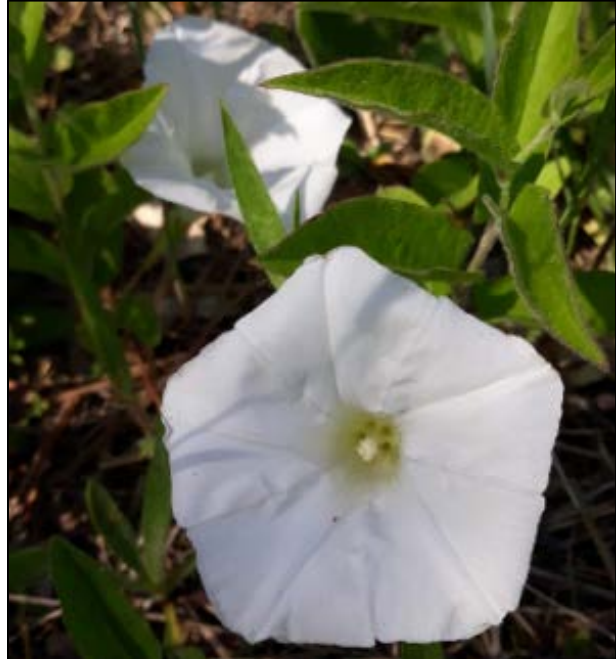
Figure 11. Low bindweed in openings in Segment 3.

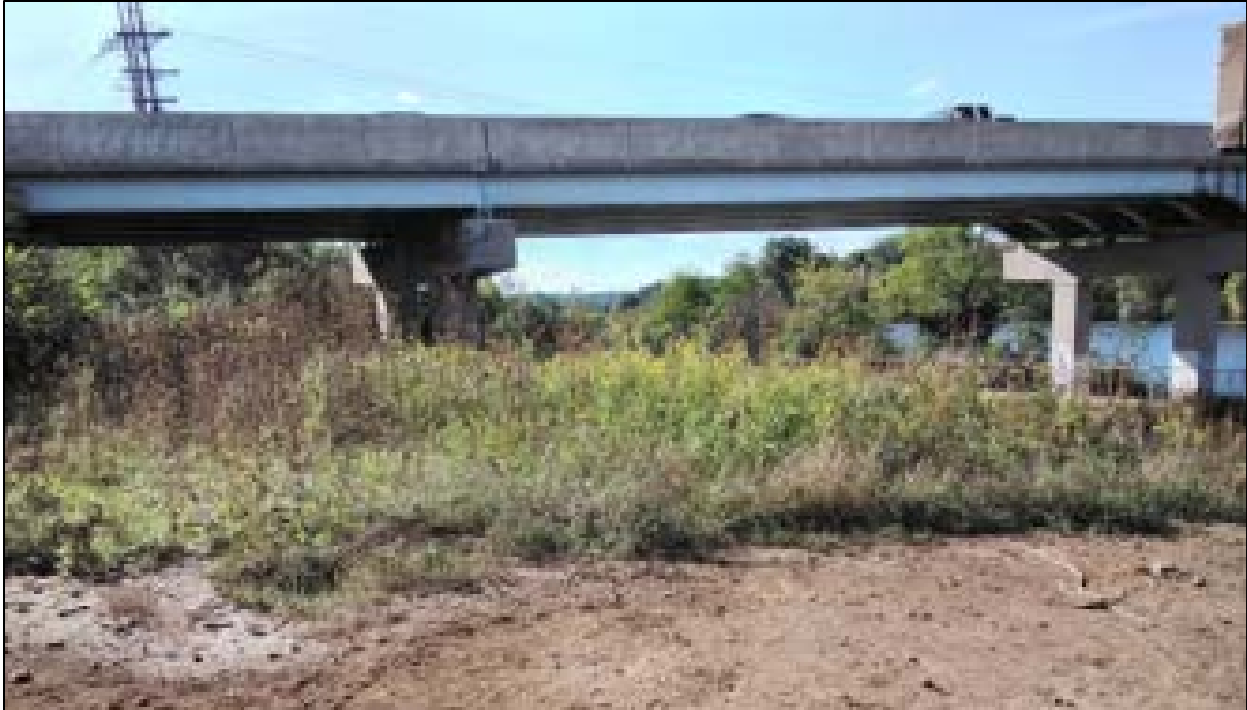
The habitat in Segment 3 alternates between small areas (10-30 feet) of old successional field communities with some prairie species, and wet ditch zones. The non-native shrub and grass species typical of the project area occur on both sides of the bridge over the Huron River (Fig. 12). In addition, the adventive shrub, false indigo (*Amorpha fruticosa*), was found growing around and under the bridge. The many culverts in this segment and throughout the project area are similarly weedy (Fig. 13).

Figure 12. Teasel and goldenrods at the Huron River bridge.

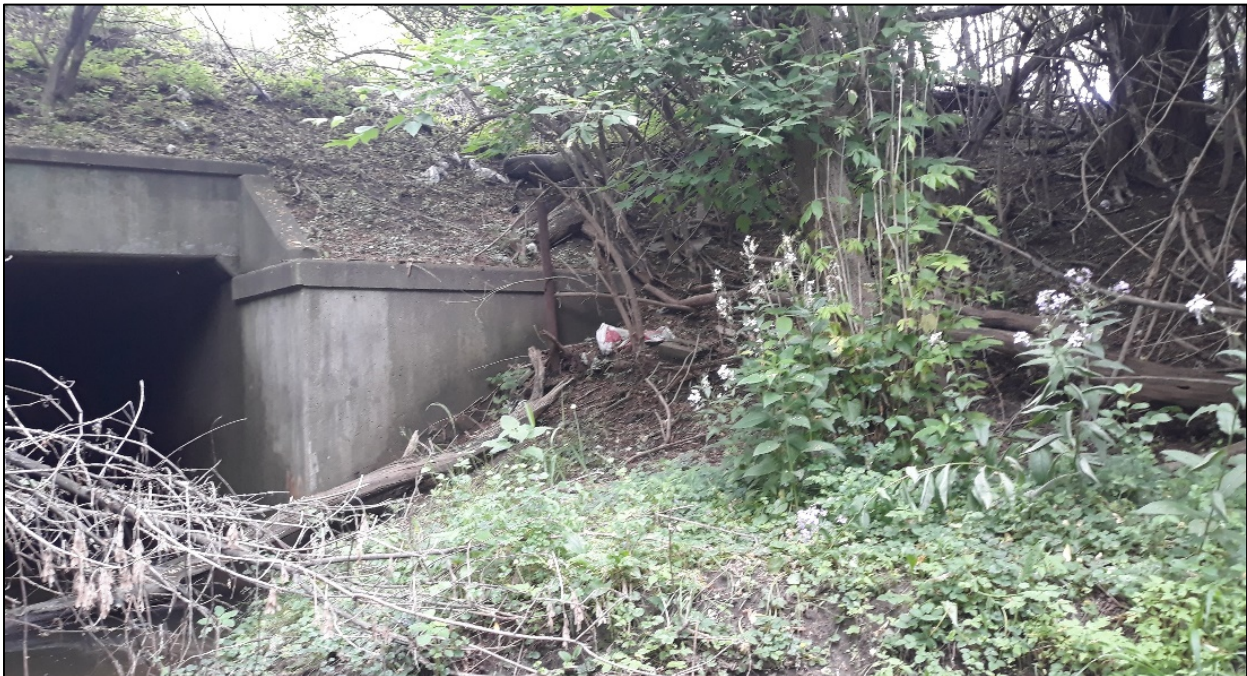
Figure 13. The many culverts throughout the project area are highly disturbed and weedy.

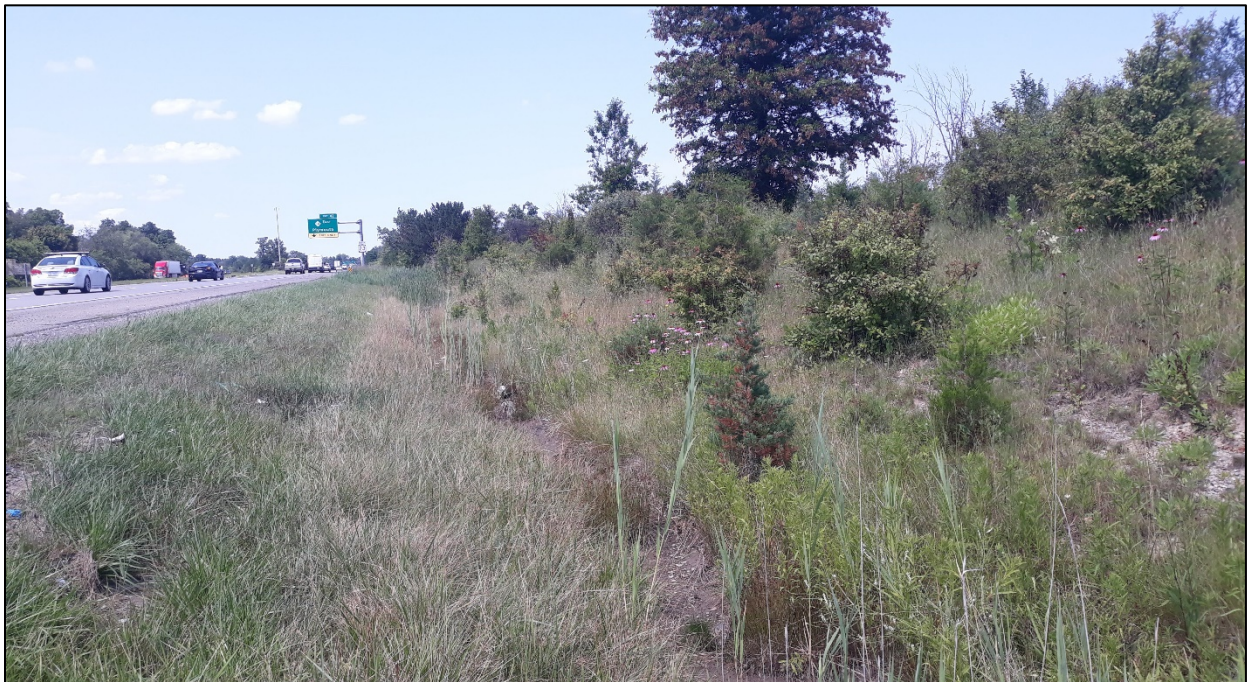
This segment includes the 400-foot wide median at the northern extent with early successional old-field vegetation (Fig.14) and a wet prairie component (Fig. 15). Whorled milkweed, small pussytoes (*Antennaria howellii*), ironweed (*Vernonia missurica*), sunflower (*Helianthus* sp.), low bindweed, rushes, sedges (*Carex granularis*, *C. lasiocarpa*, *C. spp.*), and switch grass (*Panicum virgatum*) were all present in the wet prairie area.

Figure 14. Old field vegetation in Segment 6.

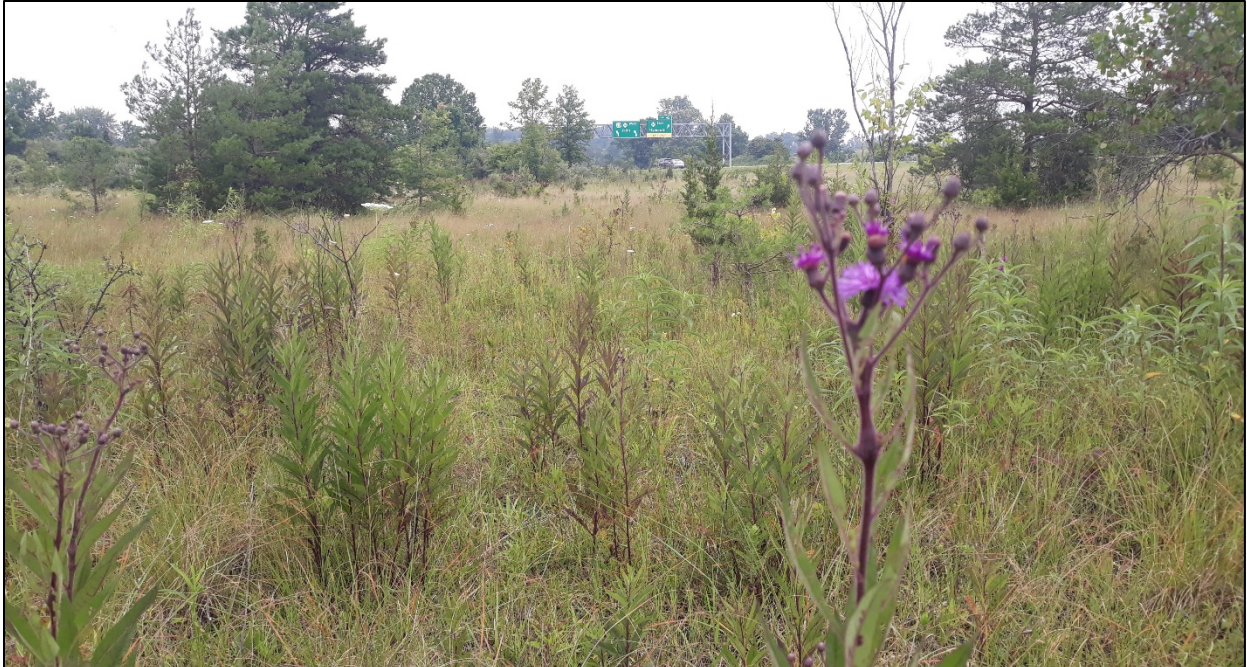
Figure 15. Ironweed in the wet prairie area of the median in Segment 6.

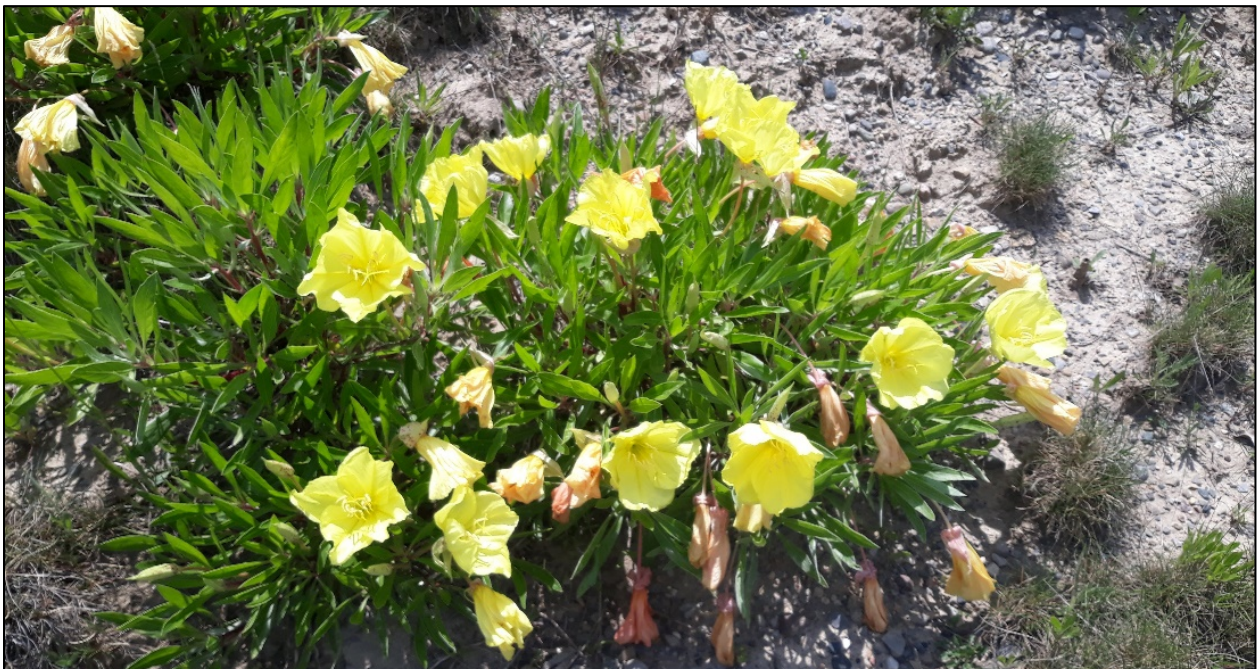
A stand of a non-native, garden plant, Missouri evening primrose (*Oenothera macrocarpa*), was found in flower (Figure 16). Its flowers are very large and showy and hard to miss. This is the first reported occurrence of this species as a garden escape and it is believed to have been either seeded or planted, as was the coneflower (*Echinacea* sp.) growing with it.

Figure 16. Missouri evening primrose – a new garden escape in Segment 6.

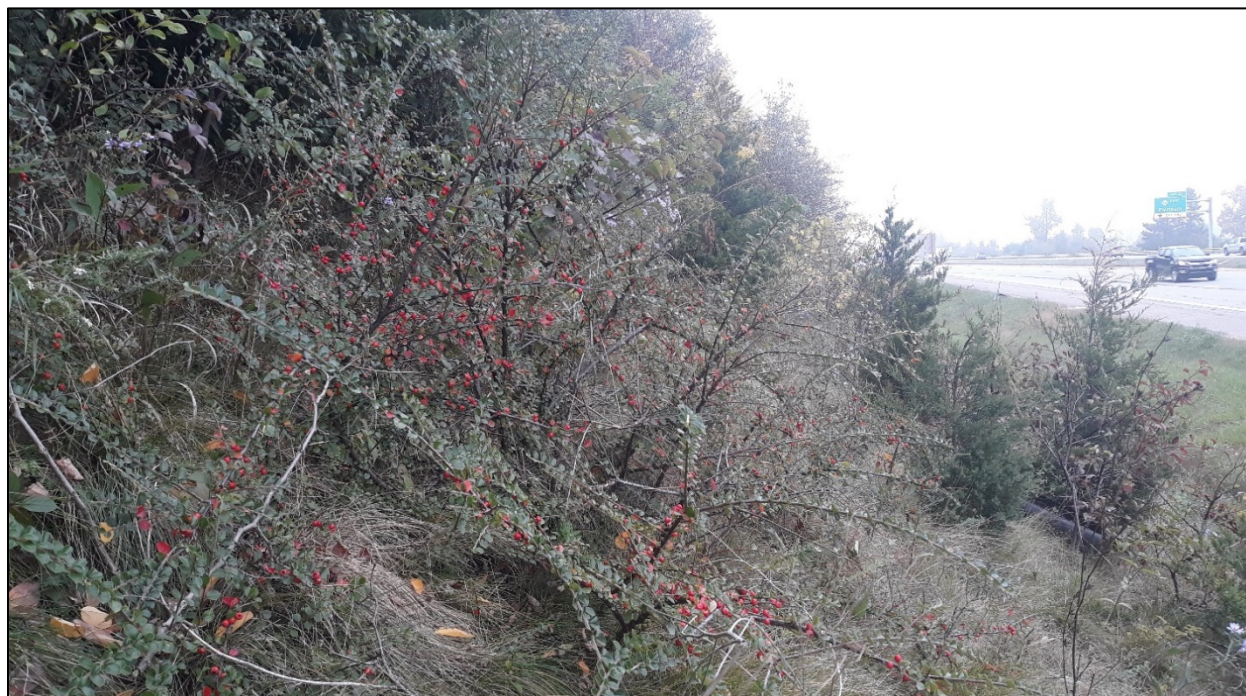
Spreading cotoneaster (*Cotoneaster divaricatus*) was found along the western portion of the northern extent of the project area (Fig. 17). This is a frequently cultivated Oriental shrub that was first collected in Michigan in 1987, when it was described as naturalized and spreading. Several female smoke trees (*Cotinus coggryria*) and a dense patch of seedlings were also found in the median and along the western right-of-way in a brush-hogged area.

Figure 17. Spreading cotoneaster established along the northern extent of the project area.

Spreading cotoneaster and smoke tree were mapped in Segment 6 and an occurrence of Japanese knotweed was mapped in Segment 2 (Fig. 18). Treatment of these occurrences is recommended. Unlike the widespread invasive species noted throughout the project area, these are isolated and more easily managed now while their occurrences are limited.
