Hydrological restoration options for Glenshera Swamp, Stipiturus Conservation Park.

*A case study for investigating the feasibility of restoring
the water regime of Fleurieu Peninsula swamps impacted
by artificial drainage.*

Mark Bachmann and Lachlan Farrington

March 2016

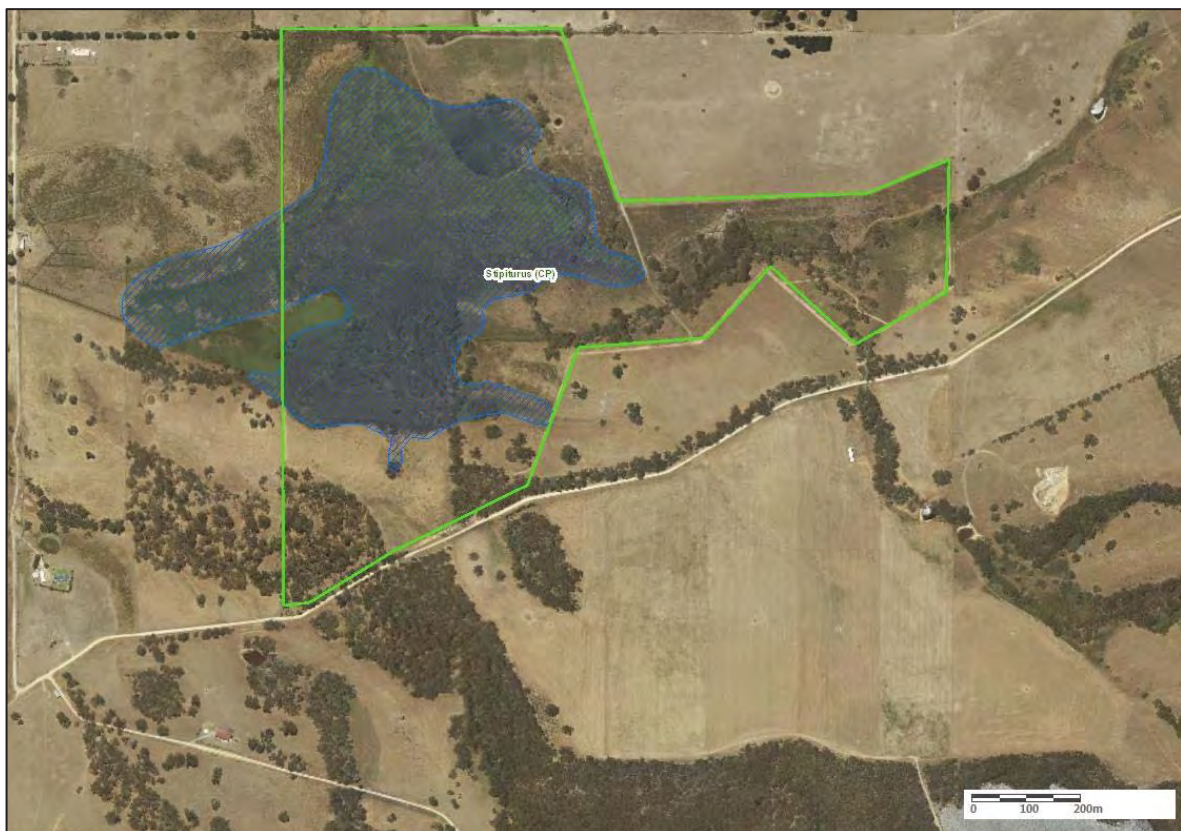
Figure 1.1 – Stipiturus Conservation Park (outlined in green), showing the current mapped extent of Glenshera Swamp (blue shading) in the DEWNR GIS wetland layer.

One site that constitutes the largest and most intact remaining example of the Fleurieu Swamp community (MLRSEWRP, 2004), occurs within Stipiturus Conservation Park (Figure 1.1) – Glenshera Swamp – approximately 6 km west of Mount Compass.

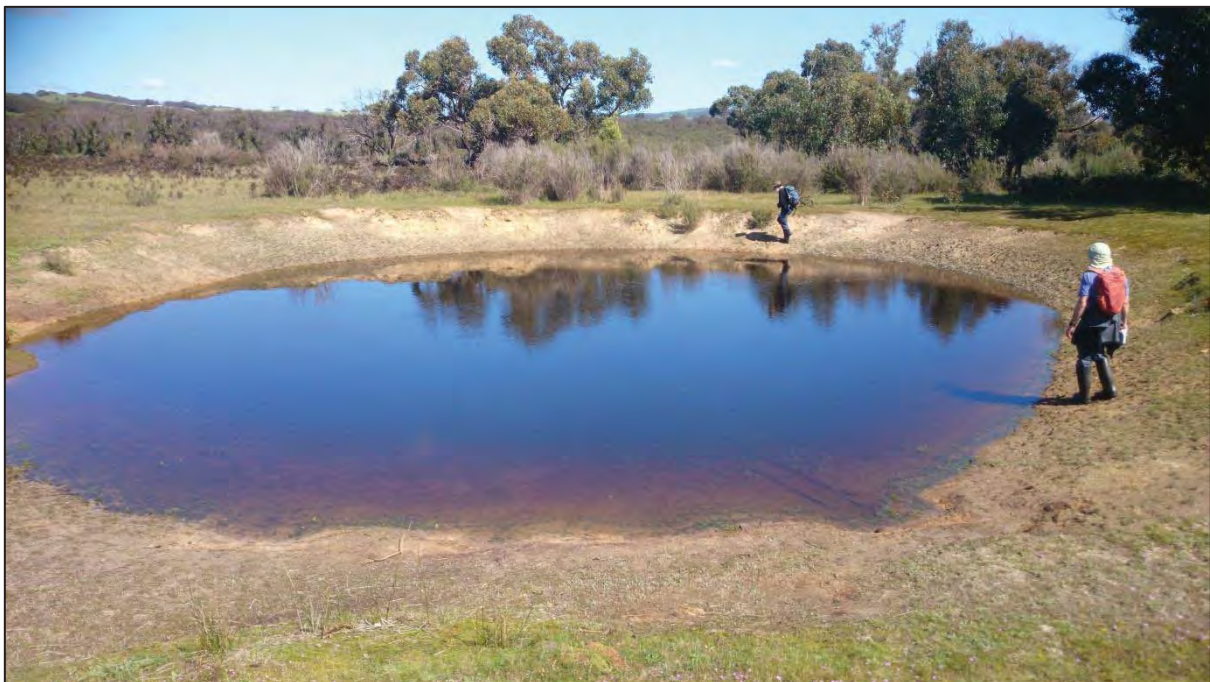
Figure 4.11 – The dam in Stipiturus CP, of 1980s construction, which intercepts hill-side seepage.

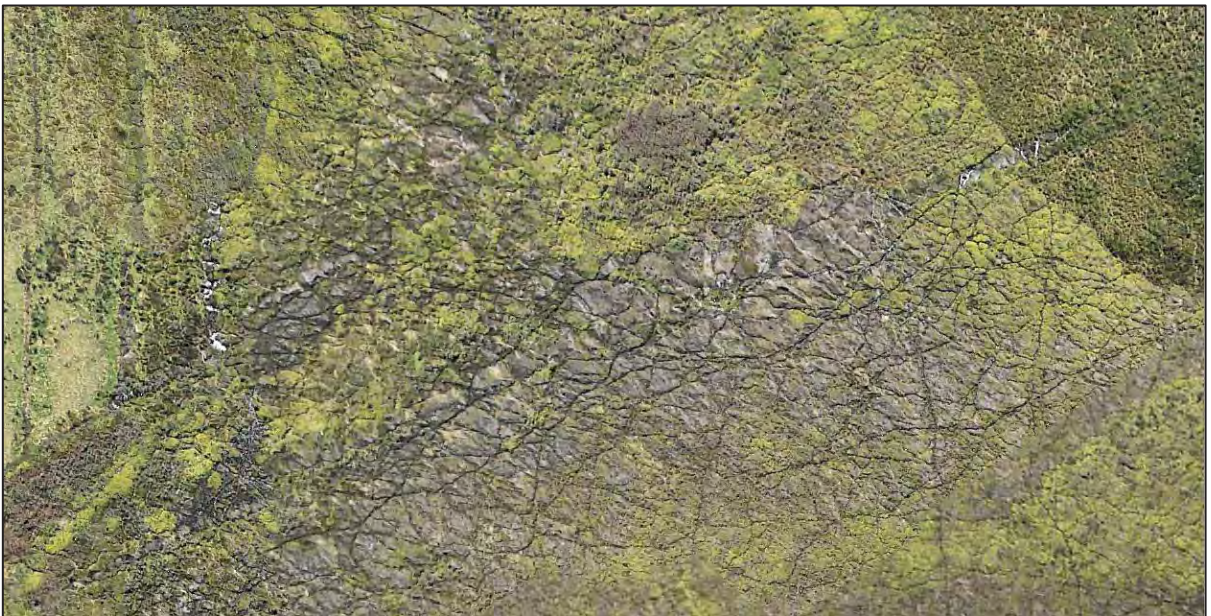
Figure 4.17 – Tracks across main swamp in Stipiturus Conservation Park, as seen from the air. Image captured October 2015.

The visible impact of tracks through the swamp vegetation can be seen in the recent aerial photograph taken as part of this project in October 2015, shown in Figure 4.17. It is worth mentioning that a number of the tracks through the swamp are also being utilised and maintained as a result of the movements of western grey kangaroos, as observed during site visits in spring 2015.

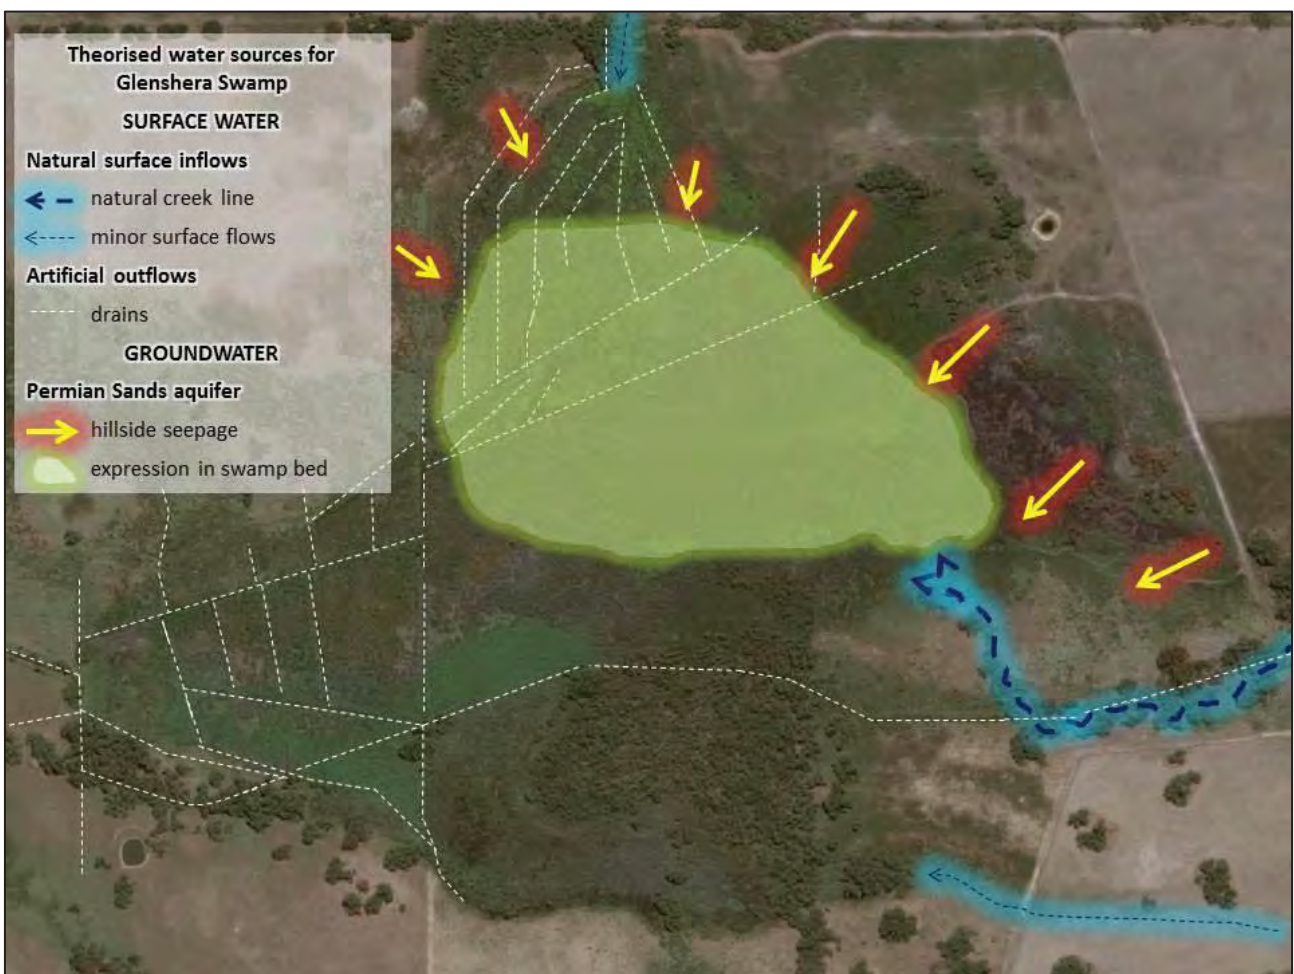
Figure 4.24 – A theorised 2D visual representation of the water sources for Glenshera Swamp

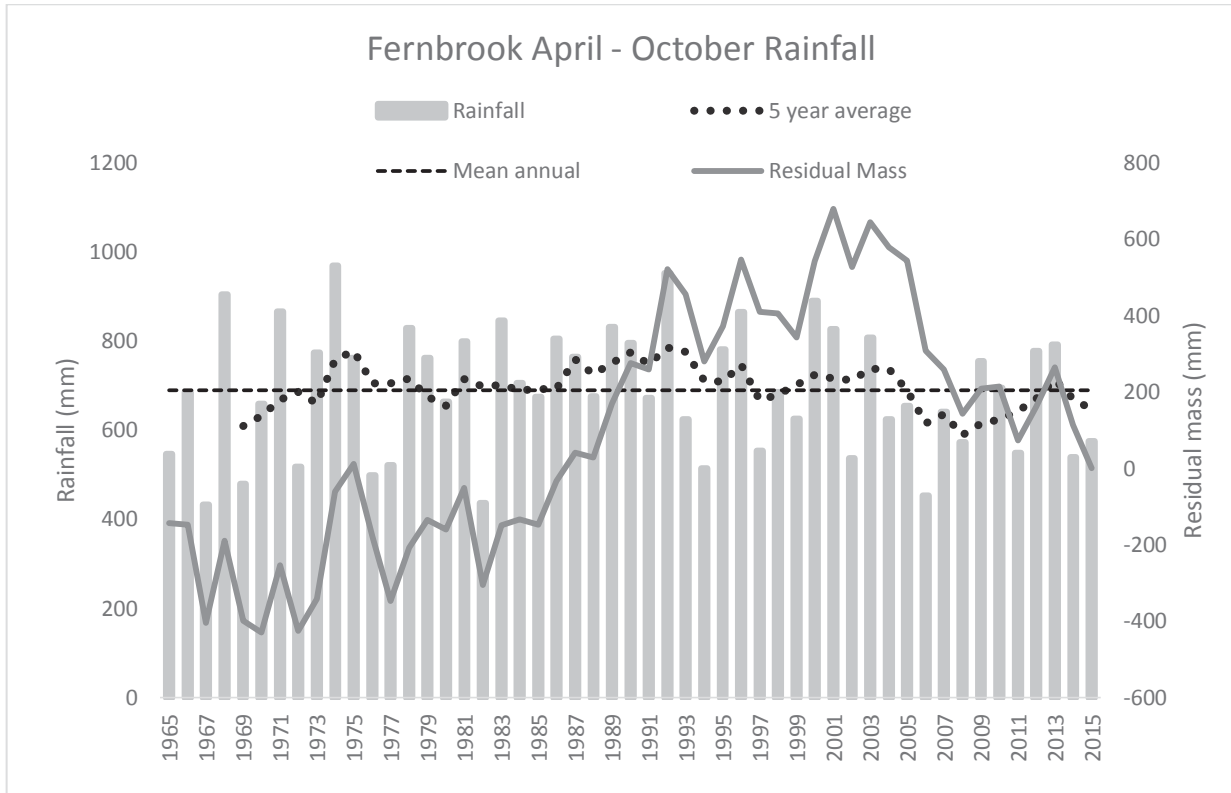
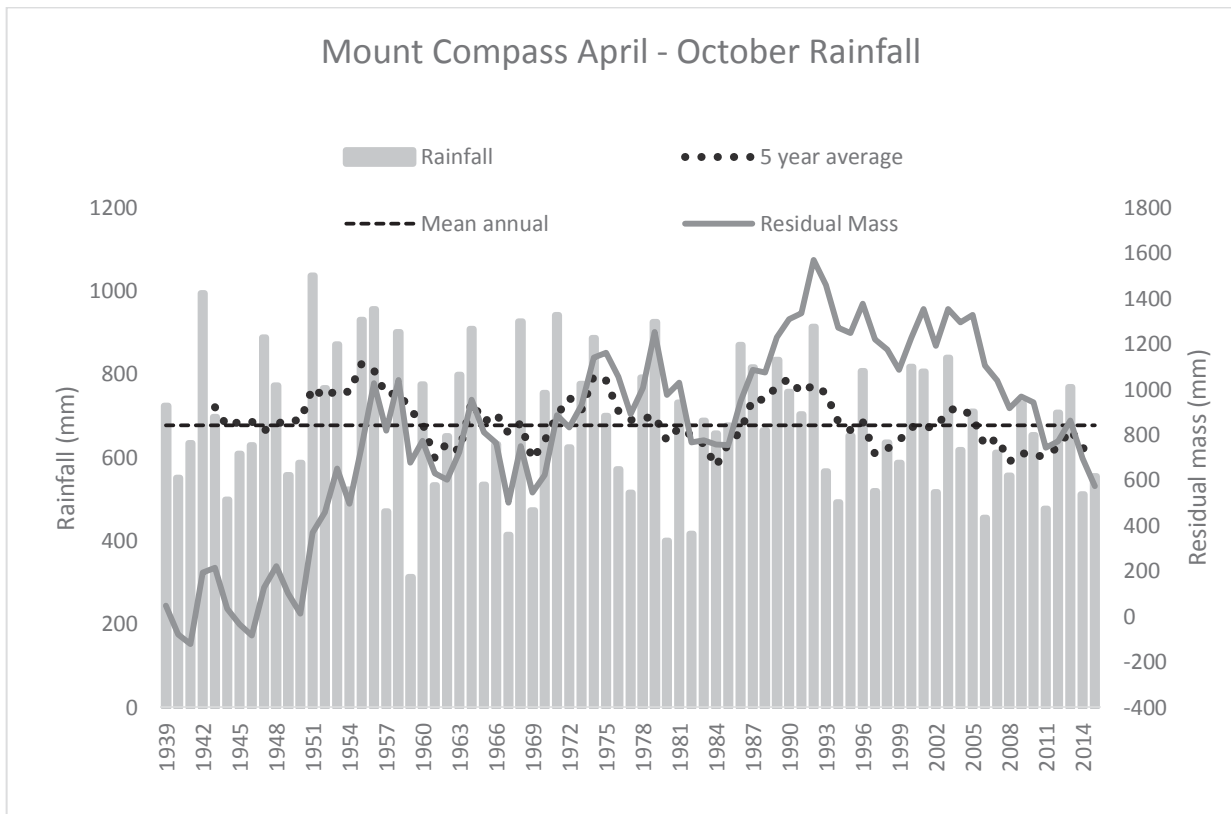
Figure 4.25 – Effective (April – October) rainfall and deviation from average for Fernbrook BOM station (23823), 1965 –2015 and Mount Compass BOM station (23735), 1935 – 2015.

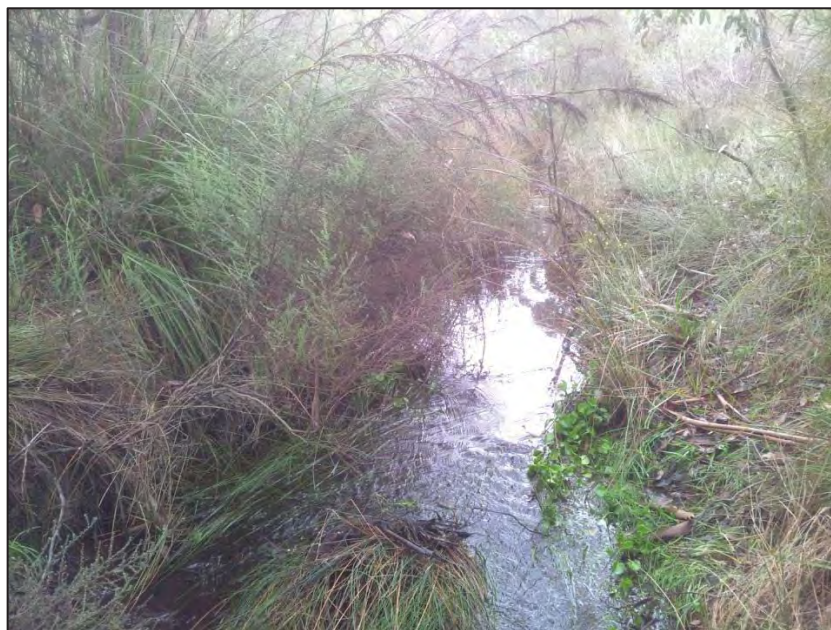
Figure 4.26 – The flow down the main bypass drain that skirts the southern edge of Glenshera Swamp on 8th September 2015.

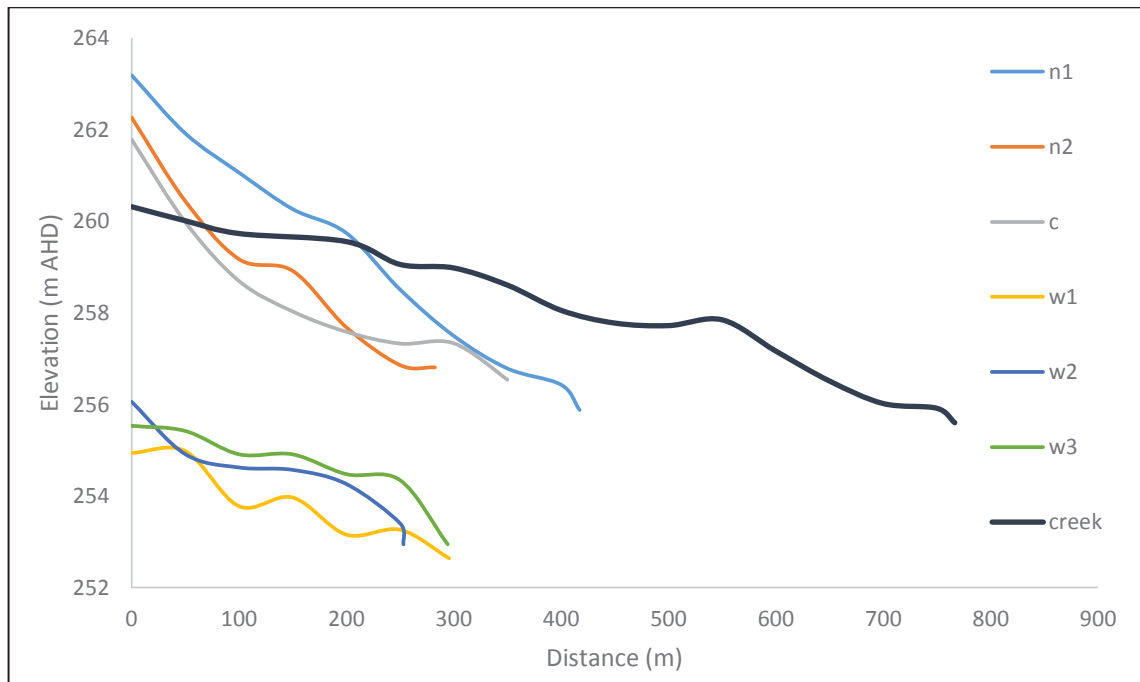
Figure 4.29 – The gradient of major drains along their length (from Figure 4.28) associated with Glenshera Swamp.

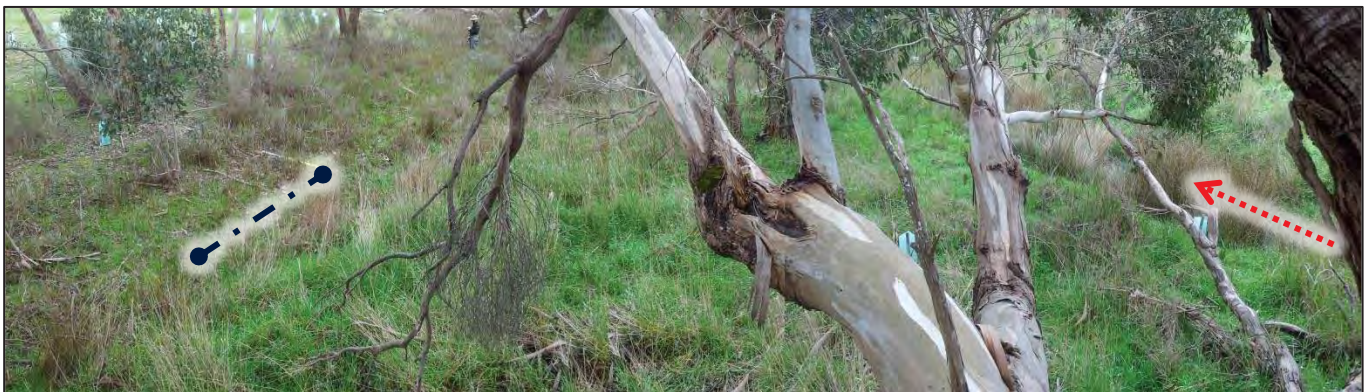
Figure 4.31 – Looking west towards the diversion point; from on the bank between the intercepted natural meandering creek line (left – blue line) and the deeper, straightened artificial drainage alignment (right – red arrow)

Upstream (to the east, see above right) of the diversion point marked on the map with an 'X', the natural meanders of the creek (which are still visible) have been intercepted multiple times as the deeper artificial drain was dug in a straight line along the same general alignment – also see Figure 4.31. With the drain on average 50 cm deeper than the natural channel, this serves not only to significantly increase the flow velocity, but also reduces the likelihood of the adjacent floodplain inundating during flows. Later in the season as flows recede, the depth of the channel subsequently enhances the drawdown of soil stored moisture from the floodplain environment adjacent to the drain.

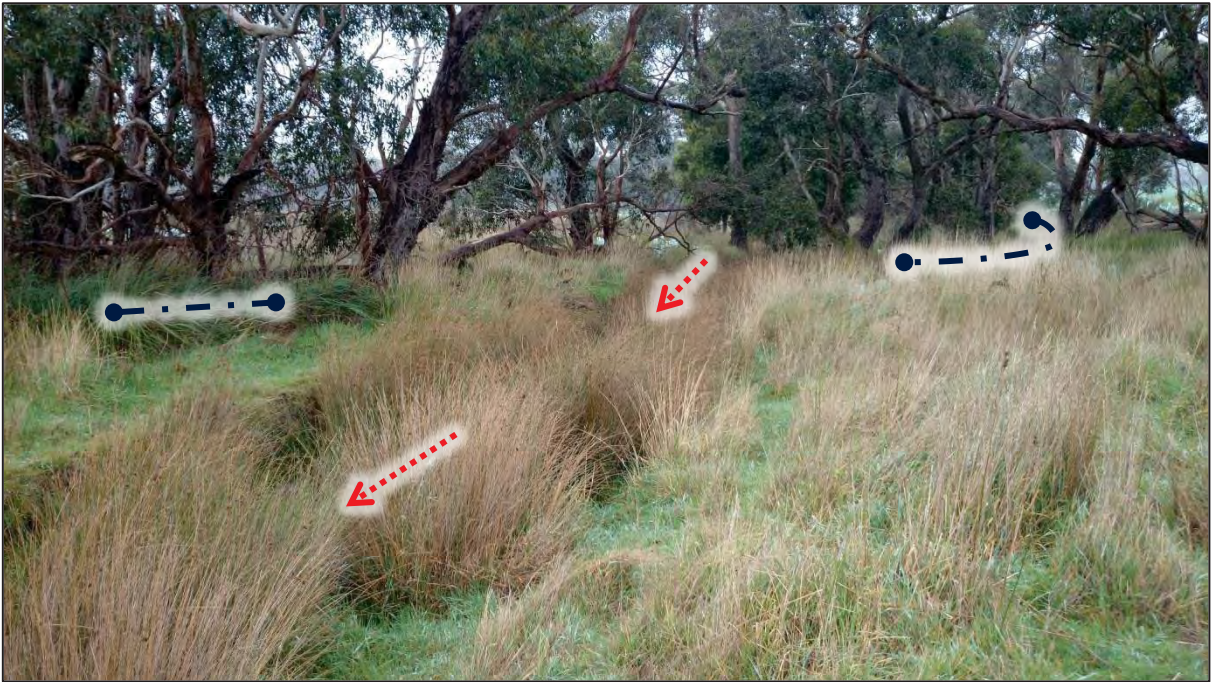
Figure 4.32 – Looking east towards the point where the creek was diverted. The original meandering flowpath to the north (blue lines) has been intercepted and isolated by the westerly flowing artificial channel (red arrows).

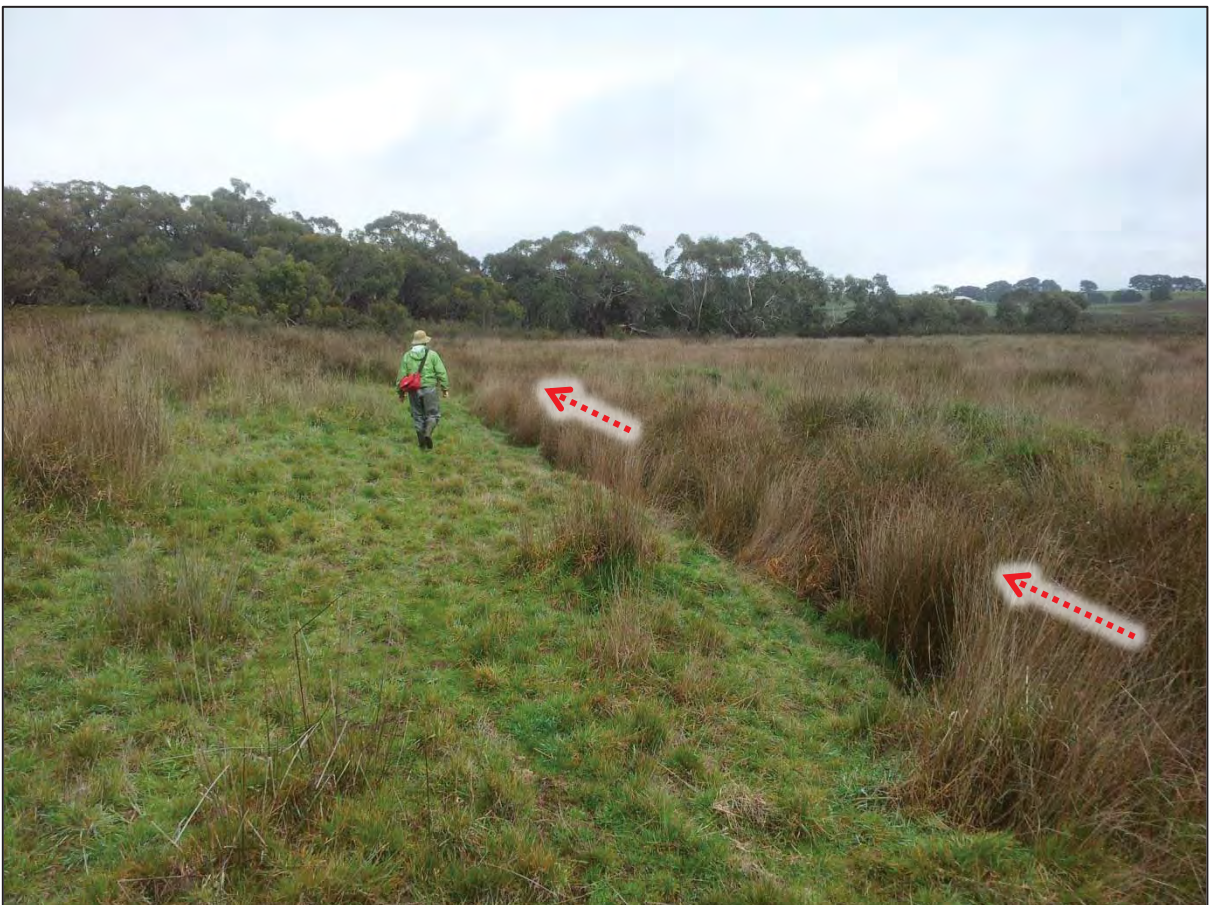
Figure 4.33 – Looking west down the drain away from the creek diversion point.

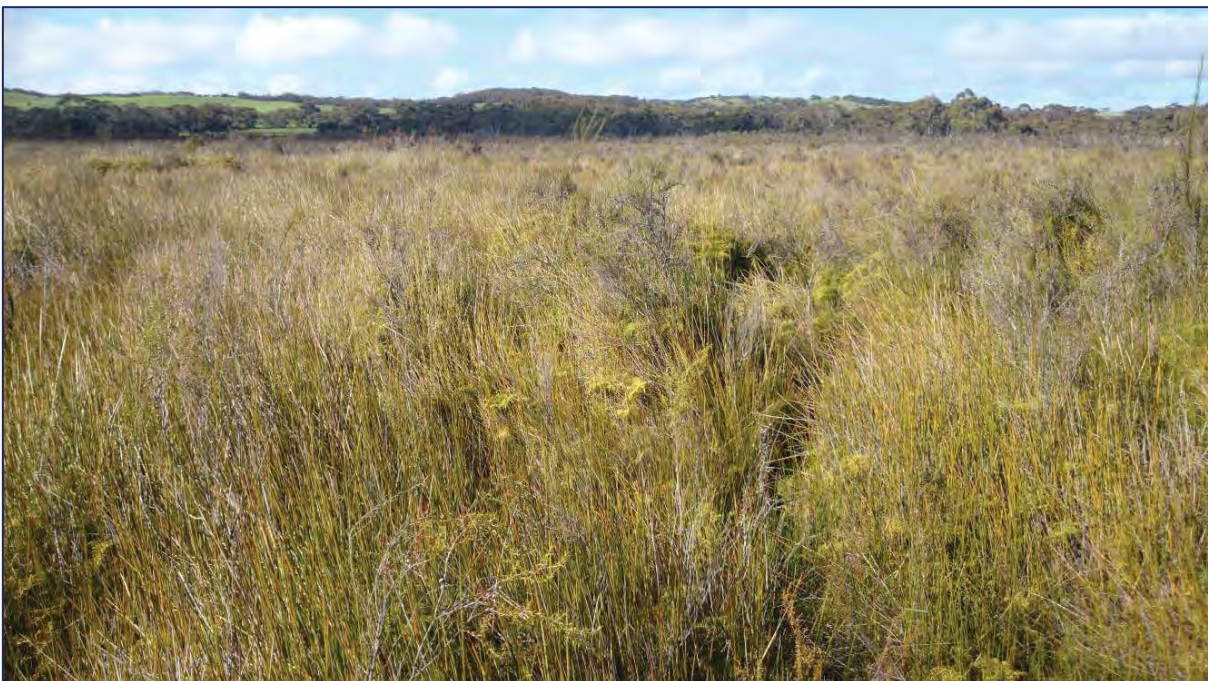
Figure 4.35 – The swamp bed, where the peat profile functions like a floating sponge.

The drains that run across the bed, and particularly those that capture flows from the wettest zone in the central and western portions of the swamp, are more than likely tapping into the groundwater aquifer that underpins the site – for part of the year at least. The impact of both reduced inflows and downstream drainage of this zone may have been masked to some degree by the capacity for the peat sediment profile, which is literally suspended by groundwater, to physically move. People who have walked across this zone (see Figure 4.35) will have noticed the sensation of feeling the ground wobble as a result of the footsteps of their companions nearby.

This also means it is possible that the peat profile may have physically dropped in response to earlier drainage attempts, possibly partly explaining why a couple of the drains that were dug across the swamp bed around 1970 are now barely visible, while others around the periphery (where the peat is not as deep) remain clearly visible. Physical subsidence of the ground is a common phenomenon associated with deep-

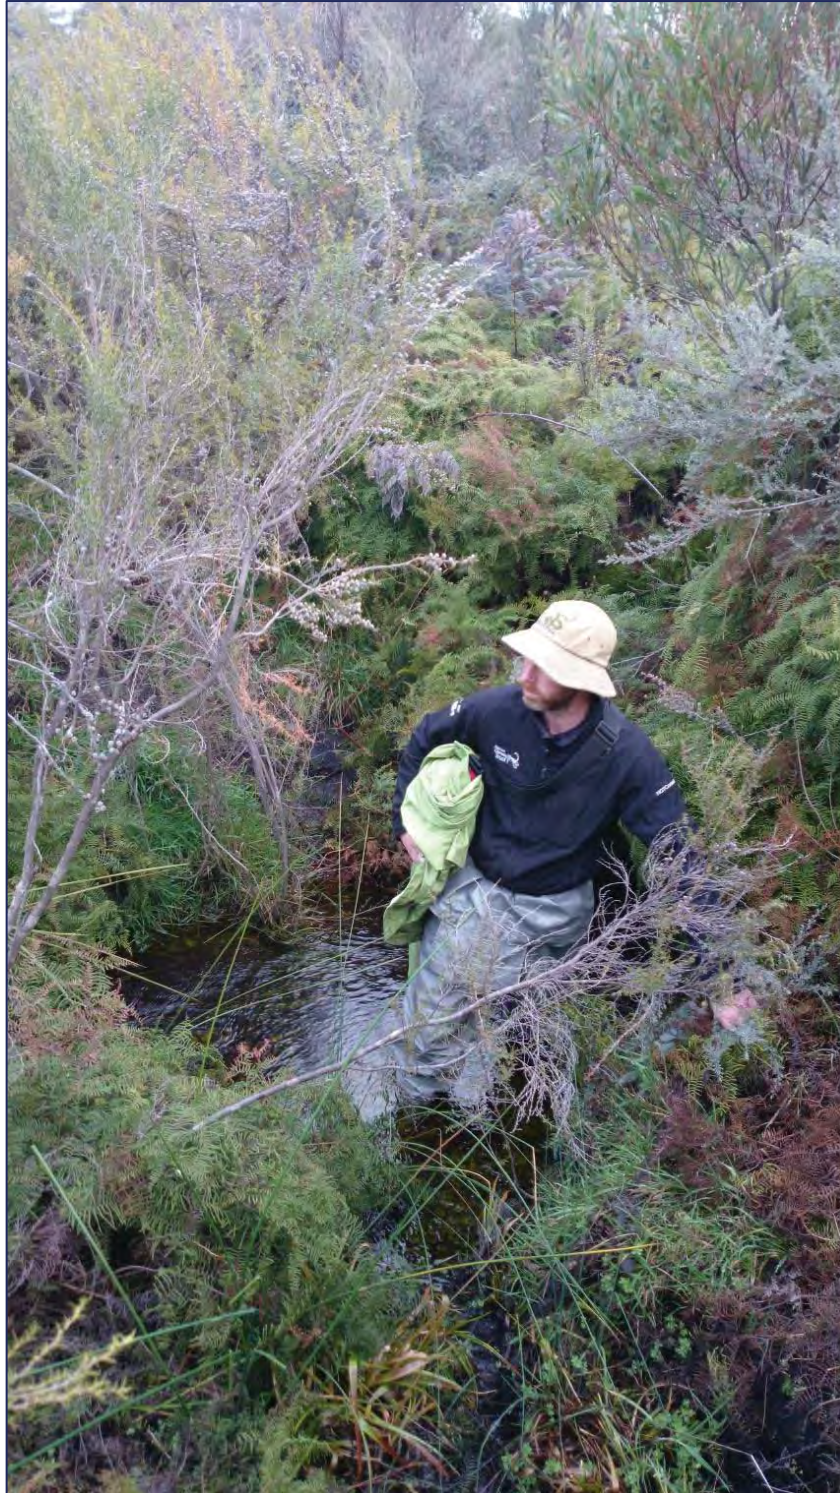
Figure 4.36 – Lachlan standing in one of the deeper (1.5-2m deep), fast flowing drains near the western margin of the swamp bed. As an indicator of depth, this photograph was taken from the natural surface level.

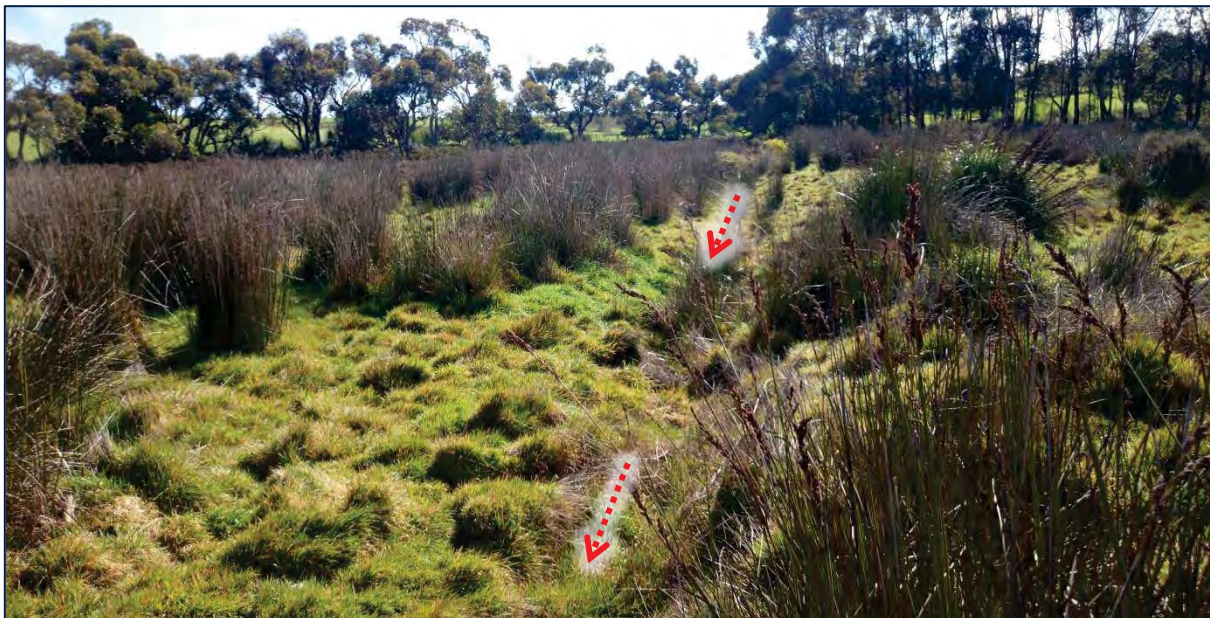
Figure 4.37 – Looking in a northerly direction towards the property boundary (the tree line), along the highest section of the outside (westerly) drain, which was drier than the drain parallel to it, being higher up the slope.

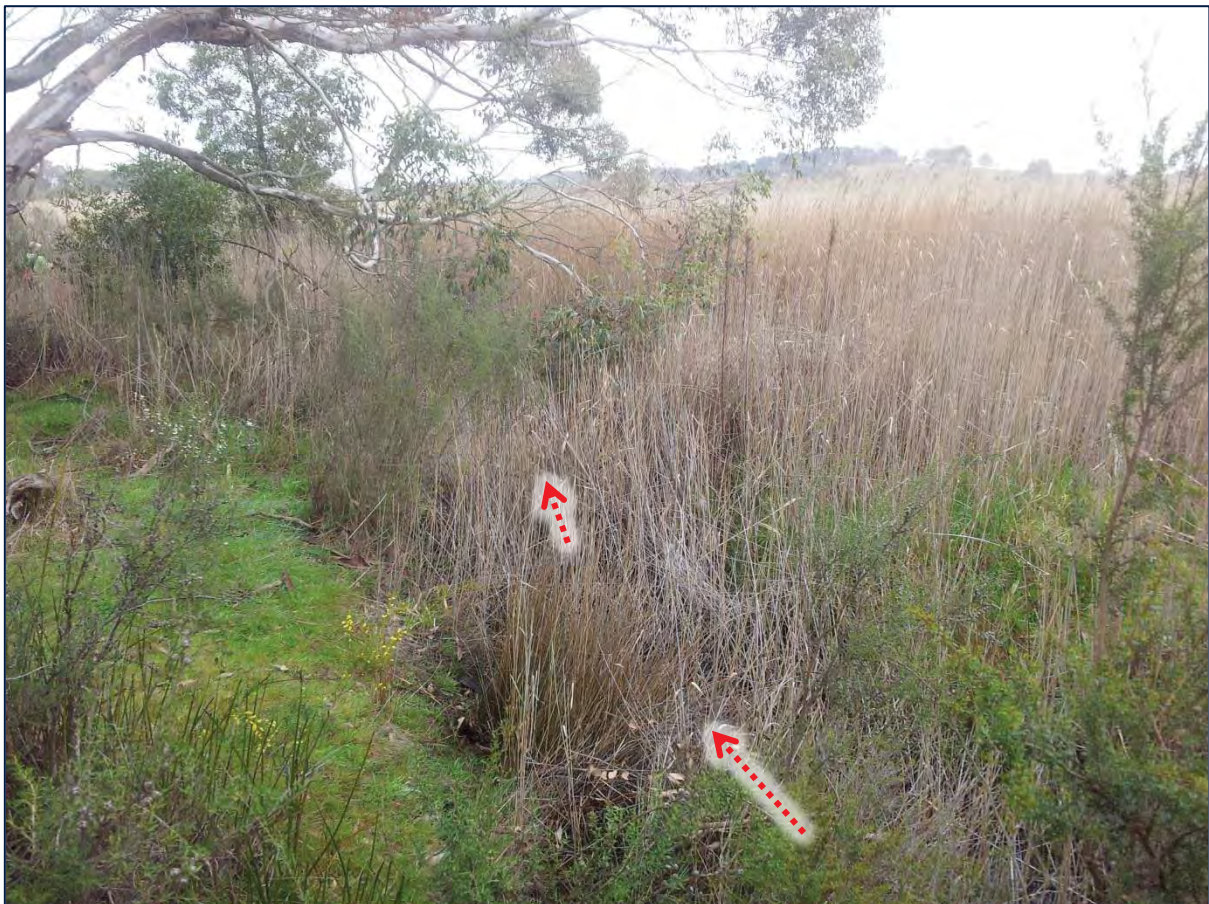
Figure 4.38 – Looking in a westerly direction where the higher gradient section of drain peters out into the dense, expanding stand of *Phragmites australis*.

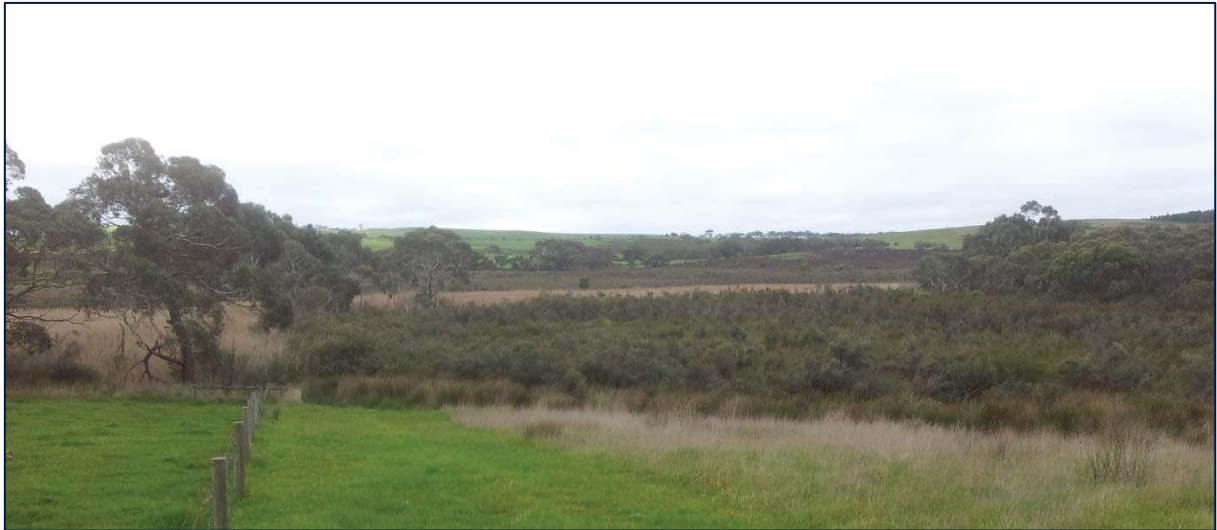
Figure 4.39 – Looking north along the western boundary of Stipiturus CP, with private land to the left. The light colour of *Phragmites australis* foliage is visible both sides of the fence.

(carrying agricultural nutrients post-clearance). These attributes are likely to have favoured the establishment and subsequent expansion of *P. australis*, which now occupies an area on the western boundary of the swamp in Stipiturus CP and extends into the neighbouring private land, as shown in Figure 4.39 and Figure 4.40 – the latter using an overlay of the diagram in Section 4.5.2 – which displays the relationship between the drain discharge point location, the expanding area of *P. australis*, and the apparent deflection of flows.

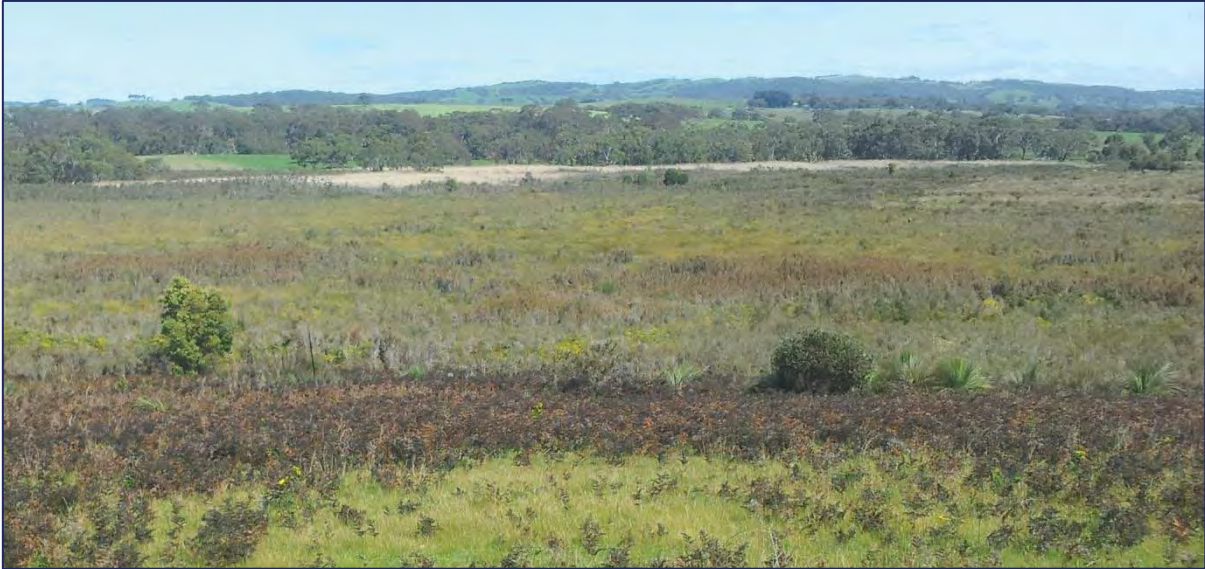
Figure 4.41 – Looking south-west towards the *Phragmites australis* reedland (light colour) across Glenshera Swamp. The drain discharge zone begins near the patch of trees in the left the image.

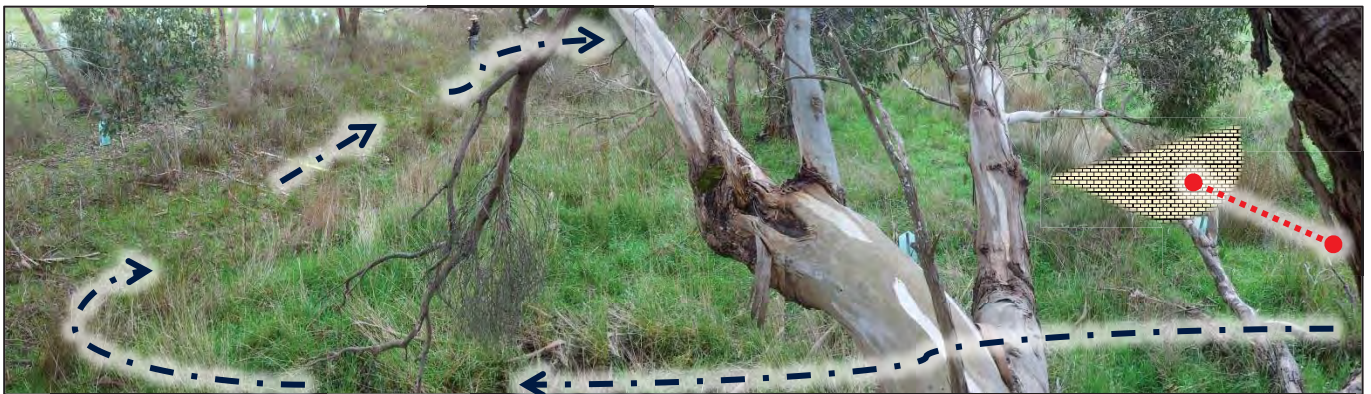
Figure 5.2 – Looking west towards the main diversion point; showing the potential reinstated meanders (left – blue arrows) while restricting flows down the artificial drain (right).

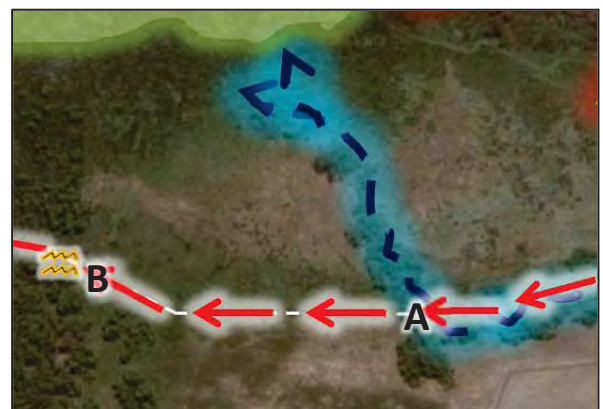
Figure 5.3 – Looking east towards the main diversion point where the creek flowpath could be reinstated (blue arrows) by blocking or regulating the westerly flowing artificial channel and breaching the spoil bank where it isolates the current flowpath from the historical flowpath.

- a diversion structure ‘A’ and artificial spoil bank breach at the final confluence between the drain and the creek, before it flows in a northerly direction – as shown in Figure 5.3.

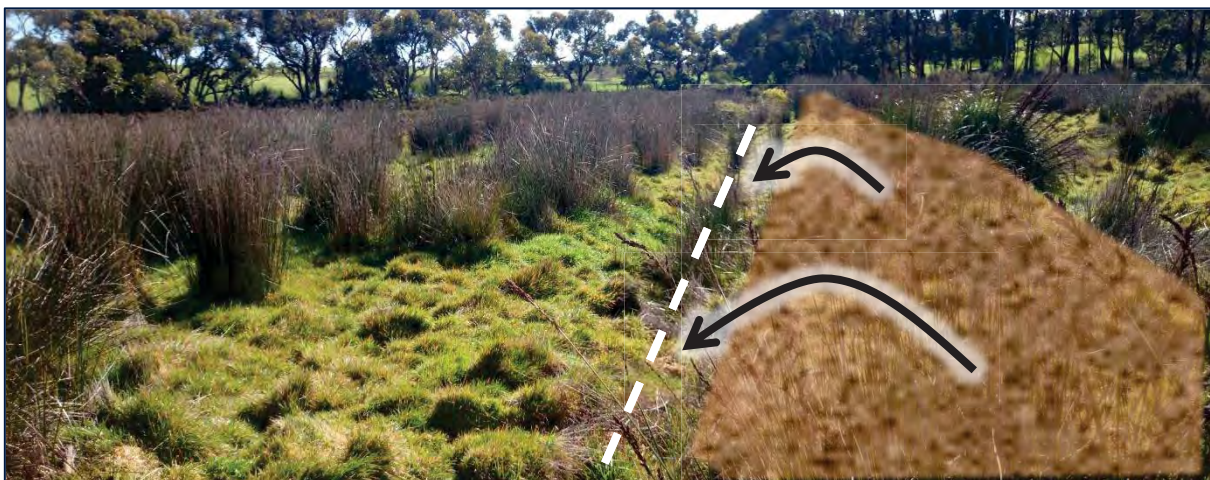
Figure 5.6 – Looking in a northerly direction up one of the hillside slope drains (white dashed line) – showing the spoil available to the right (shaded) for backfilling.

Further assessment should determine how far downslope the works extend, noting that saturation may impede machinery progress. The goal should be to backfill the drains, using the existing spoil banks which run parallel to them (Figure 5.6), for as much of their length as possible. Any remaining sections of drain closer to the swamp bed that are inaccessible should be treated using the approach previously outlined for Zones 1 and 5.

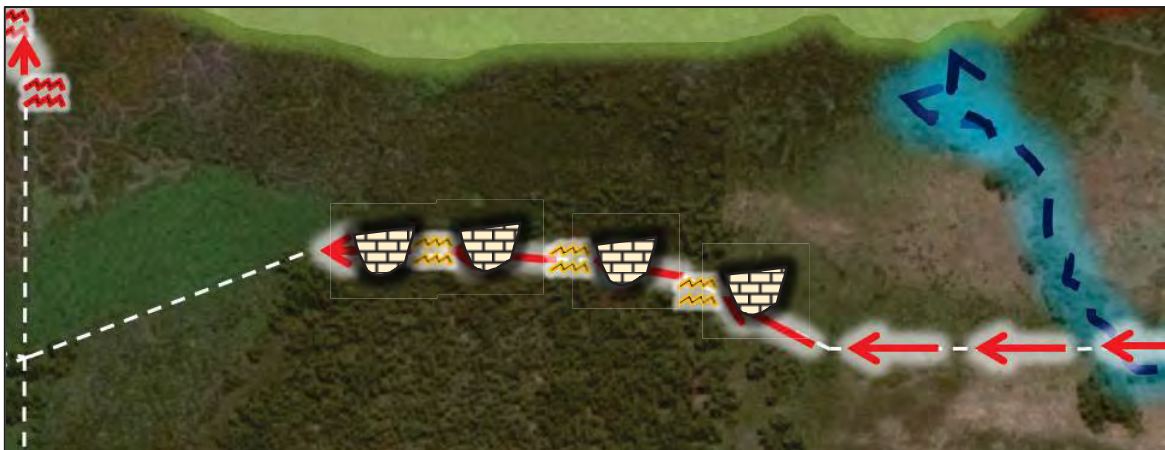
Figure 5.7 – The section of drain where a series of blocks would be installed

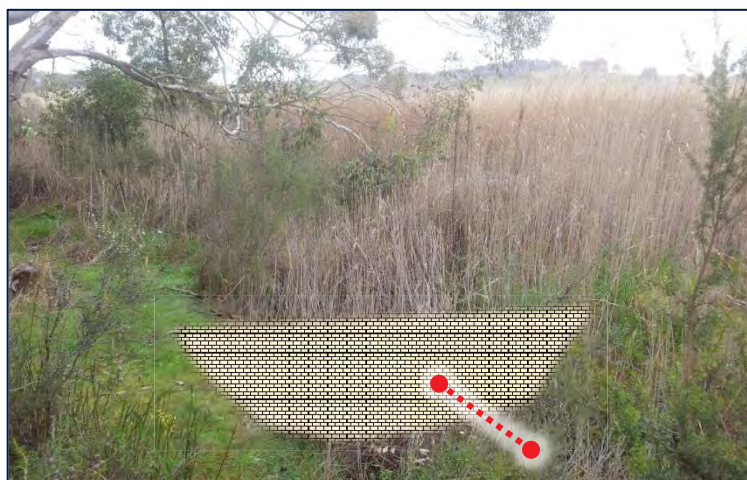
Figure 5.8 – This is the last of a series of locations along the bypass that could be blocked to render the drain inoperable – just before the drain peters out into the stand of *Phragmites australis*.

Assuming effective diversion of flows occurs upstream, the proposed blocks – see Figure 5.7 – (at spacing intervals yet to be determined, but that would be informed by the gradient of the drain) could consist of either earthen banks or biodegradable (hessian) sand bags for ease of installation. The intention would be for the works to blend into the landscape and be consolidated by regenerating native vegetation from the adjacent banks and woodland habitat (Figure 5.8).

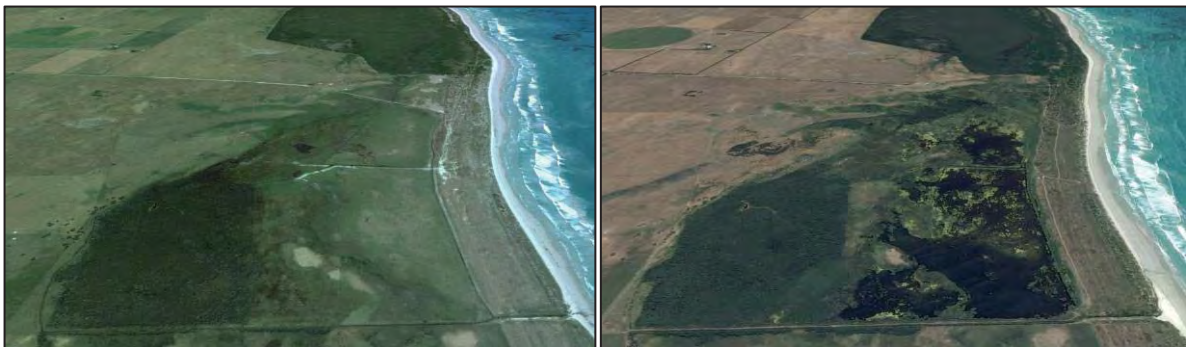
Figure 8.3 – Oblique image looking east over Pick Swamp before and after restoration; Jan 2003 (left) – Jan 2014 (right)

By the time the property was first offered for resale, approximately 30 years later in 2002, the bulk of it had been modified (drained, cleared and grazed by cattle), with the exception of the now isolated Crescent Pond (a significant spring feature) and a surrounding 40 hectare area of saturated (groundwater fed) peat fen supporting Silky Tea-tree shrubland. Despite several attempts, this remnant area was never effectively drained or cleared, but was being negatively impacted by drainage of the surrounding wetland area. After a protracted negotiation process, the 230 ha property was eventually purchased by the SA Government in 2005 for restoration and inclusion in the adjacent Conservation Park. A plan (Clarke 2007) was implemented from 2007 to restore the property, through reversal of drainage and supplementary revegetation of terrestrial and wetland fringe species only, beginning a process of spectacular natural aquatic habitat recovery (Figures 8.3 – 8.6).

The restoration of Pick Swamp has resulted in approximately 130 hectares of land being permanently re-inundated, and the aquatic component has recovered to an excellent level of ecological functionality with minimal management intervention in the intervening eight years (Bachmann & Holland 2015). This recovery was aided by the fact that Pick Swamp was strategically selected for its restoration potential; being adjacent to an existing Conservation Park and having excellent prospects for natural regeneration. As well as hosting a wide range of different vegetation associations (Ecological Assoc. 2008), Pick Swamp has become a stronghold for the nationally threatened Australasian bittern and dwarf galaxias, and the site hosts thousands of waterbirds (DEWNR, unpubl. data; Bachmann et al. 2014; Veale & Whiterod 2014). Just five years after restoration works commenced in 2007, the site was included in the Piccaninnie Ponds Karst Wetlands Ramsar site listing at the end of 2012 – a testament to the habitat recovery potential of restored wetlands.

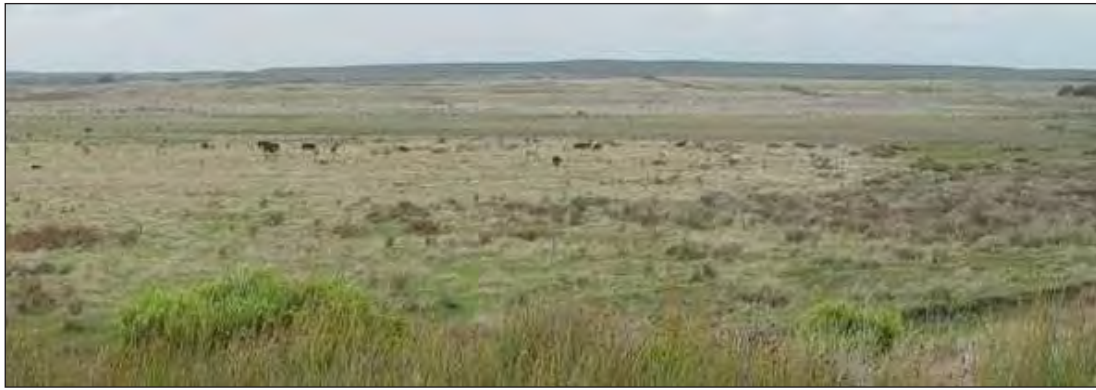
Figure 8.4 – May 2007 (before restoration)

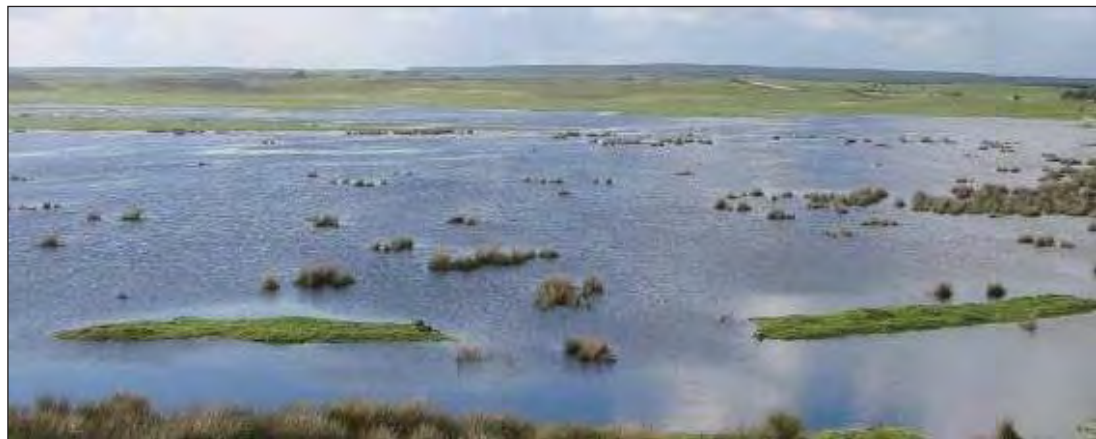
Figure 8.5 – July 2007 (several weeks after restoration commenced)

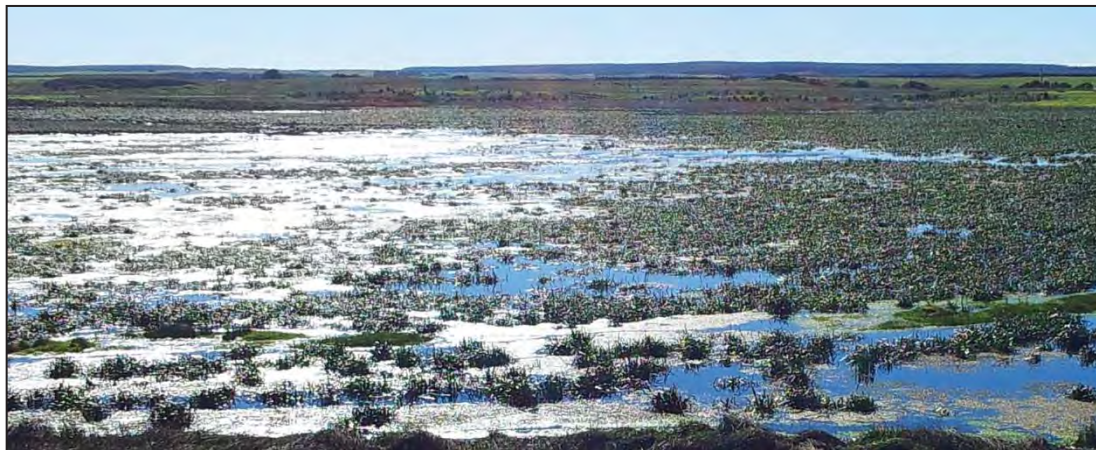
Figure 8.6 – June 2012 (5 years post-restoration – note natural recovery of aquatic plants)

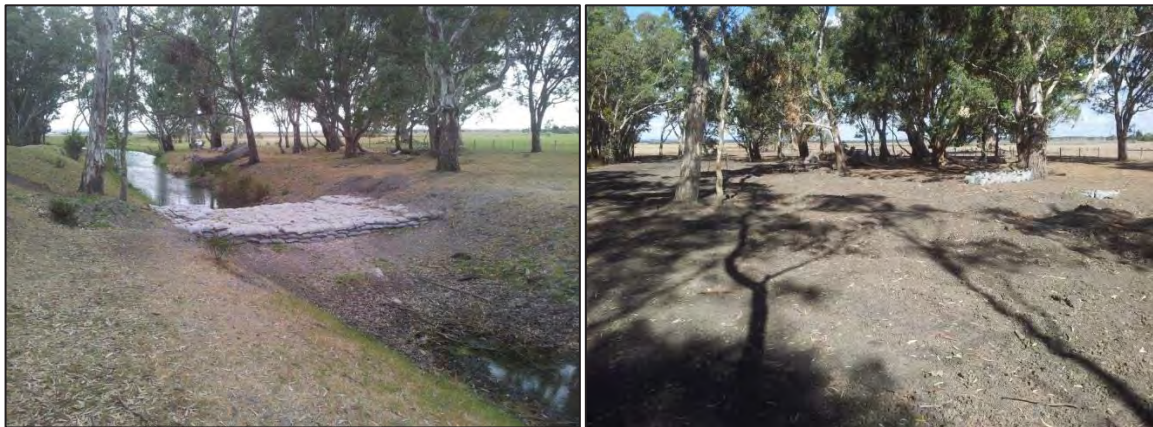
Figure 8.10 – Brady Swamp drain, trial structure before (left) & after (right) 2015 permanent works

The success of these trials has been based on their tangible ability to demonstrate, to all parties involved, the potential wetland restoration outcome for the sites; made possible by using simple, low-cost, impermanent methods. To ensure the integrity of the trial structures, the sandbags used for this purpose are made of geotextile fabric, with a minimum field service life of approximately 5 years.

The trials were critical for building community confidence and collecting real operational data (to test our scenario modelling based on digital elevation data) for informing the development of longer-term measures to increase the depth and duration of inundation. The trials ultimately led to permanent works to reinstate the breached natural earthen banks at Brady (Figure 8.10) and Gooseneck Swamps (Figure 8.11), implemented by Nature Glenelg Trust in early 2015. These works have permanently reinstated the alternative, original watercourse of the Wannon River, which now activates when the water levels in these wetlands reach their natural sill level.

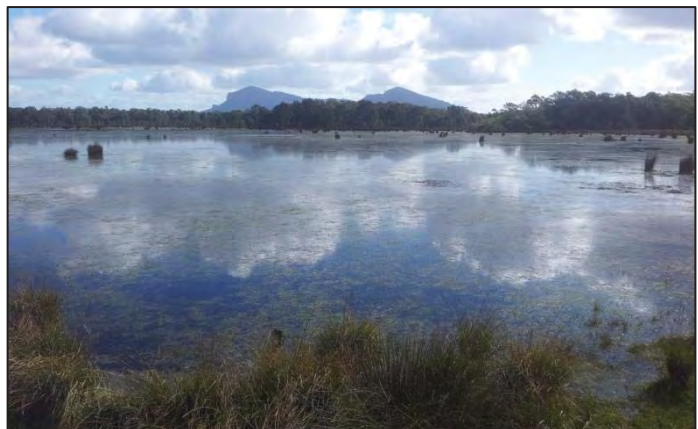
Figure 8.11 – Gooseneck Swamp in Sept 2014: the second season of the restoration trial, just prior to the implementation of permanent restoration works
