Hydrological restoration options for Glenshera Swamp, Stipiturus Conservation Park.

*A case study for investigating the feasibility of restoring
the water regime of Fleurieu Peninsula swamps impacted
by artificial drainage.*

Mark Bachmann and Lachlan Farrington

March 2016

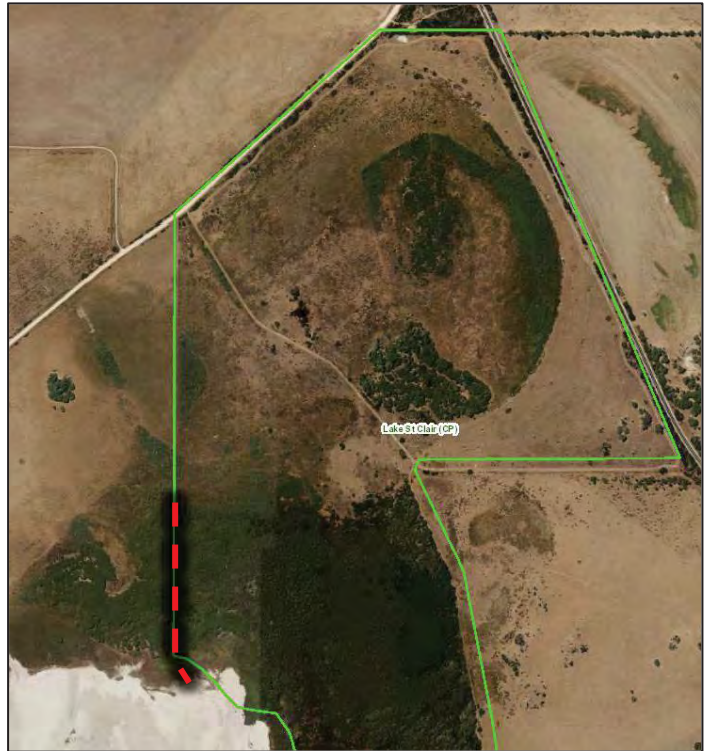
Figure 8.12 – Lake St Clair CP showing the location of the artificial boundary drain (red dashed line).

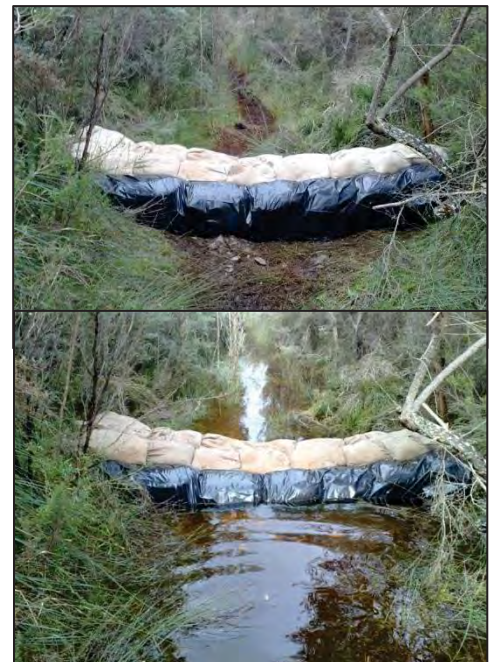
Figure 8.13 – an example of a block installed on the drain in Lake St Clair CP, before (above) and during (below) winter flows in 2009.

To minimise physical disturbance impacts in the dense vegetation communities present, restoration works involved the installation of a series of lined sandbag 'blocks' at several locations down the length of the drain in 2009 (see Figure 8.13), to prevent it from conveying flows (in either direction). The success of the works led to some blocks being permanently consolidated into earthen banks, enabling the outcomes achieved through decommissioning the drain to be perpetually secured.

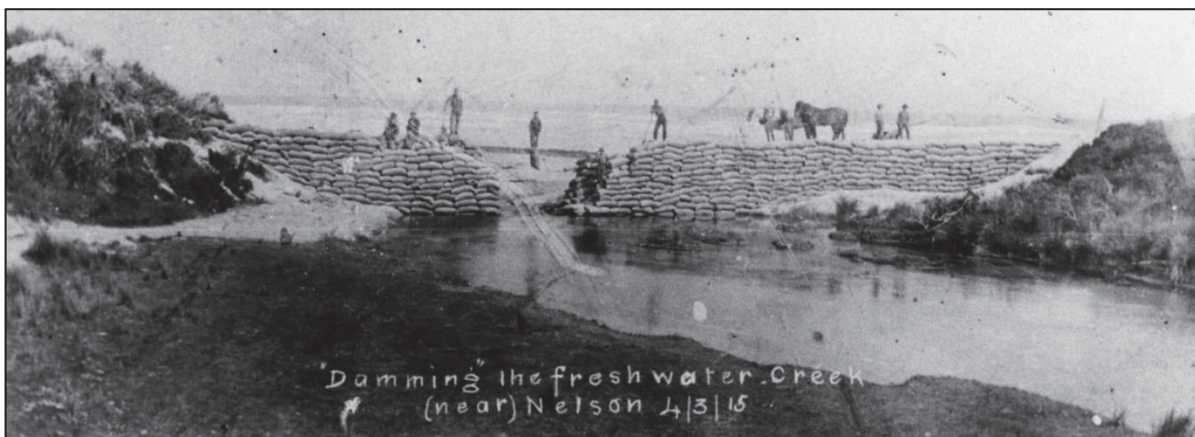
Figure 8.14 – 1915: damming of Freshwater Creek at the 1906 artificial outlet location to the sea

This early form of environmental activism was rewarded in 1915, when the state governments agreed to share the cost of damming the new outlet through the dunes (Figure 8.14) and constructed an alternative channel to the Glenelg River. This was necessary because the original flowpath between the dunes had been lost to drifting sand.

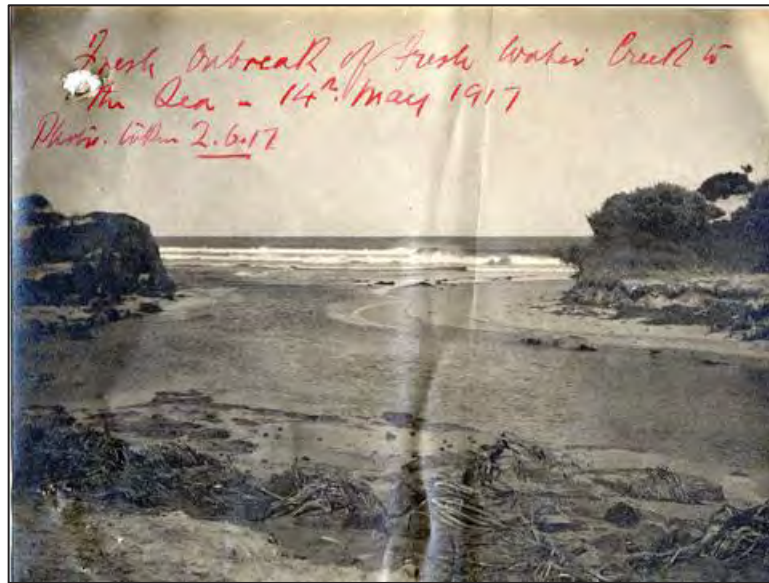
Figure 8.15 – The new 1917 artificial outlet of Freshwater Creek. Note the stranded aquatic plants in the foreground, indicating a rapid water level drop as the cutting eroded to sea level.

It was not long before the new flowpath caused controversy however, with landowners at the western end of the system complaining that the water level was now higher than prior to 1906, and was impacting on the viability of their grazing enterprises. By 1917, with water levels high and the dunes still unstable, another suspected act of sabotage led to a new outlet being cut near the state border, as shown in Figure 8.15.

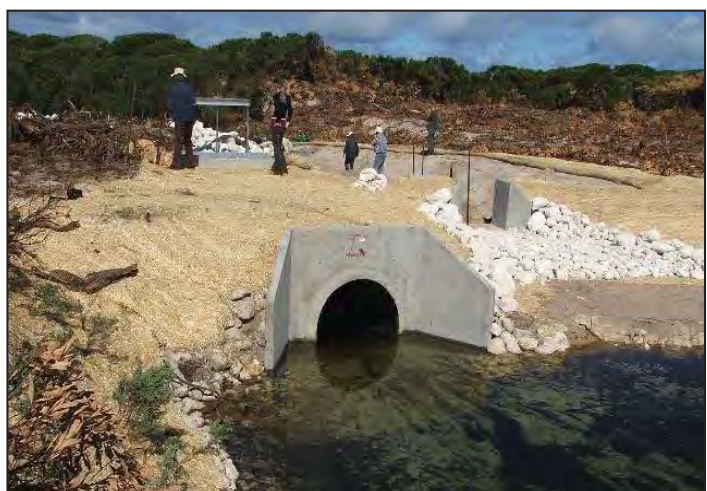
Figure 8.16 – Stage 1 weir and fishway under construction in 2006.

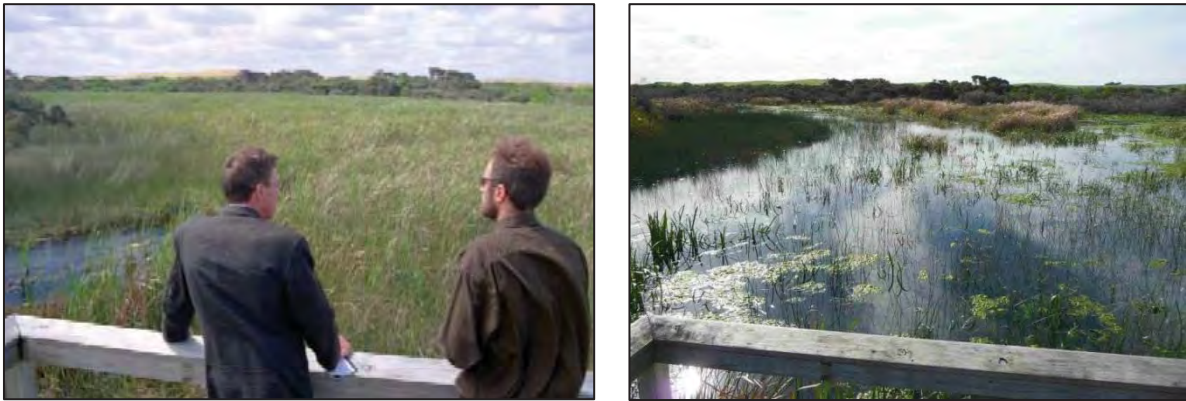
Figure 8.17 – The upstream inundation impact and habitat change caused by the stage 1 weir, showing habitat change 2006–2012.

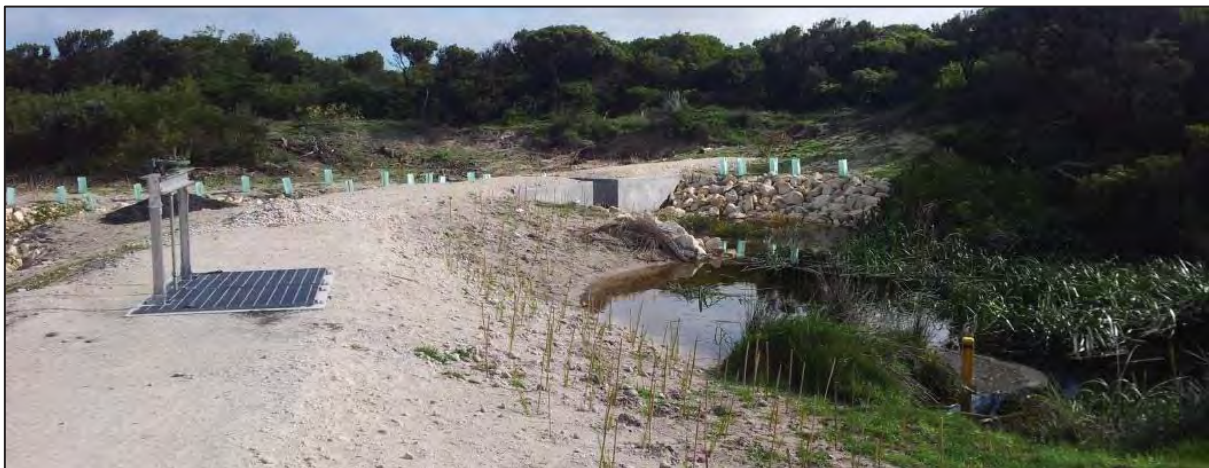
Figure 8.18 – The lifted and redesigned stage 2 weir and fishway on the main artificial outlet at Piccaninnie Ponds – upon completion in 2013.

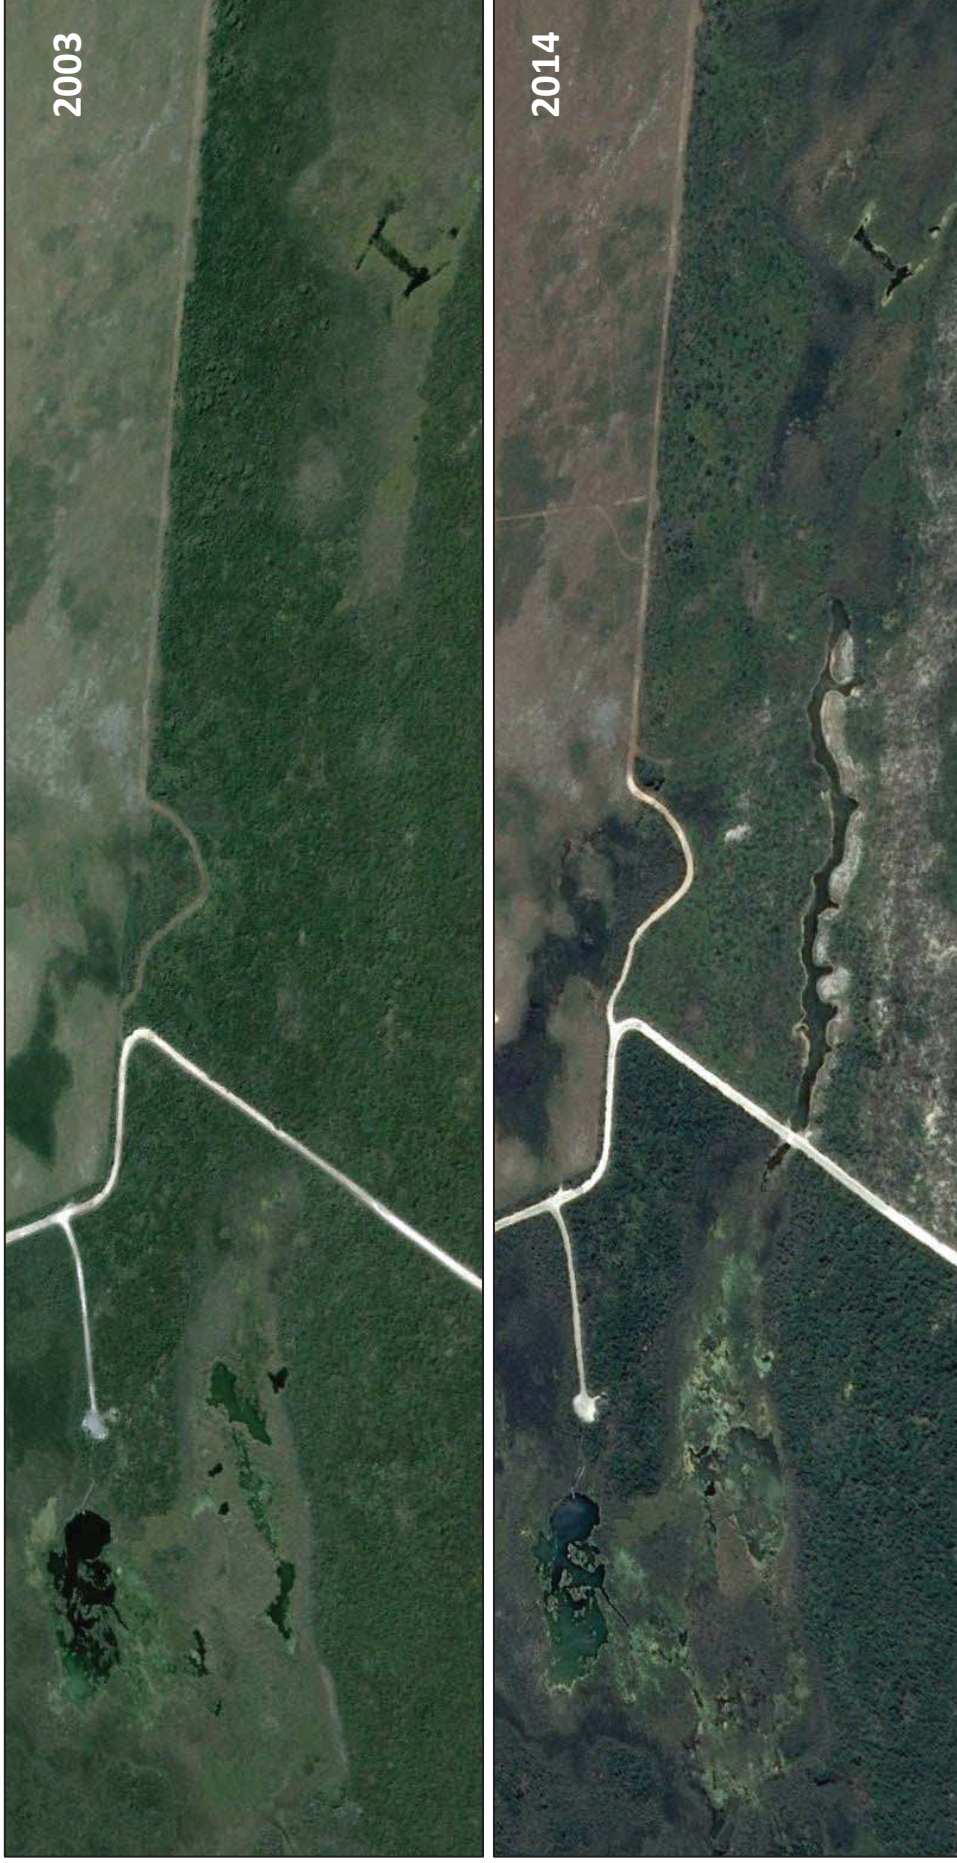
Figure 8.19 – Aerial imagery showing the reconstructed flow path and culvert location under the Piccaninnie Ponds Road. Construction occurred in 2013. The main Piccaninnie Ponds (western wetland) are in the top left of each image, while Hammerhead Pond (eastern wetland) is in the bottom right corner of each image. Also note the increase in open water habitat to the south of the main Ponds, associated with the installation of the Stage 1 and Stage 2 weir structures.

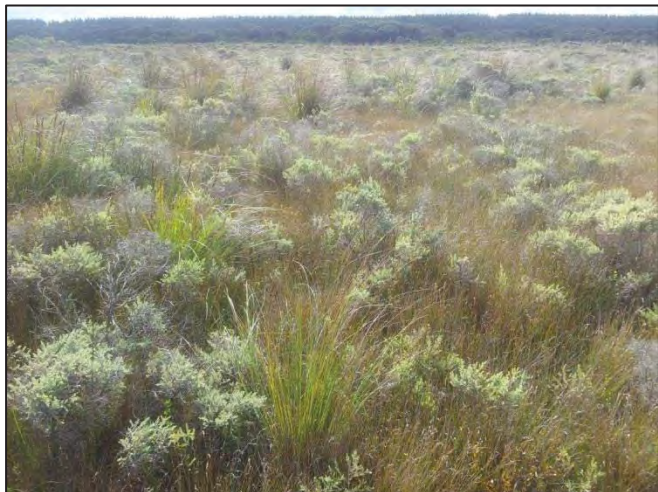
Figure 8.20 – Shrub (*Leptospermum lanigerum*) encroachment into sedgeland underway in Long Swamp.

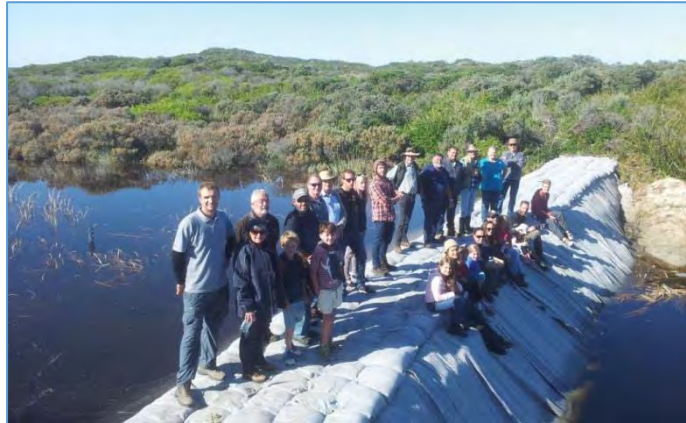
Figure 8.23 – View of the Phase 3 Restoration Trial Structure location; LEFT – prior to construction in March 2015, and RIGHT – in June 2015

following two days of preparation and nine days of sandbagging (using about 6,600 sandbags), which were put in place with the dedicated help of over 30 volunteers (see Figures 8.22 & 8.23). To achieve our target operating height, the structure was raised by a further 30 cm (an additional 400 sandbags) in August 2015.

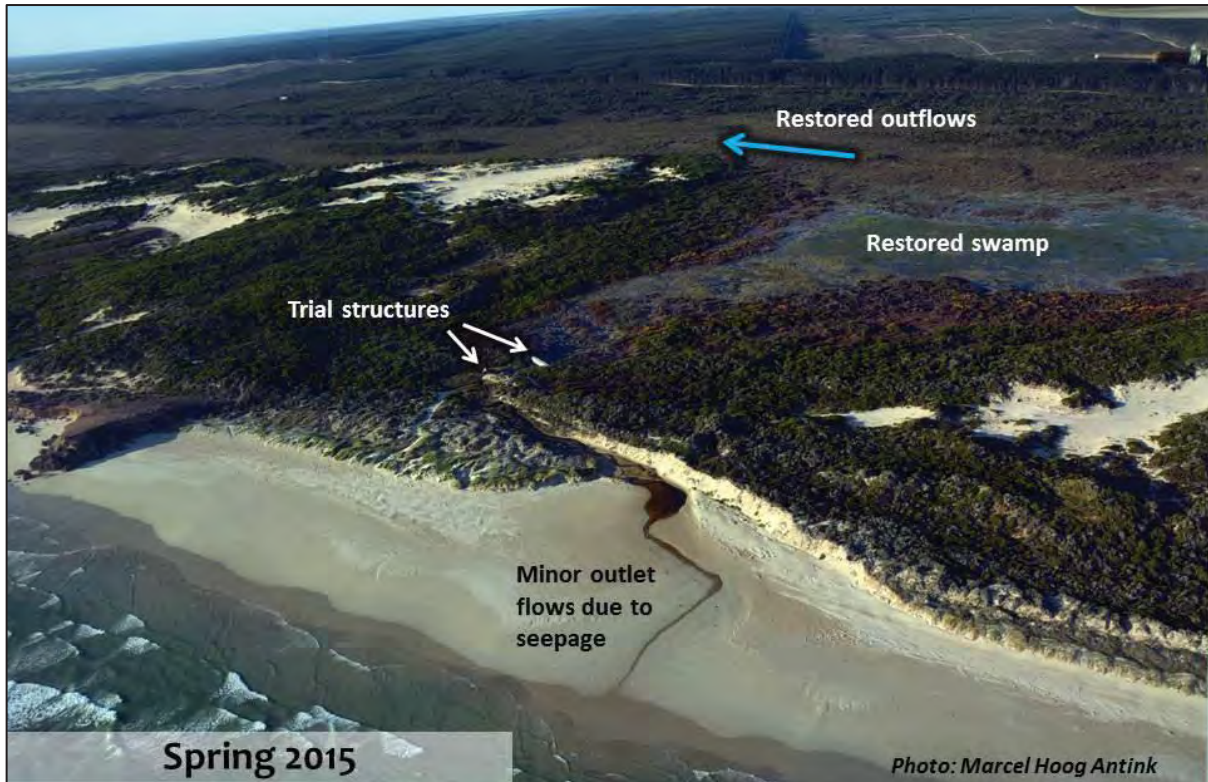
Figure 8.27 – Oblique view over Long Swamp, in the area of restored wetland habitat inland from Nobles Rocks, as its appearance has changed during the implementation of the trial.

The body of deeper fresh water first observed and mapped at Nobles Rocks in 1850 has reformed (see Figure 8.27). As anticipated, parts of this newly inundated area have undergone an obvious immediate shift; from supporting a terrestrialsing plant community to true aquatic flora. An example of this (aquatic reed beds) is shown in Figure 8.28.

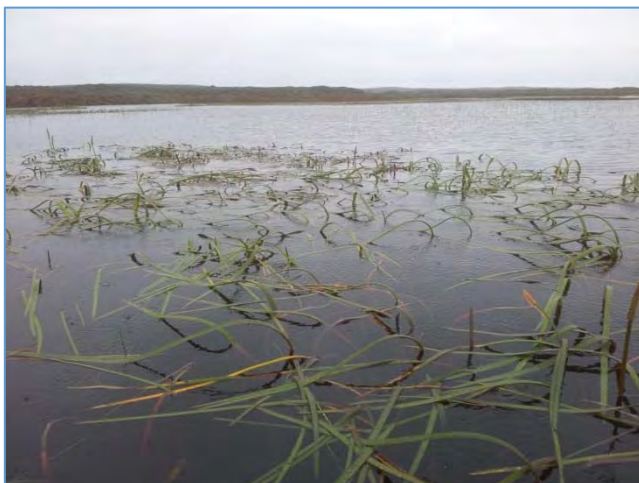
Figure 8.28 – Floating aquatic reed beds of *Triglochin procerum* favoured by the Yarra pygmy perch are rapidly reforming in the restored areas of deeper water (50-70 cm deep) in the swamp inland of Nobles Rocks.
