CONTRACT 950137

RANGER TV SUBSYSTEM (BLOCK III) FINAL REPORT

VOLUME 4a: MANUFACTURING,
PRODUCT ASSURANCE,
AND TEST

AED R-2620

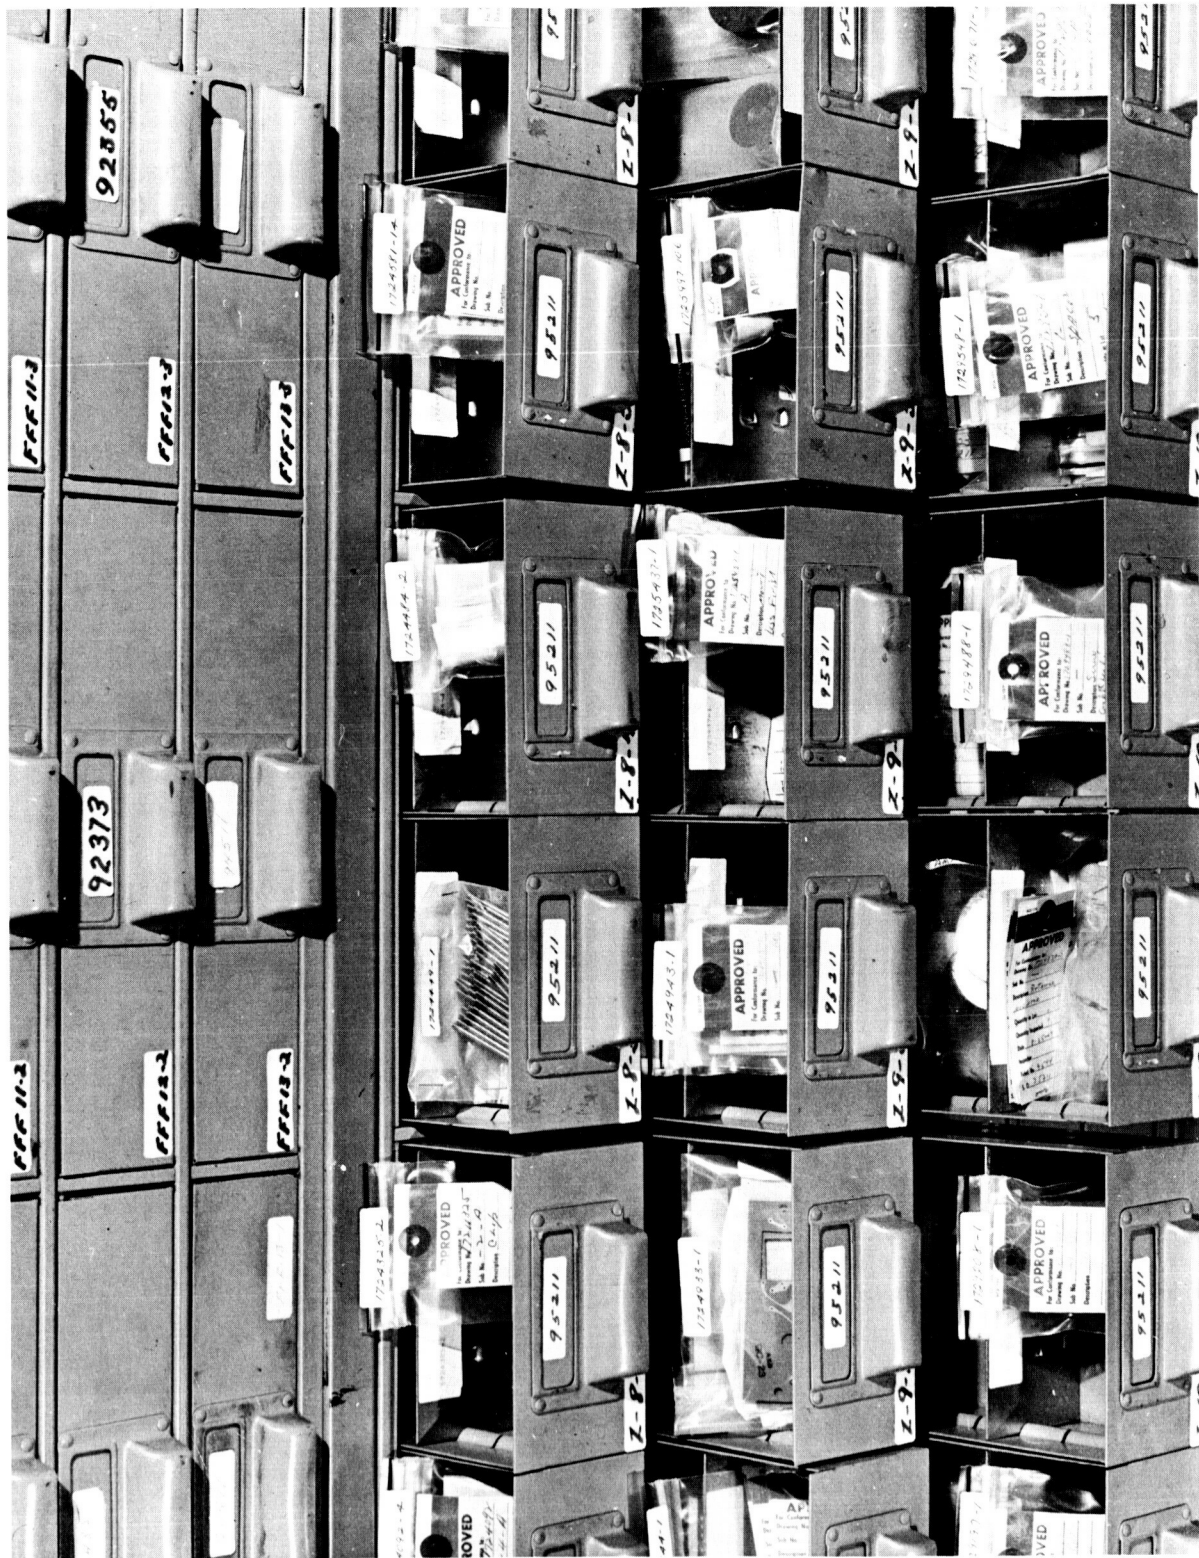
Figure 10. Method of Storing Parts in the Controlled Stores Room

A color-coding system was used to identify the date on which each item was received. The rule was to process parts on the day of arrival. Any parts left over were processed first on the following day. Parts were routed from the receiving room to Purchased Material Inspection Quality Control and then to the Controlled Stores Room. Here the parts were packaged in clear plastic zipper bags or plastic boxes and placed in drawers. The Quality-Control approval ticket and an item-control serial number were kept with the stored material to permit tracing of the items to a particular shipment. A section of the Controlled Stores drawers displaying the packaged items and their control-numbered tags is shown in Figure 10.

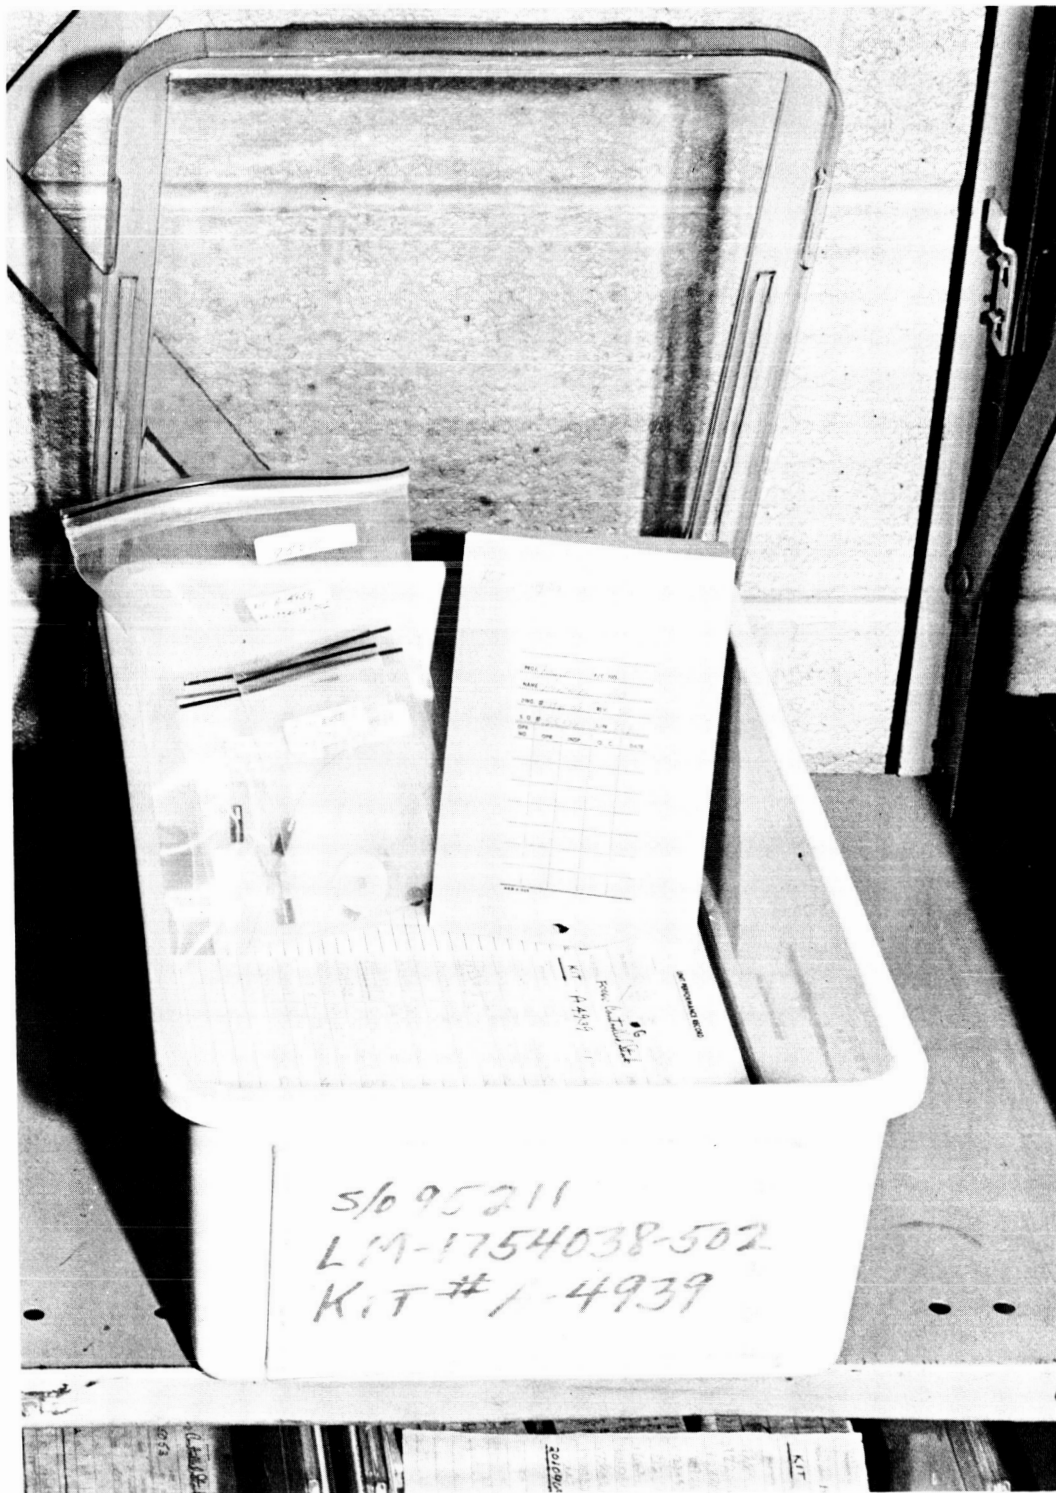
Figure 11. Tote Box for Transporting Parts

(Figure 11). Parts-traceability identification and kit identification were included in the boxes. Also stored in the boxes were a flow chart, an outline of the manufacturing procedures, and a logbook. As each step of assembly or cleaning was performed, it was entered in the logbook.
