SINNABRA (OR KHIRBAT AL-KARAK)

TAWFIQ DA'ADLI, DONALD WHITCOMB, AND RAPHAEL GREENBERG

A HYPOSTYLE HALL

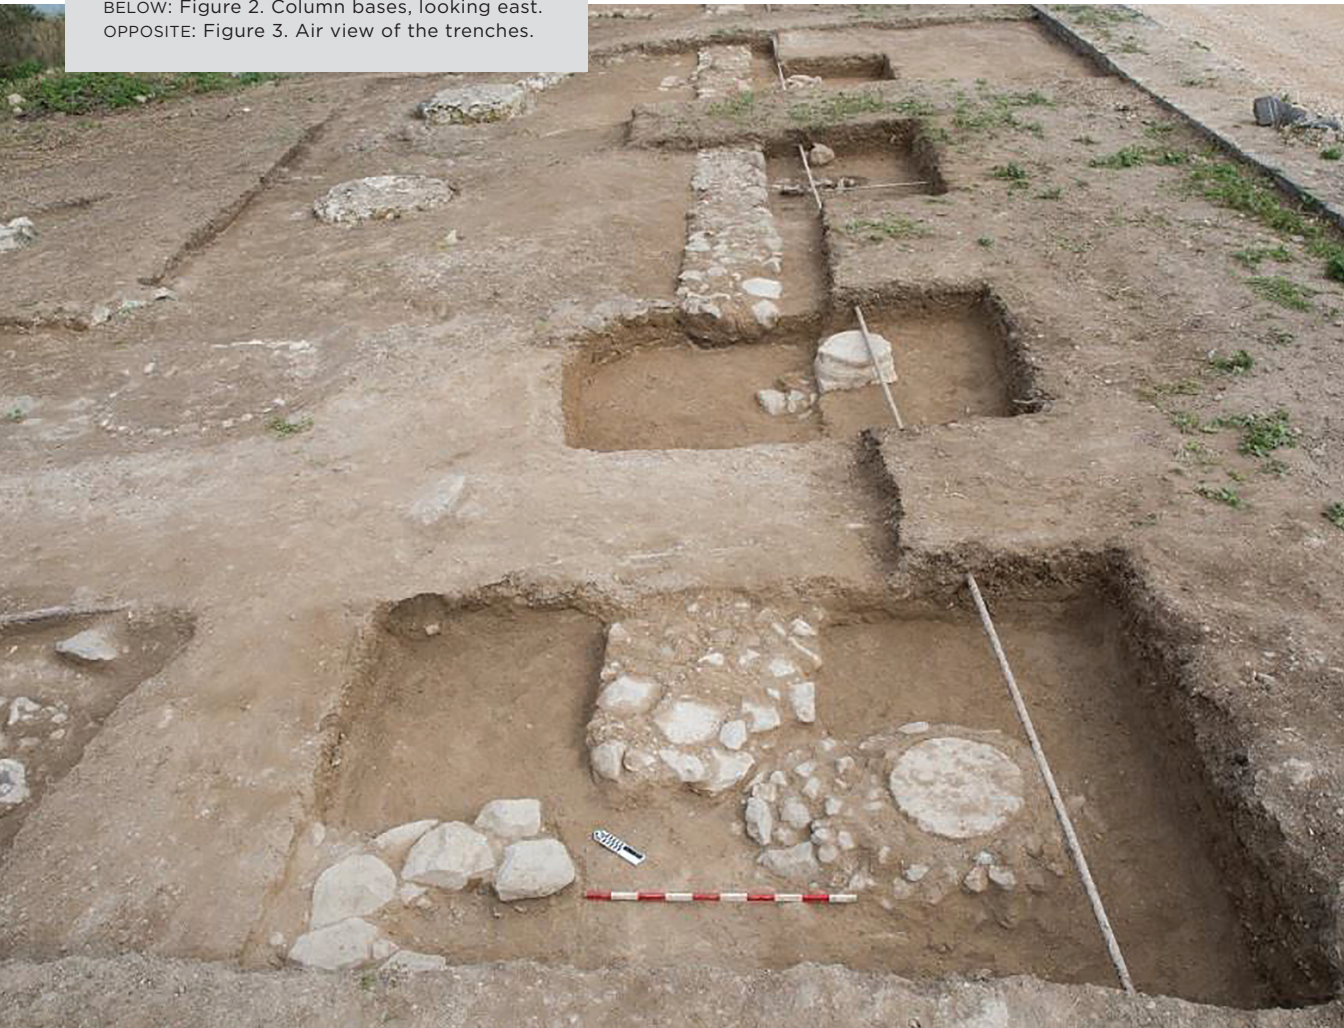
BELOW: Figure 2. Column bases, looking east.
OPPOSITE: Figure 3. Air view of the trenches.

gravel pavement. This row is composed of three reused marble bases and two built bases, and more importantly, these bases were built at similar intervals to those of the two northern rows and they are aligned with them. An eastern wall was discovered with three east–west walls on the same lines of the bases. Three west–east walls were also exposed (fig. 1, w2–4), attached to the eastern north–south wall (fig. 1, w1). The eastern wall and these short walls appear to be the eastern edge of the hypostyle hall. Another east–west wall intersected with the column bases; this wall (fig. 1, w5) probably predates the hall (fig. 2). The bases seem arranged to create a rhythm of 4 m bays. The columns begin at a 4 m interval from the northern wall of the *qasr*, suggests suggesting that the northern *qasr* wall was a common wall for both structures (fig. 3).

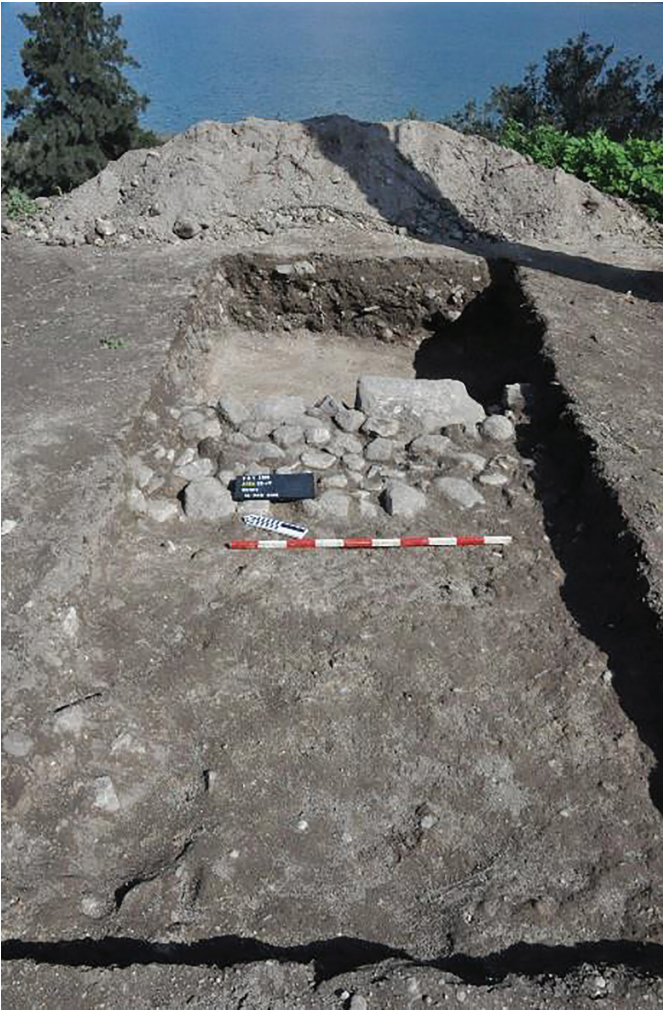
ABOVE: Figure 4. Eastern walkway and supporting wall, looking east.

During the conservation of the site throughout the year some traces of a north-south wall were revealed on the eastern edge of the mound, parallel to the *qasr* wall. Therefore, a small trench was opened to track this wall. This wall seem to be a retaining wall to a walk way that extended along the eastern border of the *qasr* (fig. 4).

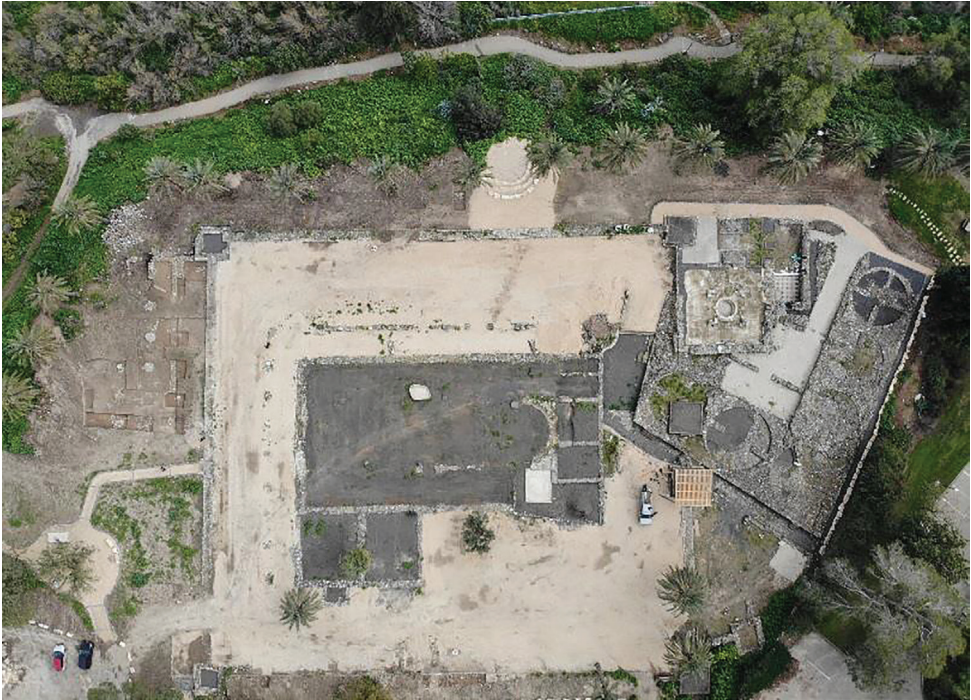
OPPOSITE TOP: Figure 5. General view of the *qasr*, from the west, after the conservation works. The bathhouse is at top right, above a large Bronze Age structure.

As reported last year, in February 2018, during our excavation season, a team of conservators launched a long-term maintenance project that lasted for almost a year. Among other things, they have brought to light some forgotten corners of the site, including the Umayyad bathhouse and parts of the palace itself (fig. 5).
