Technical Specification for AI Demer Beach

Technical Specification for Khawr Rowri

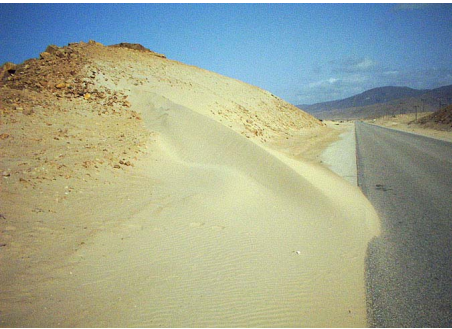
Shifting sand on road

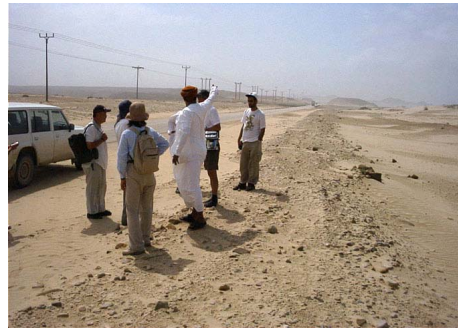
Sandy wind at site

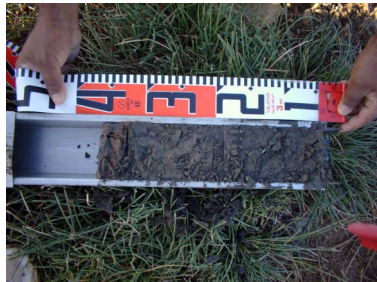
West shore of ruins (Profile No. Ro-1)

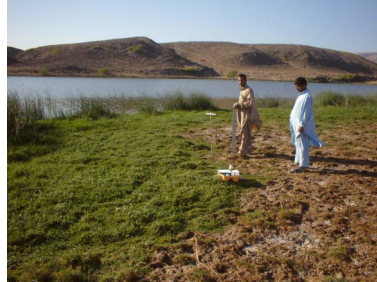
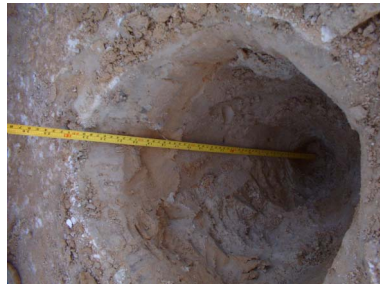
Terrace near end of branch water channel (Profile No. Ro-4)

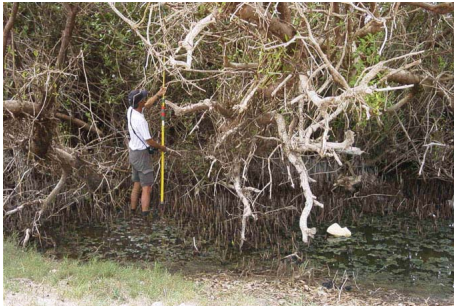
Measurement of tallest tree

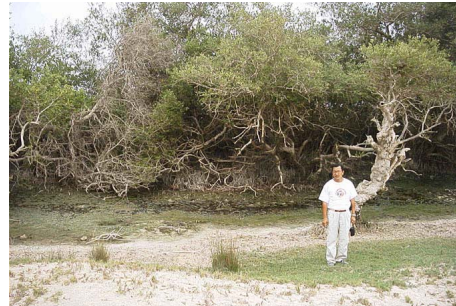
Grazing by camel

The mangroves show evidence of heavy grazing by camel and cattle and many of the young seedlings are at risk. Two small clumps of the sedge, *Schoenoplectus litoralis*, occurred in shallow water on the east side, in poor condition. At the back of the mangroves on the landward side, the reed, *Phragmites australis*, occurs, often growing in pools. If growing on the bank it shows evidence of grazing. In wet mud at the back of the mangroves, *Juncellus laevigatus* and *Bacopa monnieri* were found in poor condition. The grass, *Sporobolus virginicus*, forms a zone on the landward edge of the water. On raised edges of side channels and behind the mangroves the rush *Juncus rigidus* occurred.

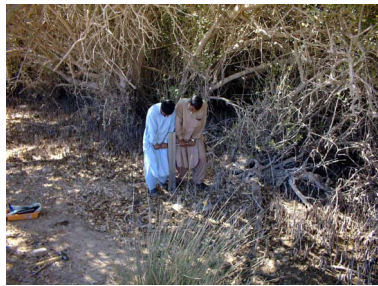
Southeast shore under vegetation (Profile No. TQ-1)

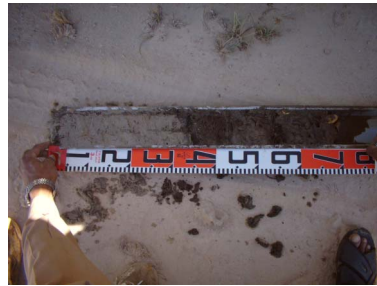
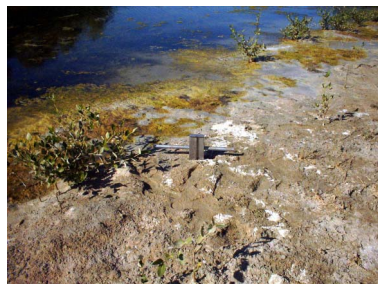
Narrow shore at beach side (Profile No. TQ-2)

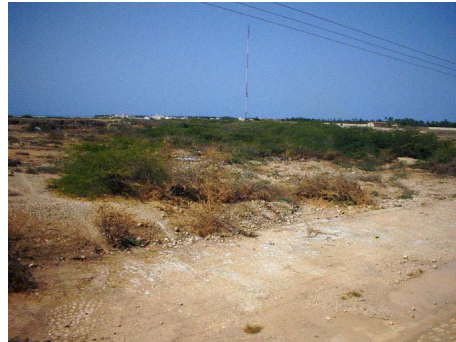
Prosopis juliflora (Mesquite) at upstream of khawr

Similar condition to previous visit. *Prosopis juliflora* should be removed by hand to avoid damage to the other vegetation.

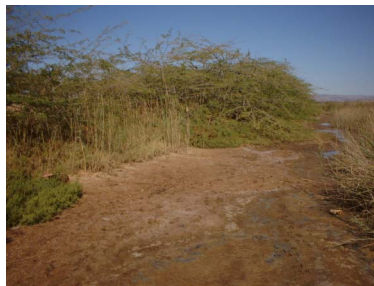
West shore, swamp area (Profile No. Da-1)

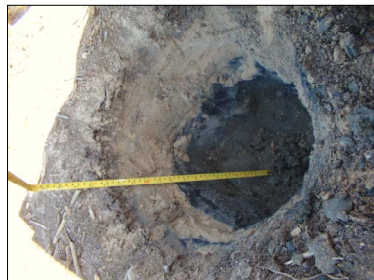
East shore near beach (Profile No. Da-3)

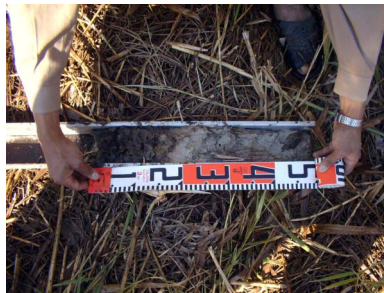
Reeds area near mouth (Profile No. Ba-1)

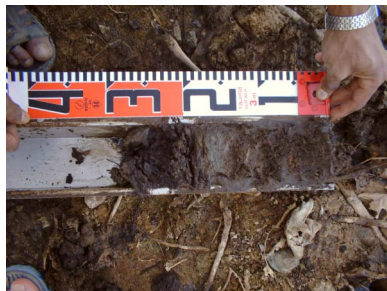
Mid-stream of west water channel, reeds (Profile No. Ba-2)
