THE PREPARATORY STUDY FOR
SECTOR LOAN ON
DISASTER RISK MANAGEMENT

CTI Engineering International Co., Ltd.
Nippon Koei Co., Ltd

Tagoloan 川治水計画
(縦断面図および計画高水位)

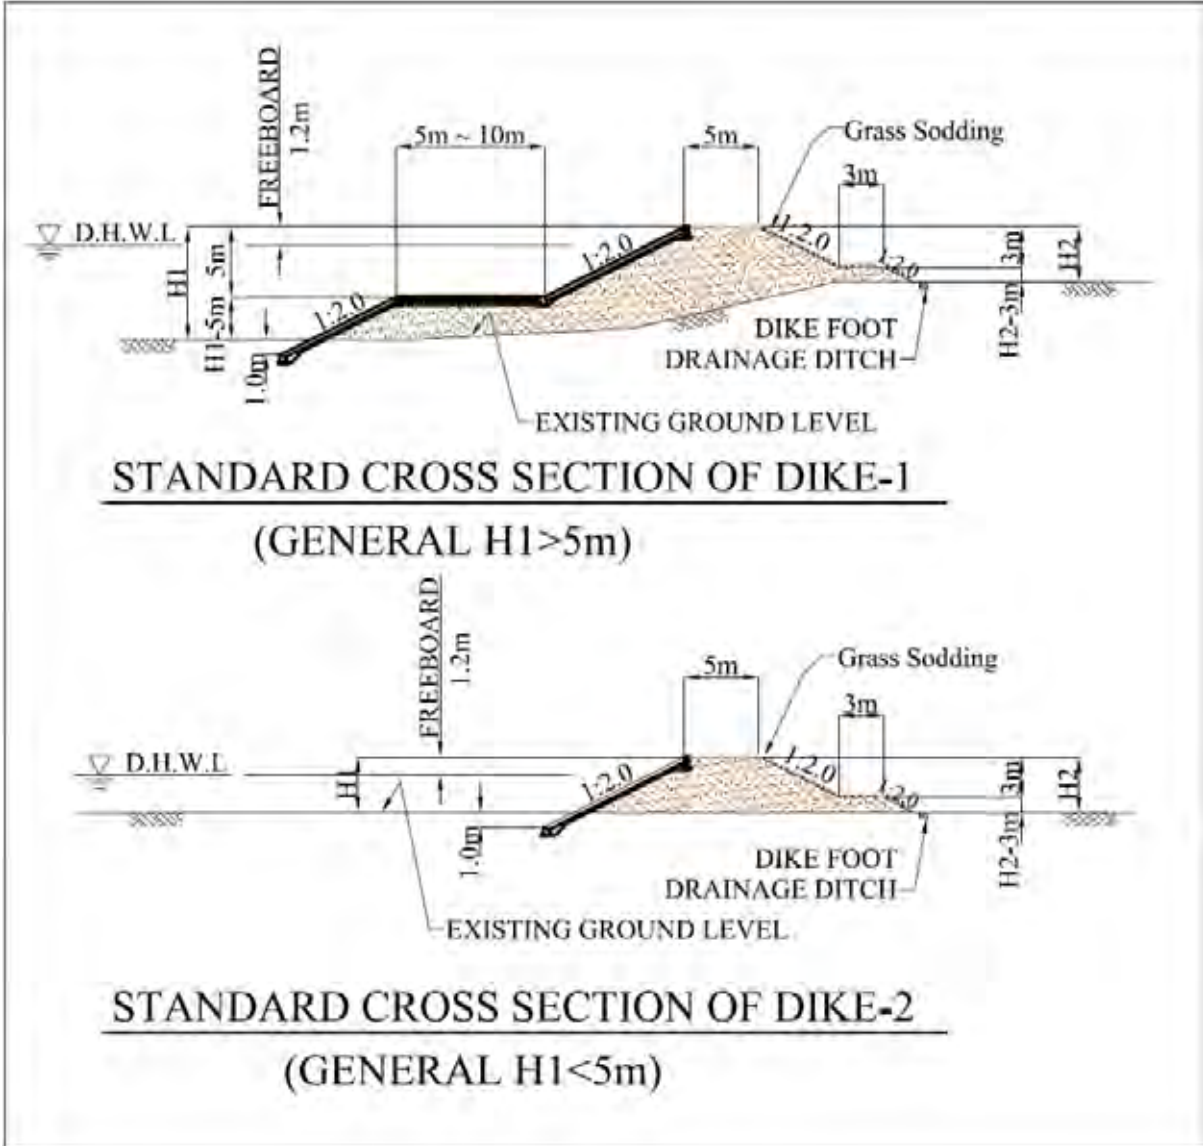
図 7.7
Tagoloan 川治水対策で提案する
河川堤防の標準断面図

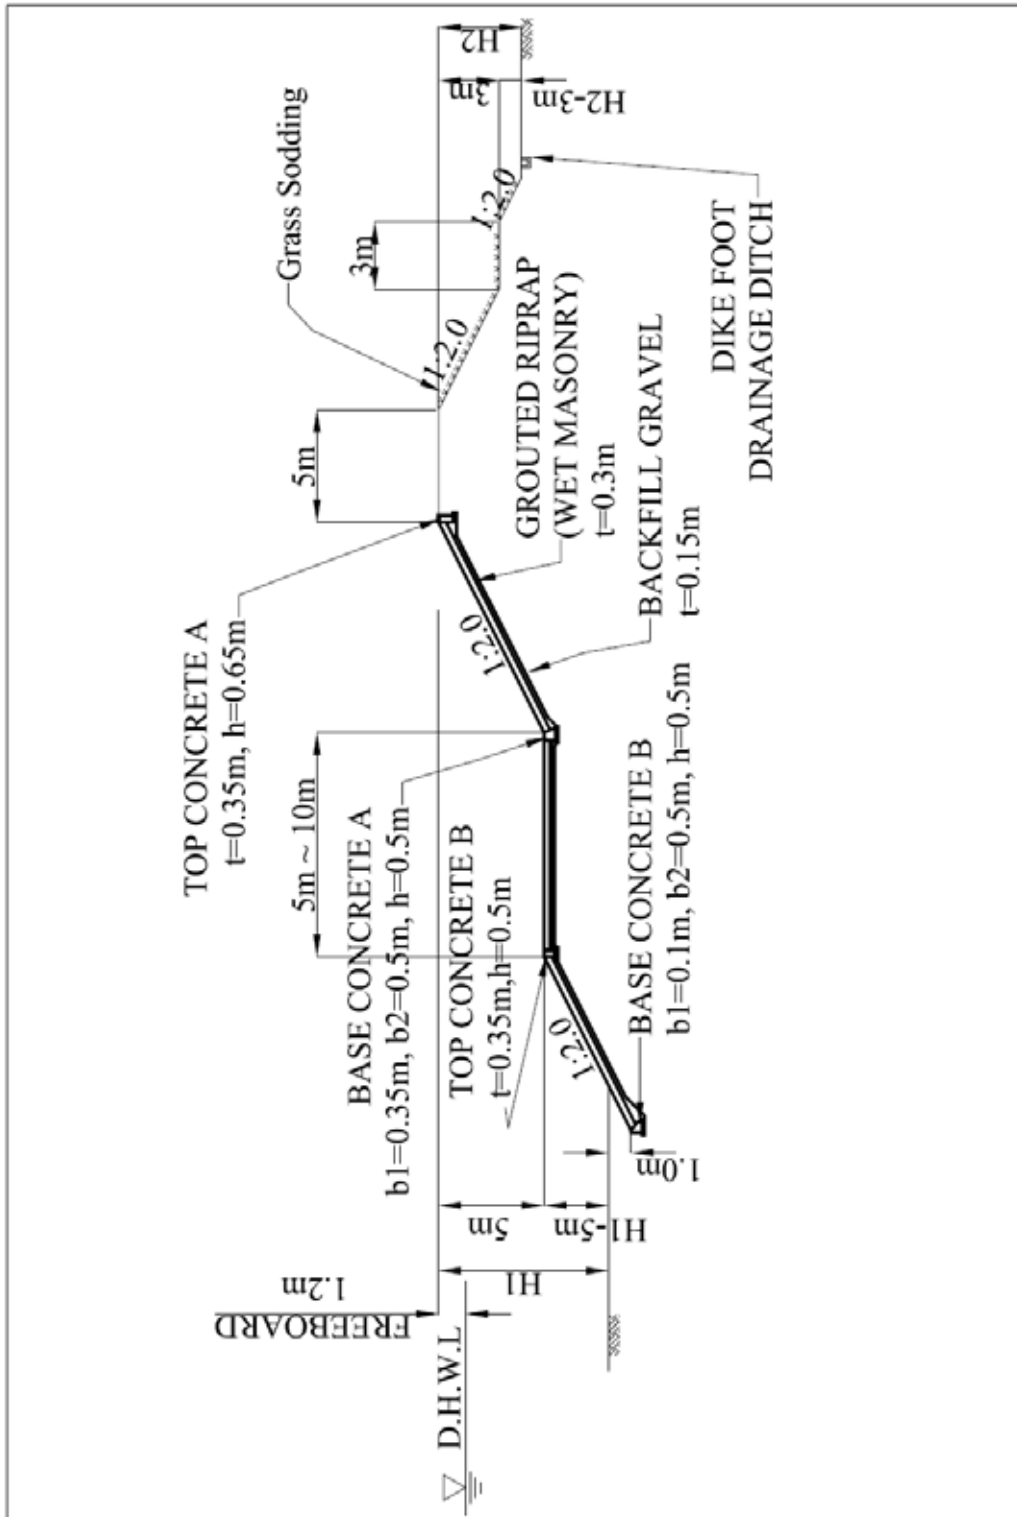
Figure 7.8

Tagoloan 川治水対策で提案する
護岸の標準断面図

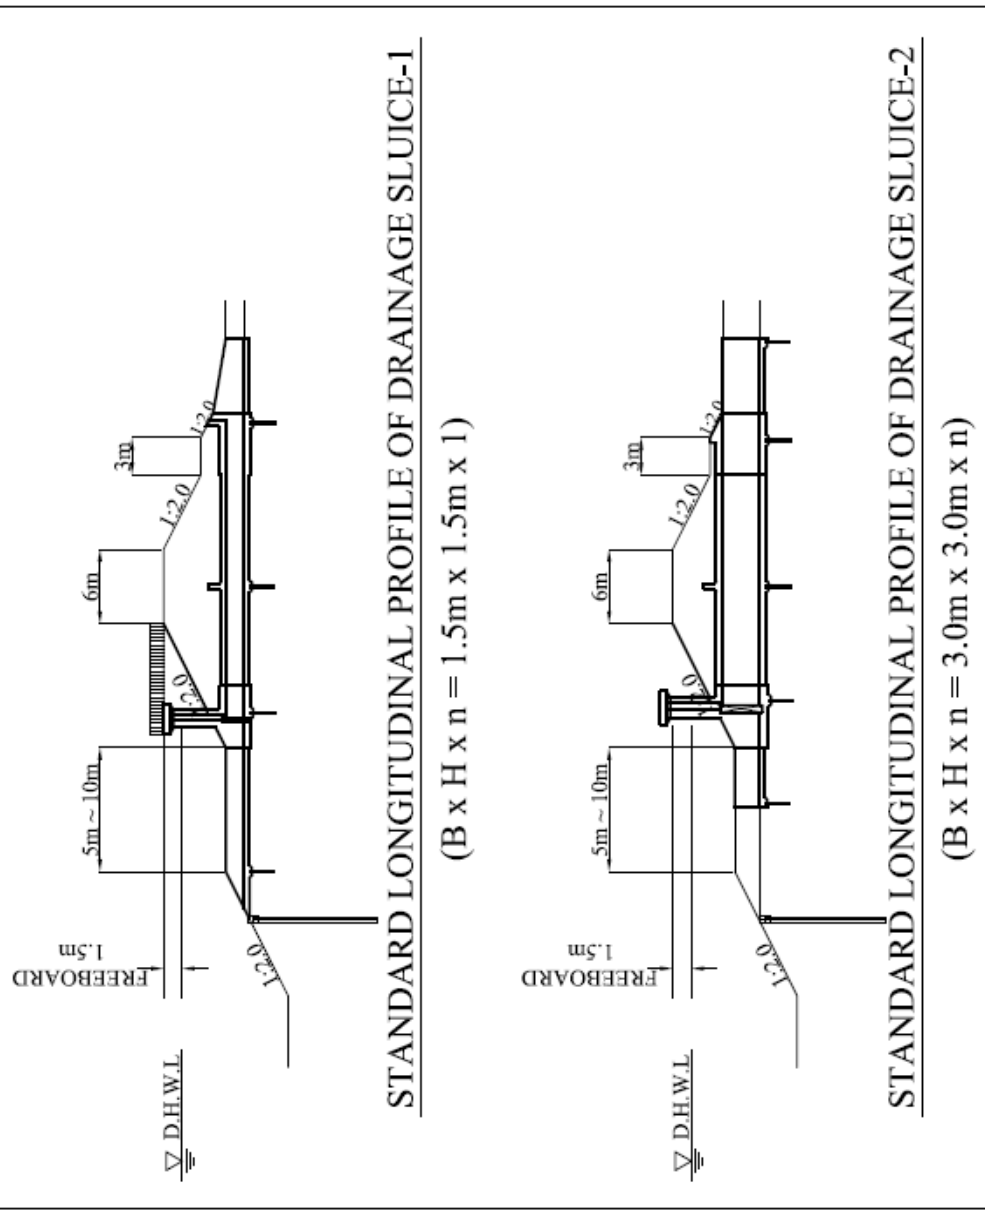
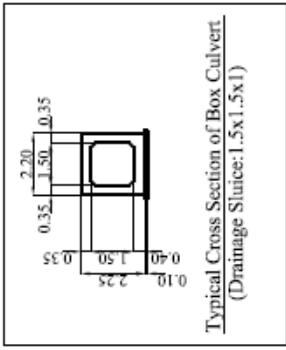
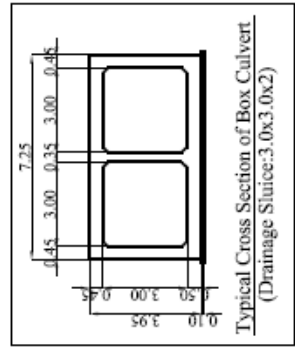
図 7.9
Tagoloan 治水対策での
排水樋門の標準図

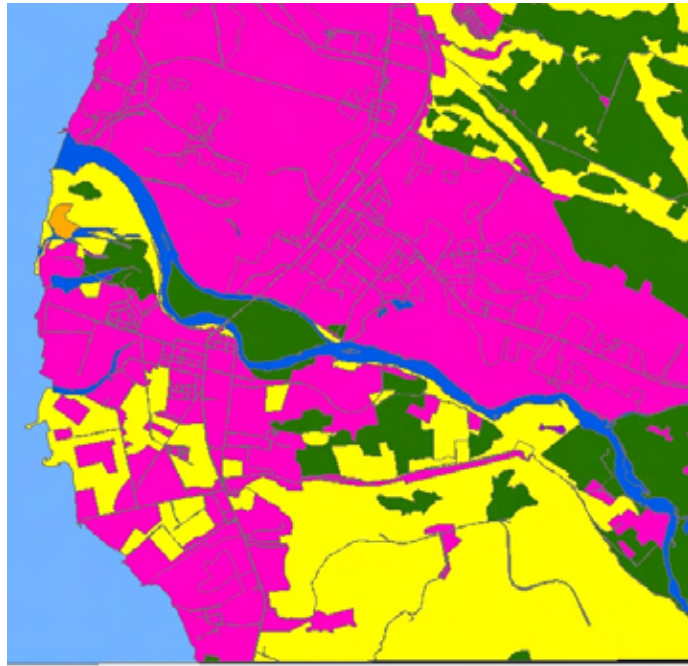
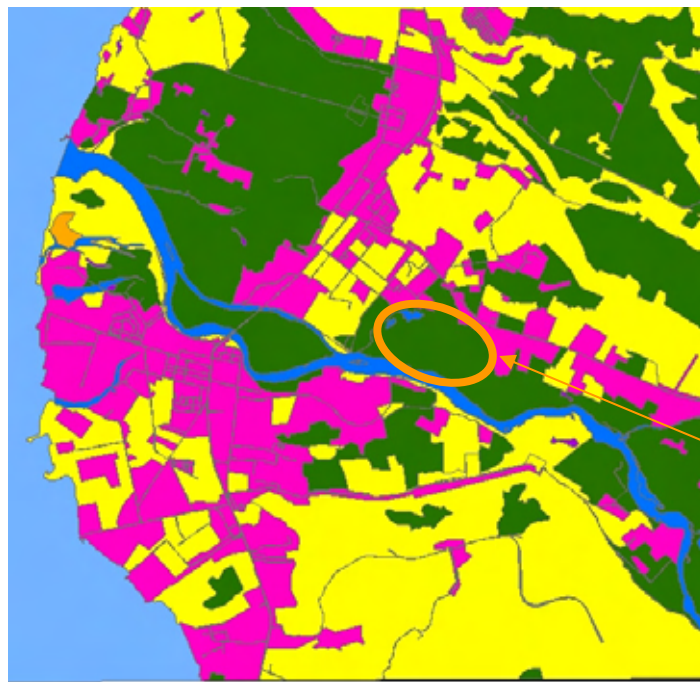
Future Land Use Condition (Newly Developed Area: 8.8km²)

Existing Land Use Condition with Expected Disposal Site for Surplus Soils

図 7.11
Tagoloan 川治水対策の
余剰土砂の土捨て場候補地

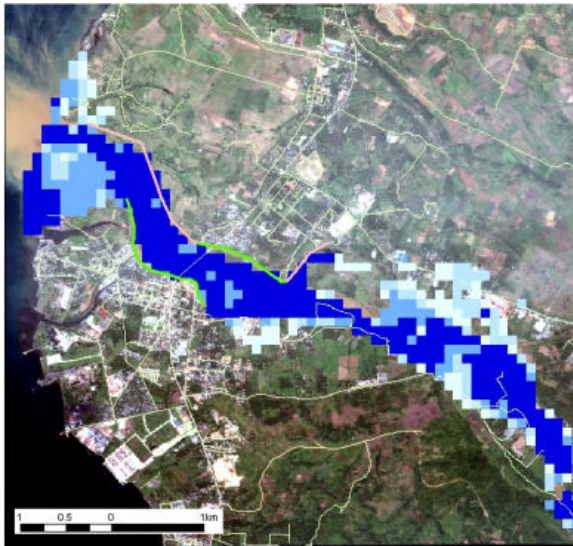
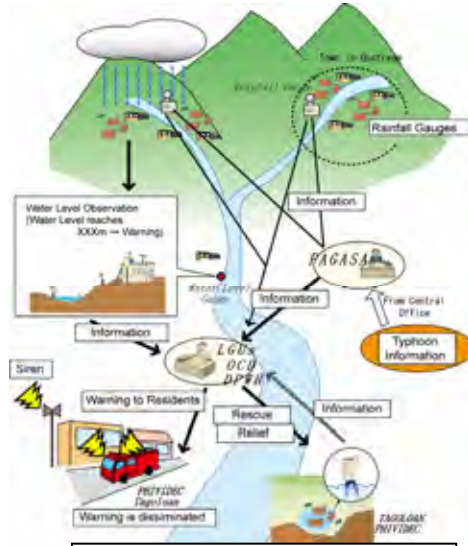
図 8.1

Flood Hazard map

Preparedness Plan and FEWS

Tagoloan 川流域の
提案する非構造物対策活動

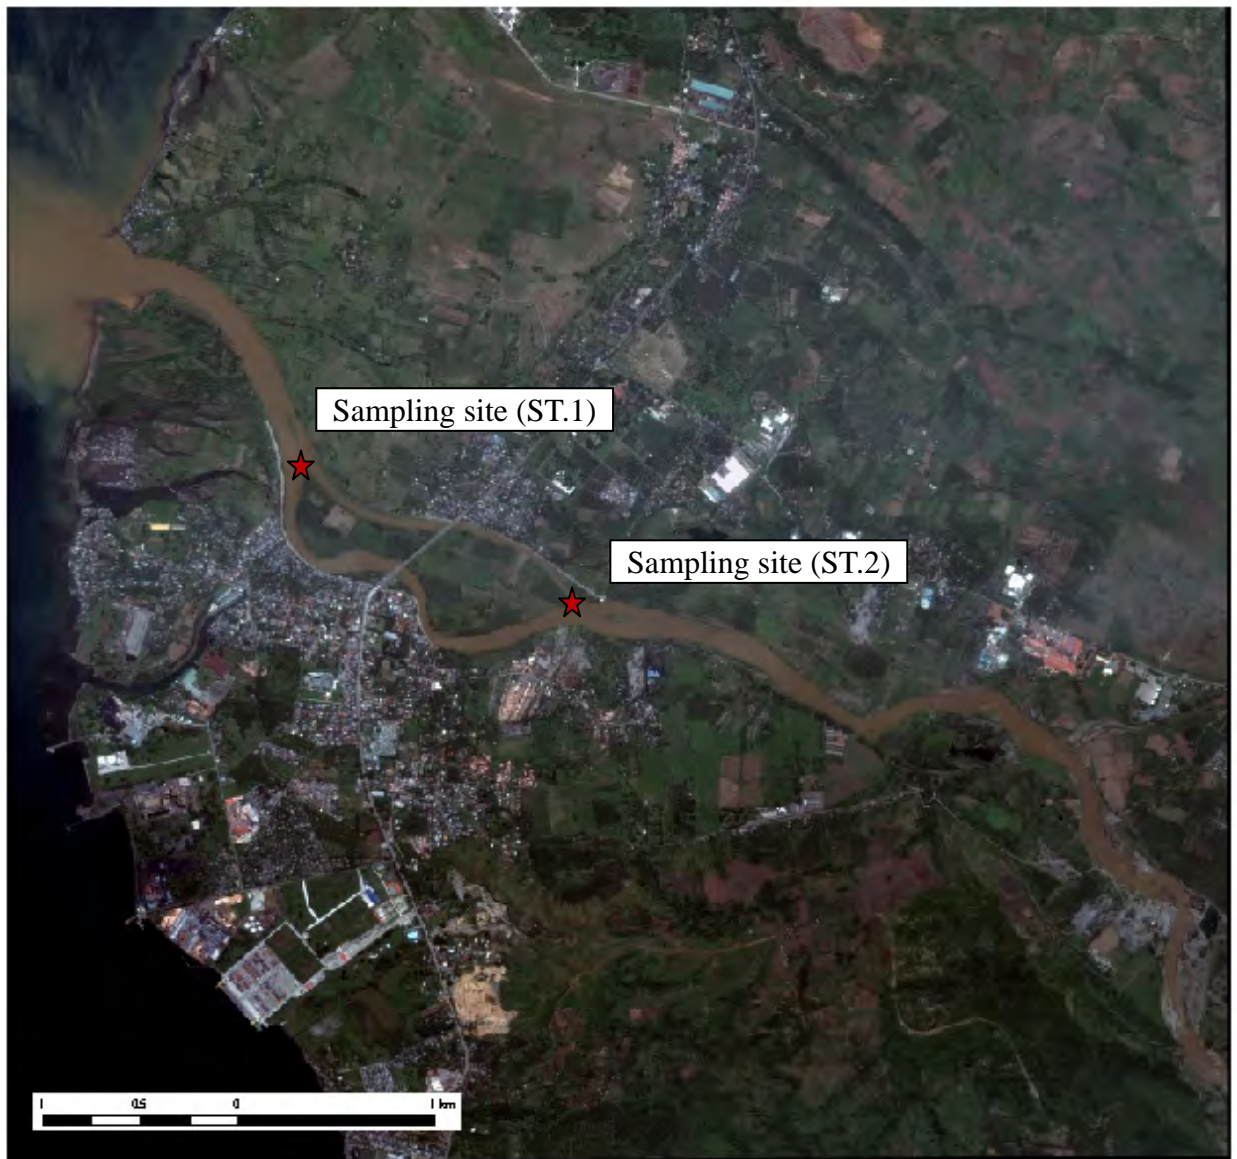
The sampling points are shown below.

Figure 1 **Sampling sites**

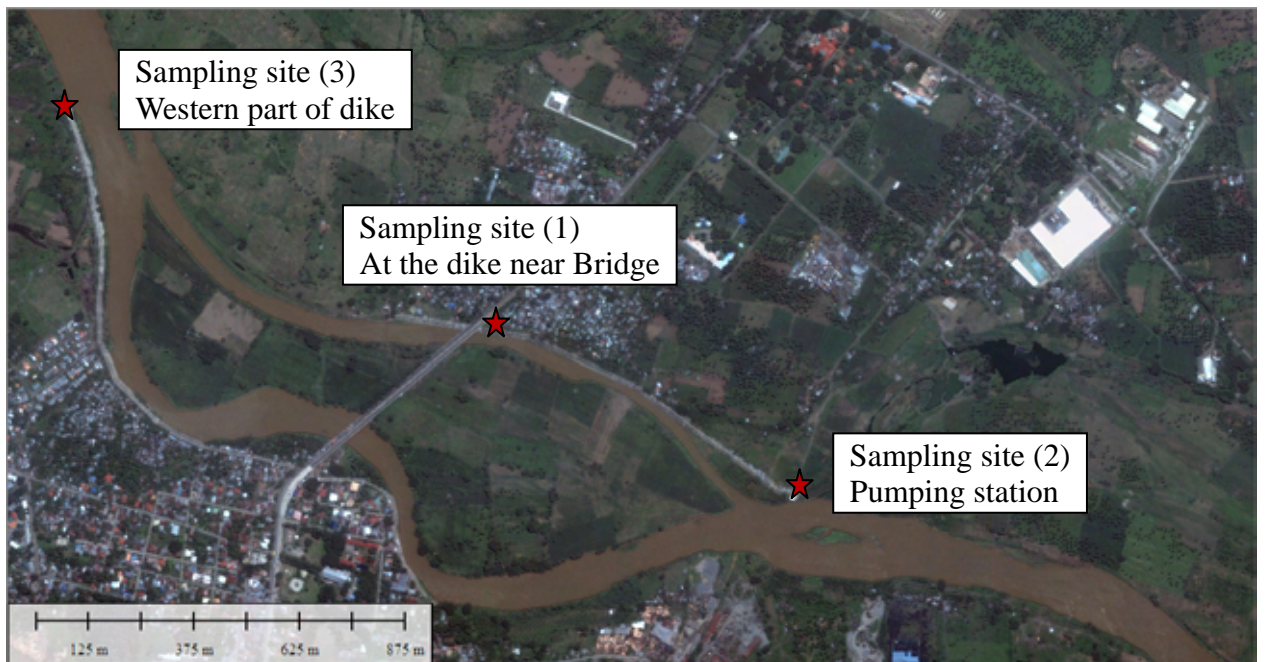
- (1) At the dike near Bridge
- (2) At Pumping Station
- (3) At western part of dike

The noise sampling stations were positioned at the nearest residential community to determine the possible impact of noise during the construction period.

Figure 1 Sampling sites

The samples were made at the diked areas, the first near the bridge, the second at the northern dike near the pumping station and the third at the southern dike at westernmost portion. There were some exceedances in the noise parameters at the bridge because of the passing through of vehicles, especially trucks, in the area which are often noisy and without noise retardants. In the other sites, however, there are no roads that will allow the passing of vehicles near the area.
