## **Appendix**

## Appendix-1-1: Alternative Routes for Chhiahtlang Bypass

### ALTERNATIVES FOR BYPASS-1, CHIATLANG BYPASS

## 2. GEOLOGICAL SURVEY RESULT

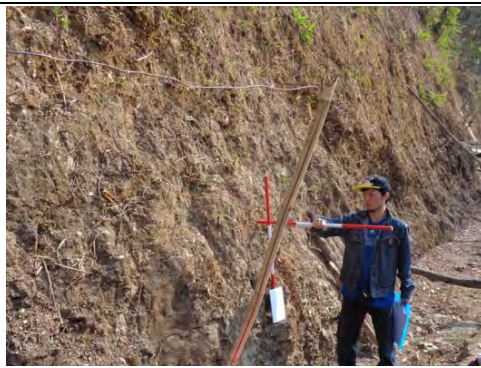
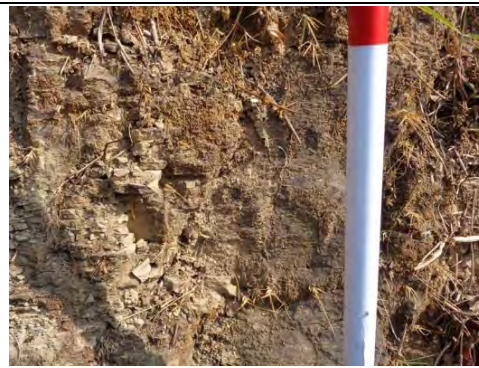
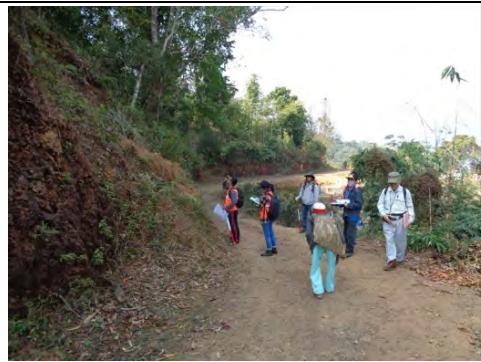
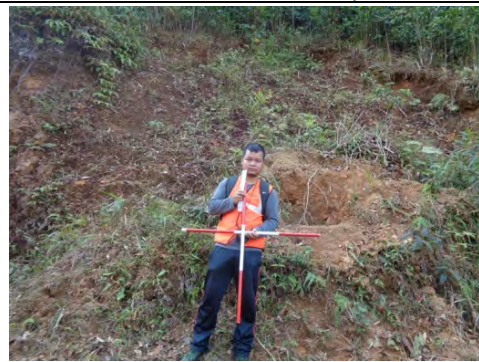
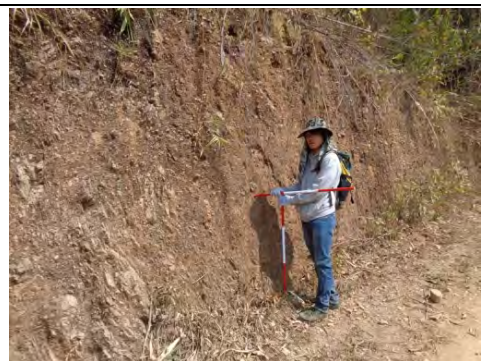
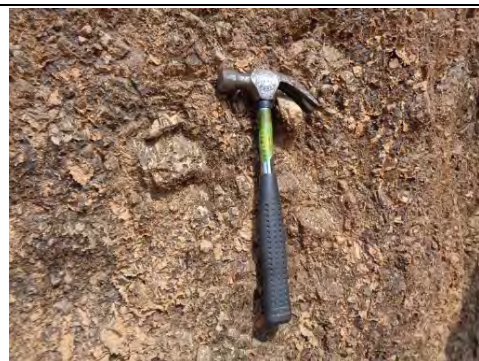
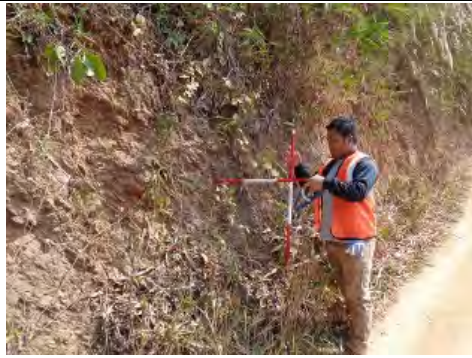
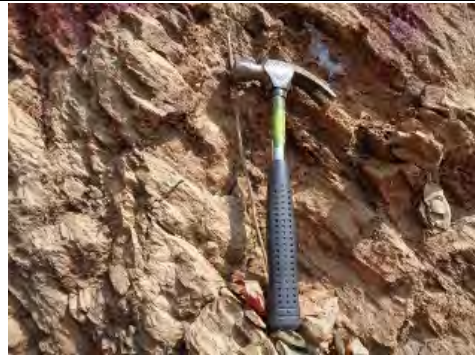
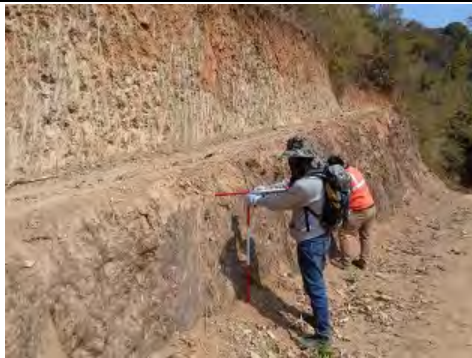
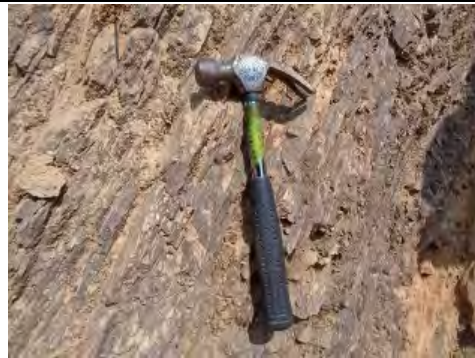
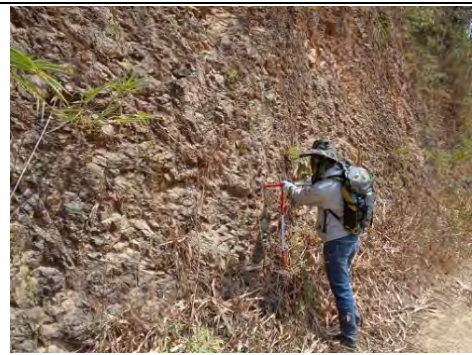
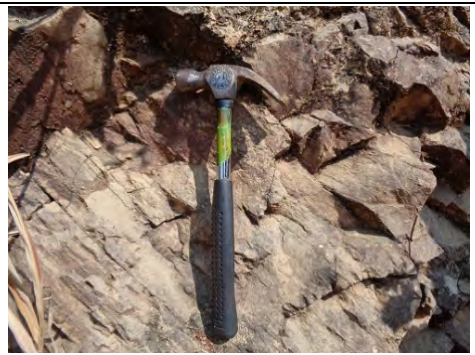
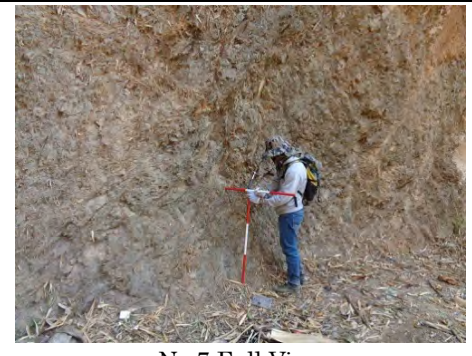
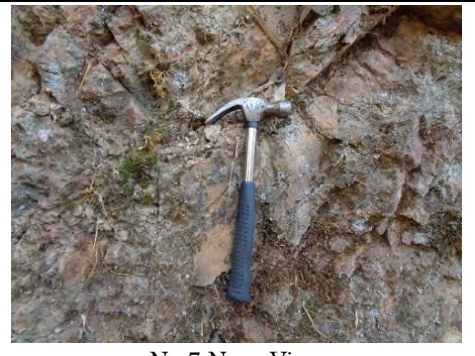
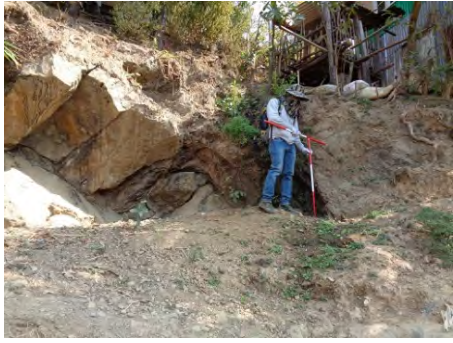
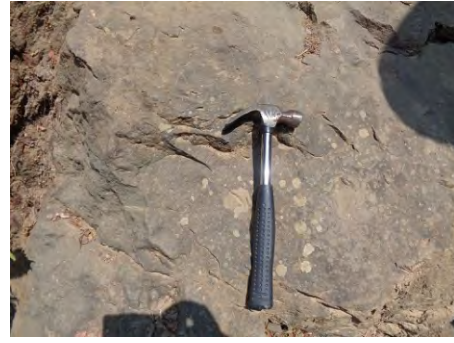
**Figure 1-2 Outcrop Conditions**

Siltstone and sandstone are mainly distributed as bedrock in this area. Weathered condition of bedrock is strong to middle, so cracked rocks are observed along the cutting slope. Color of the rock is brownish due to weathering. As a whole, self-standing of the cutting slope is good. Therefore, the slope failure is hardly seen along the road. But if the height of cutting is high, there is a possibility of slope failure. On the other hand, a hard rock of sandstone was observed characteristically at the No.8 site.

Slope No.	Location	Geology	Weathered Condition	Geotechnical Condition	Strike			Dip		Disaster Risk (due to slope cutting)
	GPS Log									
1	545	Muddy/Silty	Middle(Cracky)	Soft	N	75°	W	20°	N	Slope Failure
2	547	Muddy/Silty	Soil/Strong	Soft	—		—			Slope Failure
3	548	Silty Sand	Strong(cracky)	Soft	—		—			Slope Failure
4	549	Silty Sand	Middle(Cracky)	Soft	N	60°	E	50°	S	Slope Failure
5	550	Silty Sand	Middle(Cracky)	Soft	N	50°	W	55°	S	Slope Failure
6	551	Silty Sand	Middle(Cracky)	Hard	—		—			Slope Failure
7	552	Silty Sand	Fresh	Hard	N	15°	W	65°	S	Slope Failure
8	553	Siltstone/Sandstone	Strong and Weak	V. Hard and Soft	N	30°	E	42°	S	Slope Failure

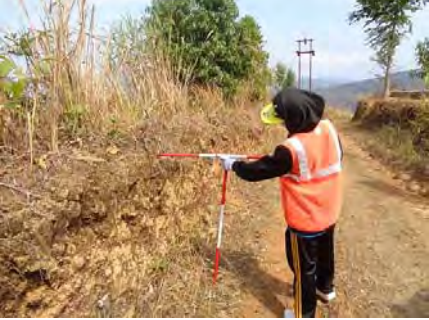
<p>No.6 Full View</p>

As a whole, self-standing of the cutting slope is good. But small slope failures are observed locally. On the other hand, the middle-weathered rocks are observed around the ridge as shown in No.6 to No.10. Probably, the strong weathered rocks on the middle-weathered rocks, which look like the sediment, are thought to have almost flowed out in the past. A part of the strong weathered rocks can be seen on the middle-weathered rocks in No.7 site. If the height of cutting is high, the weathered rocks have a possibility of slope failure.

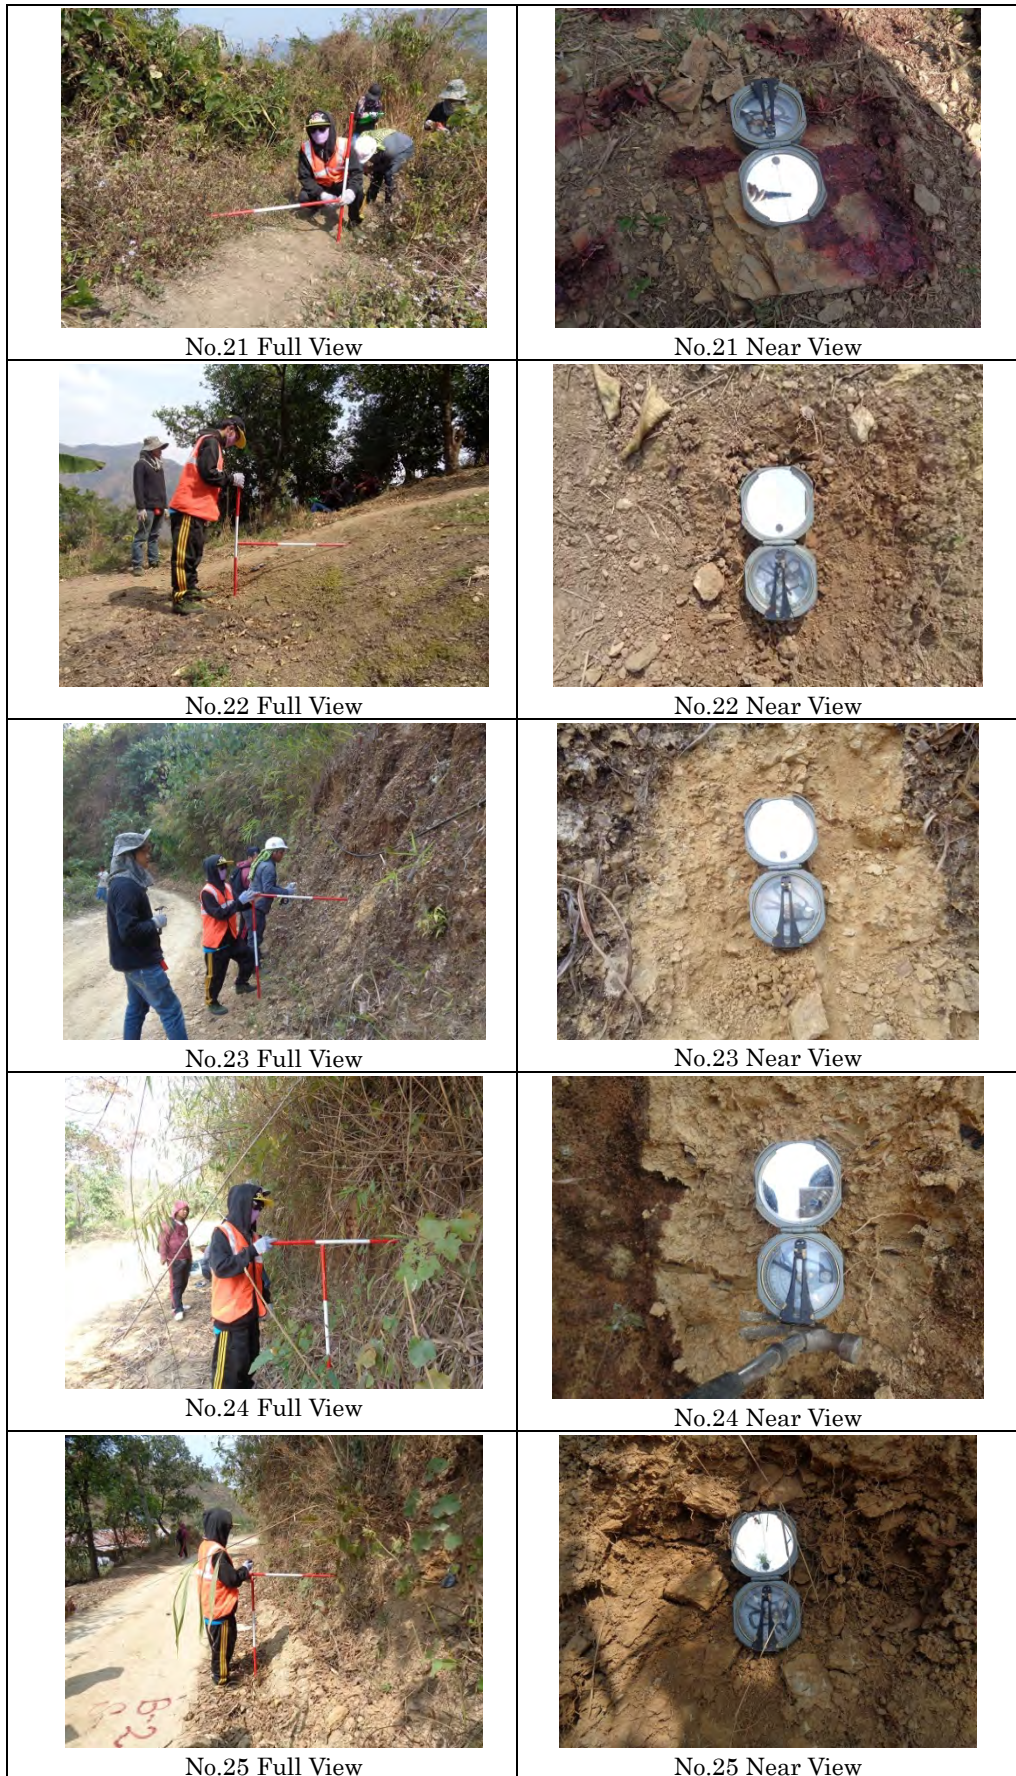
**Figure 1-4 Outcrop Conditions**

Siltstone and sandstone are mainly distributed as bedrock in this area. Weathered condition of bedrock is mainly strong to middle, so cracked rocks are observed along the cutting slope. Also, the sediment with rock is observed in places. This sediment is judged from weathered rock at present location as mentioned below (refer to Chapter 2). Color of the rock is brownish due to weathering.

Slope No.	Location	Geology	Weathered Condition	Geotechnical Condition	Strike		Dip		Disaster Risk (due to slope cutting)	
	GPS Log									
1	587	Muddy/Silty	Middle(Cracky )	Soft	N	50°	E	10°	S	Slope Failure
2	588	Muddy/Silty	Middle	Soft	N	30°	W	60°	S	Slope Failure
3	589	Silty/Sandy	Middle	Soft	N	60°	E	45°	N	Slope Failure
4	590	Silty/Sandy	Middle	Soft	—	—	—	—	—	Slope Failure
5	591	Silty/Sandy	Strong	Soft	N	18°	E	18°	S	Slope Failure(Exist)
6	592	Silty/Sandy	Soil/Middle	Soft	—	—	—	—	—	Slope Failure
7	593	Silty/Sandy	Strong	Soft	N	25°	E	38°	S	Slope Failure
8	594	Silty/Sandy	Middle	Soft	N	10°	E	40°	N	Slope Failure
9	595	Silty/Sandy	Middle	Soft	—	—	—	—	—	Slope Failure
10	596	Silty/Sandy	Middle	Soft	—	—	—	—	—	Slope Failure(Exist)
11	599	Silty/Sandy	Strong	Hard	N	10°	E	64°	S	Slope Failure(Exist)
12	600	Silty/Sandy	Middle	Soft	—	—	—	—	—	Slope Failure
13	601	Sandy	Weak(Little cracky )	Soft/Hard	—	—	—	—	—	—
14	602	Silty/Sandy	Strong	Soft/Hard	—	—	—	—	—	Slope Failure(Exist)

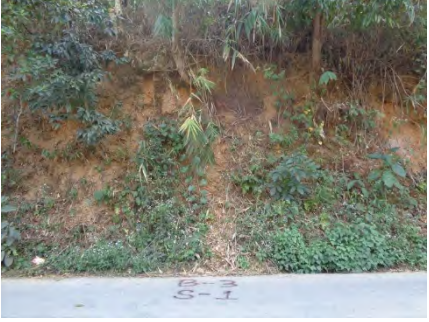
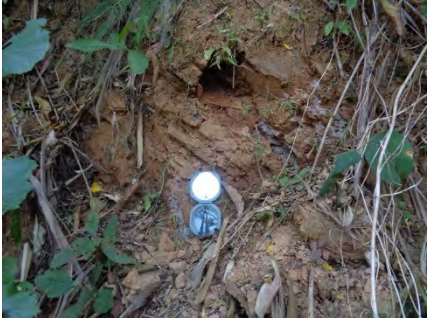
<p>No.1 Full View</p>	<p>No.1 Near View</p>

Slope No.	Location	Geology	Weathered Condition	Geotechnical Condition	Strike			Dip		Disaster Risk (due to slope cutting)
	GPS Log									
1	565	Muddy/Silty	Middle	Soft	—	—	—	—	Slope Failure	
2	566	Muddy/Silty	Middle	Soft	—	—	—	—	Slope Failure	
3	567	Sandy	Soil/Middle	Soft	—	—	—	—	Slope Failure	
4	568	Silty/ Sandy	Strong	Soft	—	—	—	—	Slope Failure	
5	569	Muddy/Silty	Middle	Soft	—	—	—	—	Slope Failure	
6	570	Muddy/Silty	Middle	Soft	—	—	—	—	Slope Failure	
7	571	Muddy/Silty	Middle	Soft	—	—	—	—	Slope Failure	
8	572	Muddy/Silty	Soil/Strong	Soft	—	—	—	—	Slope Failure	
9	573	Muddy/Silty	Soil/Strong	Soft	—	—	—	—	Slope Failure	
10	574	Silty/ Sandy	Middle	Soft	—	—	—	—	Slope Failure	
11	575	Silty/ Sandy	Middle	Hard	N	10°	E	27°	S	Slope Failure
12	576	Silty/ Sandy	Soil/Middle	Soft	—	—	—	—	—	Slope Failure
13	577	Silty/ Sandy	Soil/Middle	Soft	—	—	—	—	—	Slope Failure(Exist)
14	578	Silty/ Sandy	Soil/Strong	Soft	N	30°	W	30°	S	Slope Failure

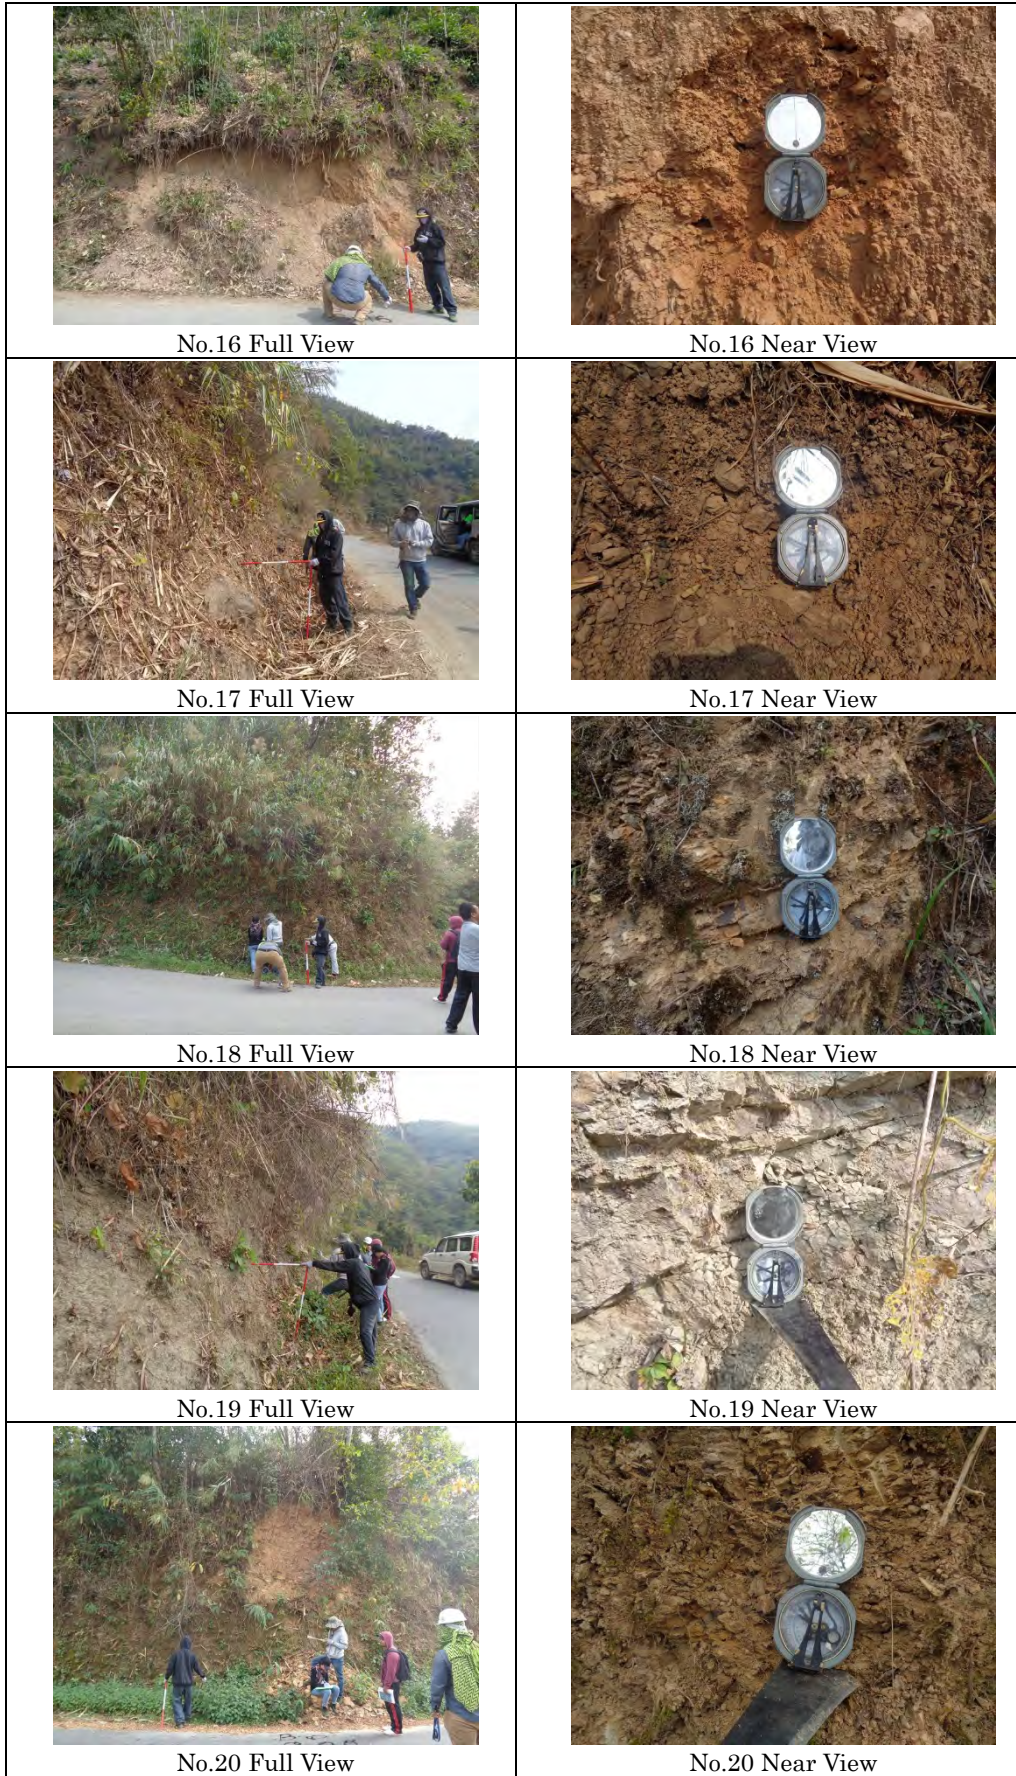
**Figure 1-6 Outcrop Conditions**

Siltstone and sandstone are mainly distributed as bedrock in this area. Weathered condition of bedrock is strong to middle, so cracked rocks are observed along the cutting slope. Also, the sediment with rock is observed in places. This sediment is judged from weathered rock at present location as mentioned below (refer to Chapter 2). Color of the rock is brownish due to weathering. As a whole, self-standing of the cutting slope is good. But as seen in No.4, No.5, No.8, No.9, No.13, No.16, and No.20, along the road, small slope failures are observed locally. Therefore, if the height of cutting is high, these weathered rocks have a possibility of slope failure.

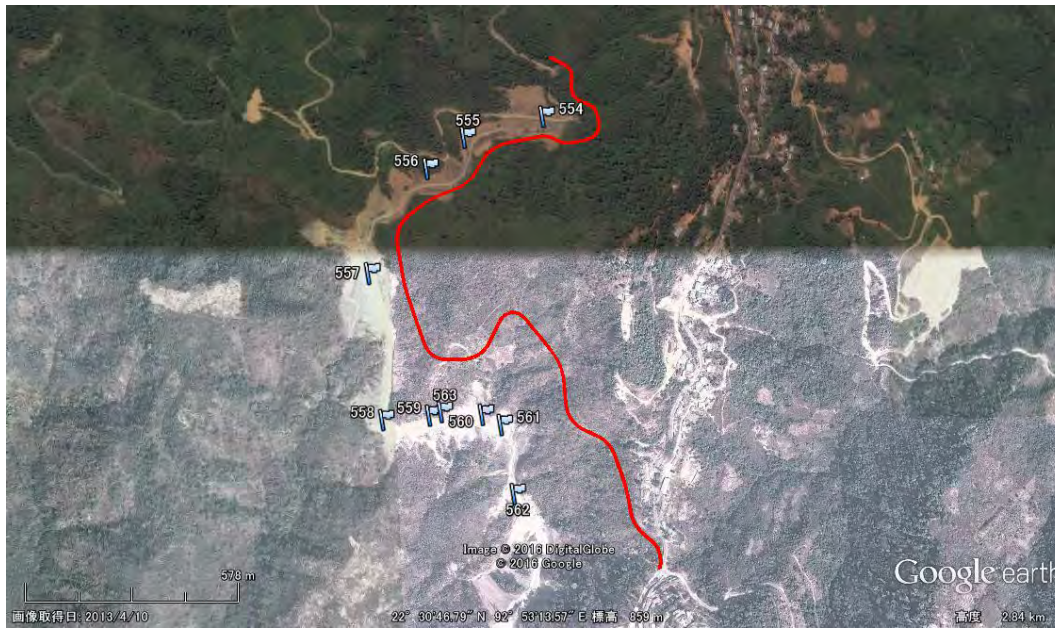
**Figure 1-7 Survey Site Locations**

Red line is the planned bypass line

Table 1-7 and Figure 1-7 show the survey site locations while Table 1-8 shows the outcrop conditions. Each outcrop condition is shown in Figure 1-8.

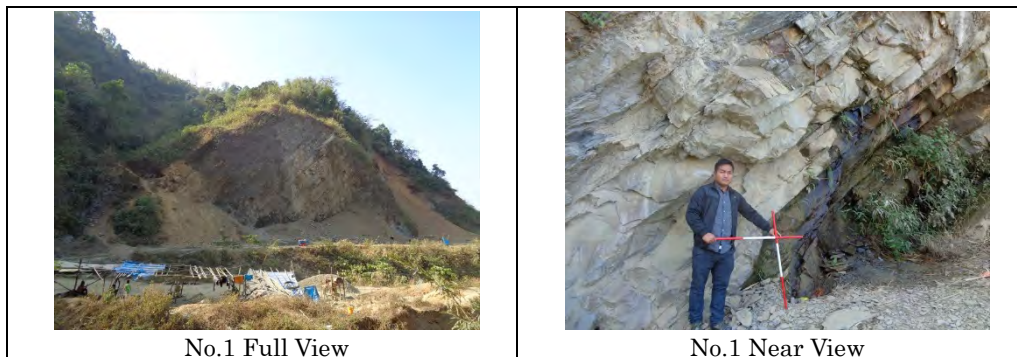
**Figure 1-8 Outcrop Conditions**

- Weathering condition of bedrock which got a lot of stress is significantly compared with other bypass areas. Therefore, this area has a condition of slope failure and landslide that easily occur.
- The active landslide which occurred by cutting was observed along the road (No.7). And this landslide has been moving at present.
- The brownish sediment which was formed by the slope failure in the past is distributed on the slope (No.10).

Actually, the sediment deposition which has a variation history is distributed on the slope along the Bypass No.4. This condition is obviously different from the other three areas (No.1-No.3).

Probably, the landslide of No.7 is thought to be the old one. Because, the disturbed outcrop is observed at the sliding cliff (refer to Chapter 3).

Slope No.	Location	Geology	Weathered Condition	Geotechnical Condition	Strike		Dip		Disaster Risk (due to slope cutting)	
	GPS Log									
1	554	Sandy	Strong/Fresh	Hard	N	30°	E	30°	S	Slope Failure(Exist)
2	555	Silty Sand	Strong/Fresh	Soft	—	—	—	—	—	Slope Failure(Exist)
3	556	Silty Sand	Strong/Fresh	Soft	—	—	—	—	—	Slope Failure(Exist)
4	557	Silty Sand	Strong	Soft	—	—	—	—	—	Slope Failure
5	558	Silty Sand	Strong	Soft	—	—	—	—	—	Slope Failure
6	559	Silty Sand	Strong	Soft	N	20°	W	48°	N	Slope Failure
7	563	Silty Sand	Strong	Soft	—	—	—	—	—	Landslide(Mass Movement)(Exist)
8	560	Silty Sand	Strong	Soft/Hard	N	25°	E	40°	N	Slope Failure
9	561	Silty Sand	Strong	Soft	—	—	—	—	—	Slope Failure(Exist)
10	562	Muddy/Sandy	Strong	Soft	—	—	—	—	—	Slope Failure(Exist)

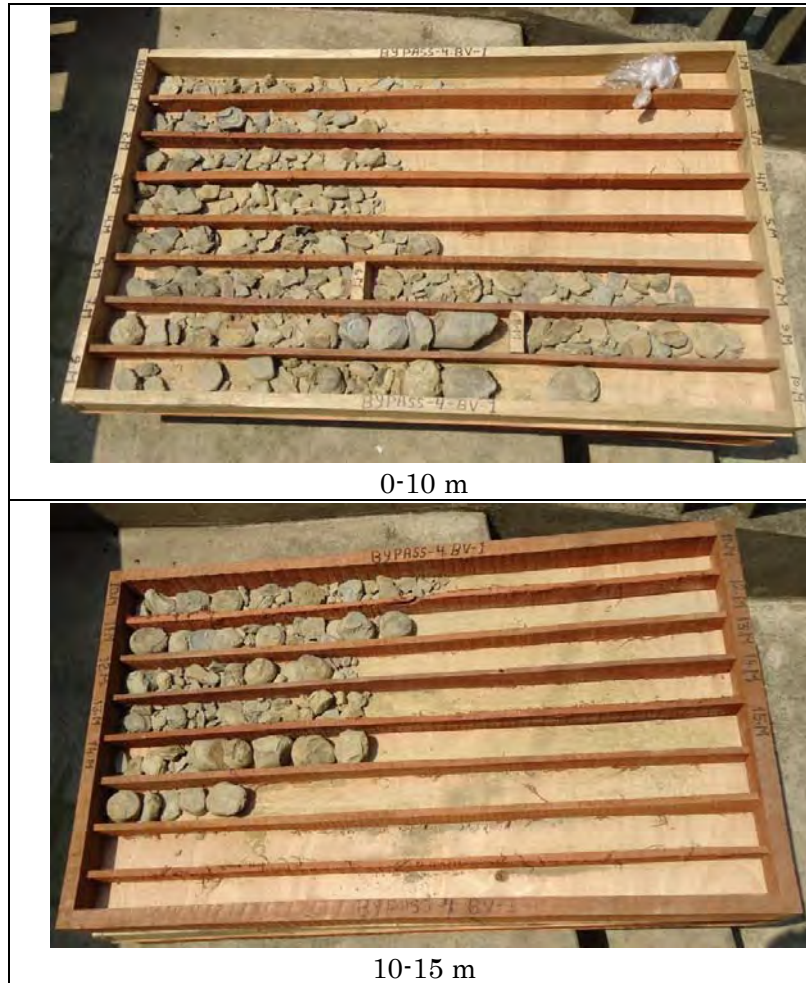
**Figure 2-2 Core Photos (BV-1)**

Geological condition is presumed as follows based on boring core. Probably, banking material is assumed to be distributed from 0.0 m to about 6.0 m. Natural ground is presumed to be distributed at about 6 m because grayish core was collected at the depth between 6 m and 8 m (Table 2-2, Figure 2-2).

Depth(m)			Geology	Remarks	Water Level (m)	Water Loss
0.0	-	6.0	Shale (Mudstone)	Weathered condition :Middle (Brownish color) Pebble shape: Banking material	5.5(07/03)	Partial
6.0	-	15.0	Shale (Mudstone)	Weathered condition :Middle (Brownish and grayish color) Pebble shape: Natural ground	8.7(08/03) 9.1(09/03)	Complete

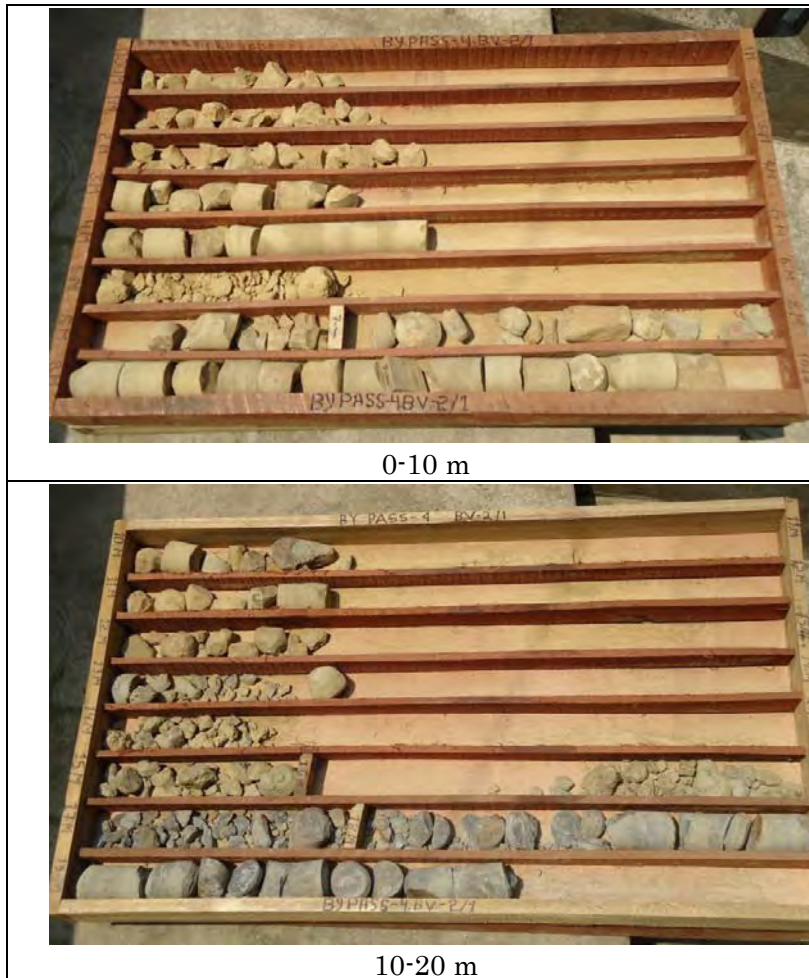
**Figure 2-3 Core Photos (BV-2)**

Geological condition is presumed as follows based on boring core. Brownish sandstone was collected between 0.0 m and 12.0 m. Almost all boring cores are pebble shape but locally short stick shape. Natural ground is presumed to be distributed at about 17.0 m because grayish core was collected at the depth between 17.0 m and 20.0 m. Slip surface is presumed to be about 10 m in depth considering landslide scale (Table 2-3, Figure 2-3).

Depth(m)			Geology	Remarks	Water Level (m)	Water Loss
0.0	-	12.0	Sandstone	Weathered condition :Middle (Brownish color) Almost collected with pebble shape (locally short stick shape)	2.1(19/03) 4.2(20/03) 6.0(21/03)	Complete
12.0	-	20.0	Shale (Mudstone)	12.0-17.0 m: Brownish color Almost collected with pebble shape (locally short stick shape) 17.0-20.0 m: Grayish color Weathered condition :Weak Collected with pebble shape and short stick shape: Natural ground

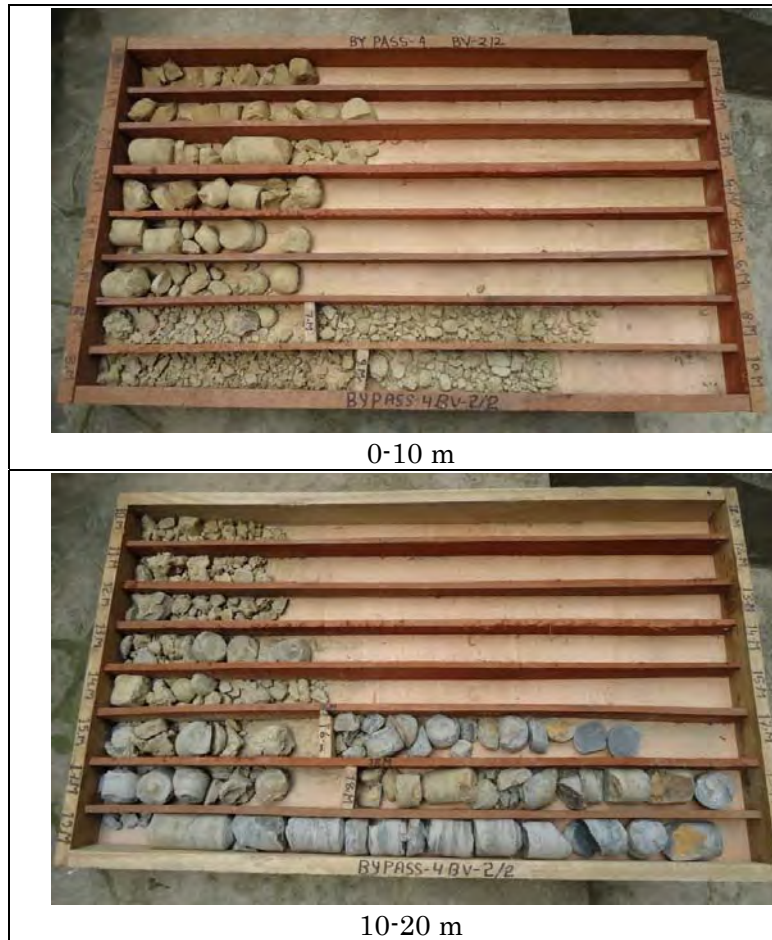
**Figure 2-4 Core Photos (BV-2S)**

Geological condition is presumed as follows based on boring core. Brownish sandstone was collected between 0.0 m and 17.0 m. Almost all boring cores are pebble shape but locally short stick shape. Natural ground is presumed to be distributed at about 17.0 m because grayish core was collected at the depth between 17.0 m and 20.0 m. Slip surface is presumed to be about 10 m in depth considering landslide scale (Table 2-4, Figure 2-4).

Depth(m)			Geology	Remarks	Water Level (m)	Water Loss
0.0	-	16.0	Sandstone	Weathered condition :Middle (Brownish color) Almost collected with pebble shape (locally short stick shape)	5.4 (23/03) 8.5 (24/03)	Complete
16.0	-	20.0	Shale (Mudstone)	Weathered condition :Weak (Grayish color) Collected with pebble shape and short stick shape: Natural ground

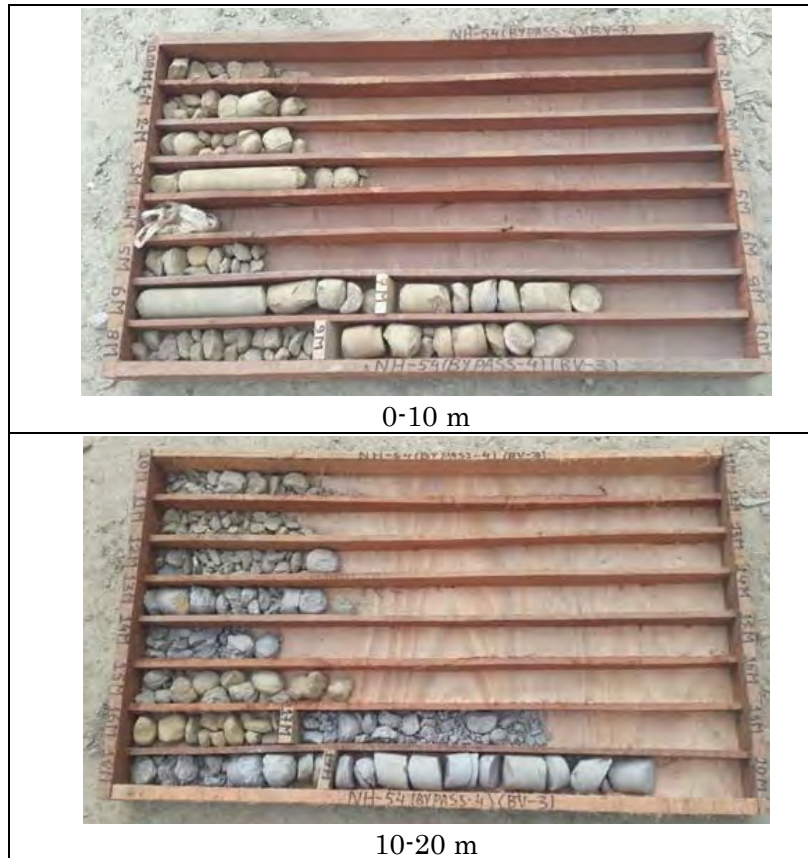
**Figure 2-5 Core Photos (BV-3)**

Geological condition is presumed as follows based on boring core. Brownish sandstone was collected between 0.0 m and 12.0 m. Almost all boring cores are pebble shape but locally short stick shape. Obvious natural ground is presumed to be distributed at about 19.0 m, because grayish core of short stick shape was collected at the depth between 19.0 m and 20.0 m. Slip surface is presumed to be between 10 m and 12 m in depth considering the topographical shape of landslide (Table 2-5, Figure 2-5).

Depth(m)			Geology	Remarks	Water Level (m)	Water Loss
0.0	-	10.0	Sandstone	Weathered condition :Middle (Brownish color) Almost collected with pebble shape (locally short stick shape)	5.3(07/04)	Complete
10.0	-	20.0	Shale (Mudstone)	Weathered condition :Middle (Brownish /Grayish color) Collected with pebble shape 10.0-12.0 m, 15.0-17.0 m: Brownish color 17.0-20.0 m: Grayish color	10.2(04/04)

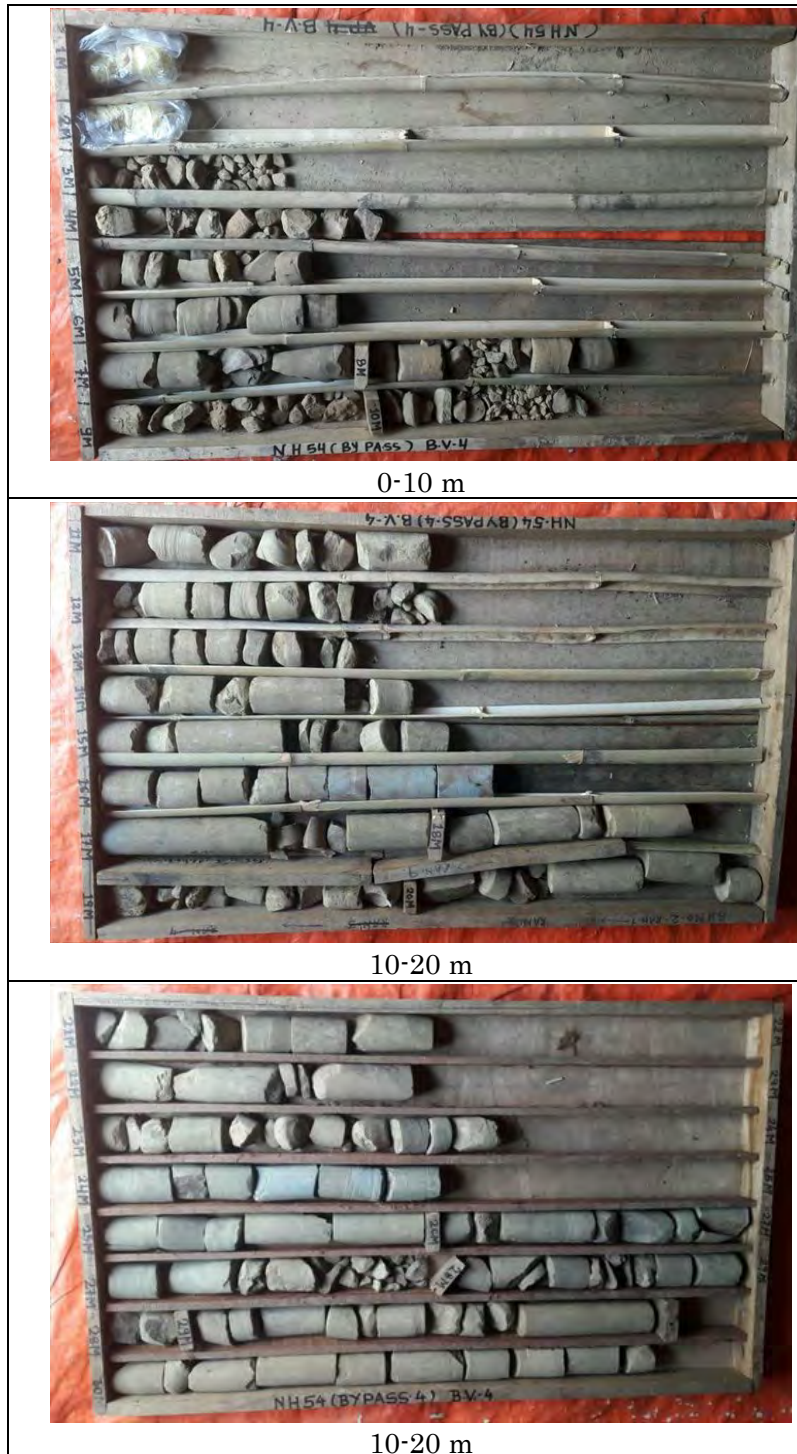
**Figure 2-6 Core Photos (BV-4)**

Geological condition is presumed as follows based on boring core. Grayish shale was collected between 2.0 m and 30.0 m excluding surface soil (0.0-2.0 m). Boring core between 2.0 m and 11.0 m is a bit crushed. Probably, this interval is presumed to be a looseness zone. Fresh rock core is collected below 11.0 m. Weathered condition is almost fresh rock. And the direction of crack is almost horizontal (Table 2-6, Table 2-5, Figure 2-6).

Depth(m)			Geology	Remarks	Water Level (m)	Water Loss
0.0	-	2.0	Sediment (Surface soil)	N-value 0-1 m: 8,13,33 1-2 m: 12,16,44		Complete
2.0	-	11.0	Shale (Mudstone)	Weathered condition :Weak /Fresh (Grayish color) Almost collected with pebble shape (locally short stick shape)	6.1(19/04)	
11.0	-	25.0	Shale (Mudstone)	Weathered condition :Fresh (Grayish color) Collected with short stick shape Crack direction: horizontal	11.8(20/04) 17.7(21/04)	
25.0	-	30.0	Shale (Mudstone) Partially (Sandstone)	Weathered condition :Fresh (Grayish color) Collected with short stick shape Crack direction: horizontal	18.7(22/04)	Partially

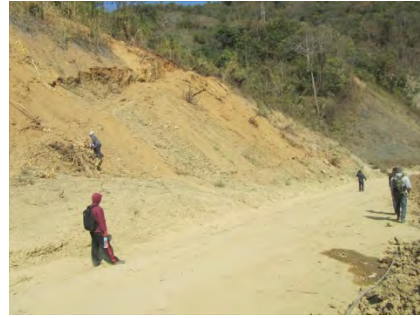
Figure 2-7 Head and Lower End of the Landslide

Location of the head and the lower end of landslide is judged as follows (see **Figure 2-7**):

No Deformation on the Road
