SANTA CLARA COUNTY PARKS

COYOTE CANYON

NATURAL RESOURCES MANAGEMENT PLAN & INTERIM ACCESS PLAN

REVISED DRAFT
AUGUST 2019

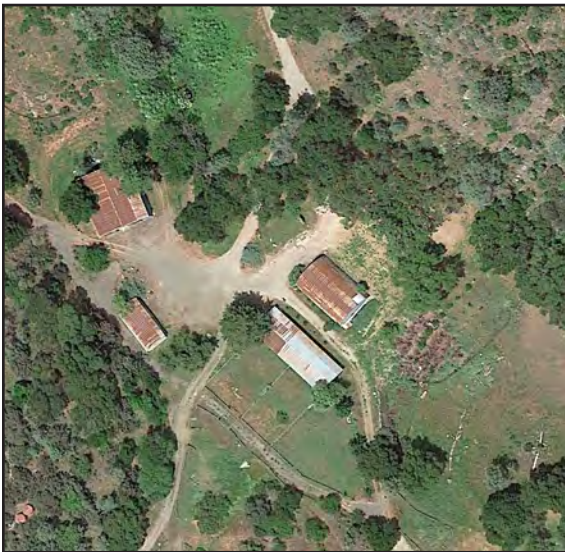
Photo 5. Aerial photograph of Ranch Complex

The two-story Achille's barn (historically known as the Fountain Oaks Horse Barn), located off Carey Avenue, was built in 1927 and is in a state of advanced deterioration. However, it does maintain a high level of historic integrity and retains its underlying early 20th-century residential scale and feeling. Since its construction, the structure was not significantly altered. The barn has a gambrel roof and is stylistically more typical of East Coast barns and is not typical of California barns of the period (Photo 4). Adjacent related structures, including a milk house, shed, cow-feeding stalls and barn, straw shed, and corrals were demolished when the property was sold in 1956.

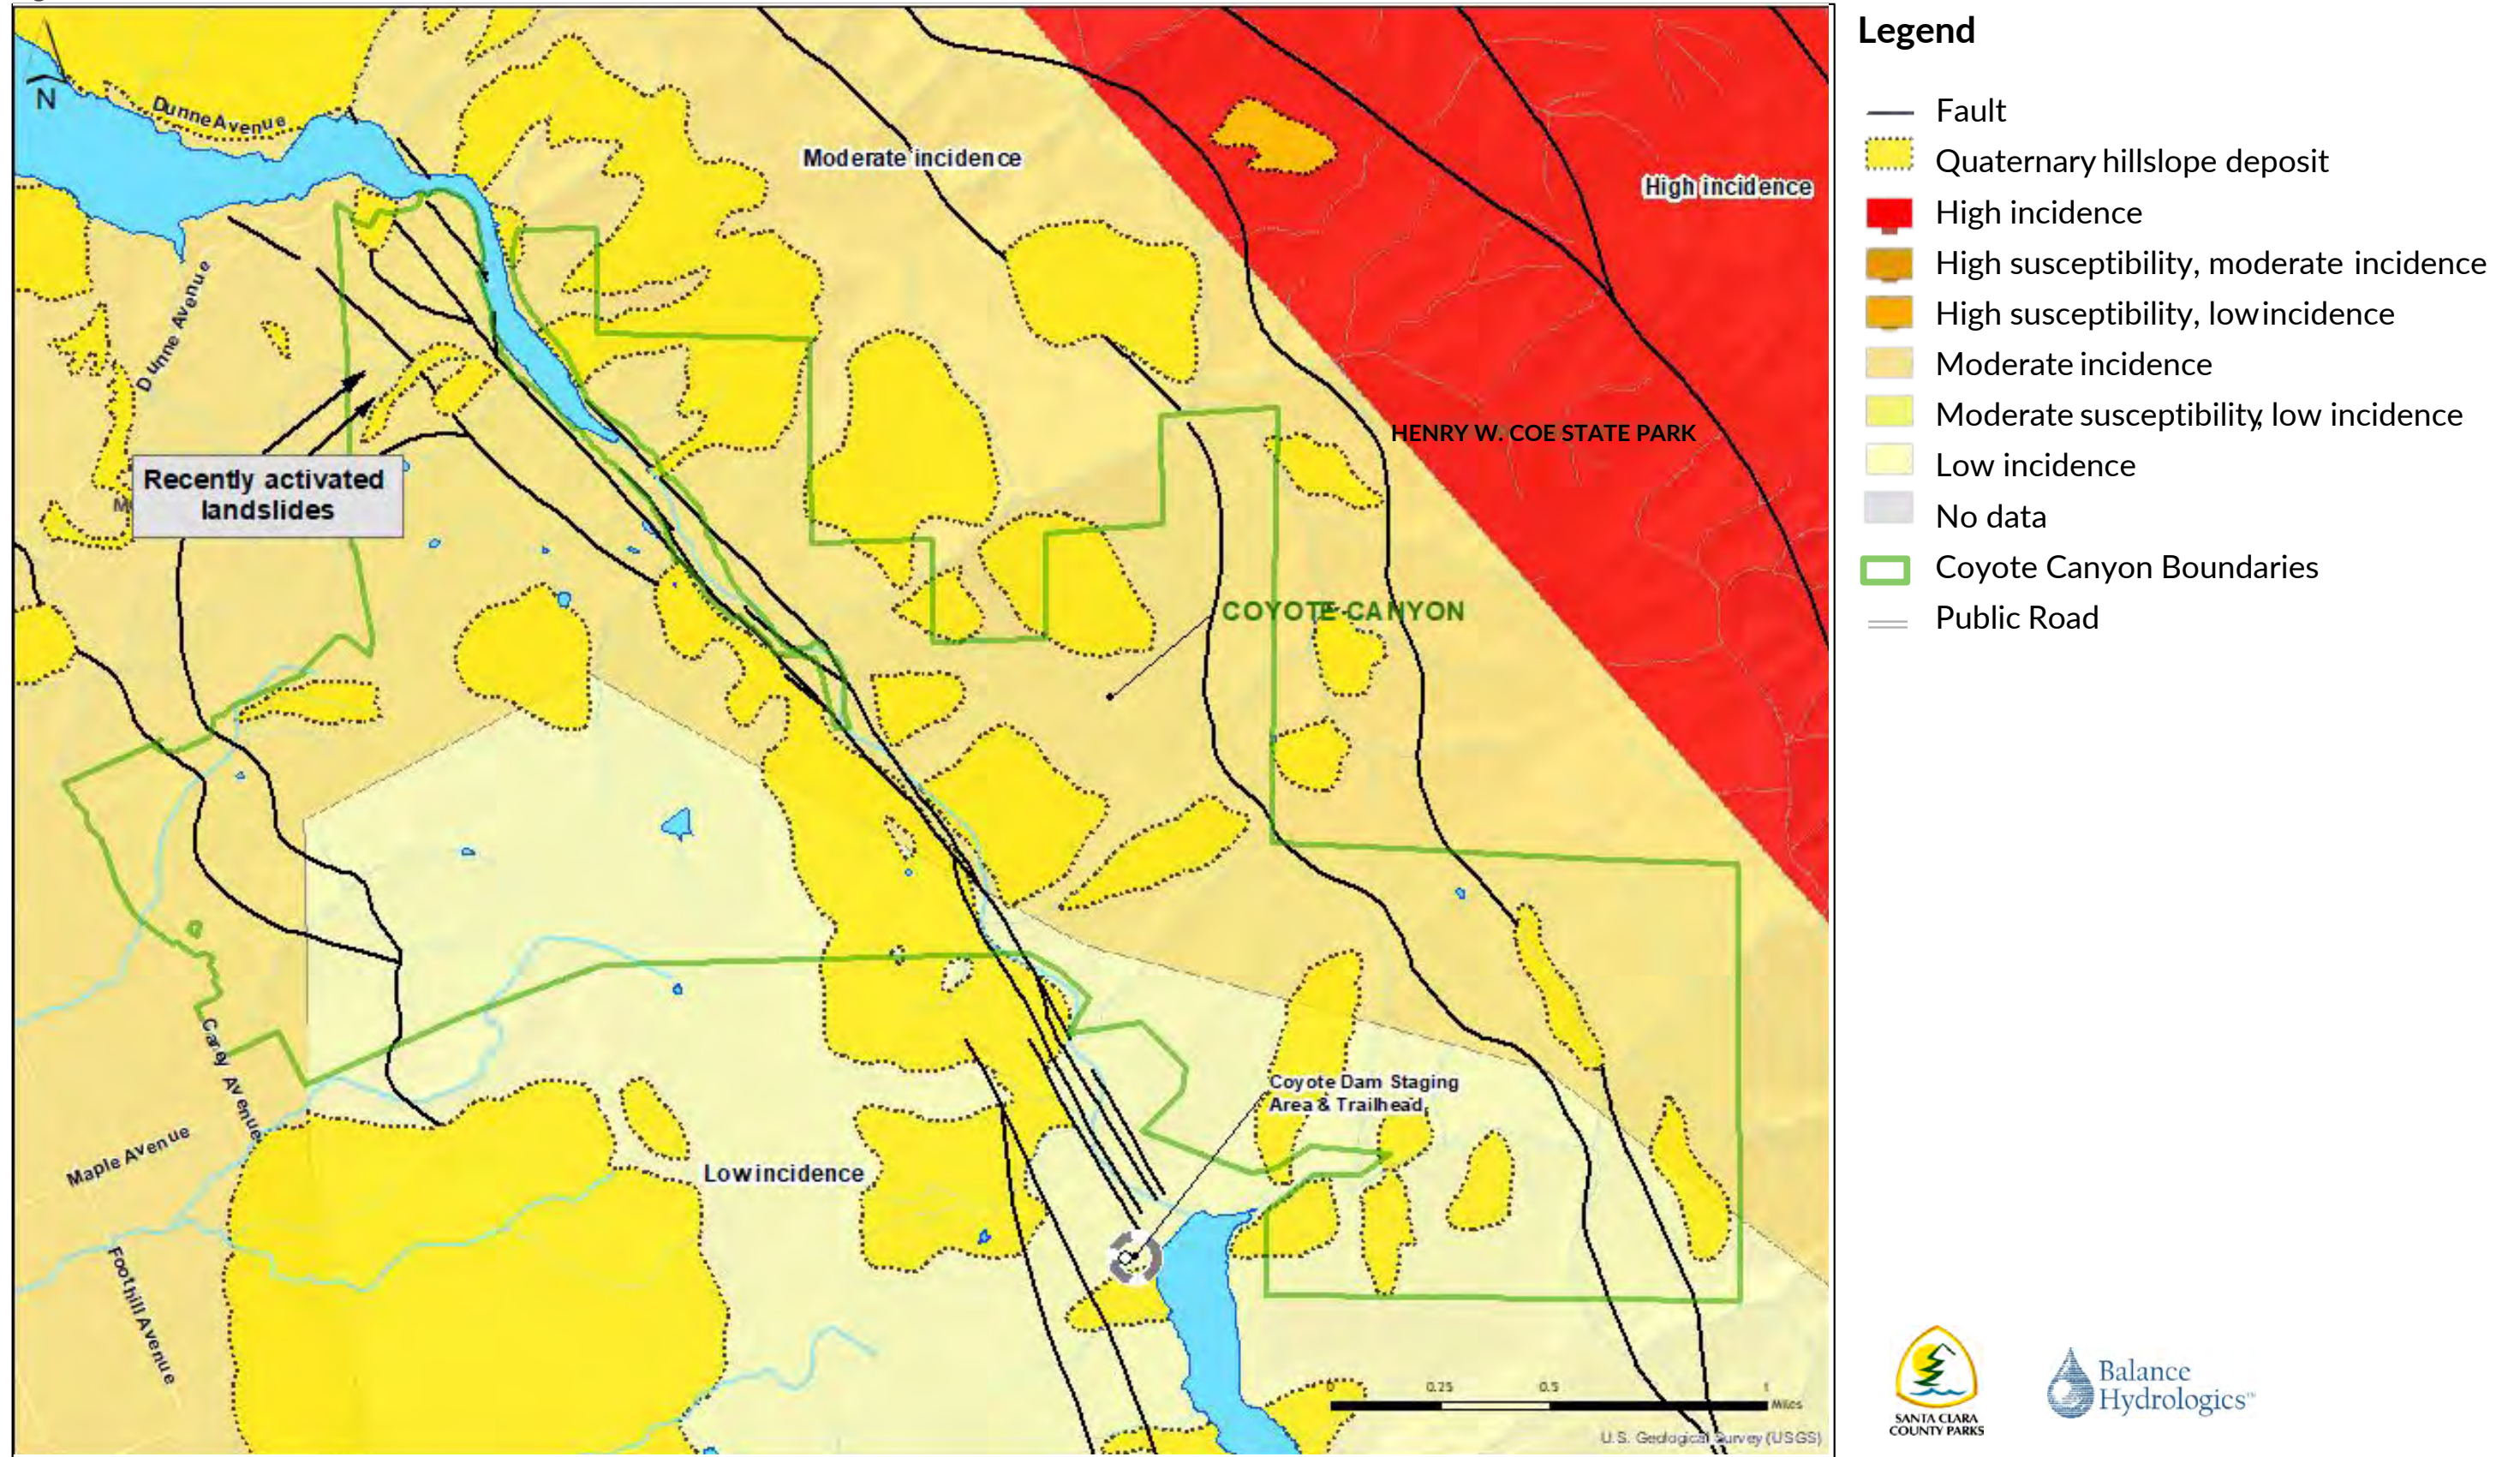
Figure 7. Erosion Hazards

The primary erosion hazards associated with the Property are those related to landslide, faults and erosion from gullies and stream channels. It may be difficult to control erosion related to landslides and faults, but gully erosion may be managed with standard treatments and strategies which can be found in the NRM recommendations section of this Plan. Much of the Property has moderate incidence and susceptibility of landslides. Evidence of slumping and hummocky topography, which are indicative of historic landslide activity, were found during field visits. Two areas appear to have active landslide and erosion, likely from the heavy rains in winter of 2017 (Figure 7). These landslide scarps are present in historic aerial imagery, and the scarps appear to have been active within the past few years. The channel downstream of these landslides exhibits signs of active channel adjustments including incised reaches, buried culvert inlets, and extensive sediment deposition at its confluence with Coyote Creek.

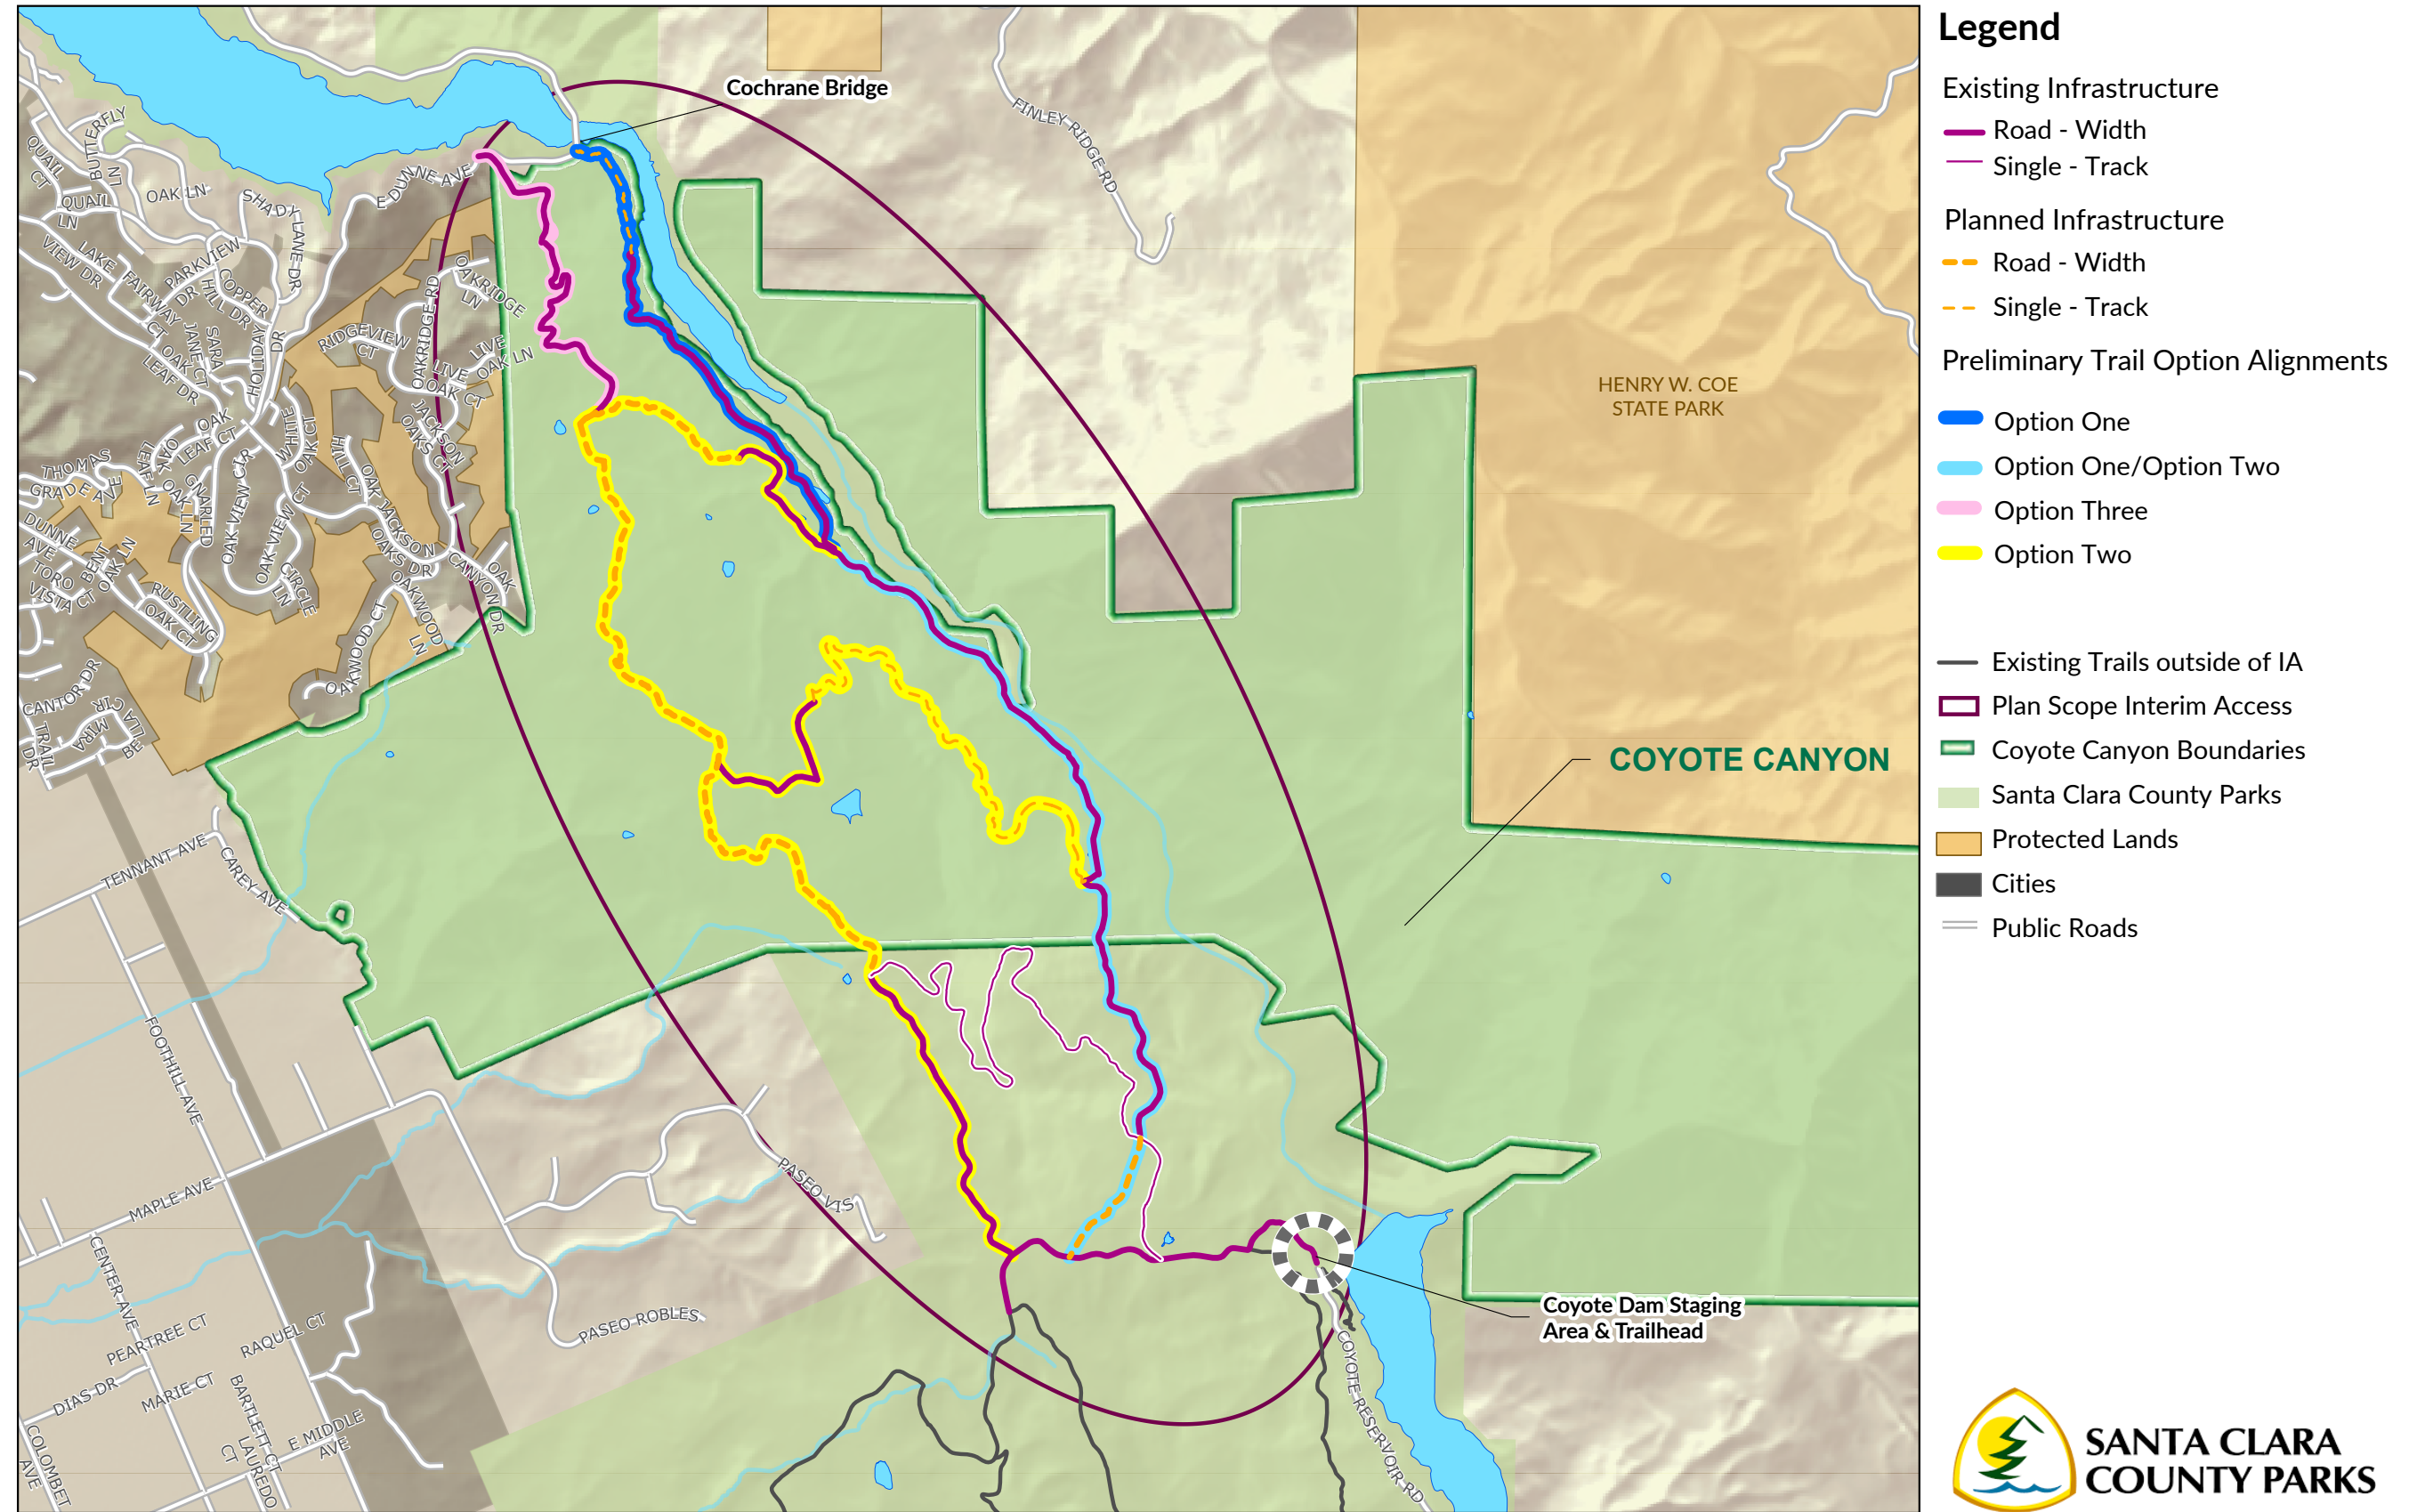
Figure 11: Preliminary Trail Options

Based on findings from phase one and phase two, the Department evaluated access and circulation on the Property through aerial imagery and Geographic Information Systems (GIS) mapping. Through this evaluation, three (3) preliminary trail options were developed, evaluated, and then presented to stakeholders and community members for input. Based on public input and additional refinement, a Recommended Public Access Alignment emerged.

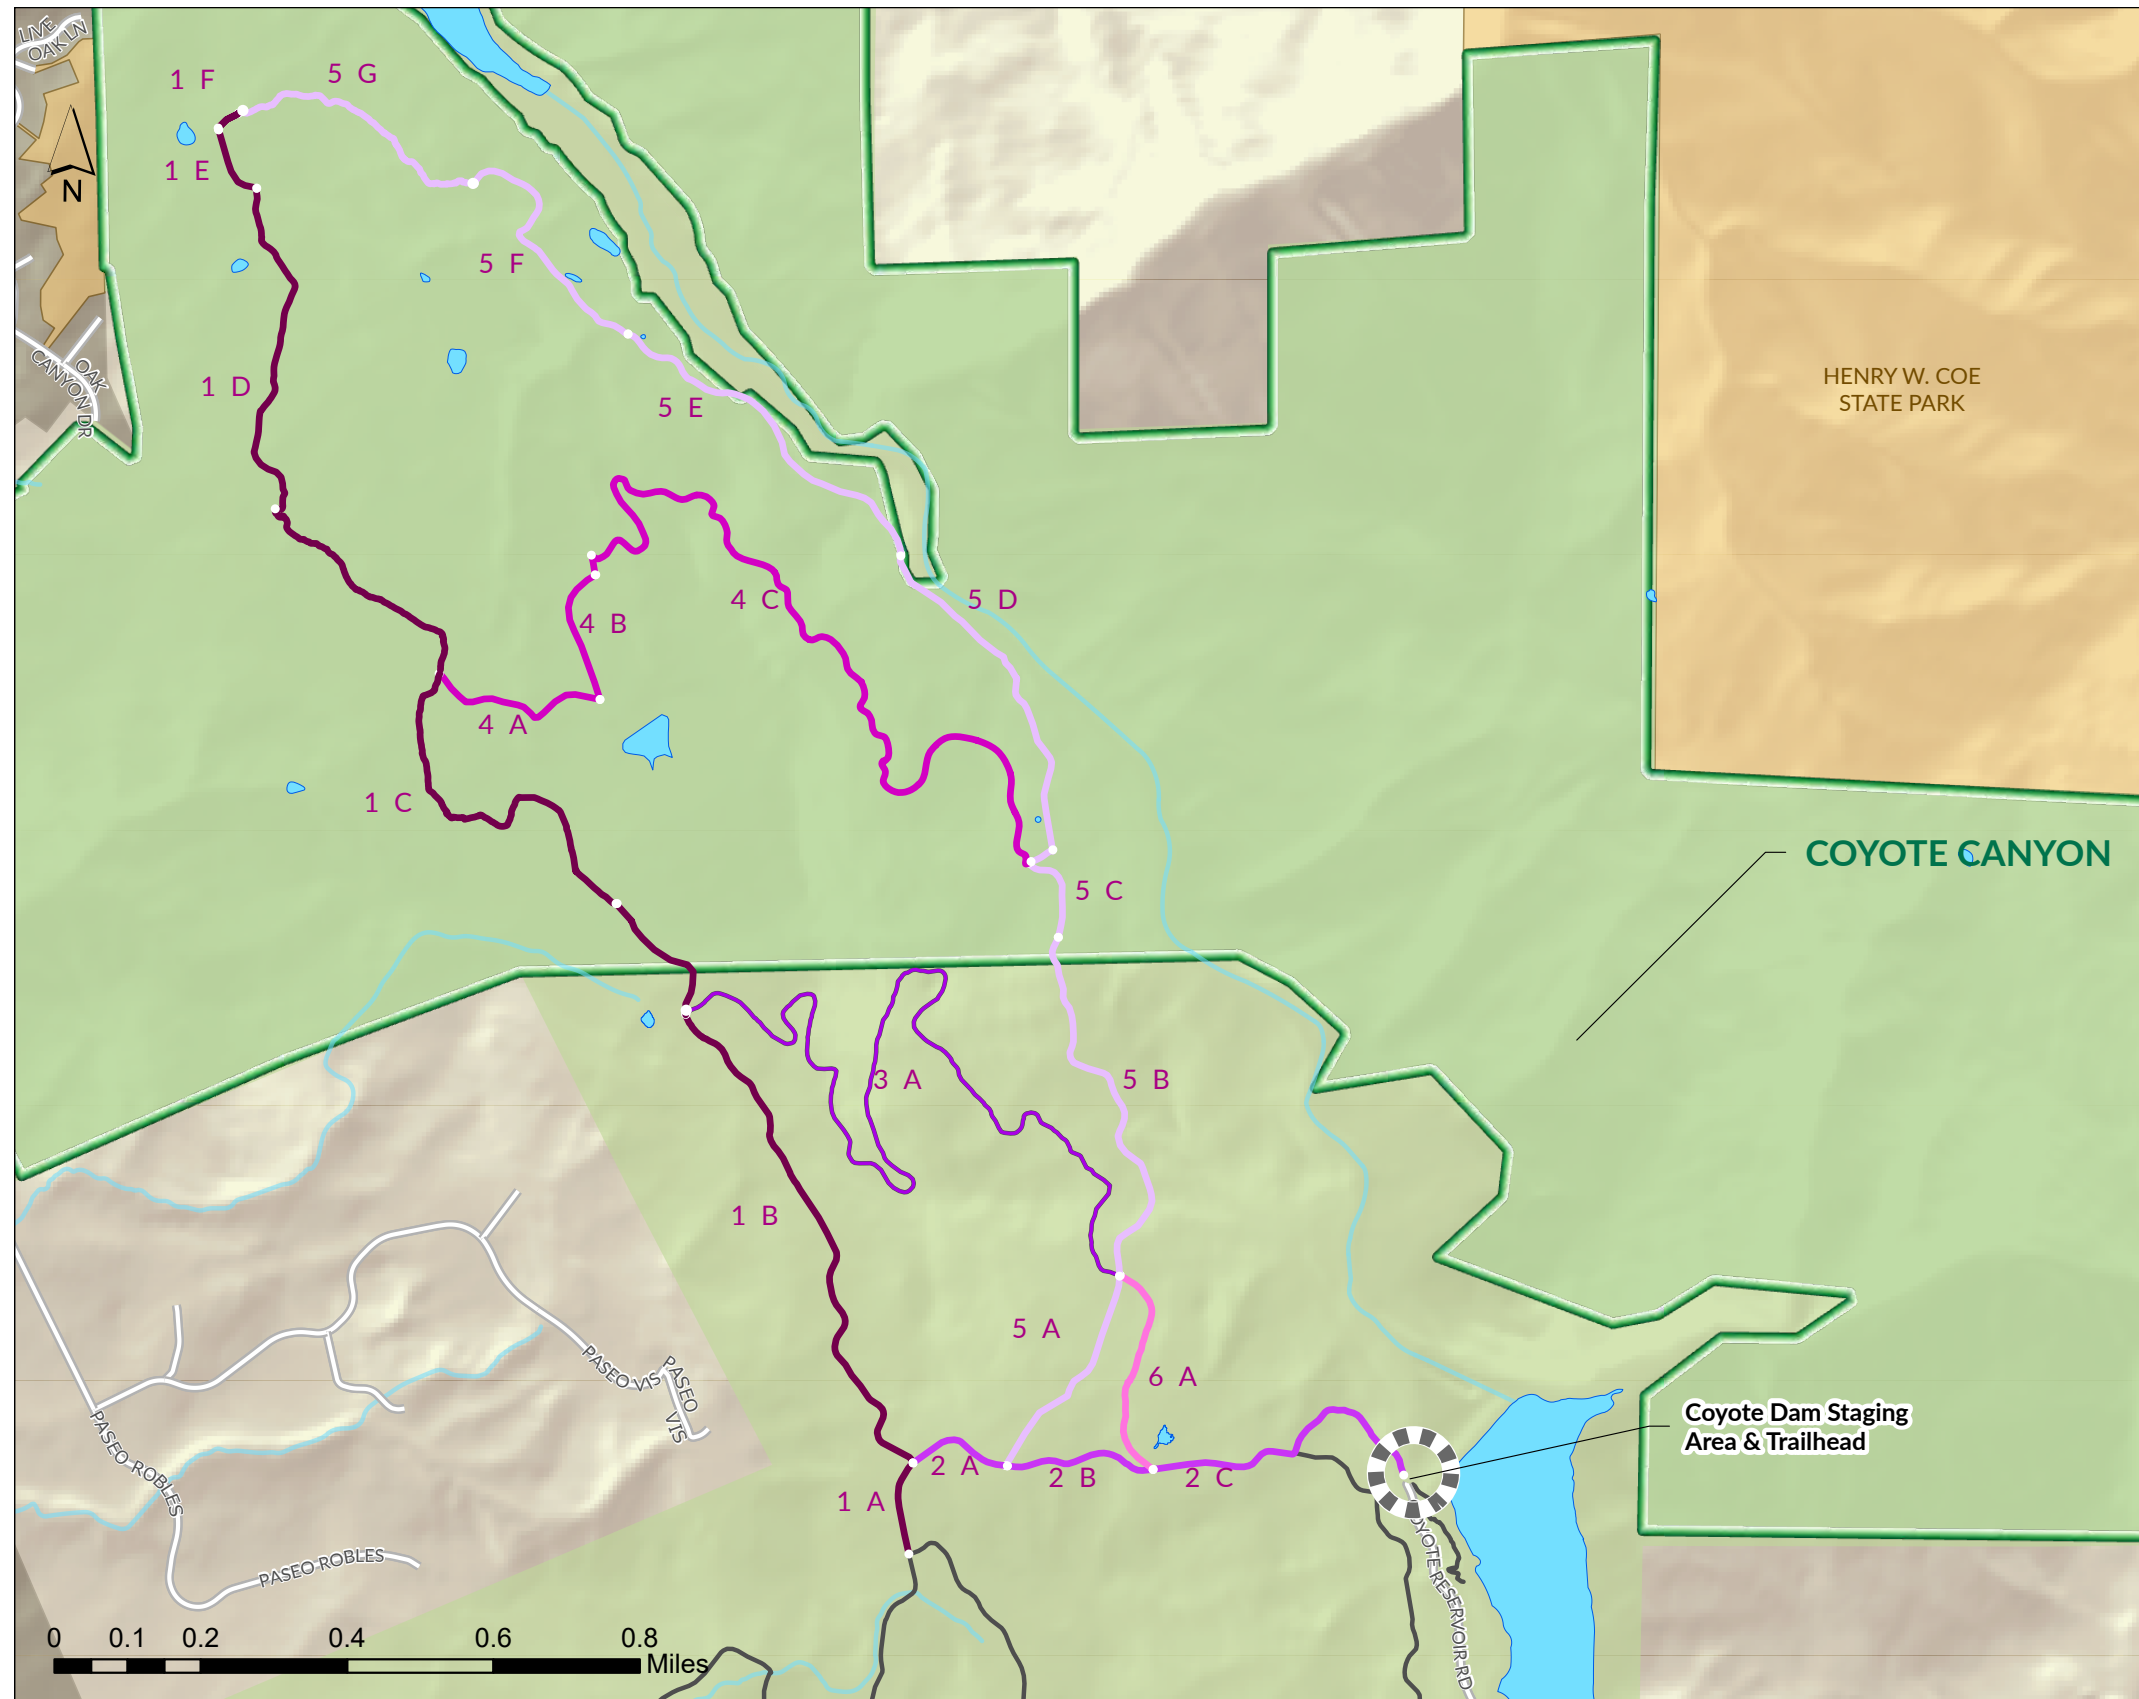
Figure 19: Recommended Public Access Alignment

Using GIS, the Project Team conducted analysis to determine if the recommended alignment adhered to the Santa Clara County Countywide Trails Master Plan Update Section D-1.1. Trails and Land Use Compatibility, which calls for trails in rural residential areas to be at least 150 feet away from an occupied dwelling, among other guidelines.

- ▶ **Segment 1A:** The use will be changed from hiking/dogs on-leash only to multi-use. This segment will be renamed the Coyote Ridge Trail and incorporated into Segment 1A – 1F. This provides users with a multi-use trail route extending from the existing Coyote Ridge Trail in Coyote Lake–Harvey Bear Ranch County Park into the new Property.
- ▶ **Segment 3A:** This segment will remain hiking/dogs on-leash only and will remain the Ed Willson Trail.
- ▶ **Segment 6A:** The use will be changed from hiking/dogs on-leash only to multi-use. The segment will be renamed the Woodland Valley Spur Trail.

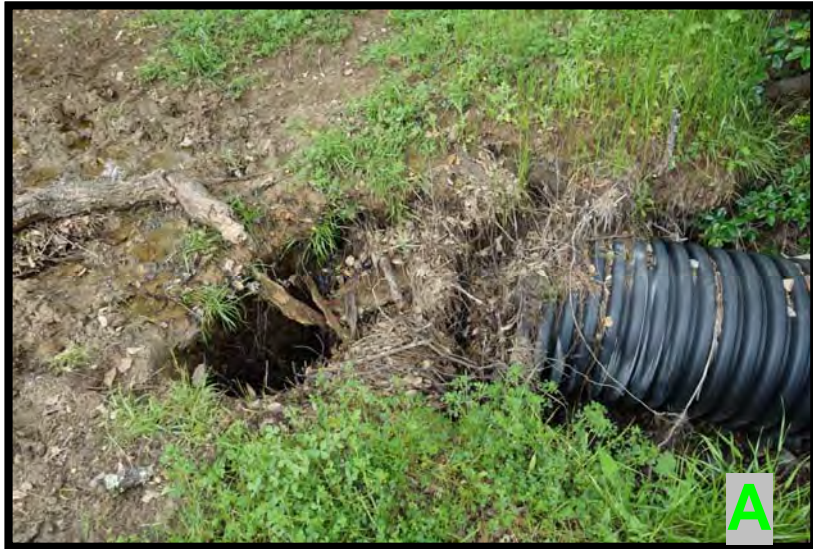
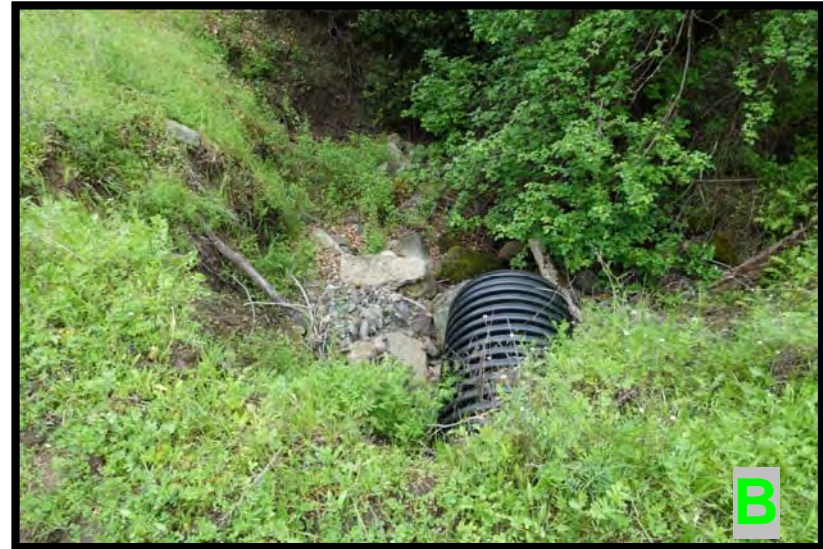
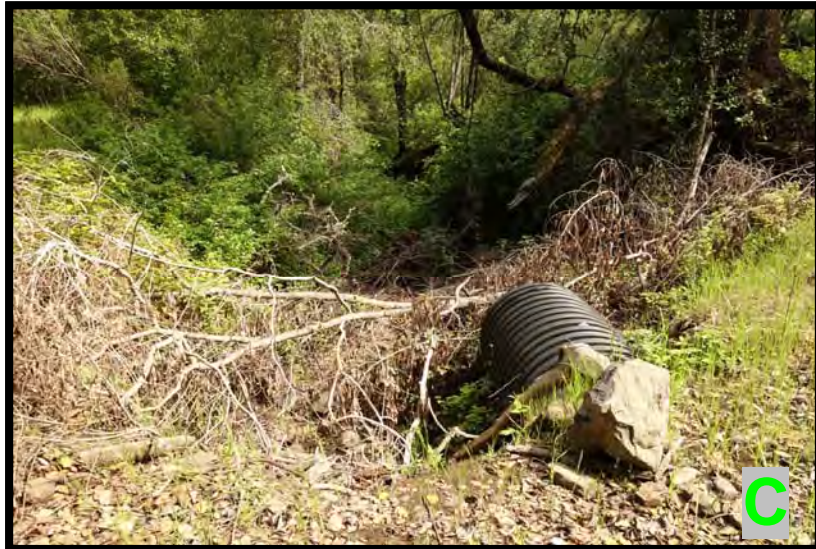
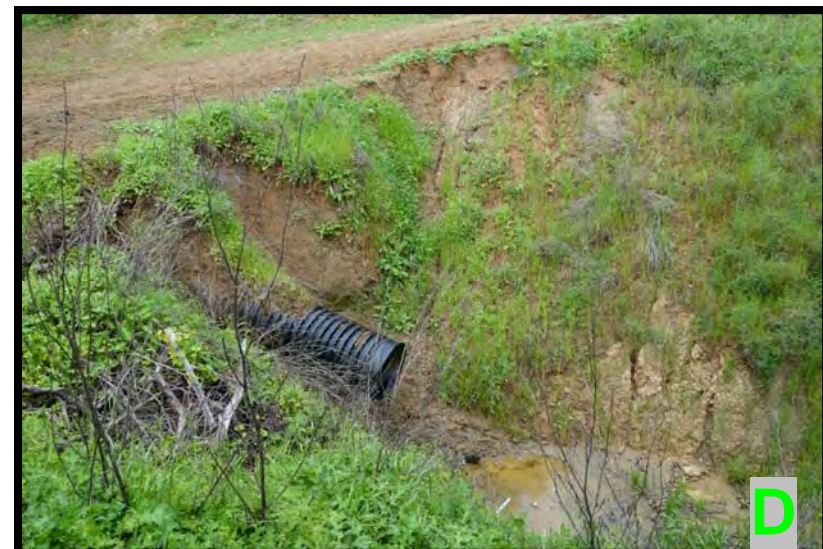
Many of the streams are incised at road crossings, particularly downstream of the crossings. Some of the culverts appear to be under-sized and clogged with sediment, with obvious signs of water moving across the road rather than through the culvert. In many locations, the water movement across the road is causing the road to erode. Figure B3 and B4 show images of buried culvert inlets and erosion and incision at stream crossings. The location of the photo points can be seen in Figure B5. Field Hydrologists observed multiple partially-buried culvert inlets, which may be the result of the culvert not being placed at a low enough elevation, the culvert not having enough slope to convey sediment, or the culvert being too small. The Coyote Canyon property is situated in a dynamic landscape and stream crossings should be planned accordingly. Channel segments that appear stable are likely to experience episodes of sedimentation and incision over the next decades. Proposed trail alignments in general, and stream crossings in particular, should consider terrain and hydrologic processes during the planning process.

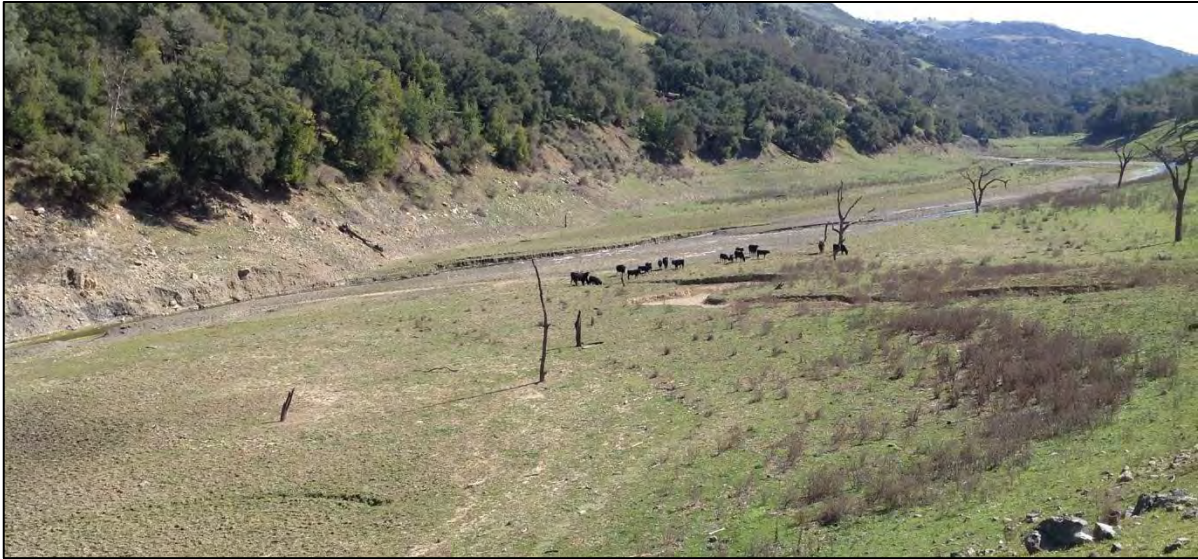
Photo 72. Cattle loafing along Coyote Creek create compacted soils, promote infestations of thistles in disturbed areas, and increase erosion.
