## HISTORIC PROPERTY DOCUMENTATION

### Pond Eddy Bridge (All Veterans Memorial Bridge)

**THRU TRUSS BRIDGE  
OVER DELAWARE RIVER  
POND EDDY PA. TO POND EDDY N.Y.  
IN DEPTH (TYPE II) INSPECTION  
GENERAL PLAN AND ELEVATION**

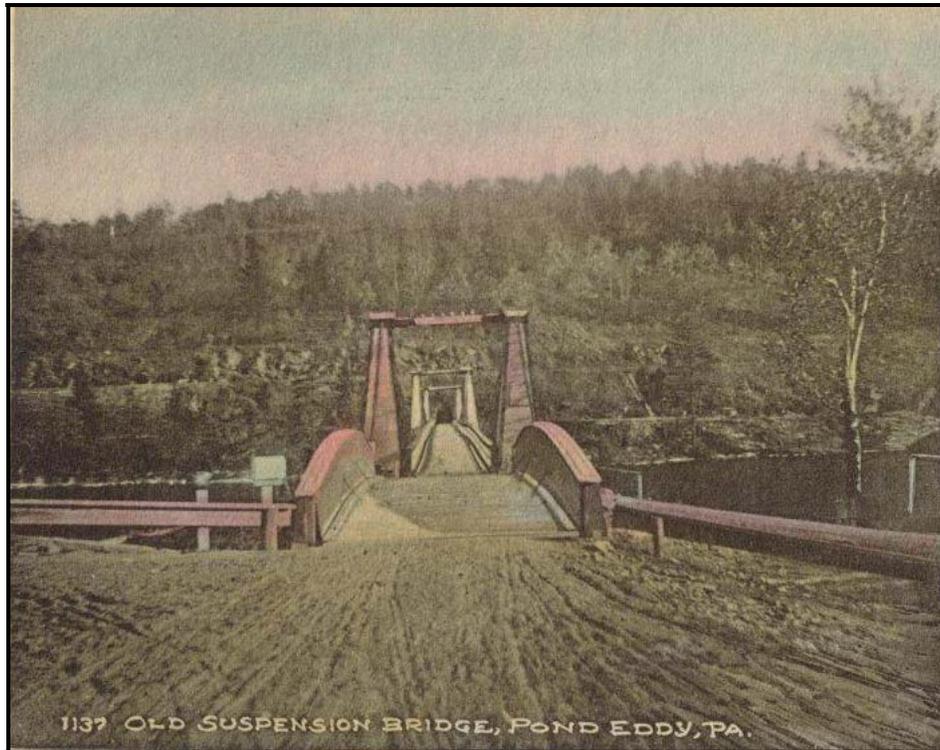
Historic Photo 1. The 1871 Pond Eddy Bridge at a time of high water on the Delaware River. A wooden bridge crossed the Delaware and Hudson Canal and the toll collector's house is at the right. Photo from *Coal Boats to Tidewater* by Manville B. Wakefield, Page 101.

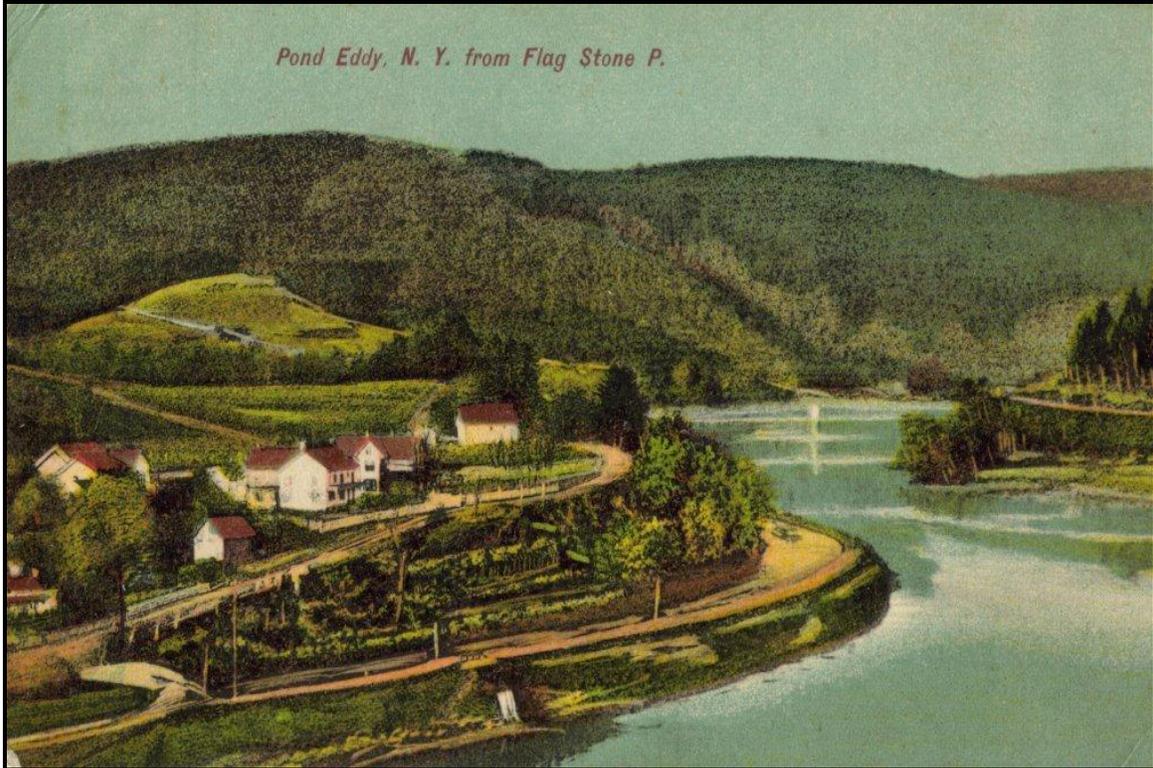
Historic Photo 2. An undated and colorized postcard of the 1871 Pond Eddy Bridge. Postcard courtesy of the Sullivan County (New York) Historical Society

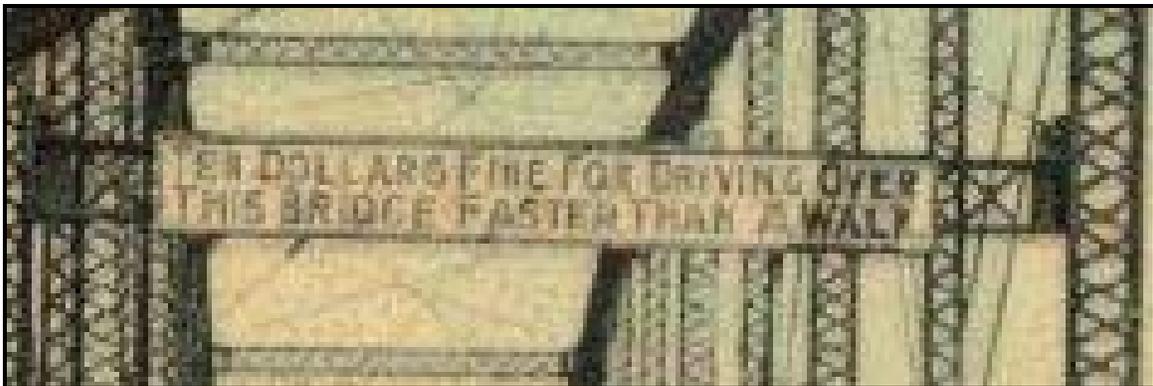
Close-up from the above postcard showing the sign originally placed at each entrance to the Pond Eddy Bridge by authorization of the Lumberland Town Board in 1905.

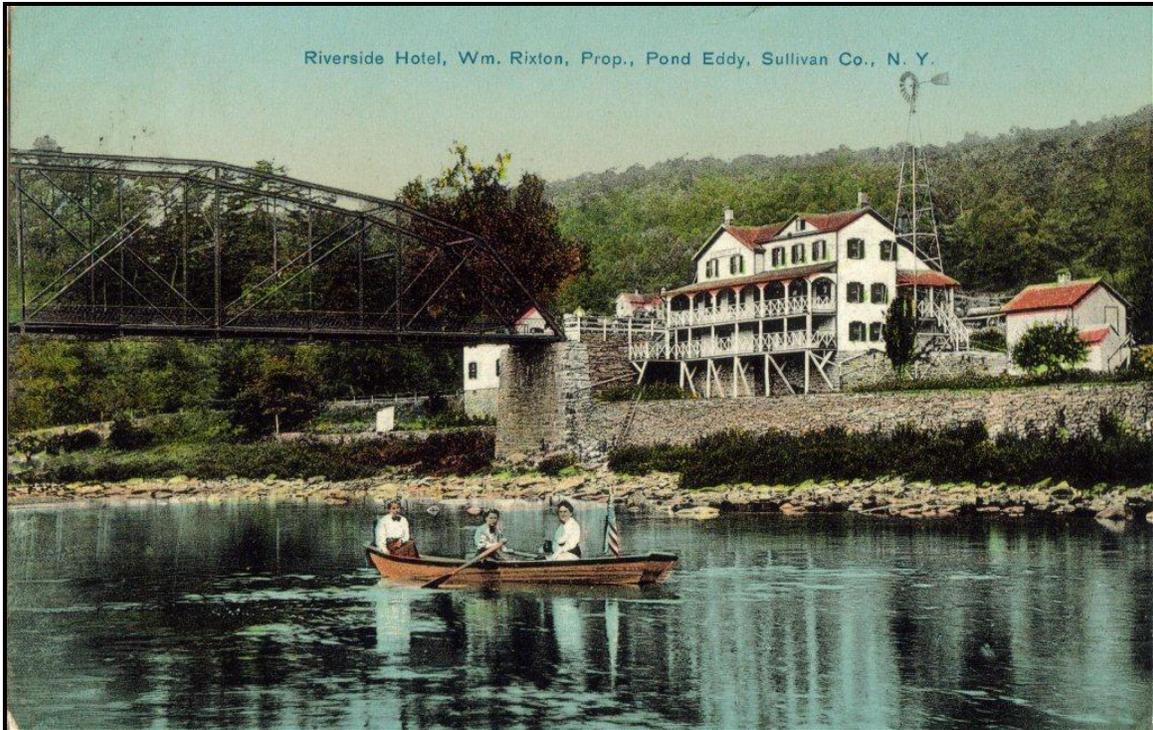
Historic Photo 6. A ca. 1908 view looking northwest of the 1905 Pond Eddy Bridge and Rixton's Riverside Hotel along the Delaware River. Postcard courtesy of the Sullivan County Historical Society

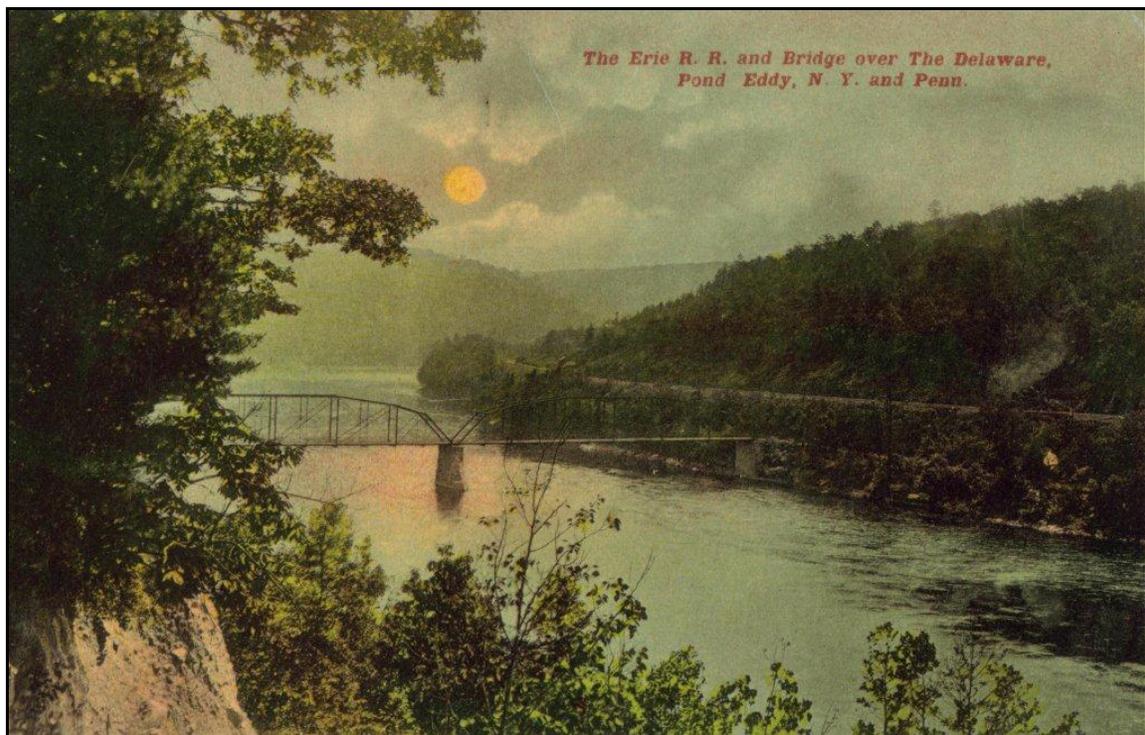
Historic Photo 7. An early twentieth century view looking southeast of the Pond Eddy Bridge and the Erie Railroad on the Pennsylvania side of the Delaware River. Postcard courtesy of the Sullivan County Historical Society.

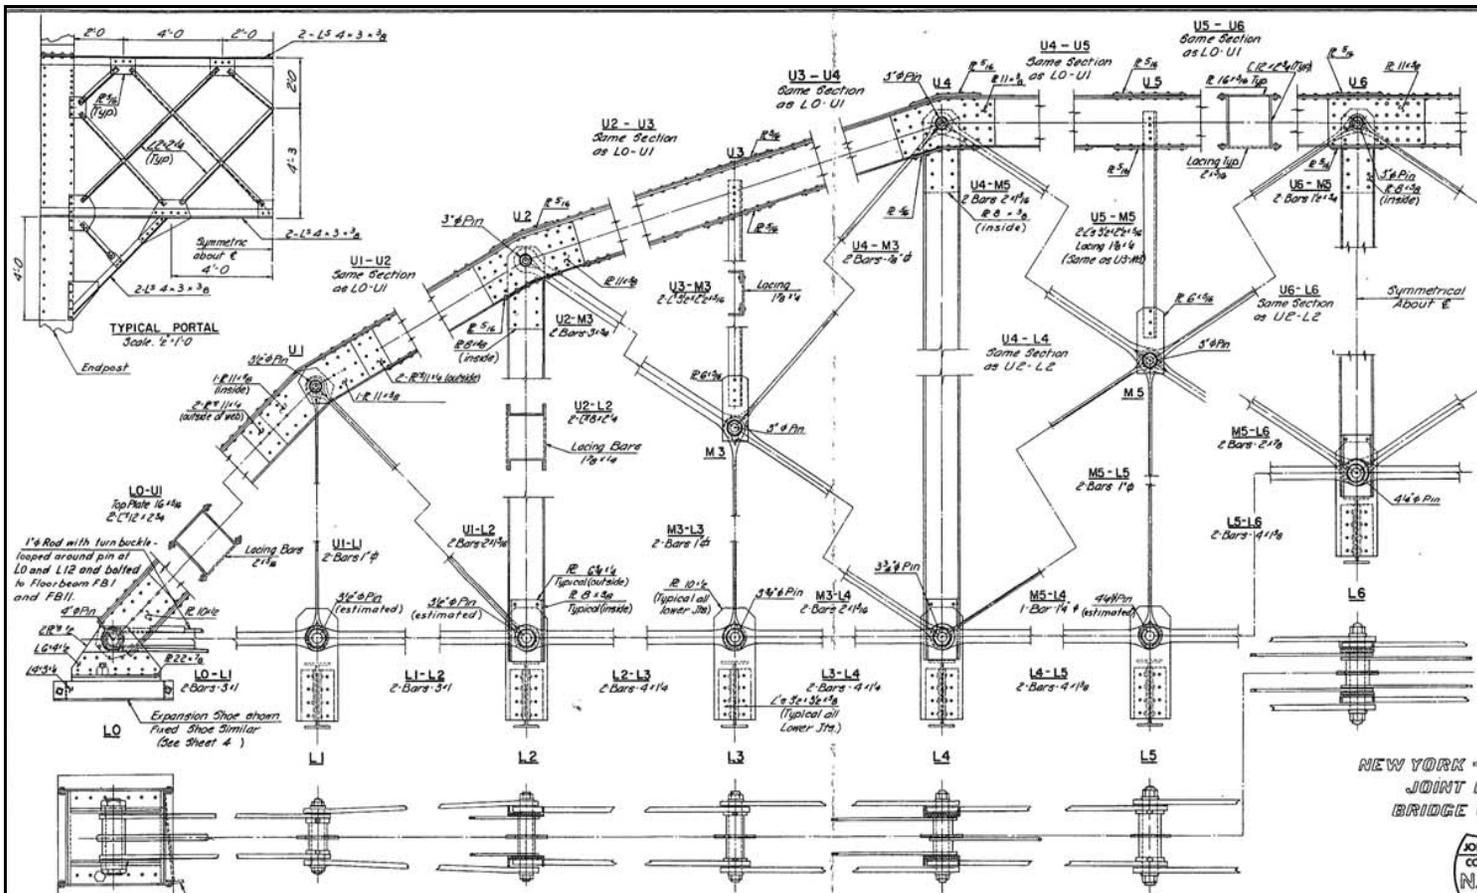
THRU TRUSS BRIDGE  
OVER DELAWARE RIVER  
POND EDDY PA. TO POND EDDY N.Y.  
IN DEPTH (TYPE II) INSPECTION  
TRUSS DETAILS

Roller enclosure angle has broken loose at L0 of West Truss of Span 1 and rollers are out of position.

**CONDITION OF TRUSS MEMBERS**  
MOST OF THE MAIN AND SECONDARY TRUSS MEMBERS APPEAR TO BE IN GOOD CONDITION, WITH SOME RUST AND CORROSION PRESENT AT AND NEAR CONNECTIONS.  
CONNECTIONS BETWEEN TOP LATERAL BRACING AND TOP CHORDS ARE BADLY DETERIORATED, AS DETAILED ON SHEET 4.

**CONDITION OF PINS**  
PINS AT UPPER AND MIDDLE JOINTS APPEAR TO BE IN GOOD CONDITION, WITH ONLY SCATTERED CASES OF RUST AND CORROSION.  
SLEEVES ON LOWER PINS HAVE DETERIORATED BADLY IN MANY CASES AND HAVE EXPOSED SOME OF THE PINS TO CORROSION.

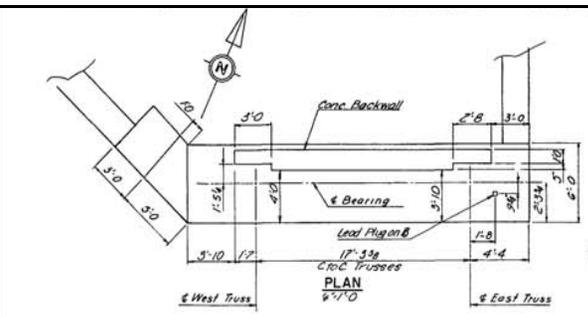
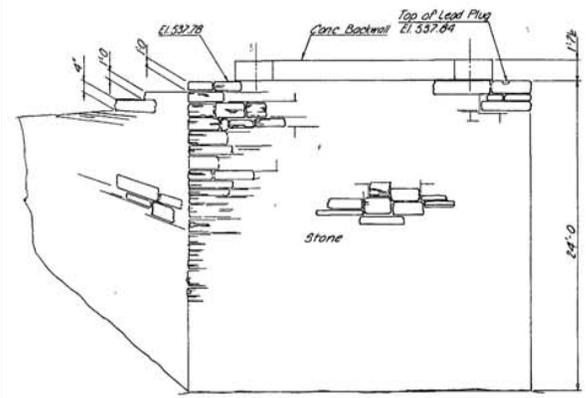
**NEW YORK ABUTMENT ELEVATION**  
Scale: 4"=1'-0"

**CONDITION OF ABUTMENTS**  
BOTH ABUTMENTS APPEAR TO BE IN GOOD OVERALL CONDITION. LITTLE SURFACE DETEIORATION WAS OBSERVED ON EITHER THE STONE OR CONCRETE PORTIONS. FOR THE CONDITION OF THE PIER, SEE SHEET 6.
