KYSTVERKET NORWEGIAN COASTAL ADMINISTRATION

**SALVAGE OF U864 - SUPPLEMENTARY STUDIES -
STUDY NO. 1: CORROSION**

REPORT No. 23916-1

DET NORSKE VERITAS

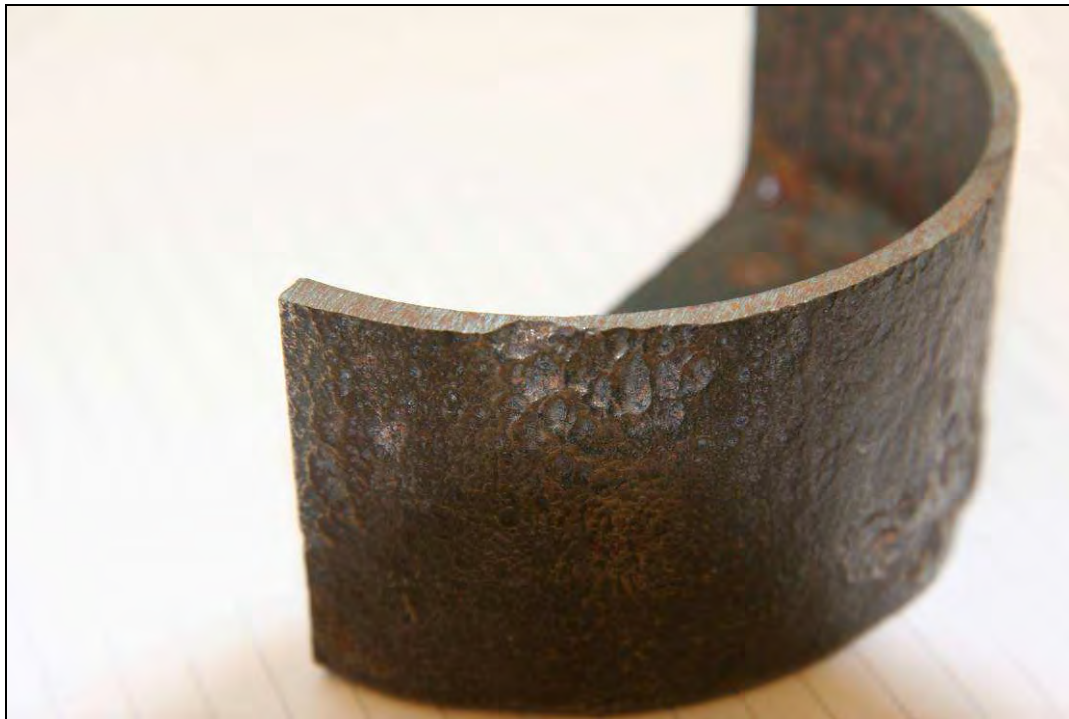
Figure A-1 Segment cut from bottom forged mercury container (diameter 140 mm) through area with maximum metal loss. (All external surfaces have been grit blasted)

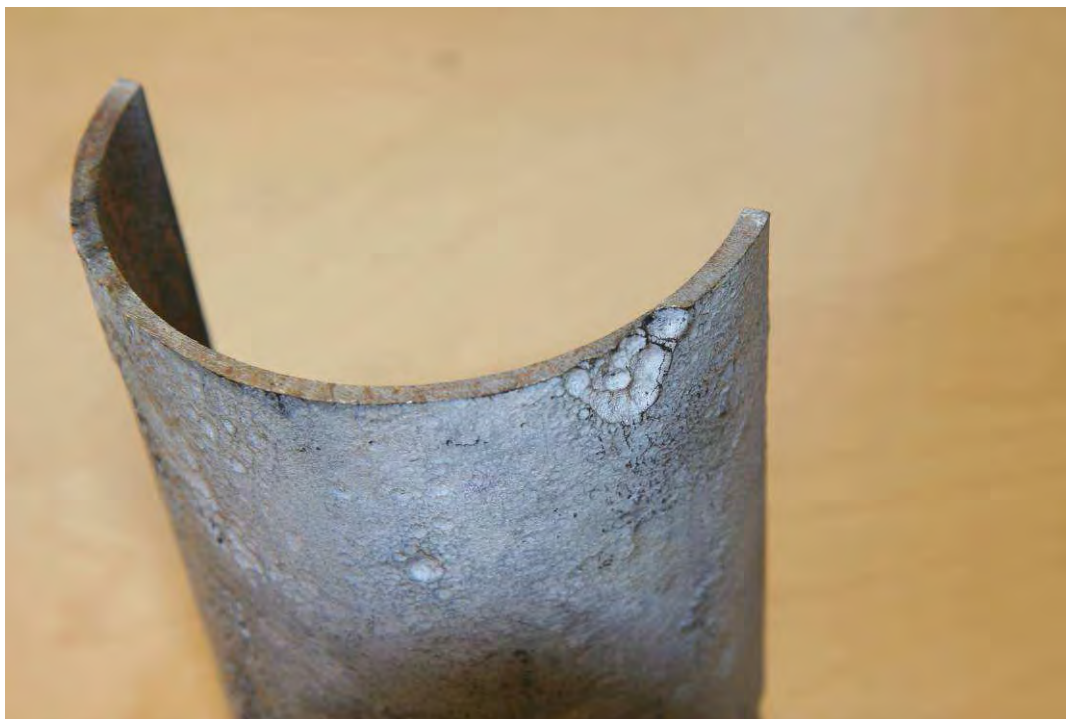
Figure A-2 Shell segment of forged mercury container cut through area with maximum metal loss

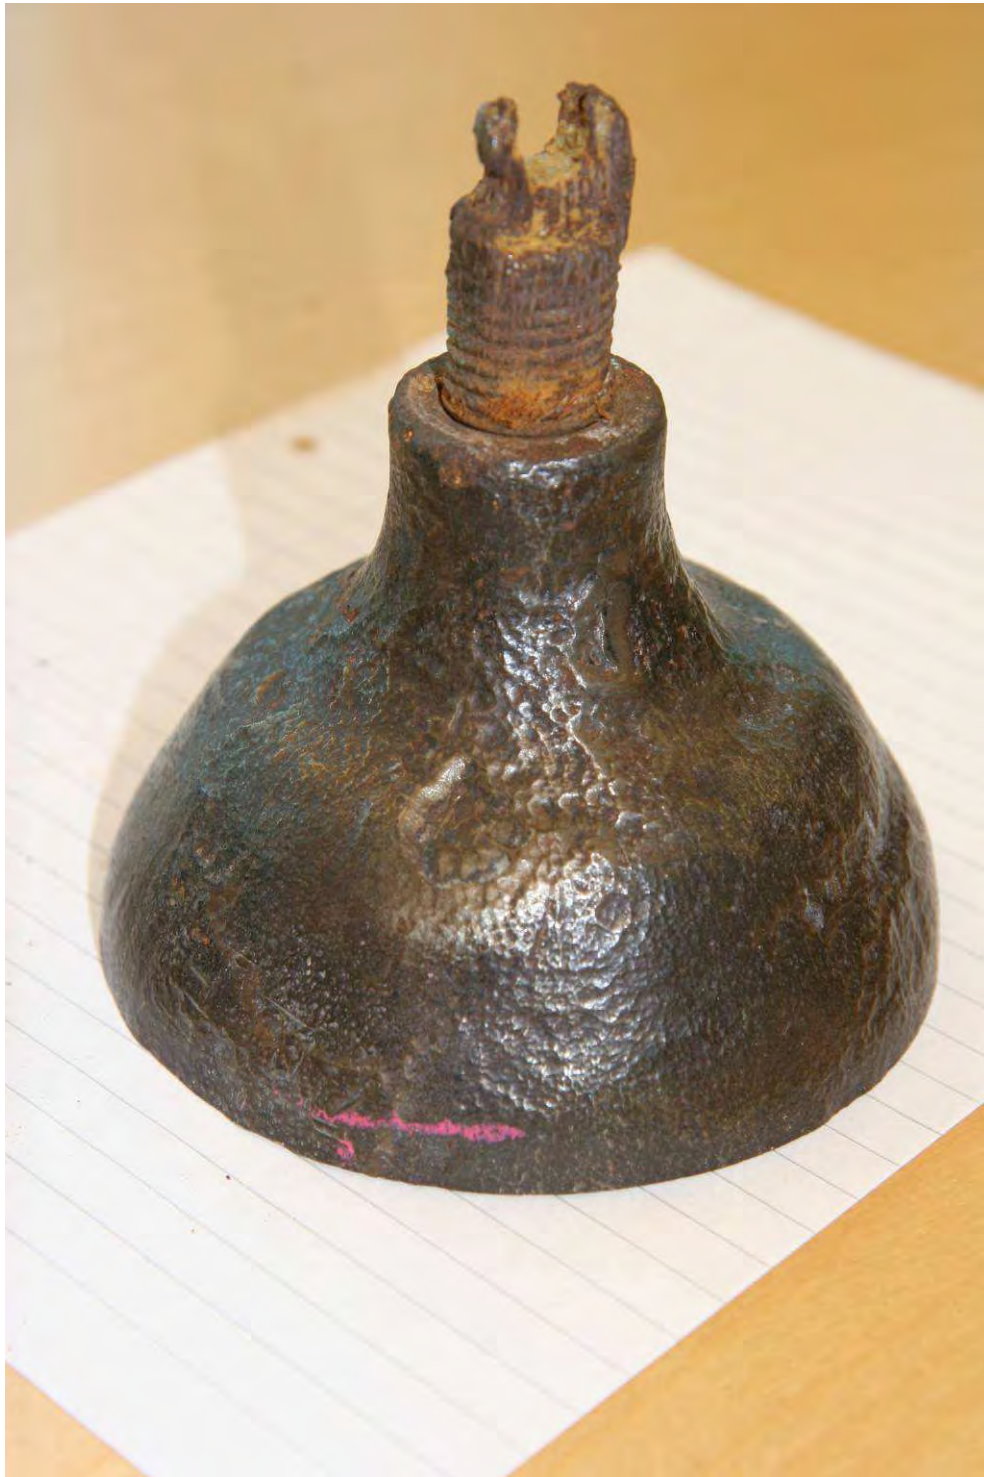
Figure A-3 Top section of forged container for mercury

- C1. The corrosion of the forged container was localised and related to bacterial activity in the seabed (MIC) and with an average (60 years') corrosion rate of 0.07 mm/yr. On other areas, the average corrosion rate was 0.02 mm/yr or less. (This container had not developed any leakage)**

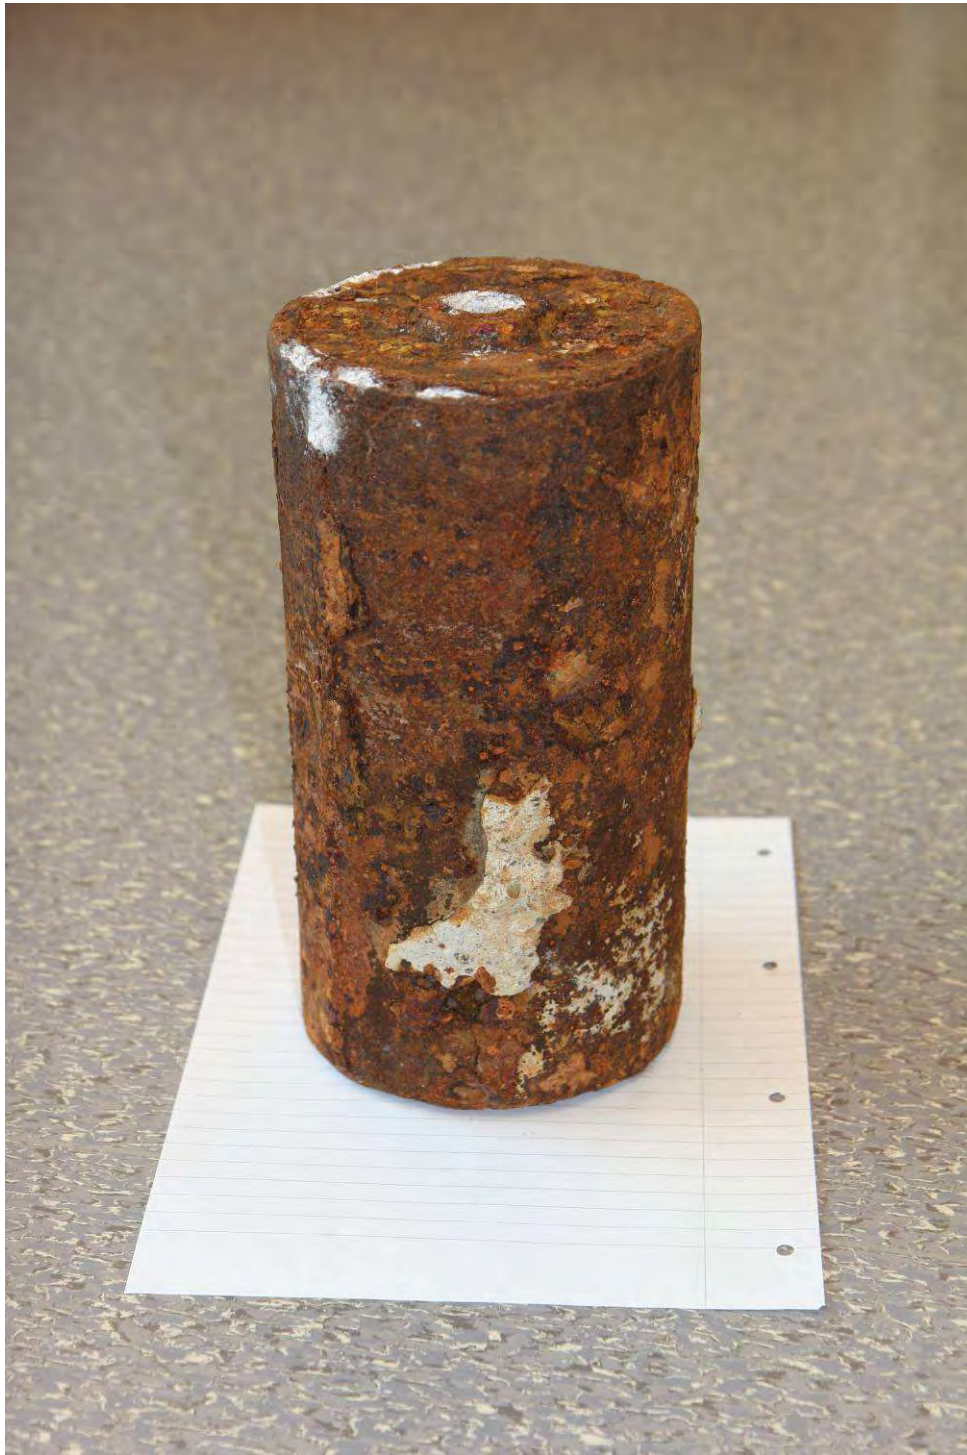
Figure A-4 Welded mercury container (diameter 130 mm)

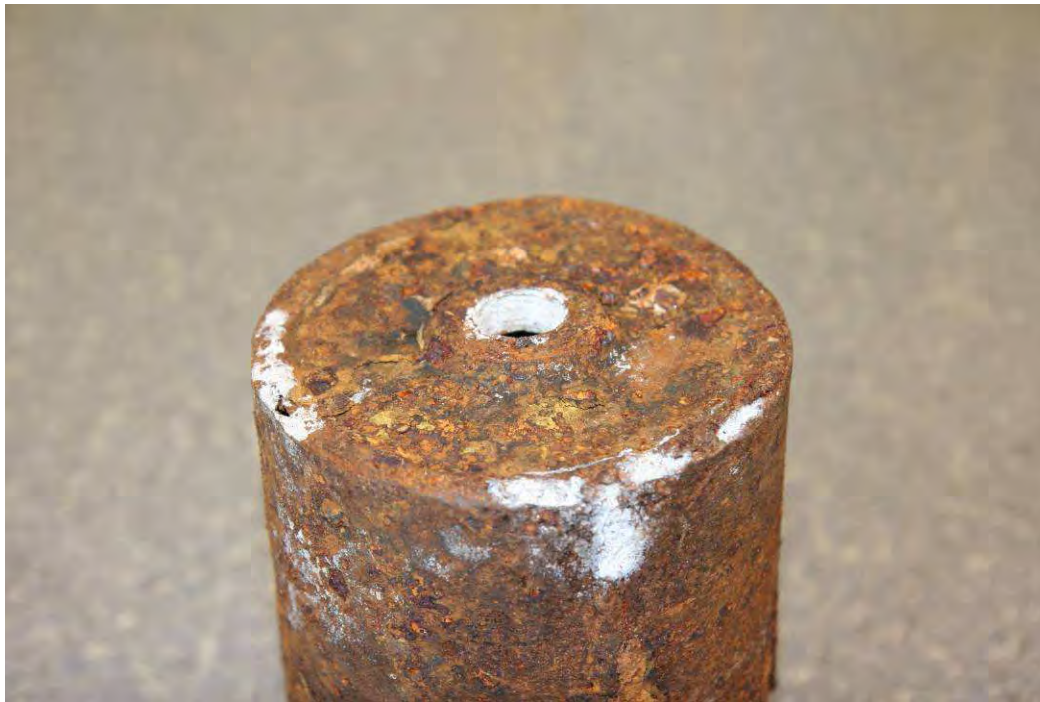
Figure A-5 Top section of welded mercury container (Leak area at the periphery to the left)

- C2. The corrosion rate of the welded container for mercury (related to MIC) was more or less uniform with an average corrosion rate estimated to 0.03 mm/yr. A pinhole leakage had developed in a weld.**

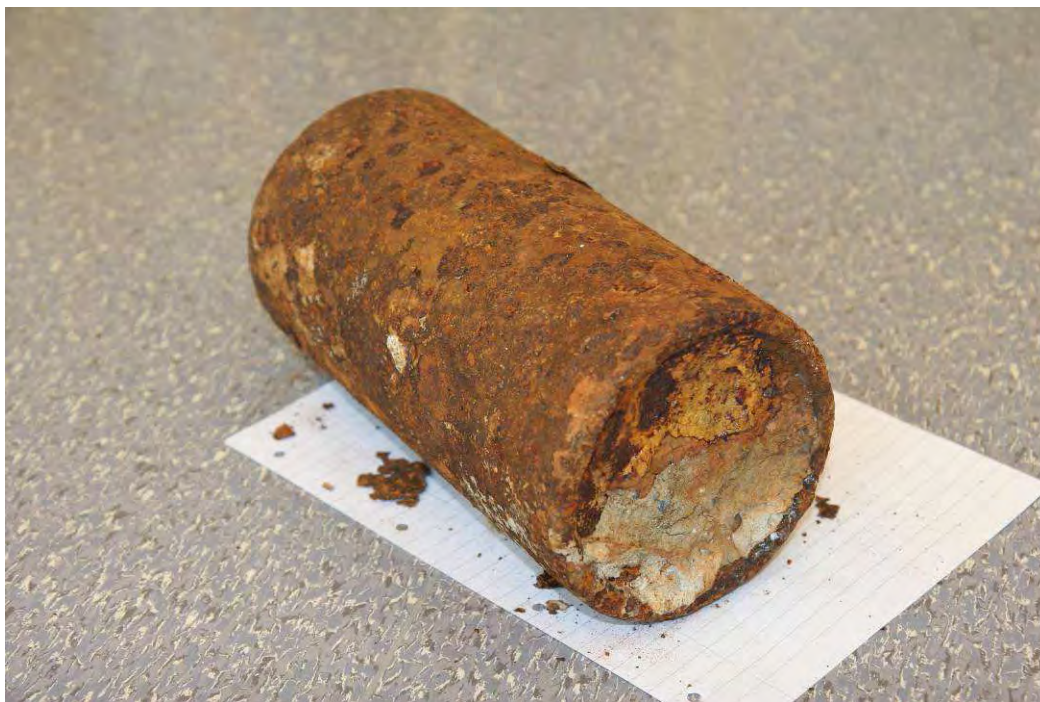
Figure A-6 Bottom section of welded mercury container

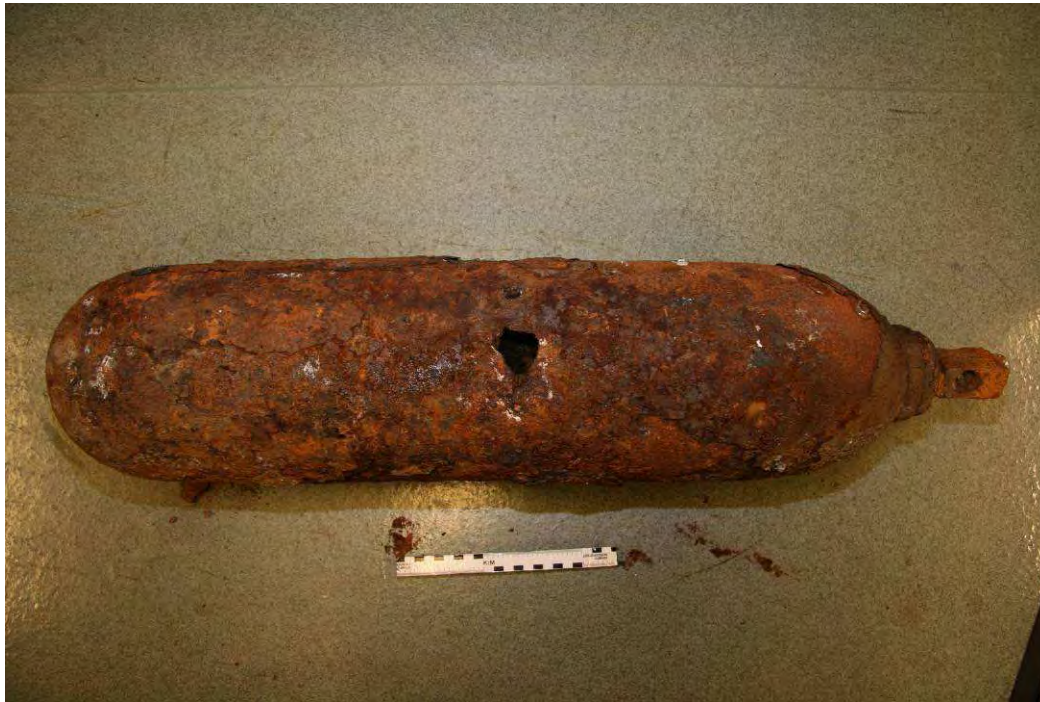
Figure A-7 Steel cylinder for pressurised gas (diameter 200 mm)

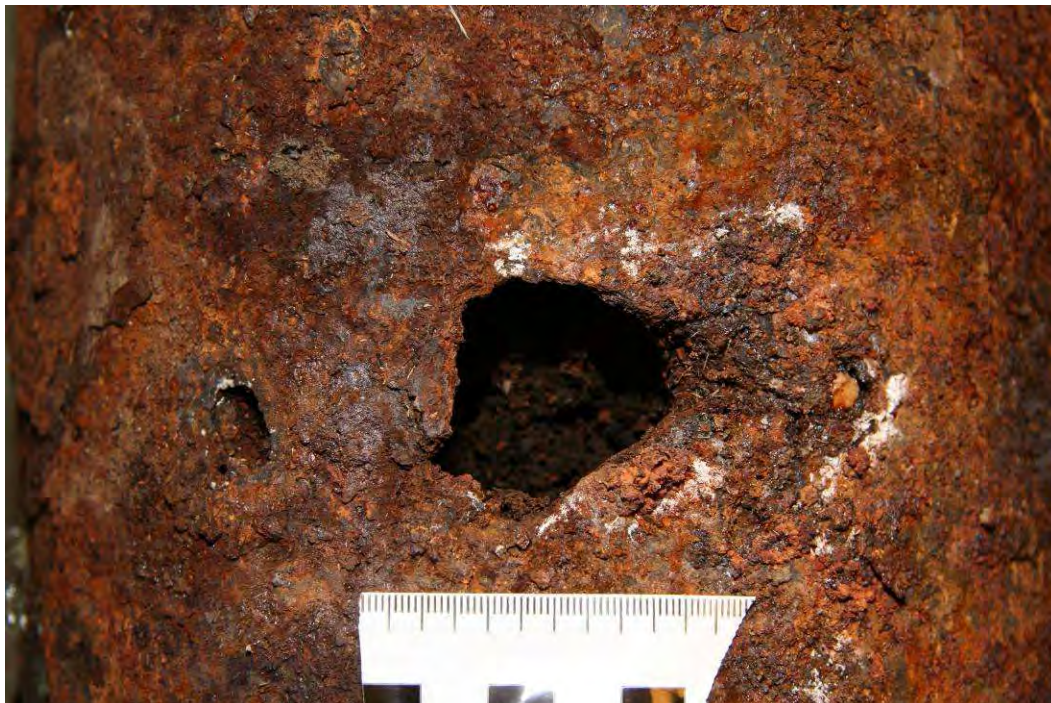
Figure A-8 Close up of pressurised gas cylinder wall penetrated by corrosion

- C3. The steel cylinder for pressurised air was severely corroded (by MIC) as both uniform and localised corrosion attack with an average corrosion rate estimated to 0.05 mm/yr and 0.12 mm/yr, respectively. The cylinder wall had been penetrated by corrosion.**

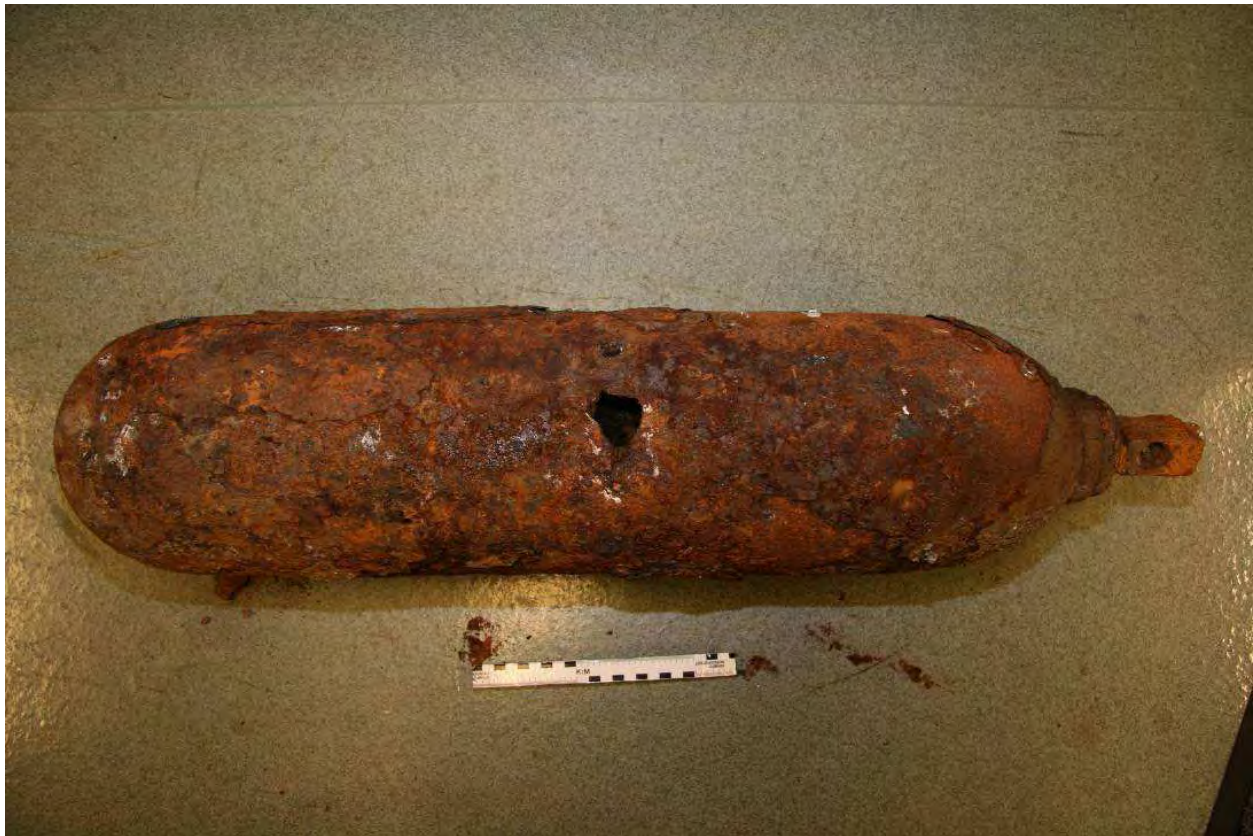
Figure 5-1 Steel canister for pressurised air (diameter 200 mm)

Taking into account the expected form of corrosion and the potential corrosion rate, plus the relatively high probability that much of the pressurised air has already escaped by leakage, the probability of a rupture of a cylinder with pressurised air (including the cylinder contained within the shell of the torpedoes) as a result of a salvage operation is assessed to be remote. The probability of corrosion of other components associated with the explosives and causing ignition of the explosives are assessed extremely remote.

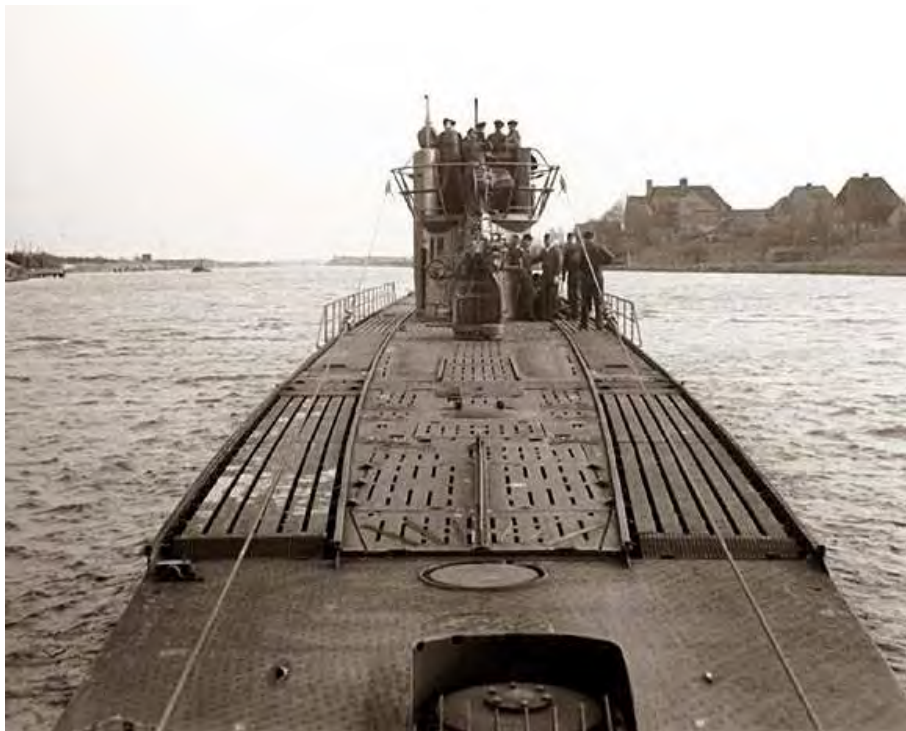
Figure 8-3 The after deck of U-166, a type IX C submarine (similar to U-864, but approximately 11 metres shorter) /7/. This picture shows the wooden trapdoors on each side which torpedoes are stored beneath. A total of 12 torpedoes is expected to have been stored like this on U-864.

In total 27 torpedoes can be stored on the submarine. 12 of these are stored on the outside of the pressure hull underneath the casing (see Figure 8-3, page B-4).
 Inside the submarine: 4 torpedoes in the torpedo tubes fore (see Figure 8-2, page B-4) and 6 in fore torpedo room, 2 torpedoes in the torpedo tubes aft and 3 in the aft torpedo room.

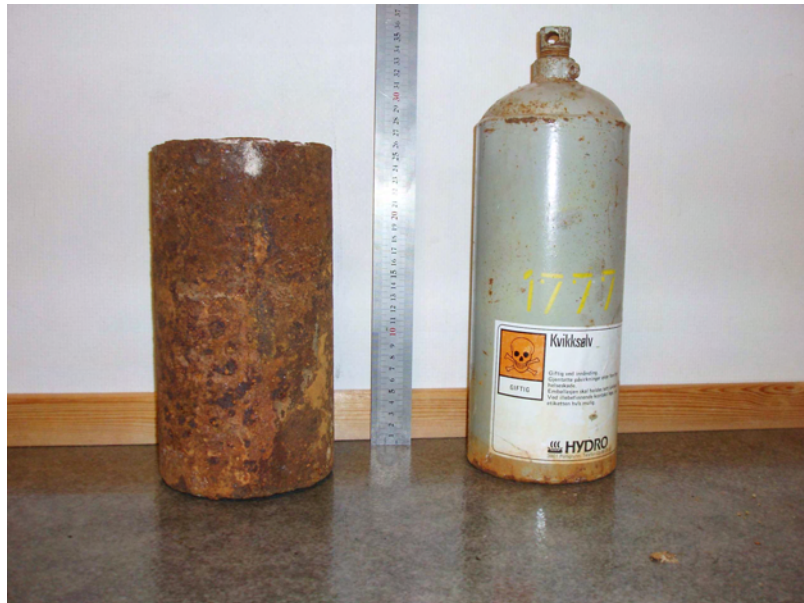
Figure 4-1. Original and modern mercury canisters

Forged container (flask shaped)	Welded container (cylinder shaped)
Length of cylindrical section: 280 mm	Length of cylinder: 250 mm
Diameter (OD) of cylindrical section: 115 mm*	Diameter (OD) of cylinder: 130 mm
Thickness of cylindrical section: 5 mm	Thickness of cylinder: estimated 10 mm (+1/-2 mm)
Length of top section: 85 mm	Weight empty – 4.2 Kg.
Length of plug (above flask connection): 40 mm	
Both of these containers hold 2.5 litres of mercury weighing around 35 Kg.

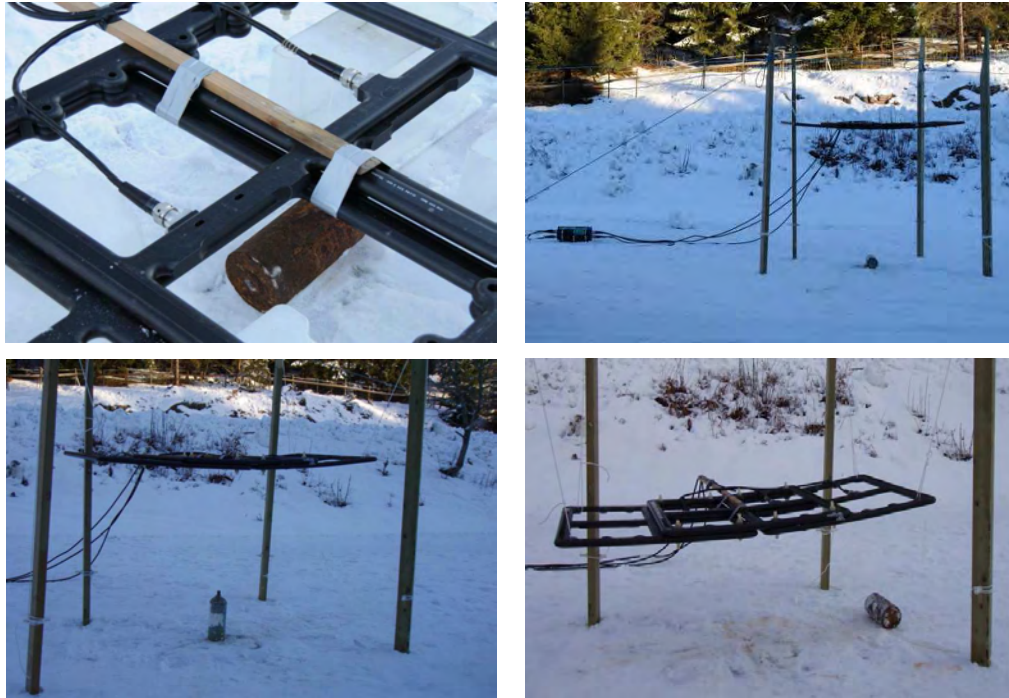
Figure 4-4. Target Scaling (Calibration) at Asker

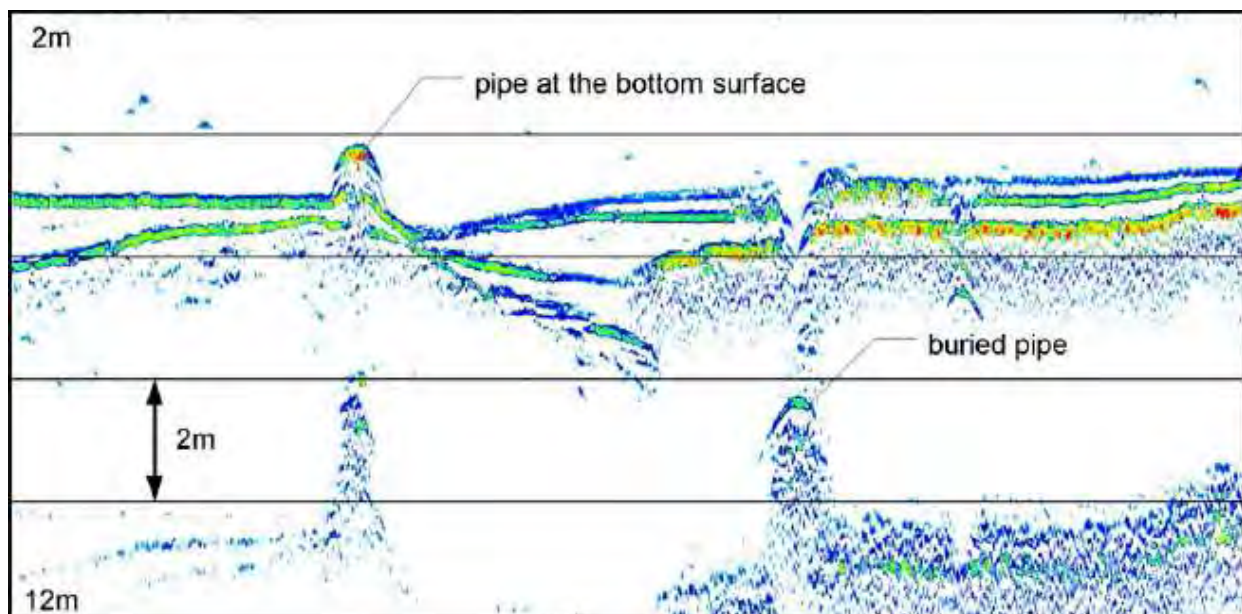
Figure 4-6. Echo print sub-bottom profiler (shallow water pipeline survey; Range 2m - 12m. (/3/))

An operating height of 10m will give a 60cm diameter footprint – and this may mean that on a 150cm grid, some targets may be missed by the acoustics.

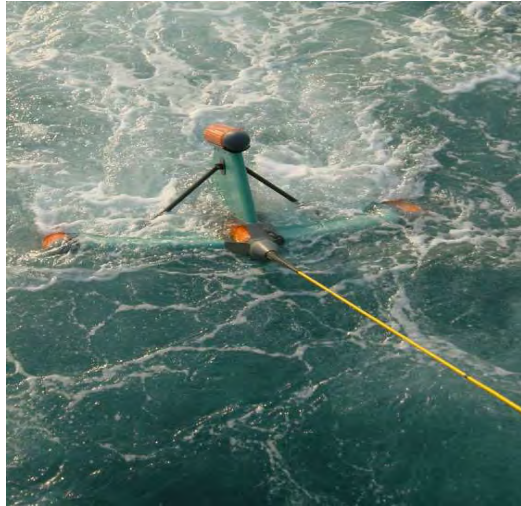
Figure 4-8. The three-axis gradiometer system. (/13/, /8/)

While the Gradiometer technique has significant advantages over acoustics and metal detectors in terms of characterizing the mercury canisters – it also presents significant challenges for deployment of the sensor in the U-864 environment.

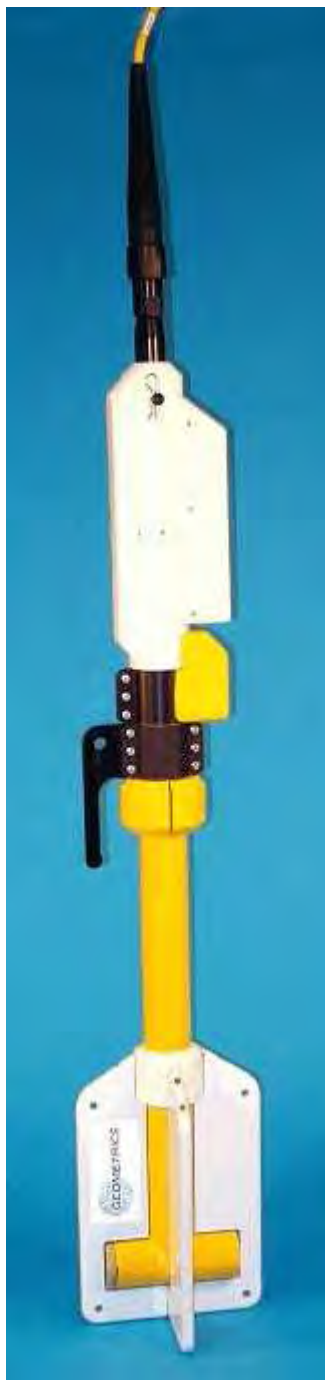
Magnetometer hard casing
7.Feb. 2006

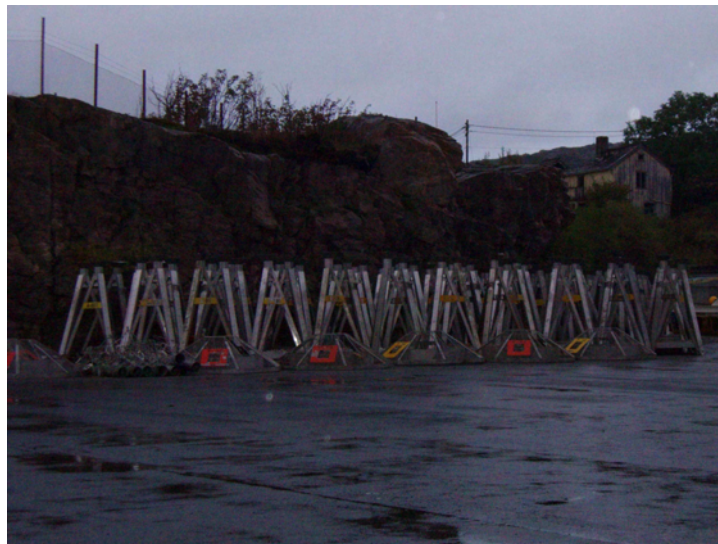
Figure 5-2. Ormen Lange Transponder stands in Kristiansund

However, once the survey area is ‘monumented’ with transponder stands, they do not have to be moved until all survey or recovery interest in the area is completed. All users of the acoustic network will achieve repeatability to within less than a 50 cm radius 95% of the time, wherever they are in the network.

These techniques have been successfully used in the development of the Ormen Lange gas-field and all of the vessels used during this construction have access to the wideband acoustic LBL equipment which predominated.

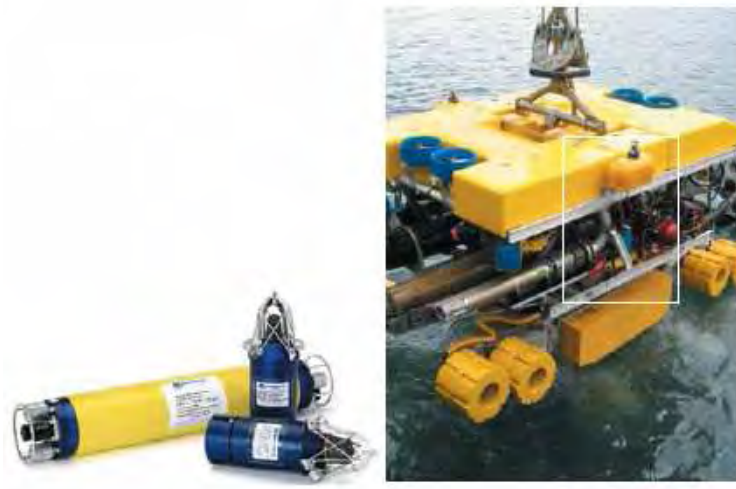
RovNav 5
(Below and Middle) A RovNav LBL transceiver shown installed on a trenching vehicle

Figure 5-3. Typical ROV mounted equipment for LBL positioning (/12/)

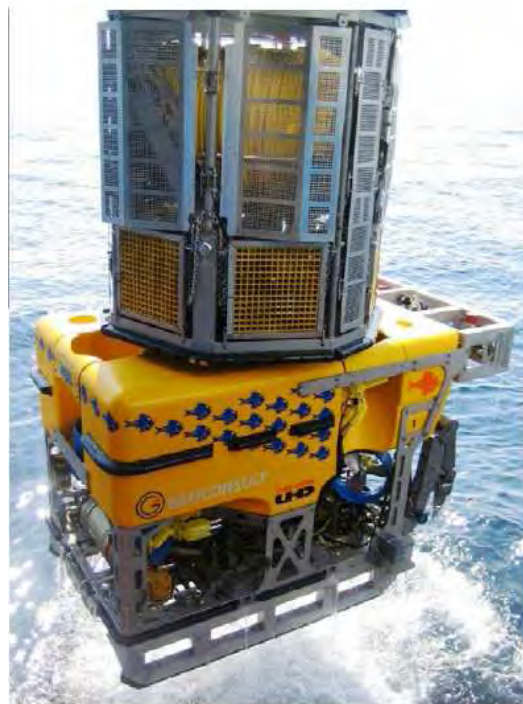
A typical work class ROV is shown below. The vehicle is deployed from its ‘docking station’ near the sea-bed and moves independently within an area constrained by its umbilical. The ROV is able to survey at 2 or 3 knots if required and delivers data in real time to the surface vessel. For long survey lines the surface vessel will ‘follow’ the ROV – steered by the vessel’s Dynamic Positioning system.

Figure 6-1. Work Class ROV (/12/)

ROV’s are usually equipped as standard with gyro, attitude sensor, depth and altitude sensors and cameras. They can be positioned using acoustic USBL or LBL techniques.

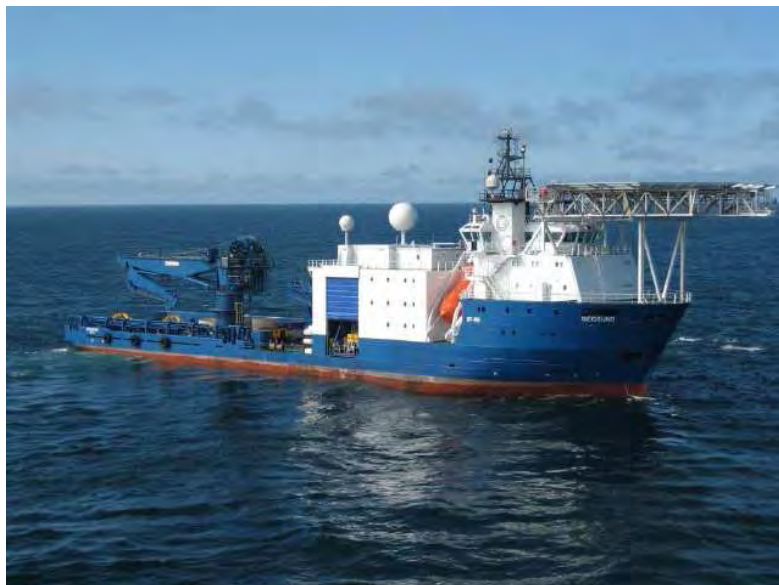
A typical survey vessel is shown in Figure 6-2 on the next page. The vessel will be able to deploy one or more ROV's through a moon-pool in the centre of the vessel, or through a door in the side of the vessel. The vessel is positioned on the surface by high accuracy RTK GPS, and the position is offset typically to a USBL transceiver which propagates position to the sub-sea vehicles.

Figure 6-2. DOF Subsea's "Geosund"

Data from sensors on the ROV is transmitted to the Survey Instrument Room where it is time-tagged, annotated with position and saved for post-processing.

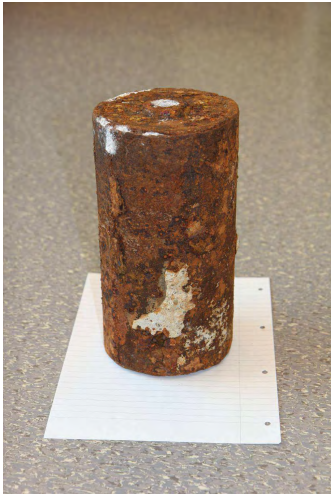
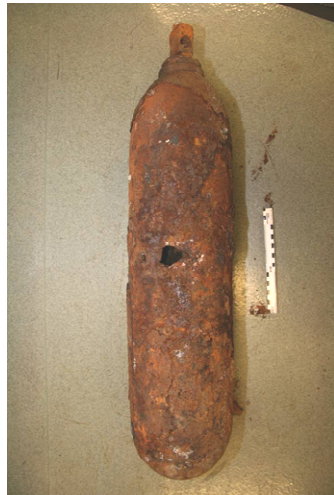
Tabell B-1 Characteristics of mercury containers

Welded container (cylinder shaped)		Forged container (flask shaped)

Length of cylinder:	250 mm	Length of cylindrical section:	280 mm
Diameter (OD) of cylinder:	130 mm	Diameter (OD) of cylindrical section:	115 mm
Weight empty	4.2 kg	Thickness of cylindrical section:	5 mm
		Length of top section:	85 mm
		Length of plug (above flask connection):	40 mm
Both containers hold 2.5 litres of mercury (Hg) weighing around 35 kg			
Mass density of seawater is taken as $\rho_w = 1025 \text{ kg/m}^3$			
Estimated parameters:		Estimated parameters:	
Volume:	0.0033 m ³	Volume:	0.0055 m ³
Buoyancy force (B):	33.4 N	Buoyancy force (B):	55.10 N
Mass of steel:	4.2 kg	Mass of steel:	7.5 kg
Total mass:	39.2 kg	Total mass (M):	42.5 kg
Weight in air (W):	384.5 N	Weight in air (W):	417.3 N
Transversal drag coefficient (C _{Dt})	0.56	Transversal drag coefficient (C _{Dt})	0.56
Axial drag coefficient (C _{Da})	0.85	Axial drag coefficient (C _{Da})	0.20

Projected transversal area (A _{pt})	0.0325 m ²	Projected transversal area (A _{pt})	0.0549 m ²
Projected axial area (A _{pa})	0.0133 m ²	Projected axial area (A _{pa})	0.0104 m ²

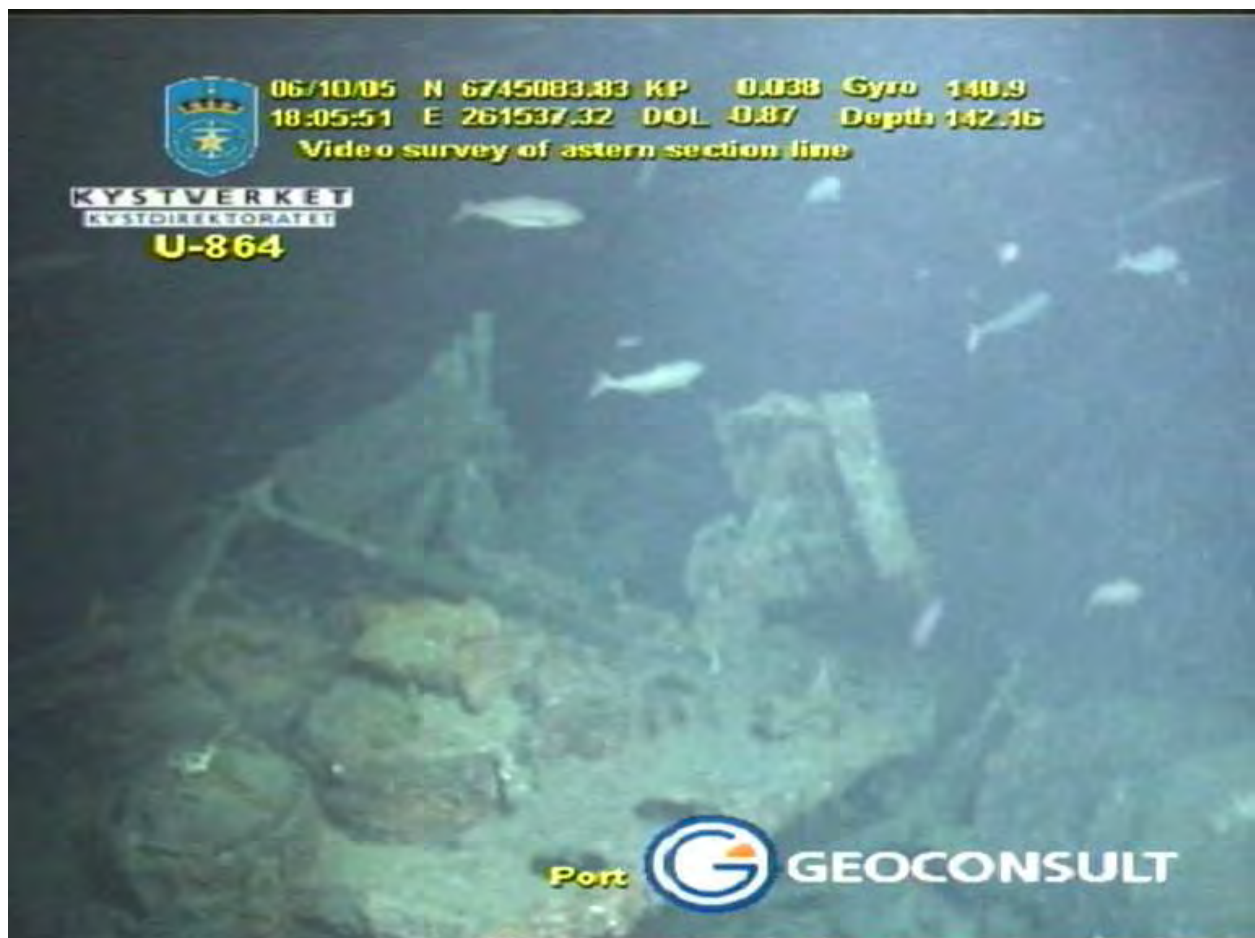
Figure 6-10 Picture of target 08. (Possible top of conning tower)

Target	Description from ref. /2/	Approx size
08	Possible top of Conning Tower	7.8 by 3.9 m
15	Large debris with ribs, pipe, possible part of outer hull, close to torpedo impact	2.6 by 1.9 by 1.4 m
37	Break point on sub (stern section)	1.3 by 3.2 by 1.5
66	Large debris	3 by 2.1 by 2 m
71	Large accumulation of debris, possible part of conning tower, ladder	1 by 1.3 by 0.5 m
78	Large debris, large tube with fin like feature, possible part of conning tower, snorkel	5.5 by 2.4 by 5.5 m

This picture is taken from “DNV Technical Report – Salvage of U864 – Supplementary Studies – Midship Section, Report No. 23916-4”, and claims possibly to be “top of conning tower”. This looks very much like the top “Winter Garten”, the top anti-aircraft gun platform aft of the tower.

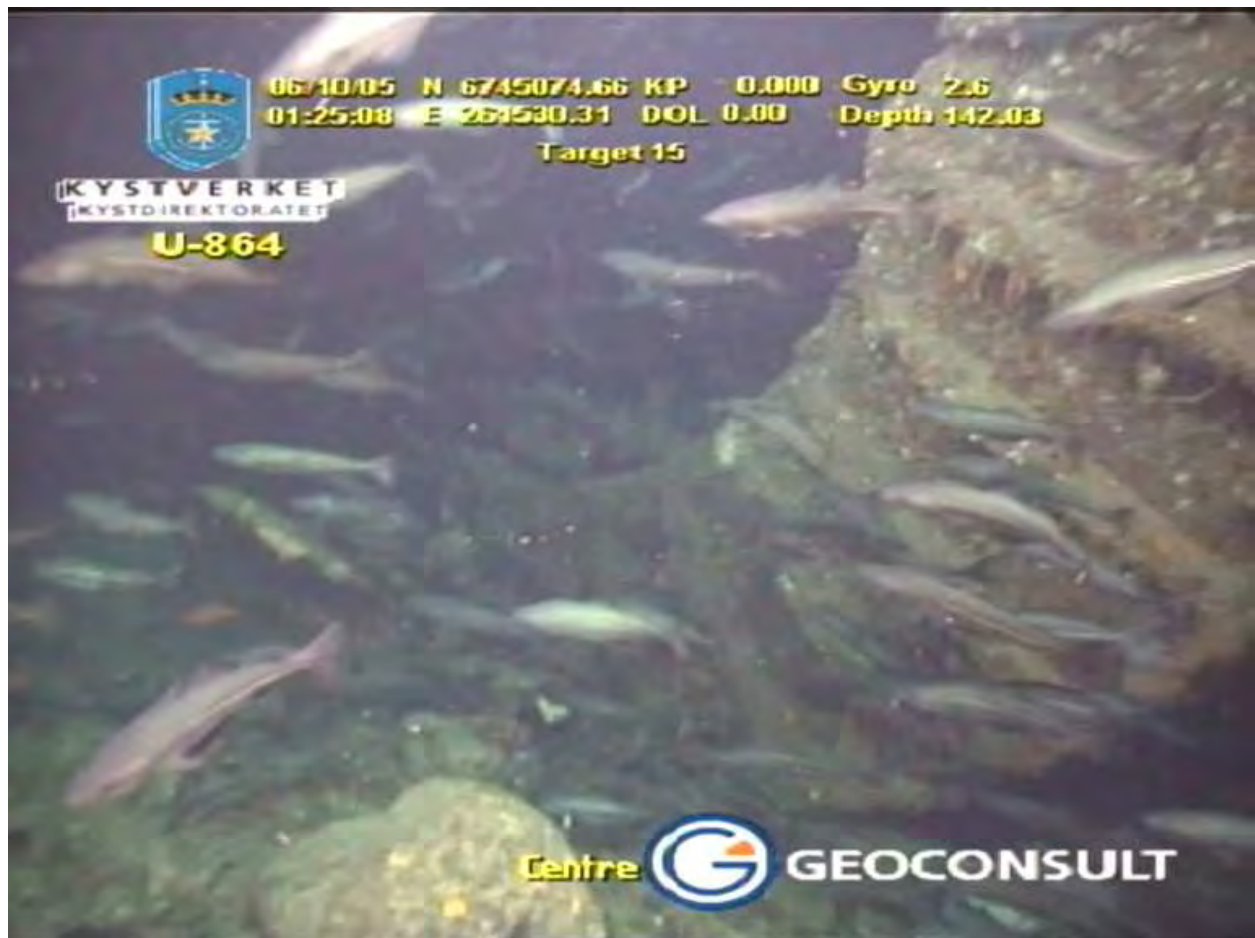
Figure 6-11 Picture of target 15. (Part of outer hull)

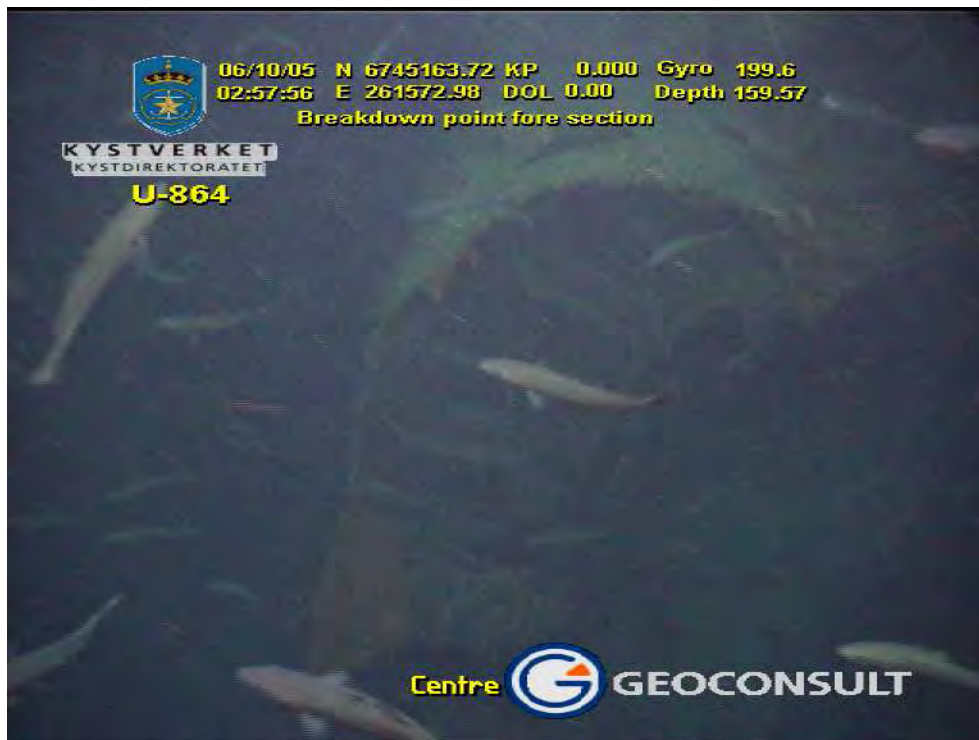
Figure 6-12 Picture of target 37. (Part of outer hull, Saddle Tank)

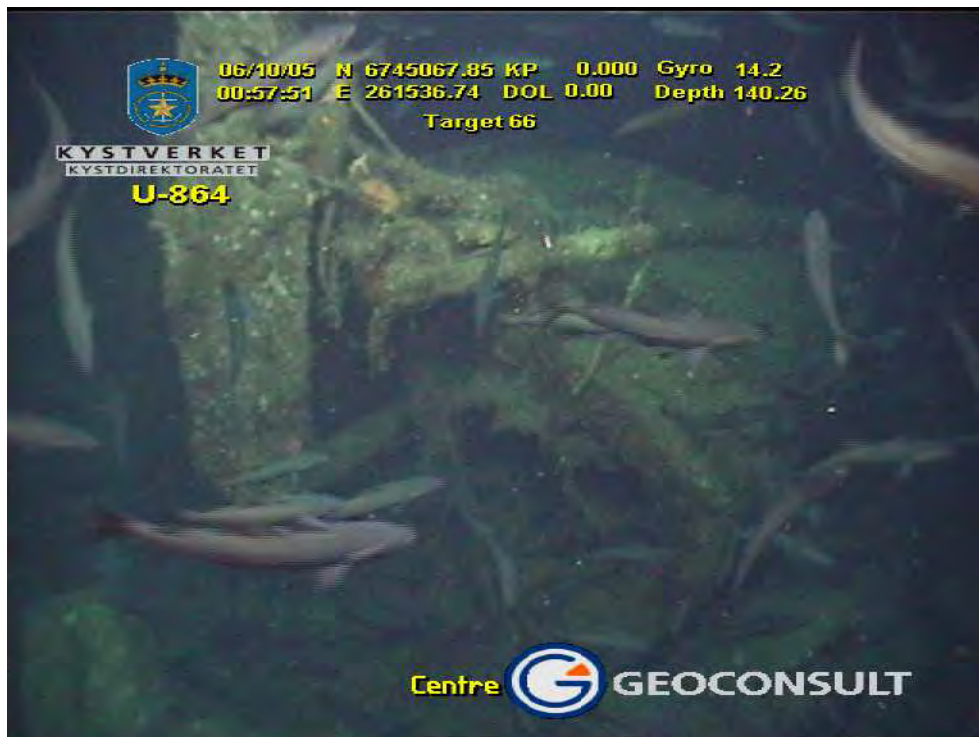
Figure 6-13 Picture of target 66. (Possible part of conning tower ?)

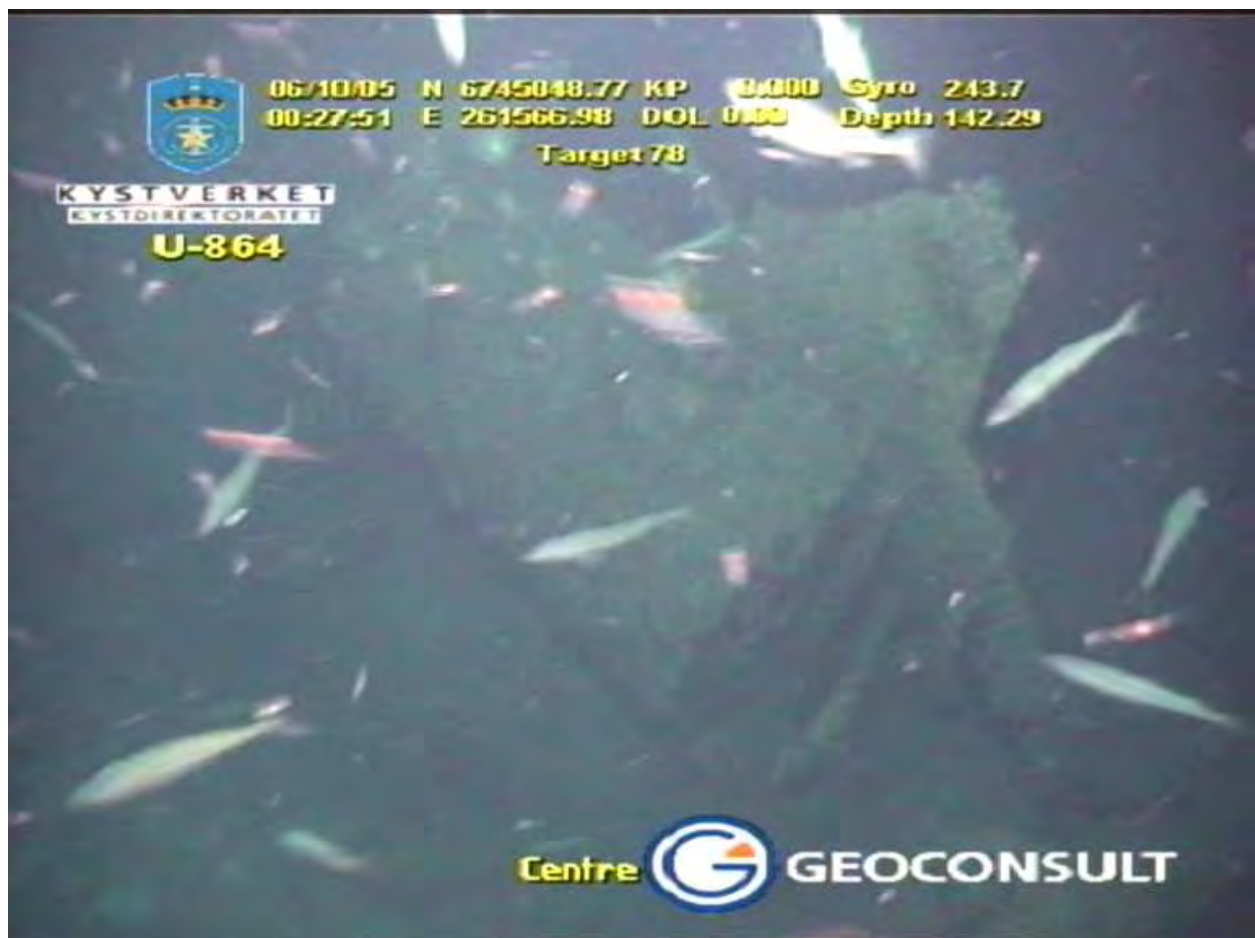
Figure 6-14 Picture of target 78 (Part of outer hull, with saddle tank?)

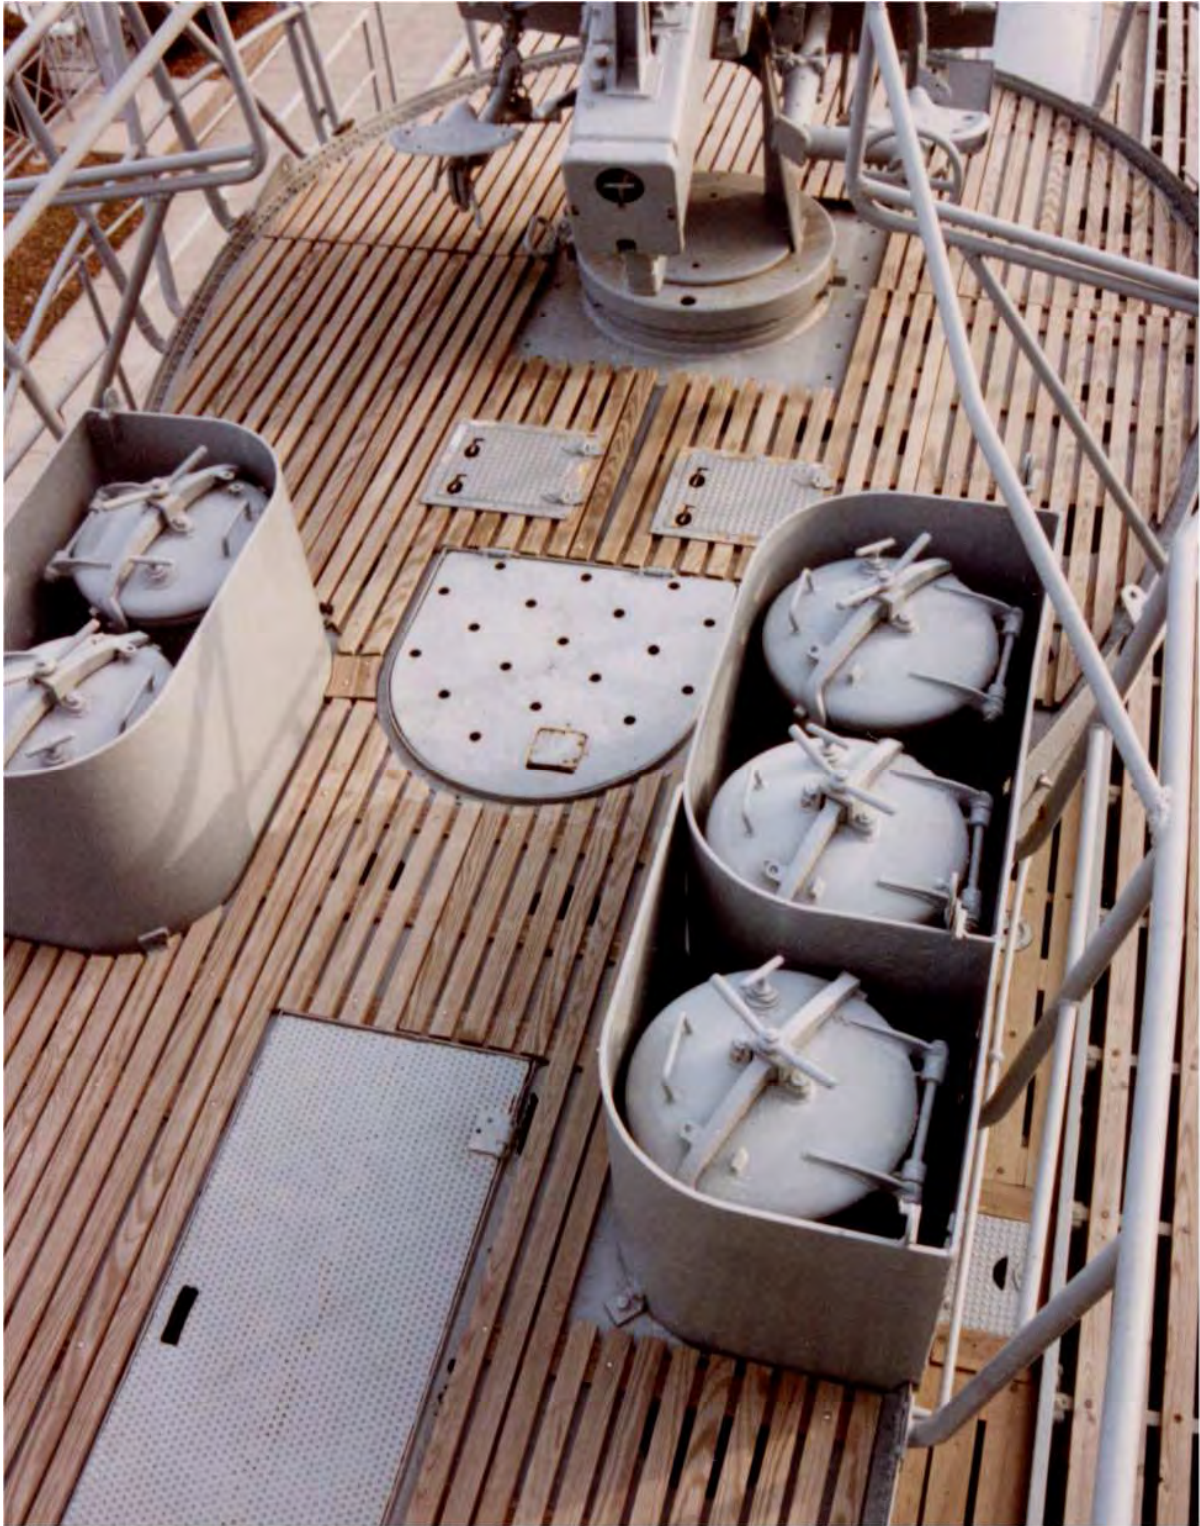
The picture below is taken of the same top anti-aircraft gun platform on the U-505, which lies in Chicago, USA. Note that the configuration of the ammunition containers could vary from type to type of U-boat.
