KYSTVERKET NORWEGIAN COASTAL ADMINISTRATION

**SALVAGE OF U864 - SUPPLEMENTARY STUDIES -
STUDY NO. 1: CORROSION**

REPORT No. 23916-1

DET NORSKE VERITAS

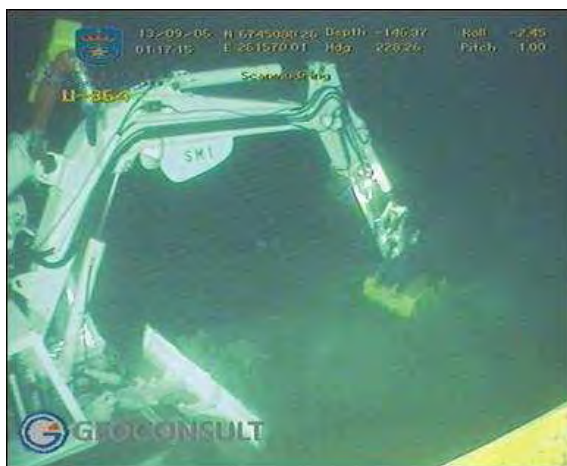
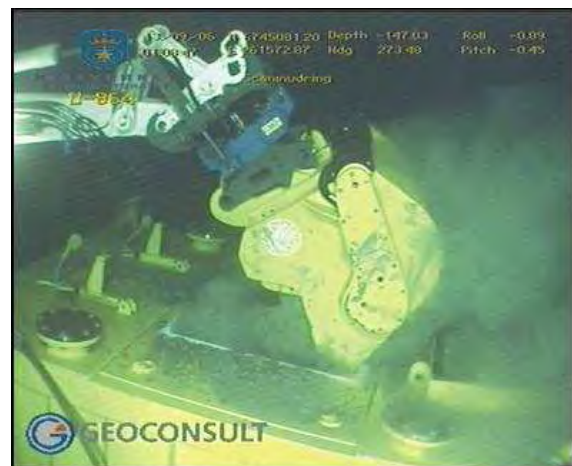
Figure 4-3 Excavator equipped with a visor bucket (system developed by Scannudring and used for dredging to reach the keel of U-864 in 2006)

(Figure 4-3). The machine has a dredging unit and a built in documentation system. The capacity is in the same order of size (100 metric ton/hour) as for the ROV with suction hose, maybe even a bit higher under favourable conditions. An advantage of the excavator is that it can remove sediments with low water content. The grab is closed when it moves towards the container. It generates turbidity when emptying the grab into the container, and it may be around 20 % loss of sediments in the process. A possible solution for reducing the loss of sediments would be to have an underpressure in the container, causing the sediments to be sucked into the container.

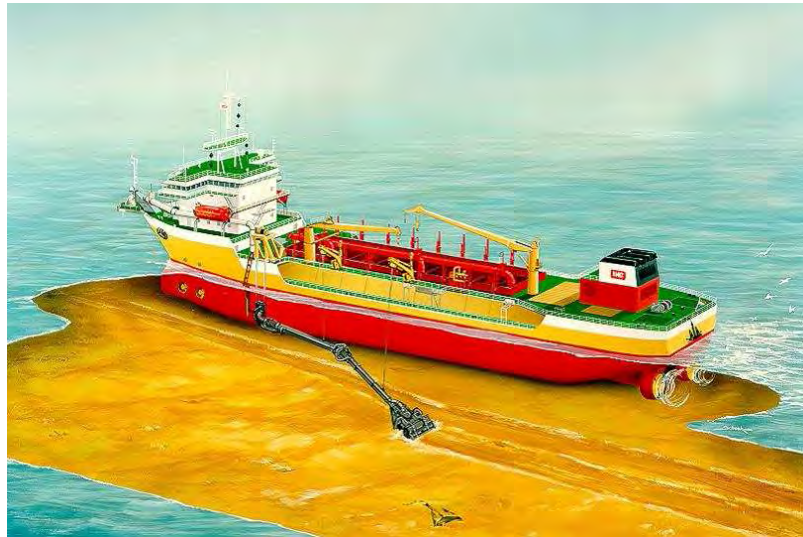
Figure 4-4 Trailing suction hopper dredge (TSHD)

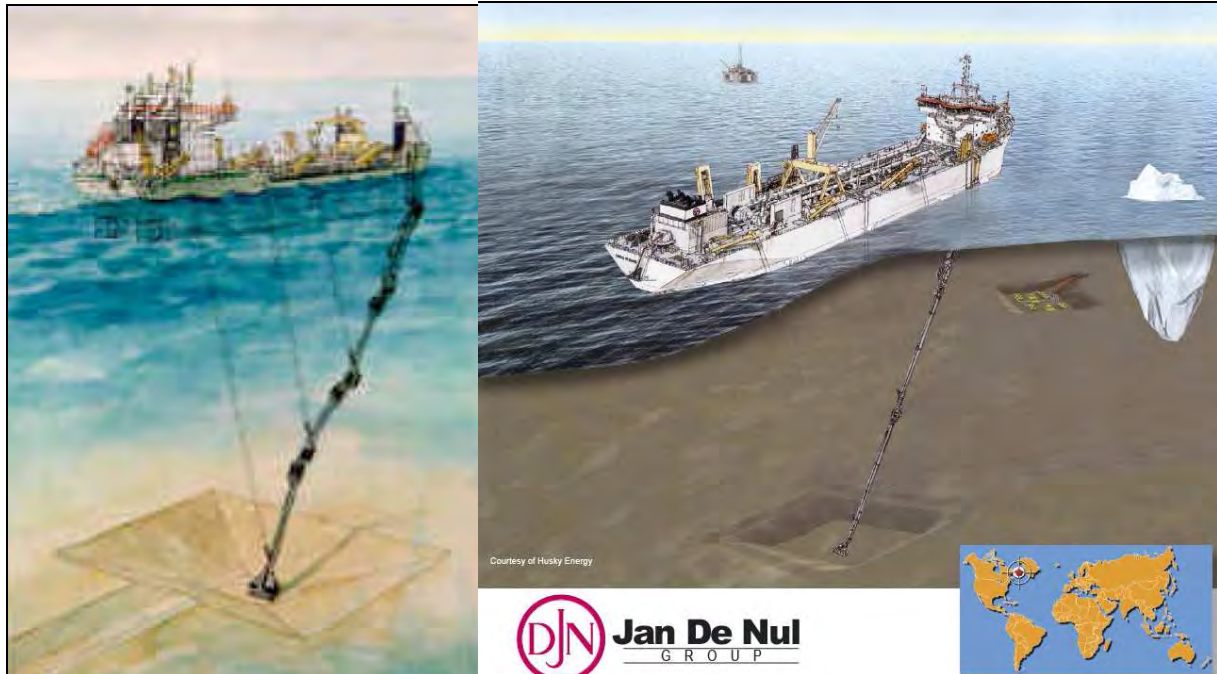
Figure 4-5 Left: Dredging down to 106 m water depth (from Glory Holes project, Canada /3/. Right: Dredging down to 130 m depth (continuation of Glory Holes project, Canada /4/,

Among dredging works for deep water done with a TSHD is the Glory Holes project in Canada, see Figure 4-5 .

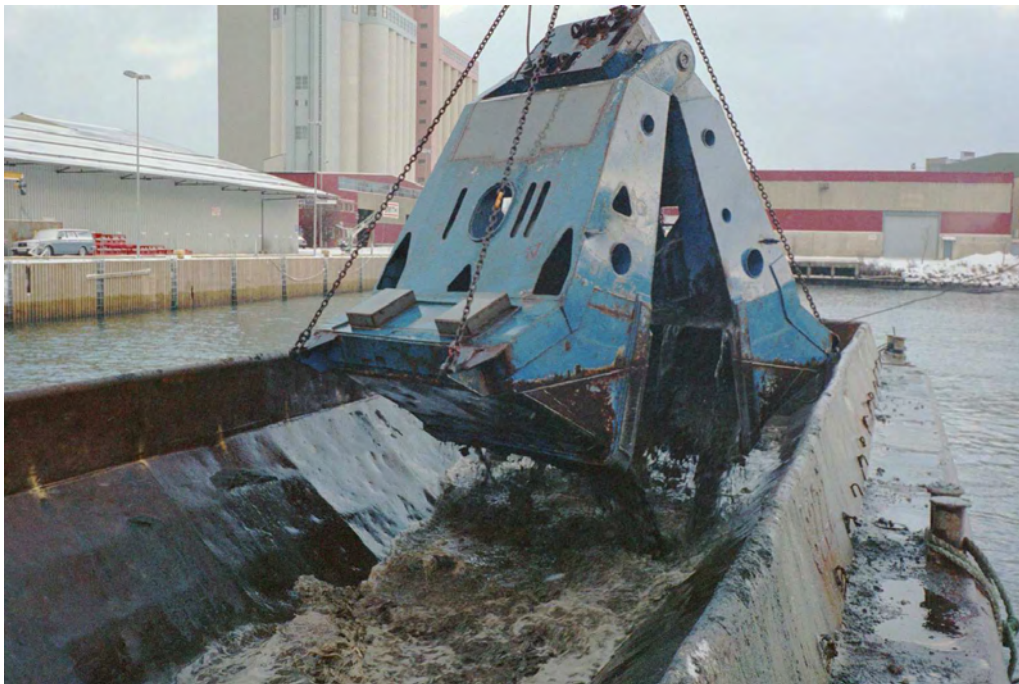
The closed level cut clamshell can be used for environmental dredging and for large water depths. The accuracy depends on the water depth, for most purposes the vertical accuracy is +/- 30 cm, for the actual water depths (150-175 m) the positioning should be assisted by an ROV. The closed level cut clamshell can dredge material with a water content close to the natural water content (see Figure 4-7). The method is robust and not very vulnerable for debris on the seafloor.

Figure 4-7 Closed level cut clamshell (photo from environmental dredging works in Trondheim harbour, Norway)

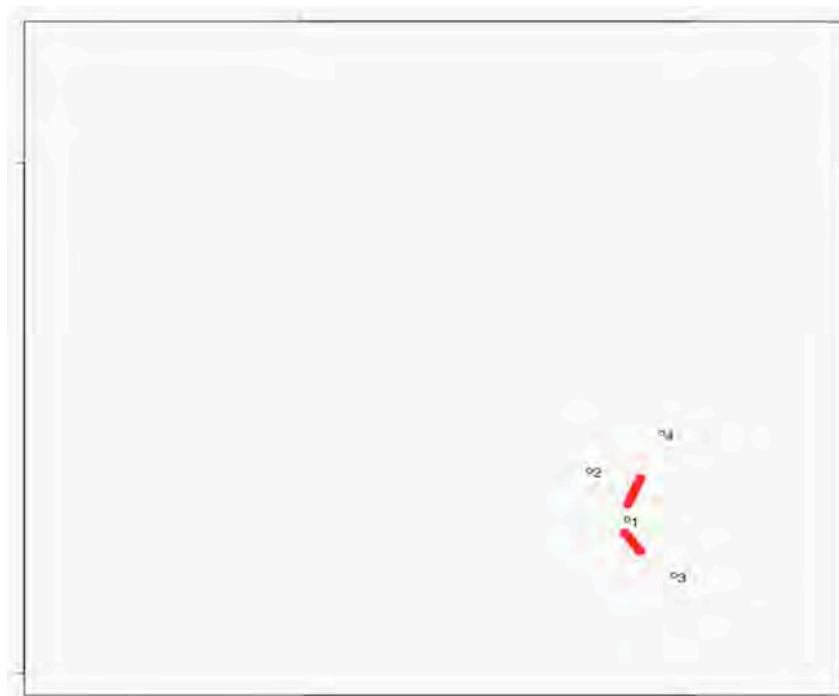
b.

Figure 3a. Model bathymetric grid, latitude/longitude coordinates, and release point 1 (a); and an overlay of release point and wreck part locations.

Model bathymetry was created from a recent 1-km by 1-km XYZ survey data supplied by DOF (formerly Geoconsult). The data were trimmed to form a regular grid covering a rectangular area about 0.9 km square with the wreck slightly in the southeast quadrant of the rectangle. The original horizontal XY coordinates (UTM) were converted to the coordinates required by SSFATE (latitude and longitude). The grid resolution scale for transport was 10 m in the horizontal and 1 m in the vertical. The model grid is shown in Figure 3 along with water depths, wreck part locations, and release point locations used in model simulations.

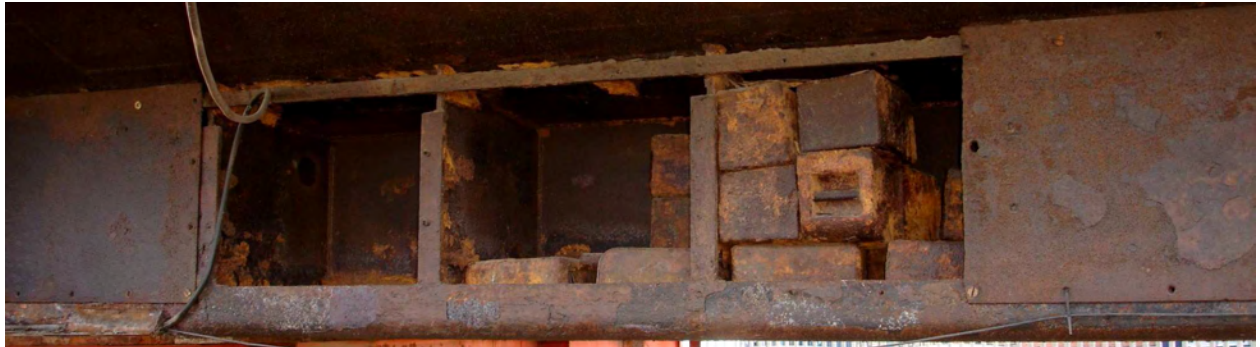
Figure 5-2 The storage room in the keel of U-534 (Type IX C, similar to U-864 but approximately 11 metres shorter)

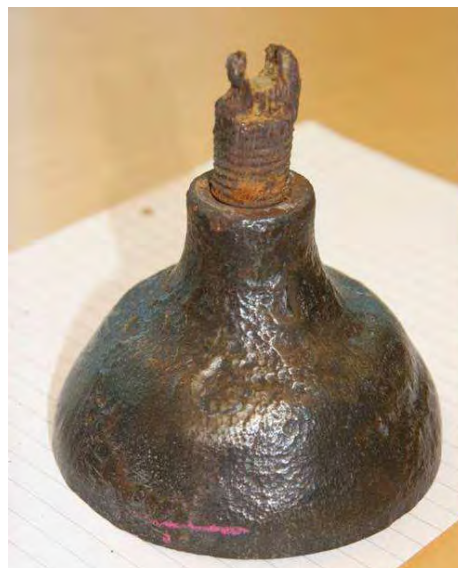
Figure 5-3 Top section of forged container for mercury

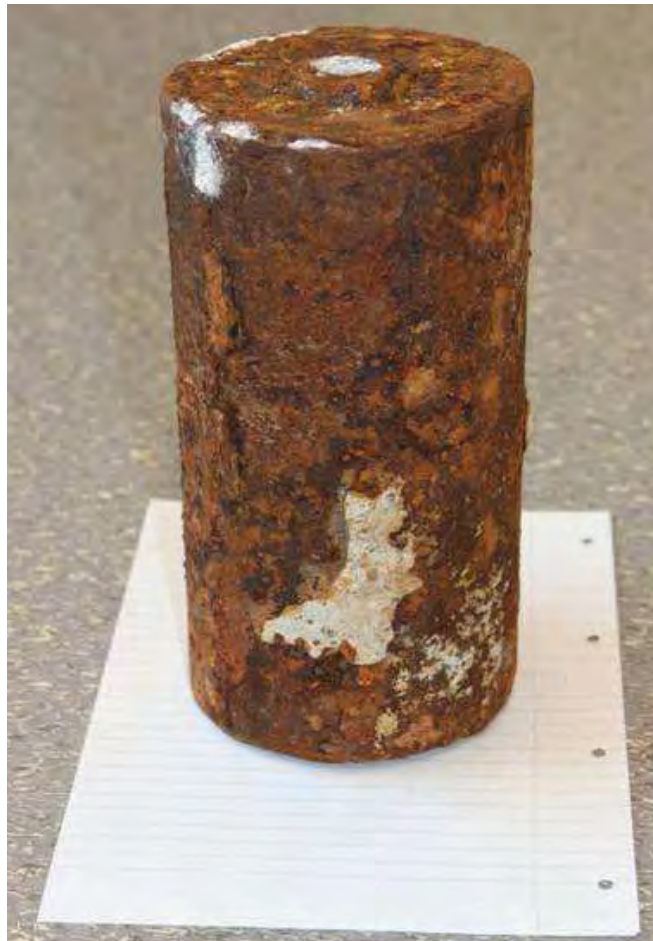
Figure 5-4 Welded mercury canister (diameter 130 mm)
