**Hafodty Farm farmhouse and barns,
Llansilin, SY10 7JN**

Bat survey with mitigation plan

23 June 2020

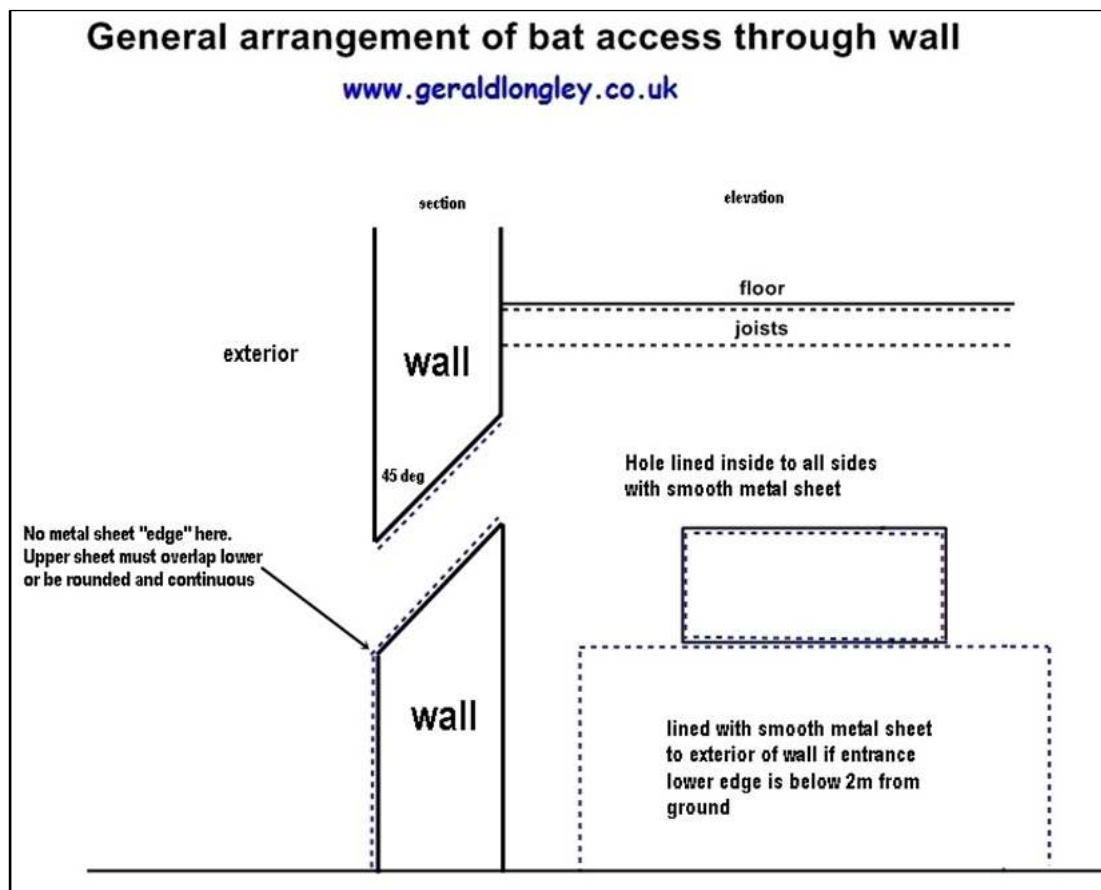
- ix) A rectangular bat entrance/exit will be provided as a hole in the northeast facing wall. The entrance will be 500mm in width and 200mm in depth. It will be angled up through the wall at 45° in section. It will be installed with its upper edge at about 1.7m from ground level. If the eaves’ height is greater than 2m it can be higher. It is to enter the interior in the ground floor room (not into the loft) just below the loft floor. To deter cats jumping/climbing in the entrance, the bat entrance will be lined to all 4 sides in smooth metal sheeting. The area of exterior wall below the bat entrance will also be covered in a smooth metal sheet 1m wide over the timber cladding from ground level bending into the

entrance hole with no "edge" there. The sheet will be as smooth as possible with any sheet overlaps being upper sheet over lower sheet. See the diagram 'General arrangement of bat access through wall' below.

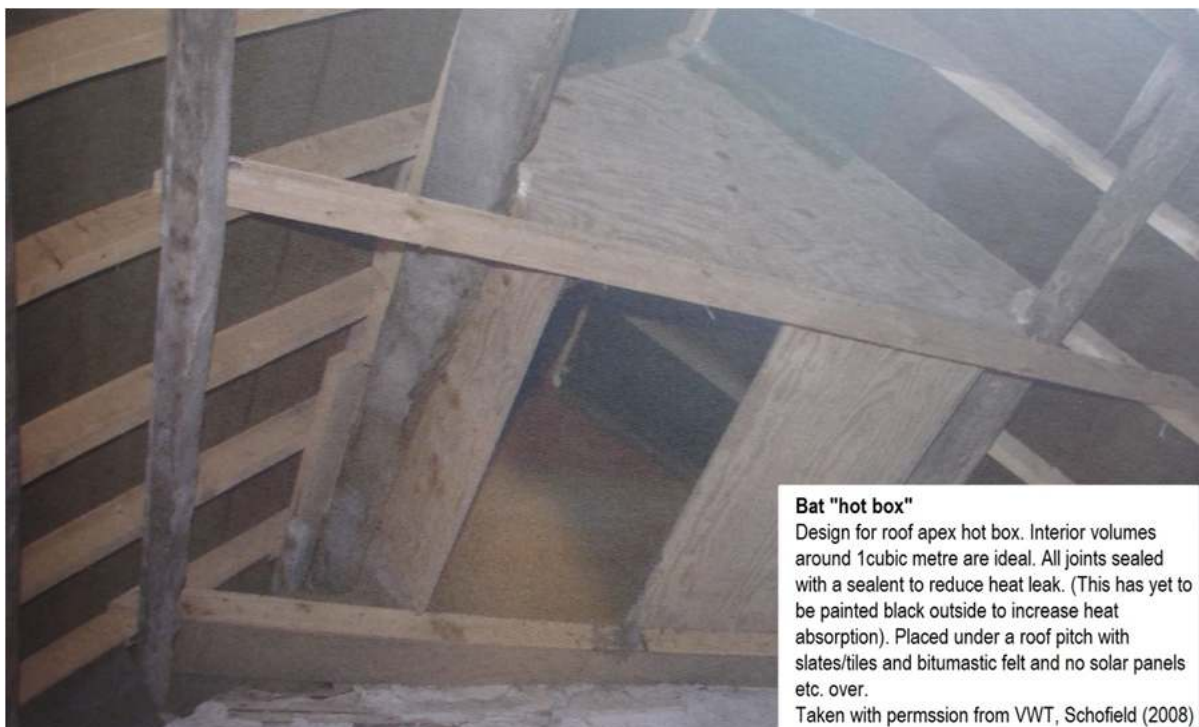
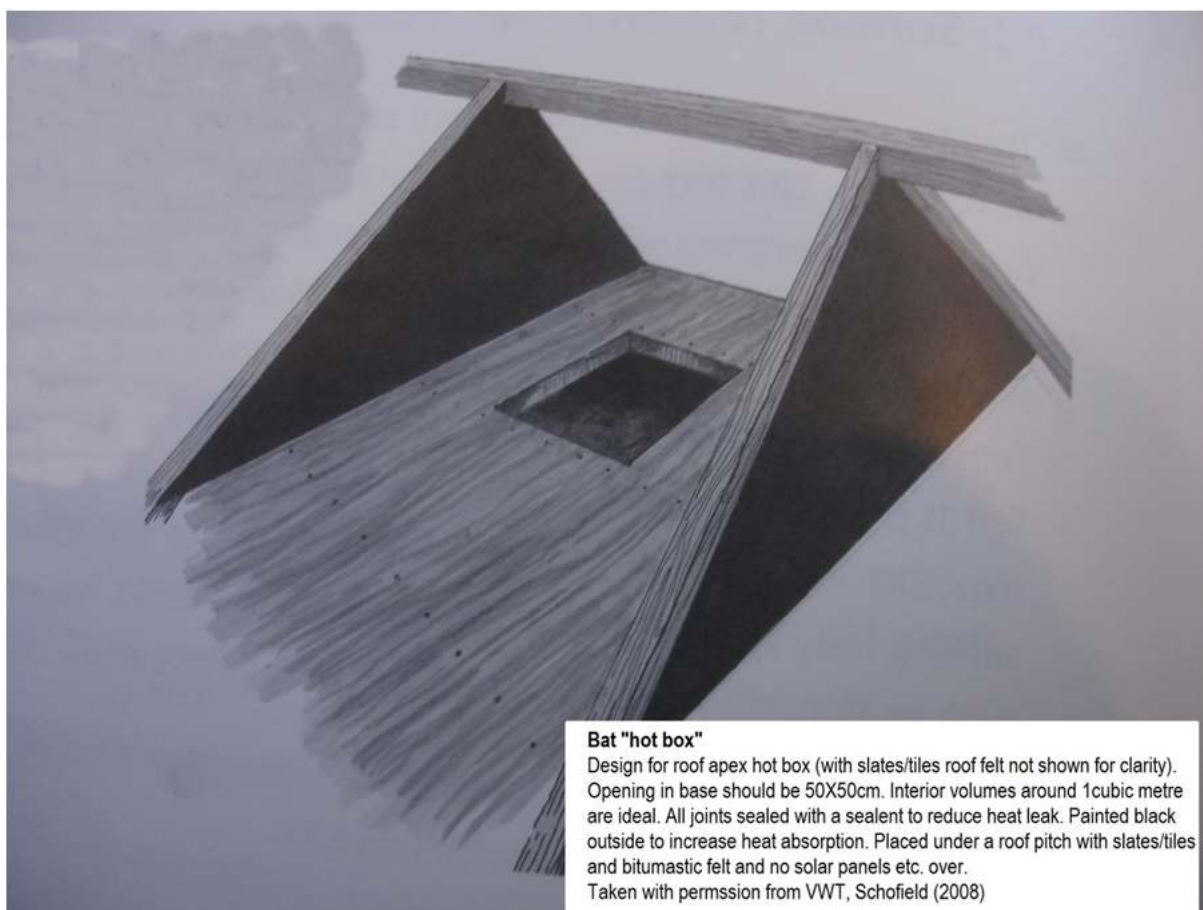
- x) In the centre of the loft, a “hotbox “ will be constructed of sterling/OSB and untreated timber, to be approximately 2m long, and 1m deep, sealed with mastic at its joints, painted black on the outside with a bat access hatch through its “floor” of 45cm by 45cm. See illustrative photo of an unpainted hotbox installed and a drawing with roof and slates removed for clarity (below).

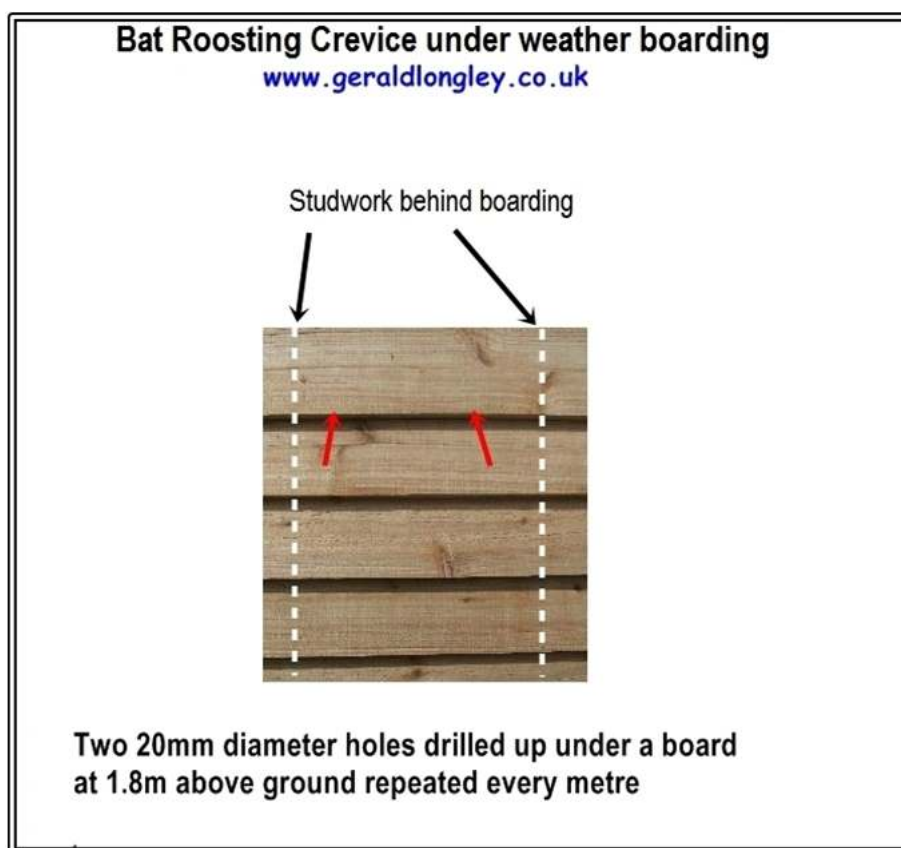
- xiv) The tanalised, horizontal exterior timber cladding will be on battens 50mm deep and will have pairs of holes, 20mm in diameter, at approx. 1m spacing, drilled up vertically at the bottom edge of a cladding board, at approx. 1.8m from the ground on each elevation to allow access for bats behind the cladding into the cavities between battens.

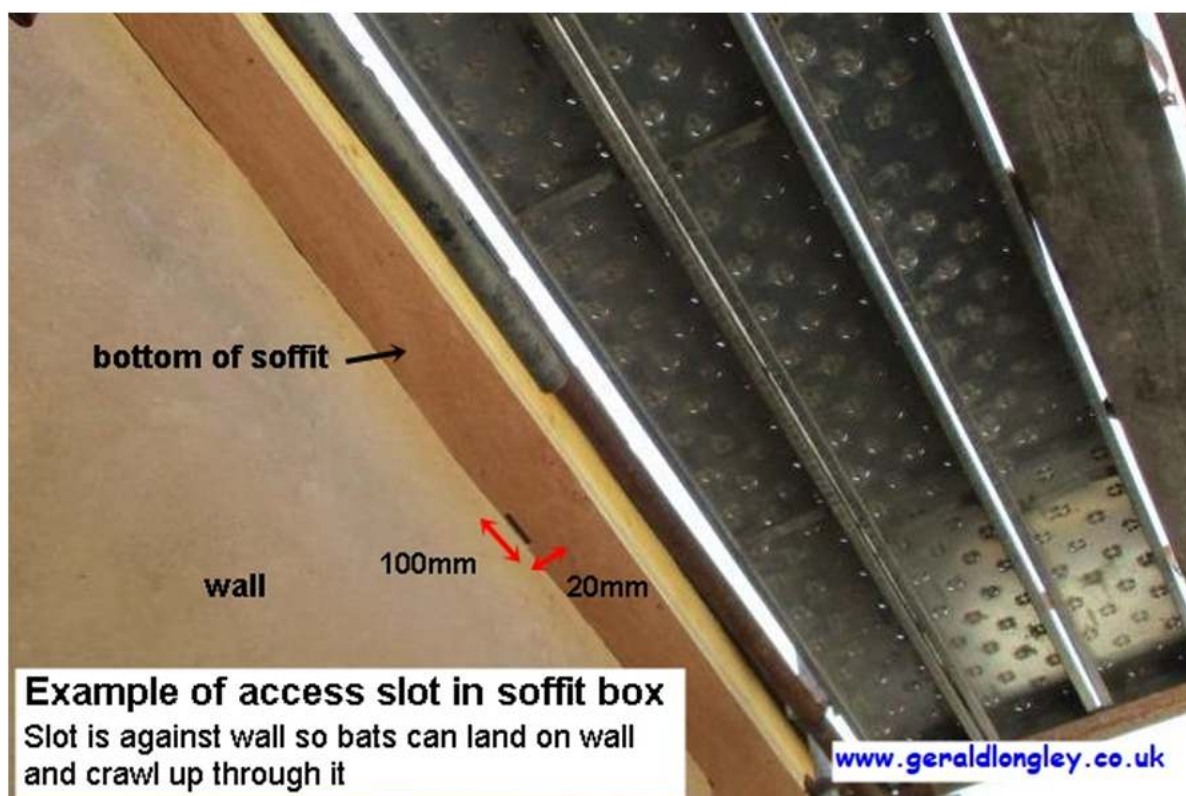
- xv) At the eaves and along the gables soffit boxes will be built with rectangular bat access slots at their wall edge about every metre. Similar slots will be made at the apex of the gables. All slots will be 100mm long and 20mm deep (and no larger) giving access to the soffit boxes and the wall tops. See the photograph 'Example of access slot in soffit box' below.

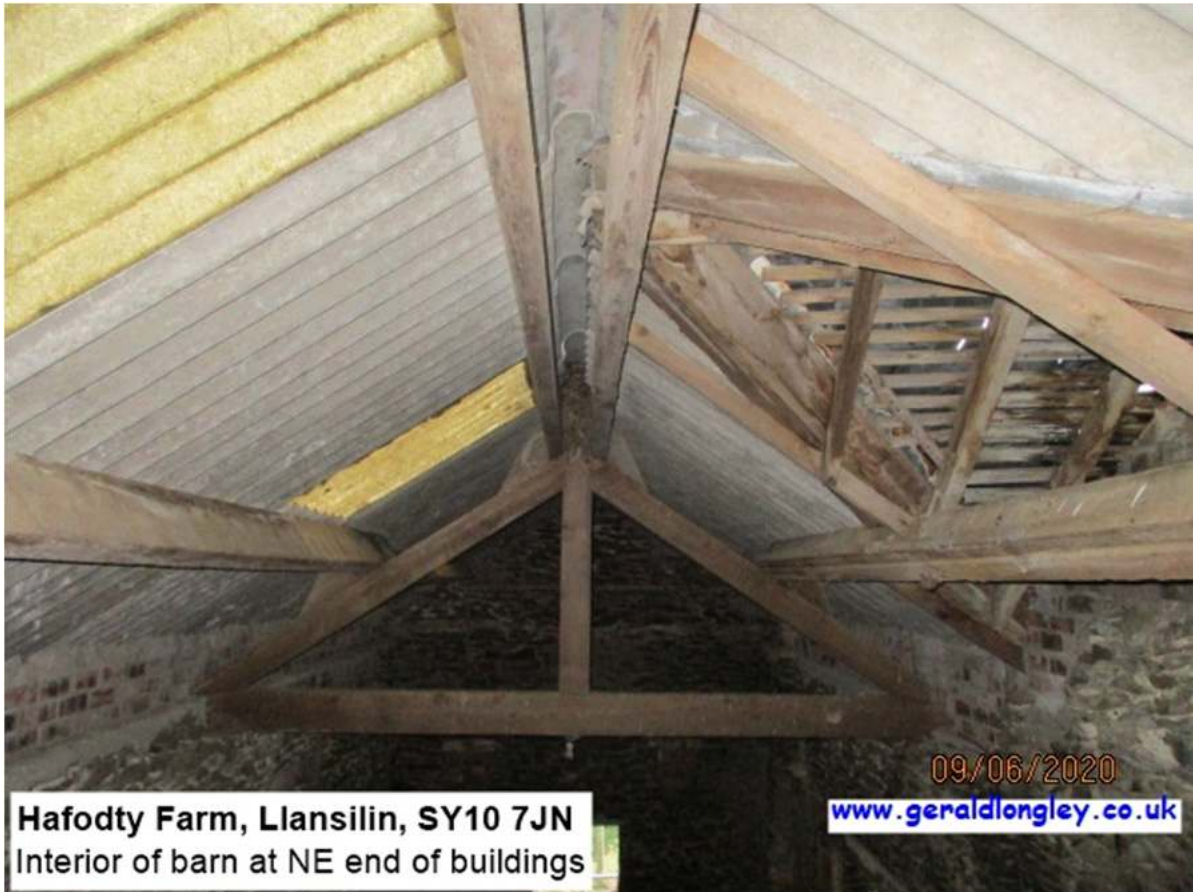
Hafodty Farm, Llansilin, SY10 7JN
Interior of barn at NE end of buildings
