# Prescott Creeks Preservation Association

## Watson Woods Riparian Preserve Restoration Project

*Arizona Water Protection Fund Commission Grant #: 08-158WPF*

*Final Report*

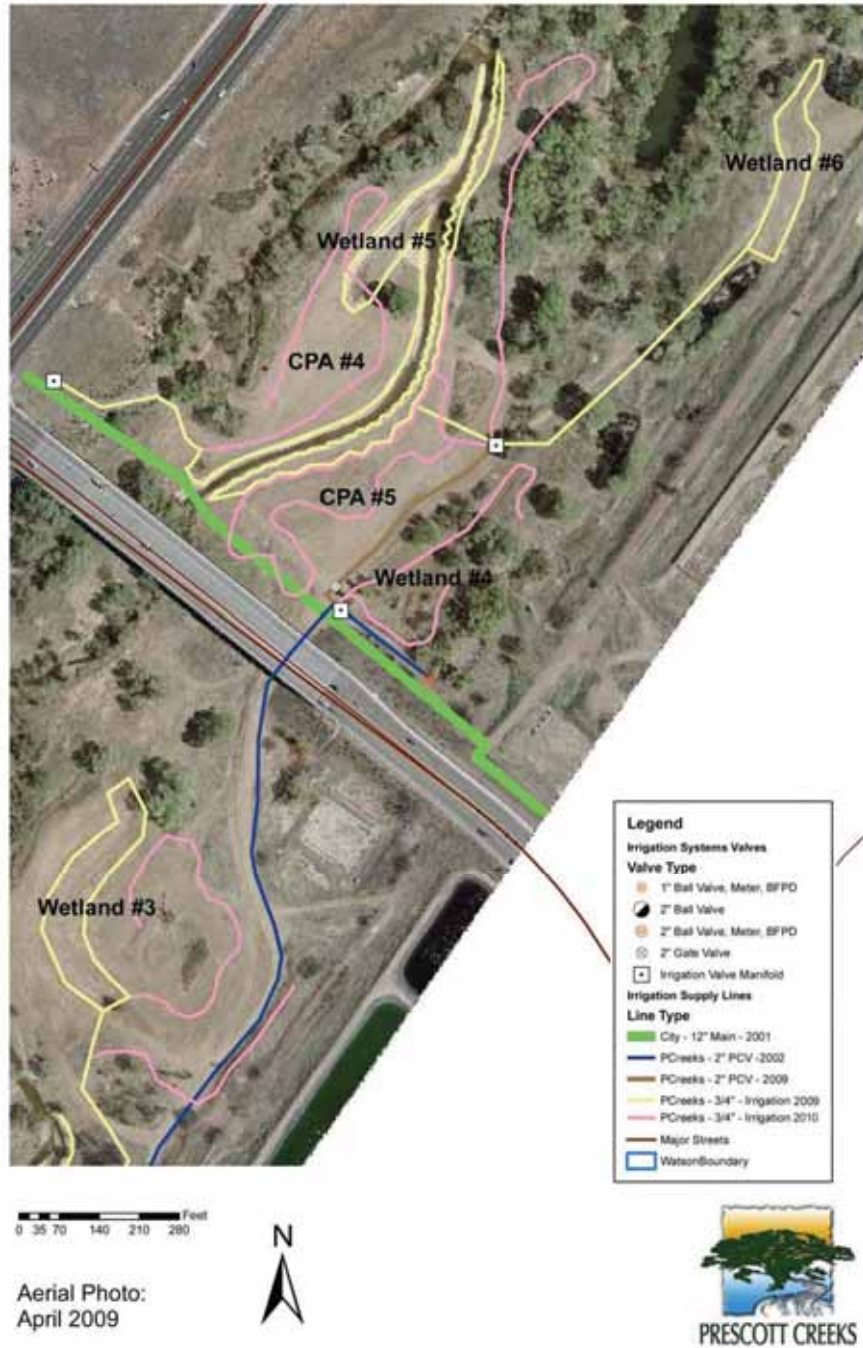
Figure 4-Irrigation As-Built Drawing (North)

The system consisted of a series of 2" main lines (PVC), 3/4" flex tubes, and "spaghetti" tubes, all of which was automatically operated through a control unit/valve box. The irrigation system operated from approximately May-October, and planting areas were typically watered for 4 hours 2-3 times per week on a staggered schedule. Prescott Creeks considers this system to be beneficial to the restoration project, particularly due to the relatively dry conditions in 2011 and 2012.

The first stage consisted of irrigating areas immediately adjacent to the restored reaches of Granite Creek. While successful, this stage was extensively damaged from the January 2010 flood. During post-flood repairs, Prescott Creeks focused on providing irrigation to off-channel areas (critical planting areas and wetlands), which represents the second stage of the system. Figures 4 and 5 illustrate both stages of irrigation within the Preserve.

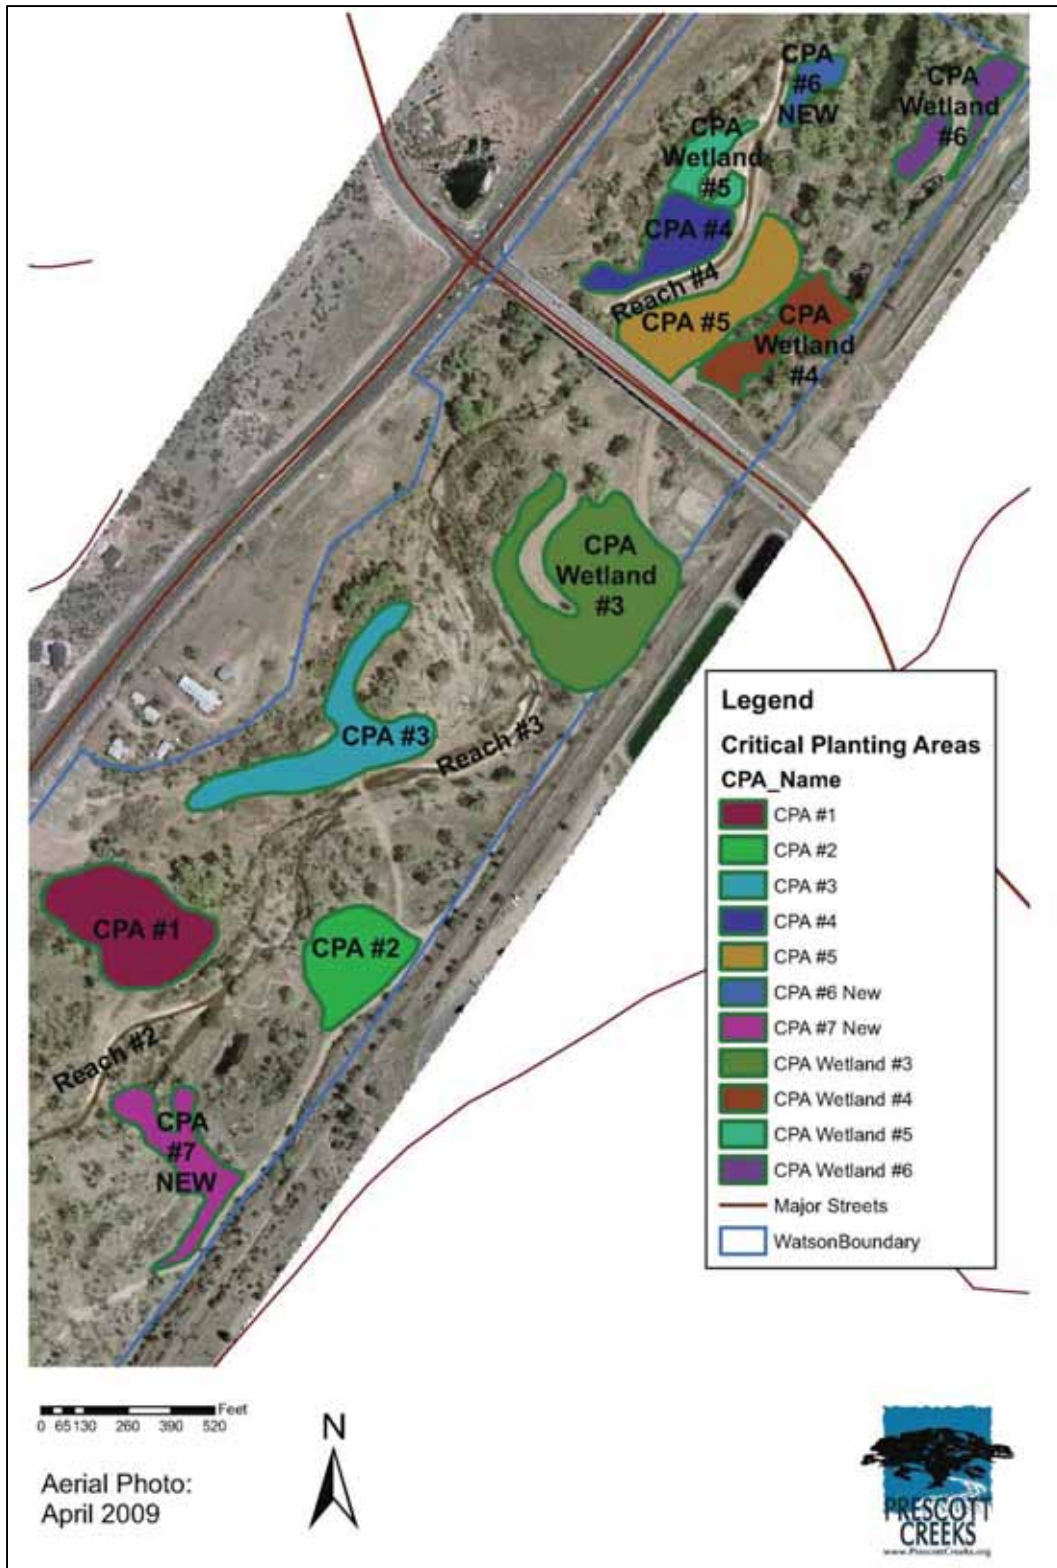
Figure 6-Final Planting Design

Figure 6 illustrates the final location/extent of critical planting areas and wetlands. In addition, Appendix E contains fully engineered “as built” drawings.

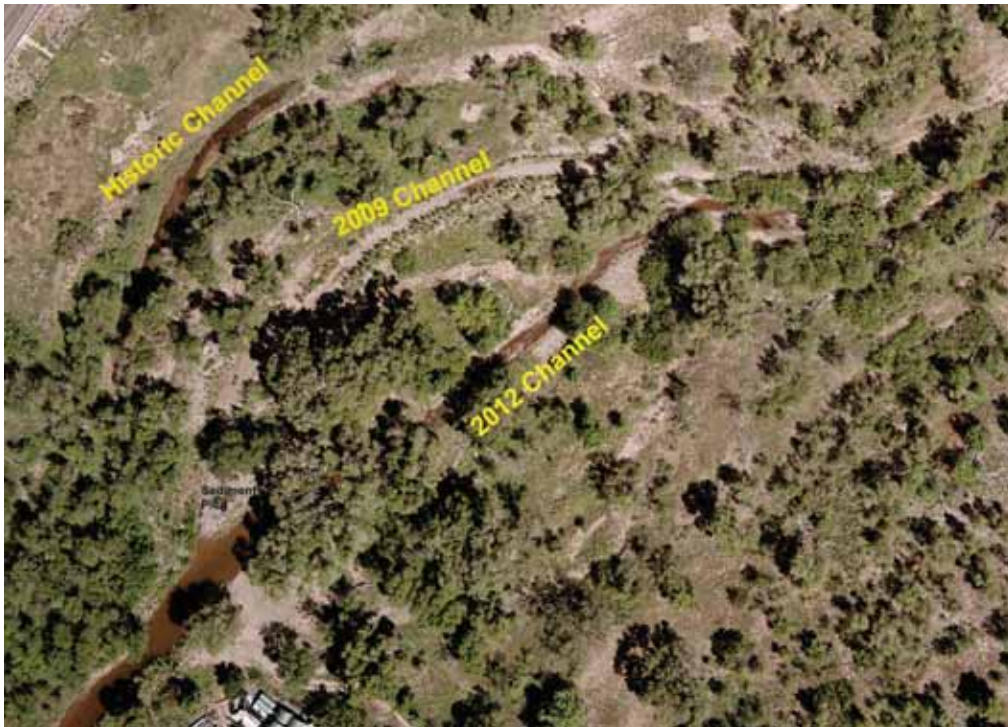
**Figure 7-Reach 1 Channel Location (2012)**  
*The historic channel location is now a wetland*

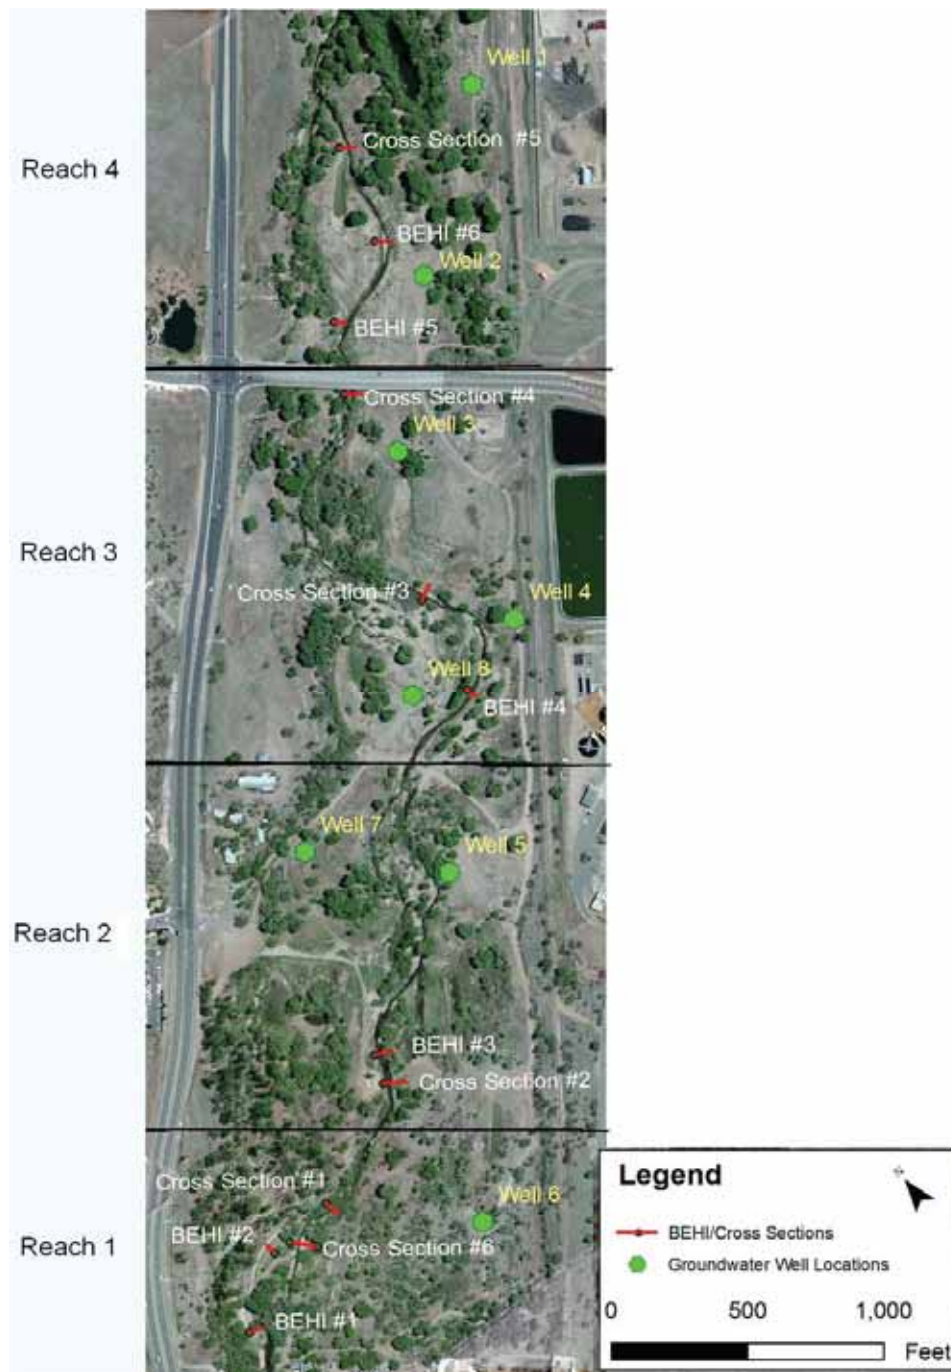
Figure 11-location of monitoring cross sections, BEHI, and groundwater wells

Post-construction monitoring occurred in April 2009, September 2009, October 2010, September 2011, and September 2012. Monitoring evaluated the success of installed structures and bioengineering treatments completed in the project area. Six cross-sections in the project area were re-surveyed to measure channel stability and six banks were re-surveyed using the Bank Erodibility Hazard Index (BEHI) to monitor bank stability (Figure 11). Photos were taken annually at eleven photo points as well as at each cross-section and BEHI location.

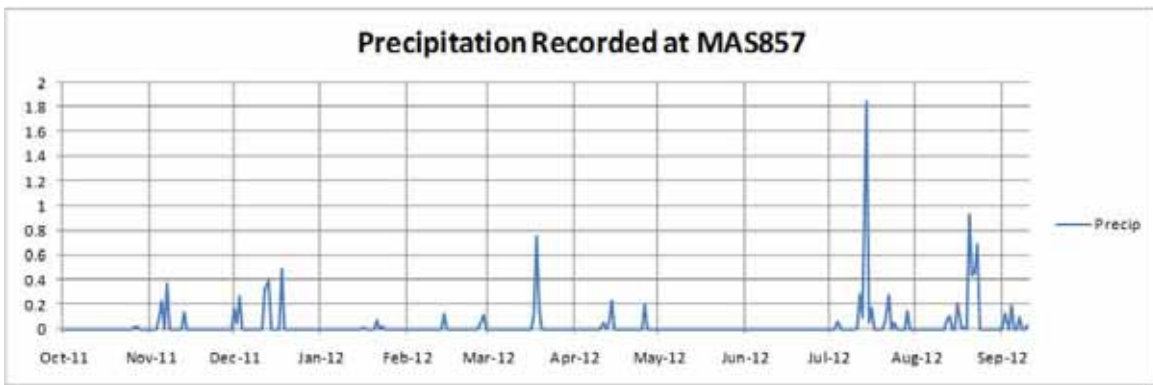
Drought conditions prevailed in the Prescott vicinity during 2011 and 2012. Approximately 10.8 inches of precipitation was recorded at the local weather station (APRSWXNET -MAS857). On average, Prescott sees around 19 – 20 inches of precipitation annually. All months with the exception of December 2011, July 2012, and August 2012 saw below normal precipitation. December, July and August saw average precipitation amounts (Figure 13).

**Figure 13-Daily Precipitation totals for 2012 at weather station MAS857**  
 The weather station MAS857 is located approximately 1.6 miles from Watson Woods

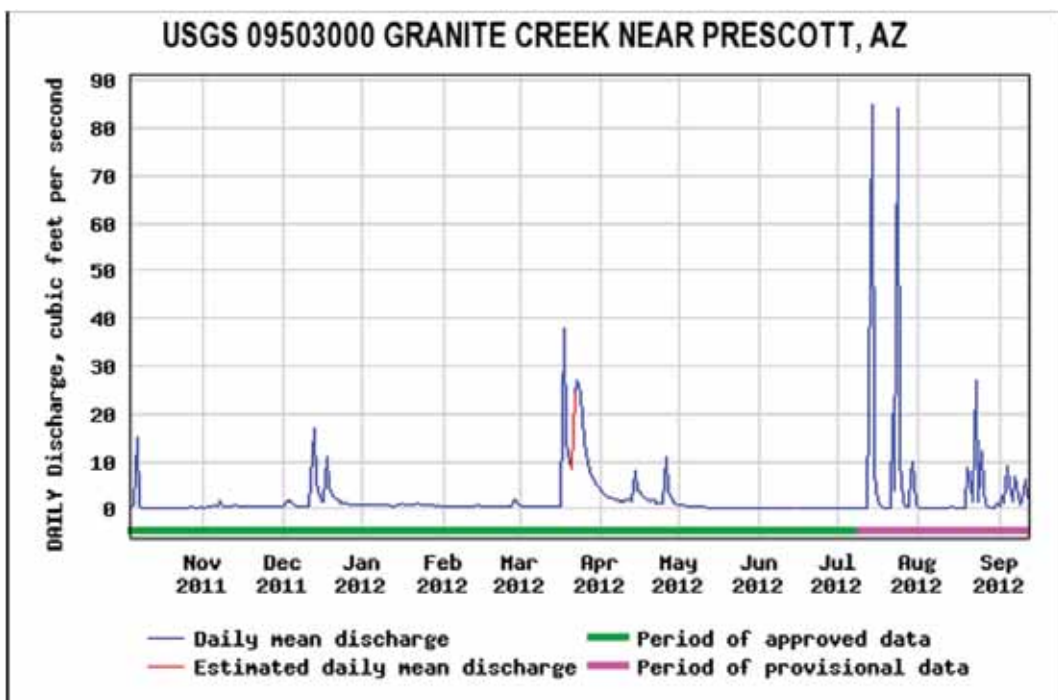
**Figure 14-Mean Daily Discharge at USGS gage 0903000 for November 2010 to mid-October 2011**  
 The mean discharge is the average flow for the day. The double spikes in July 2012 show an almost identical mean discharge on those two days, but magnitude of flows was much different.

During the previous year, there were three periods where stream flows in the Preserve significantly exceeded baseflow. In March, stream flows approached 200 cfs. Then in July, several storms produced flows that were near bankfull over a three day period. The final large flow of the year was on July 24<sup>th</sup> with a flow near 1,200 cfs (close to a 2 year event, Table 2 and Figure 15). These flows allowed for the distribution of sediment, but did not cause any damaging erosion. The vegetation along the banks withstood the flows without any damage.

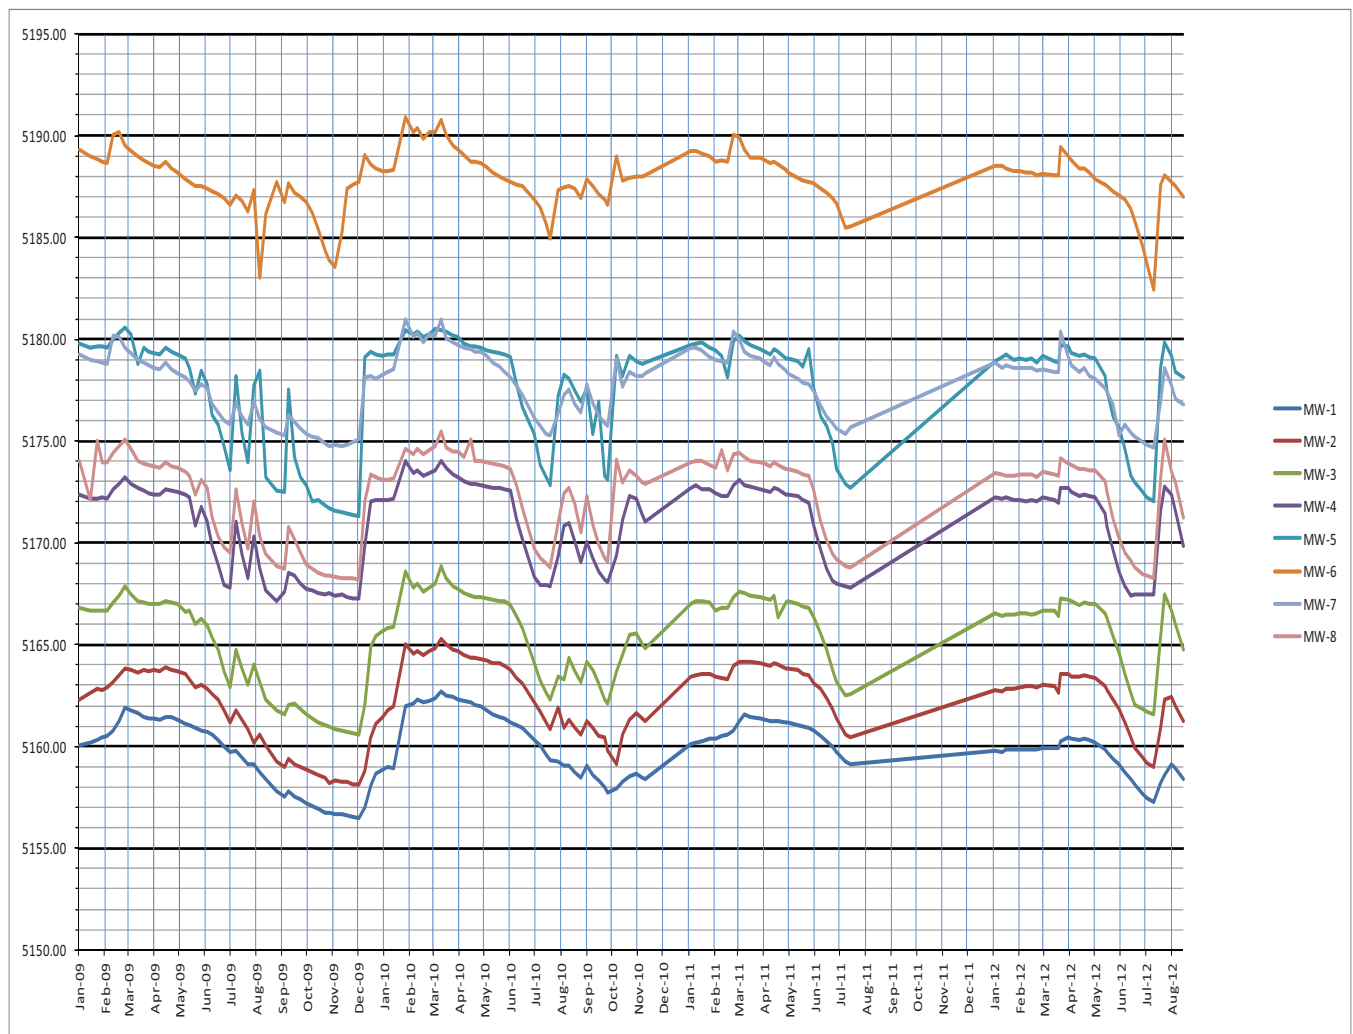
The period from June to mid-July 2012 saw some of the lowest groundwater elevations since fall 2009 but the levels came up quickly once the monsoonal rains started. The plants that were stressed the previous year were growing robustly at the time of the monitoring efforts, possibly indicating that additional root growth since the previous year allowed the plants to withstand this dry period.

**Figure 16-Monthly water elevation (ft) at each well from January 2009 to August 2012**  
*2012 saw higher groundwater elevations while 2012 had generally lower elevations*

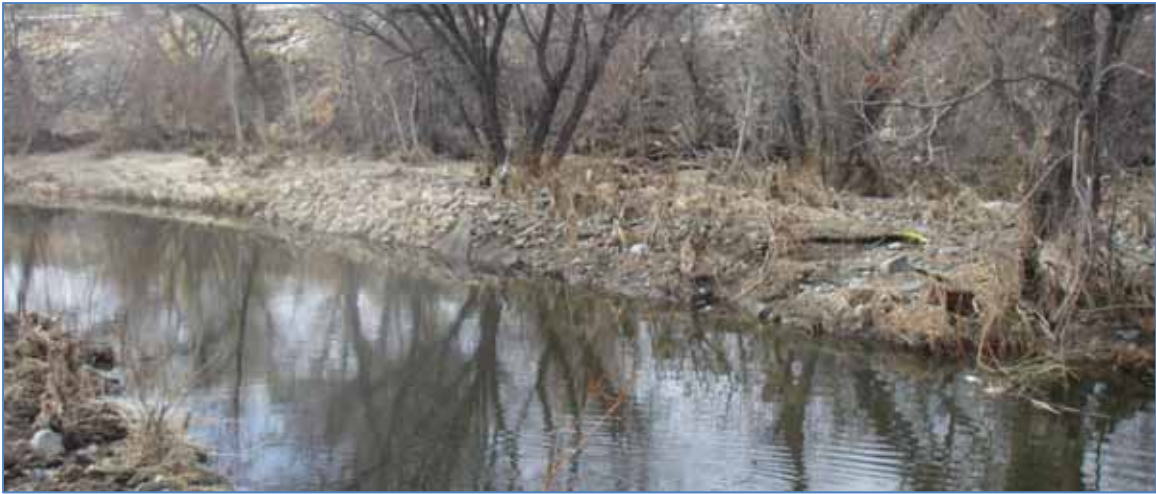
*2010, taken after flood event*

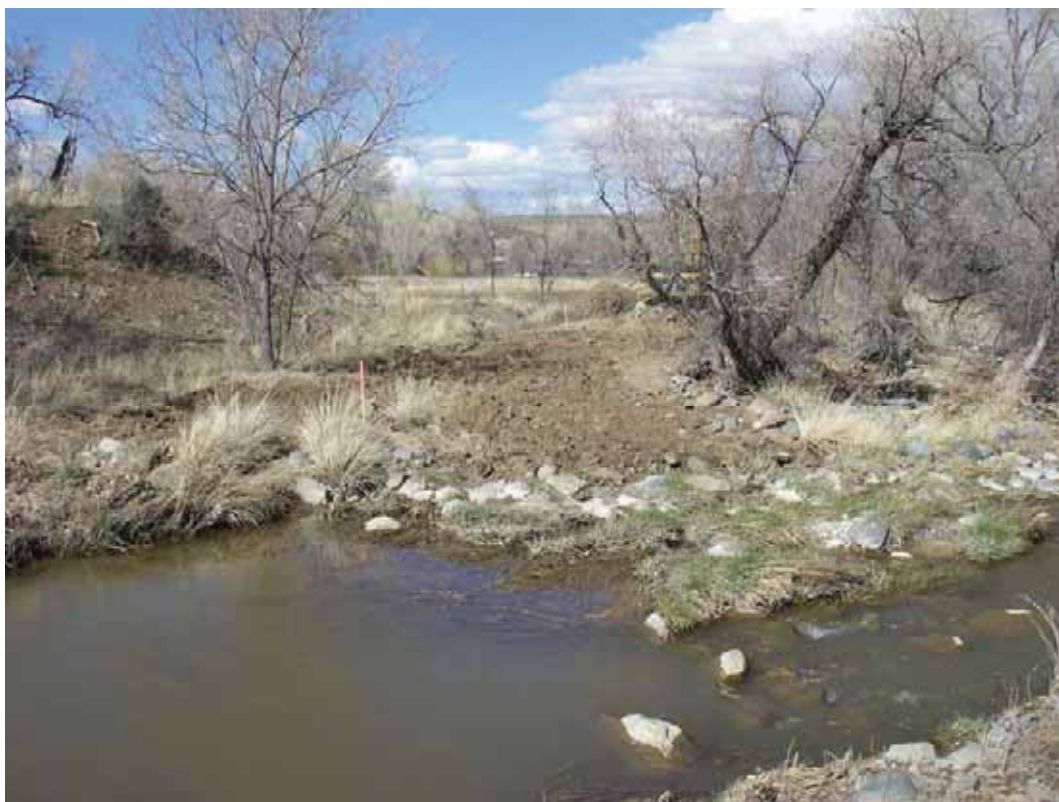
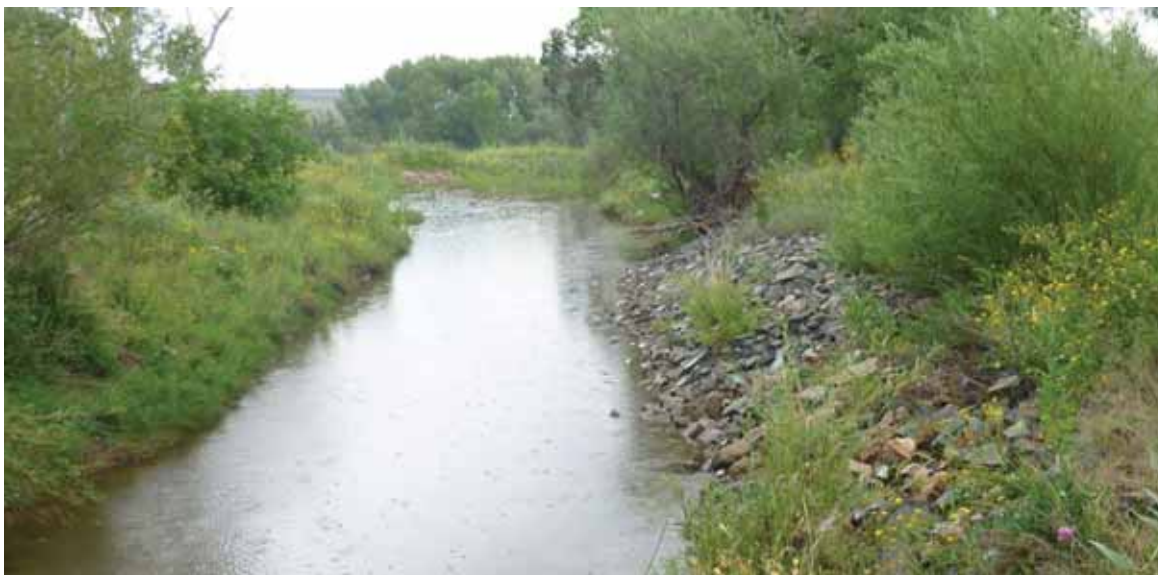
**Figure 18-Rock Plug in Reach 2**  
*This Structure was repaired in 2010*

*2009 prior to installation of new channel and rock plug on right*

*2012*

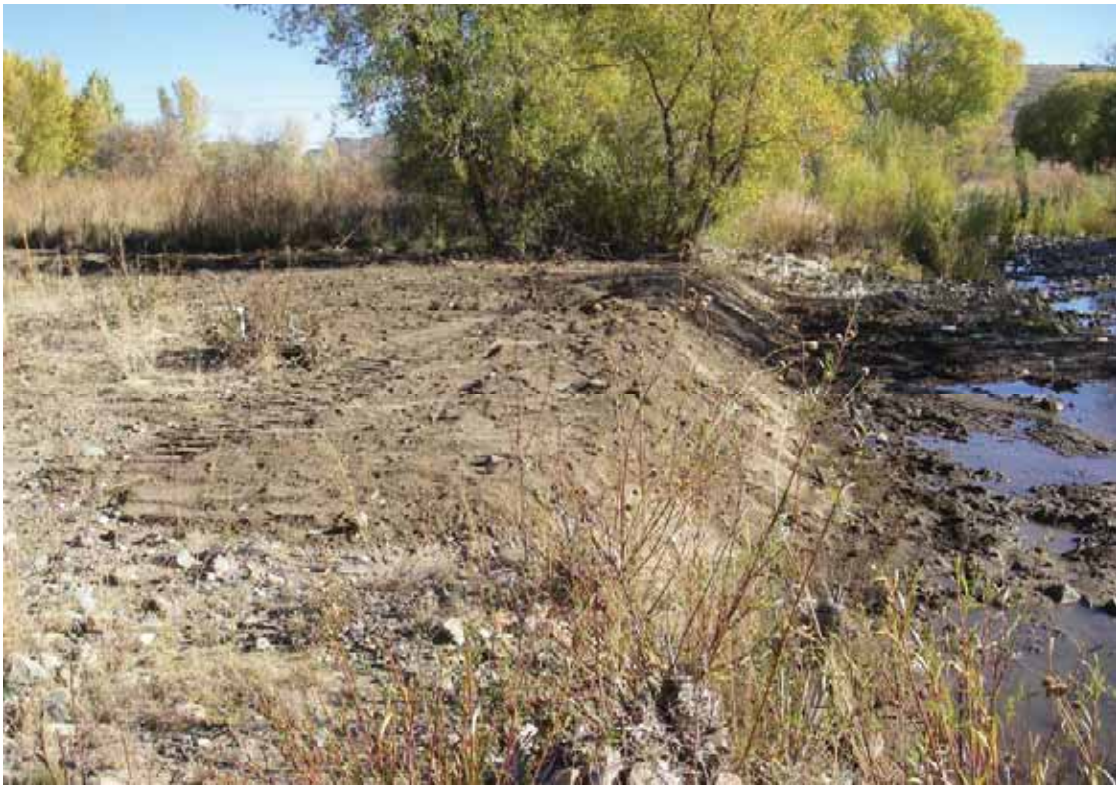
*2010 after repairs to the bank post flood*

In Reaches 1 and 2, toe rock that was damaged during the flood was repaired with graded angular rock. After the section of bank needing repairs was resloped, non-woven geotextile was placed on the slope prior to the placement of the rock. The height of rock is 3 ft above the channel bed and extends 2 ft below the channel bed. This rock repair ties into the intact rock still in place.

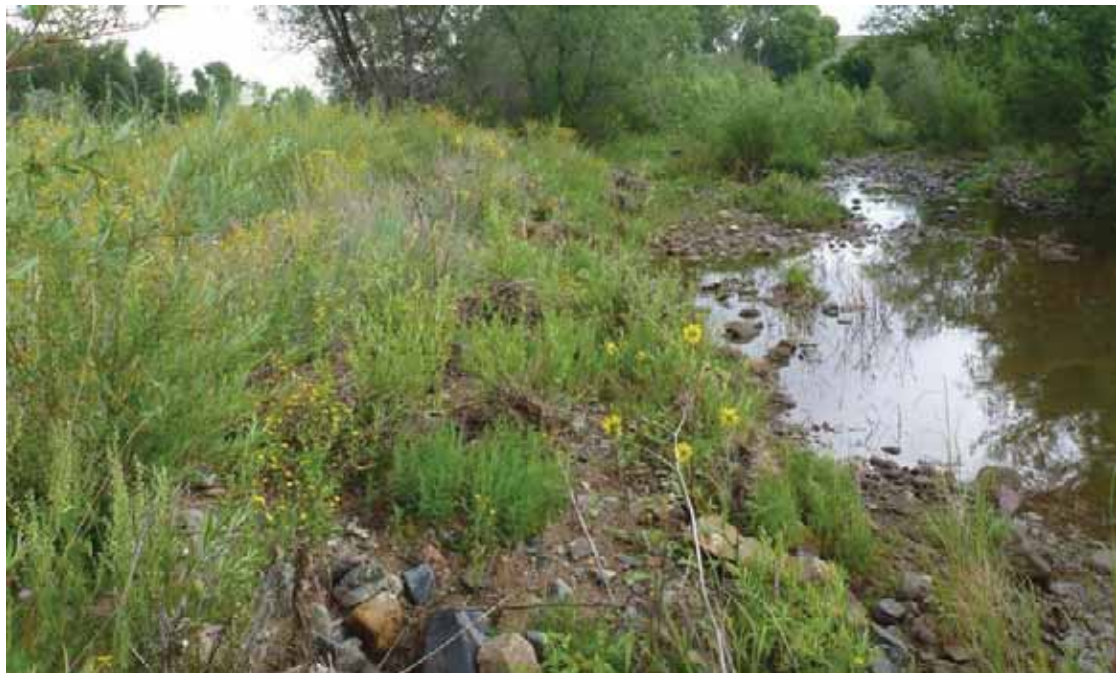
*2012 after two growing seasons. Recent flood debris can be seen at the top of the bank*

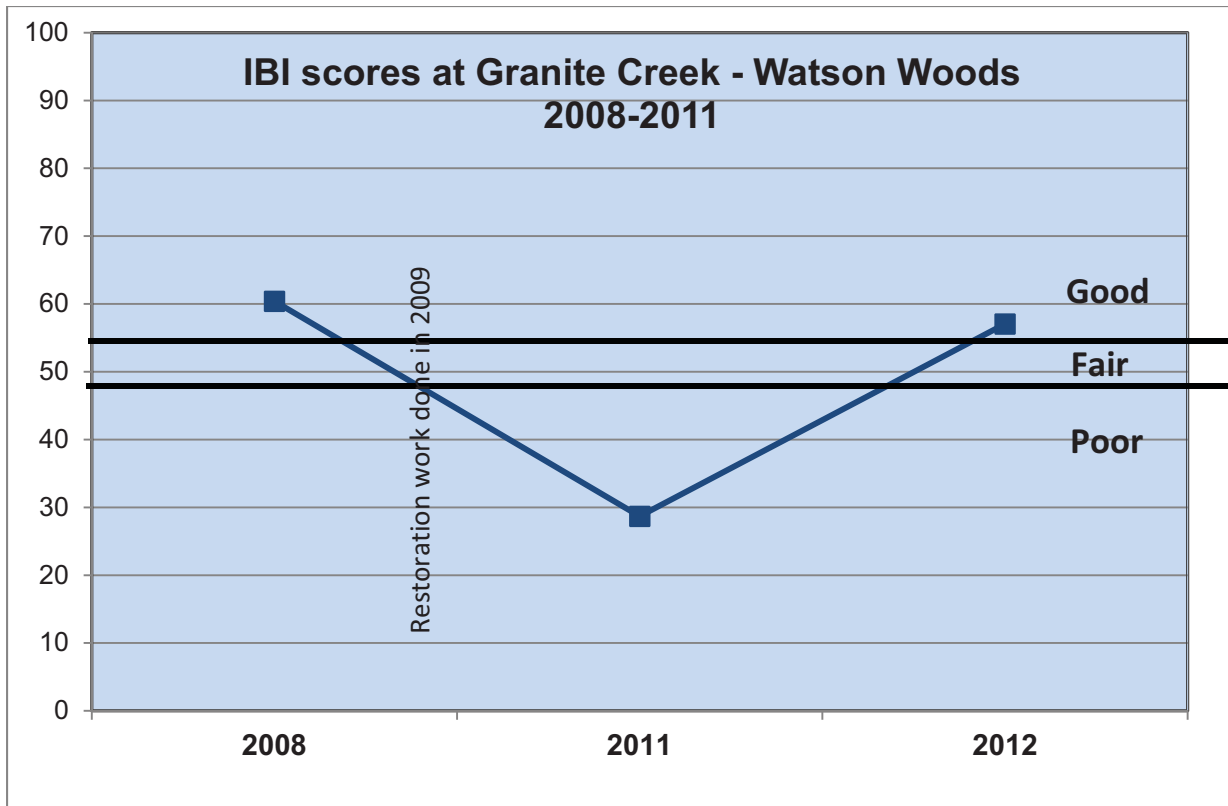
The bioassessment scores varied widely from year to year at the Granite Creek-Watson Woods site (Figure 41). The Intermittent IBI score was greatest in 2008 (pre-restoration), then fell to half the score following the channel restoration work in 2009, then recovered to near 2008 levels by spring 2012. The Intermittent IBI scores for this site met criteria for “good” condition in 2008 and 2012, but failed to meet the lowest criteria in 2011 (poor condition). The 2011 sample was different in part because the sample was dominated by midges (55%) and low taxa richness with respect to other taxa groups.

**Figure 41-Trends in the Intermittent IBI Score at Watson Woods**

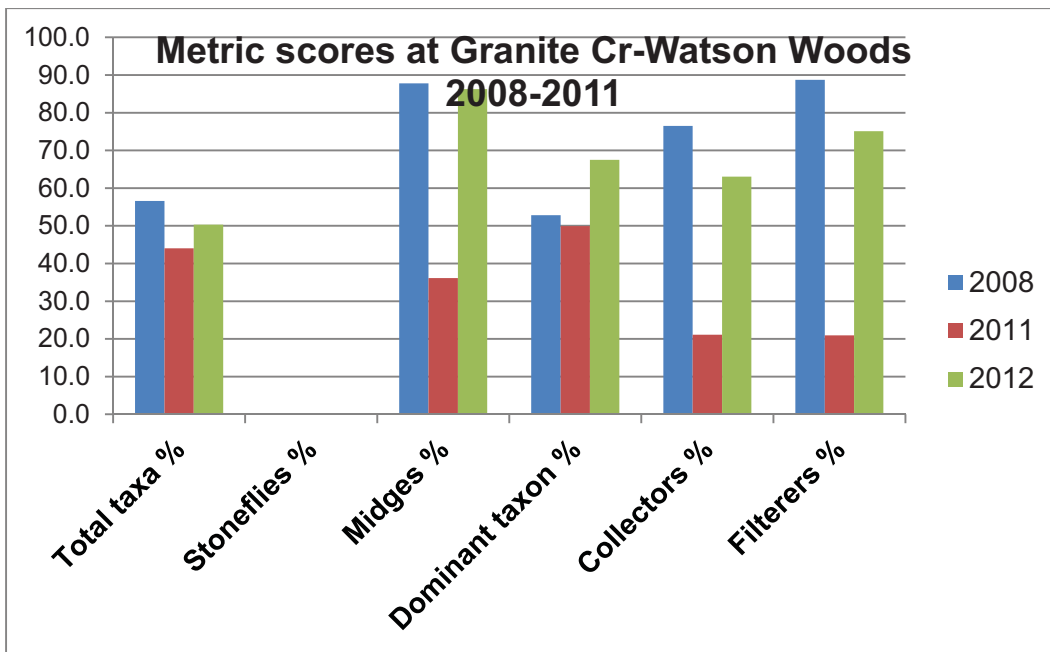
Figure 42-Trends in Macroinvertebrate metric scores at Watson Woods

Macroinvertebrate metric scores exhibited a similar pattern, with most metric scores being greatest in 2008 and least in 2011 (Figure 42). The high percent composition by midges in 2011 had a large effect on the bioassessment: 1) it resulted in a low percent midges “score” (percent of reference threshold) and 2) contributed to the low percent collectors “score” because at the family level Chironomidae are considered “collectors”. While a dip in bioassessment score was expected following the major channel modifications of the restoration project and then a gradual recovery, a drop in IBI score of 50% in 2011 and subsequent recovery of 50% the following year was much larger than expected.

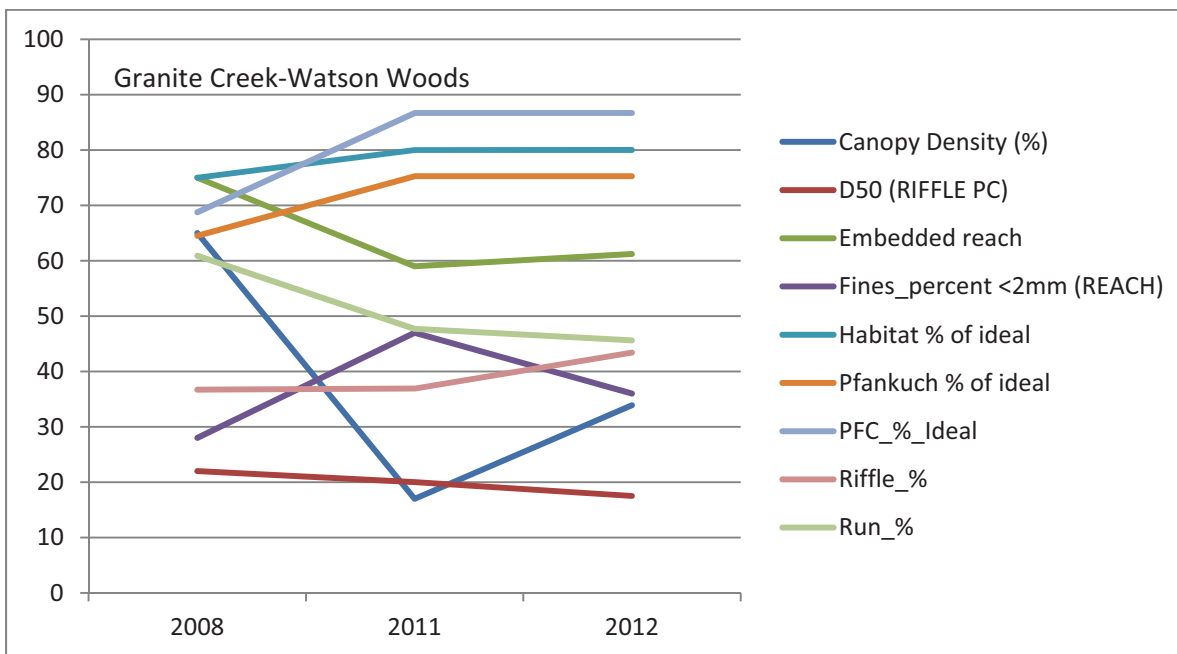
Figure 43-Trends in Habitat Conditions at Watson Woods

There were also changes in habitat parameters during the 5-year study period. Habitat conditions did improve in the Watson Woods reach with canopy cover, Habitat index score, Pfankuch channel stability score, riparian PFC score and percent riffle habitat all increasing following the channel restoration work. Percent embeddedness and the riffle-D50 value decreased. These are all positive improvements in substrate and channel habitat for aquatic life (Figure 43). While the habitat values at the end of this survey in April 2012 do not yet achieve mean reference site habitat values, the substrate and channel conditions have improved substantially which will eventually be reflected in the aquatic life.

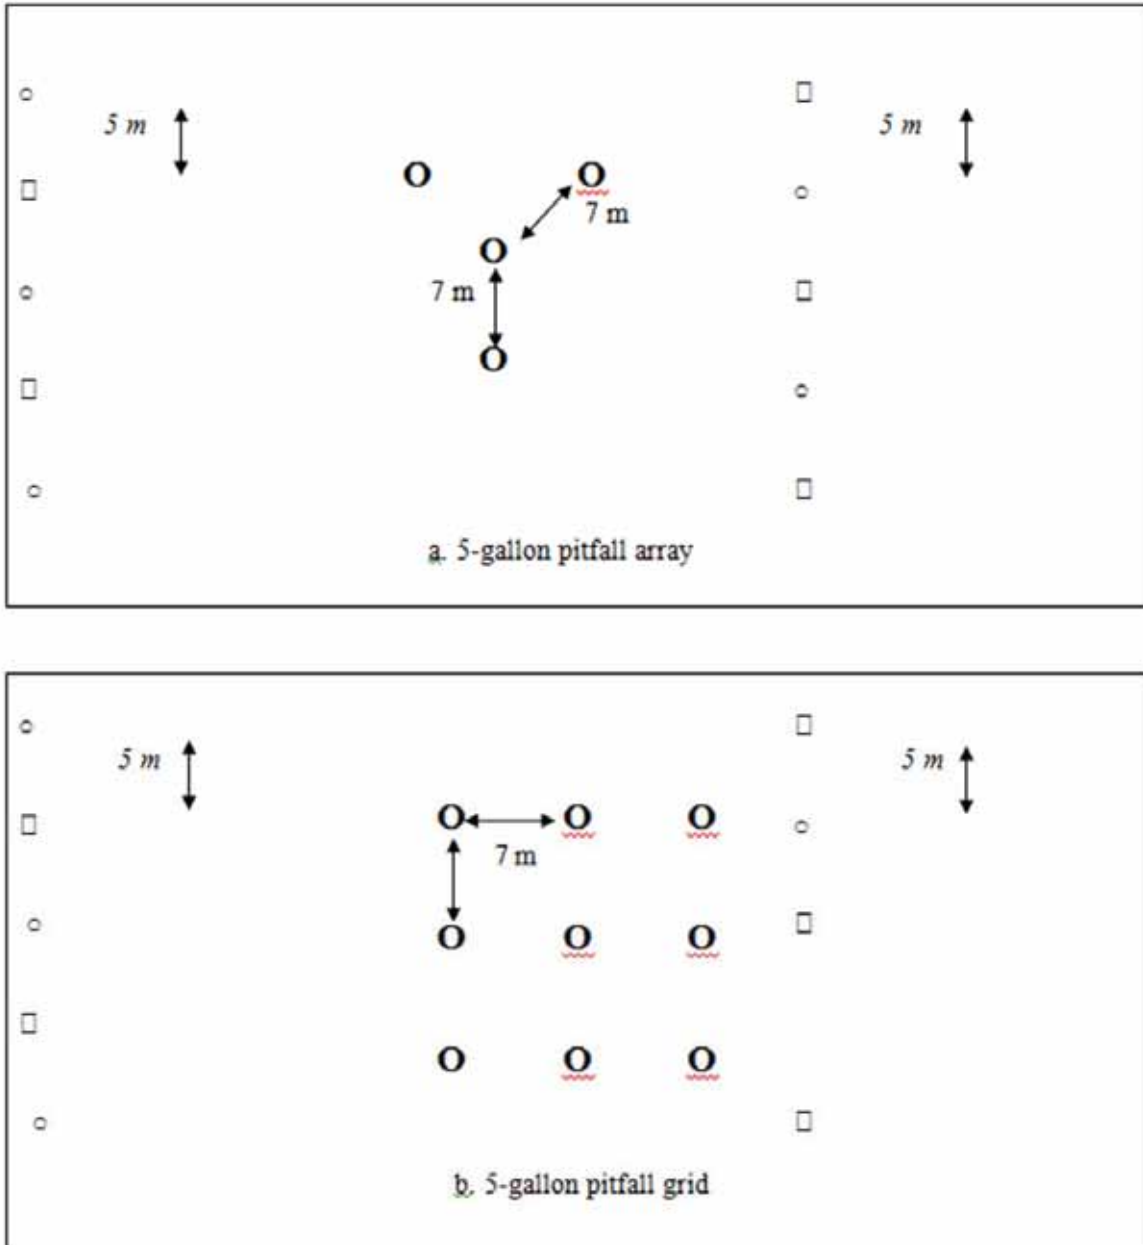
**Figure 51-Diagram of Sampling Sites**

Each pitfall grid consisted of nine five-gallon plastic buckets sunk flush with the ground, each spaced seven meters apart (Figure 51b, Nowak and Spille 2001). Each bucket was covered with a 2 x 2 ft x ½ in (60 x 60 x 1 cm) plywood coverboard raised slightly off the ground. Each bucket had multiple holes punched in its bottom and sides to allow drainage.

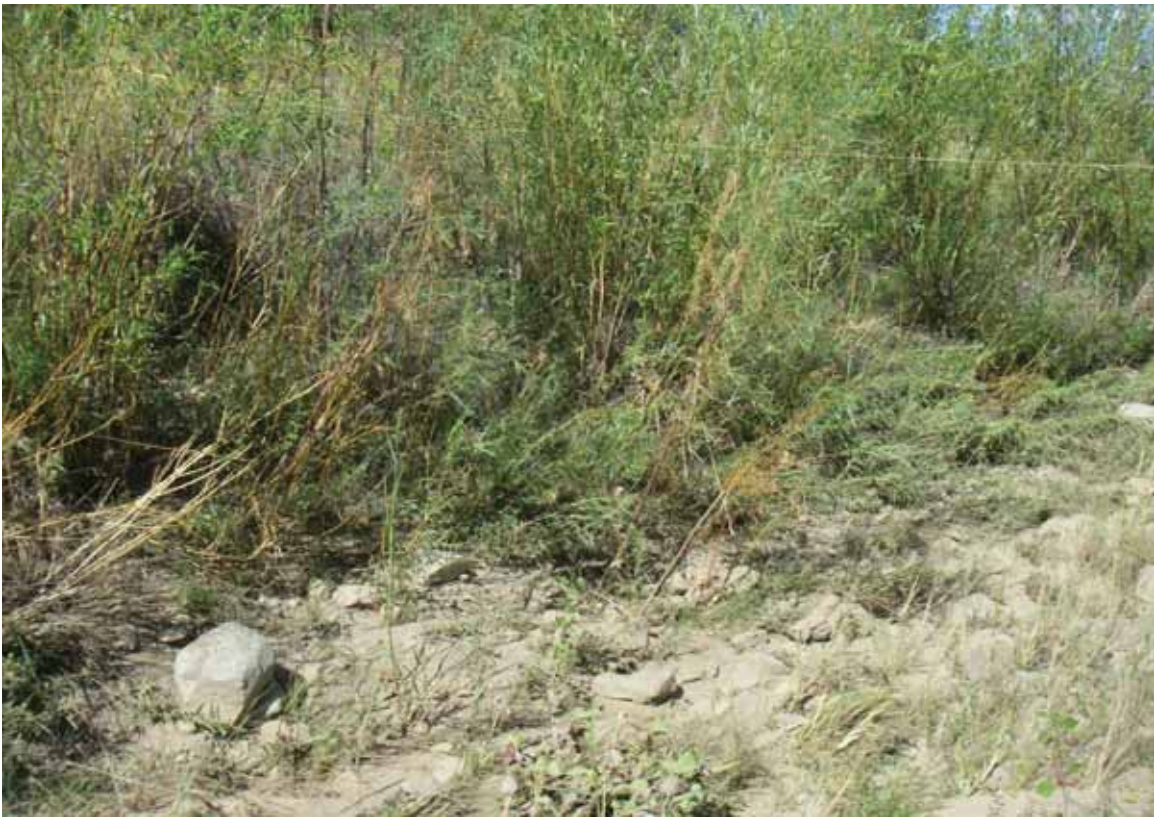
**Figure B 27: BEHI 5 photo taken September 2011.**  
*Vegetation is lying over due to previous weeks flow.*

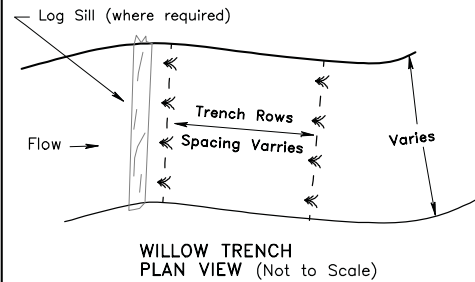
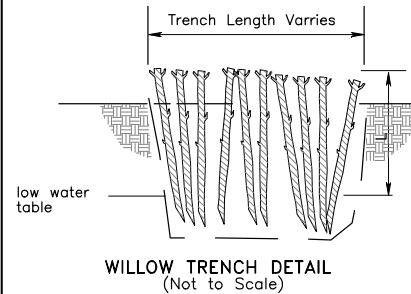
**NOTES**  
 Use 1/2 to 2 in. cuttings.  
 Trenches excavated with backhoe or mini-excavator down to watertable elevation. A continuous row of willow cuttings (approx 4/foot) are installed. Trench is then backfilled with excavated material and watered.
