# Condition and Management Survey of the Archaeological Resource in Northern Ireland

## CAMSAR Report

CAMSAR: A Condition and Management Survey of the  
Archaeological Resource in Northern Ireland

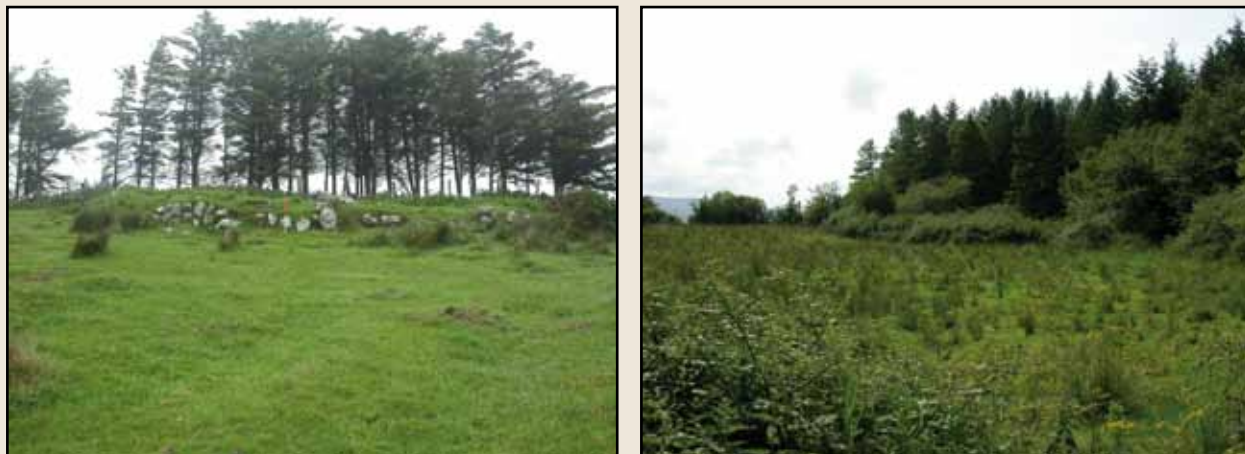
**Plate 2 Ballyreagh Lower/Ballyvoy Cashel (ANT 009:010) has been part-planted with conifers. Tonardrum/Cavantreeduff Rath (FERM 228:011) has been part-planted with conifers.**

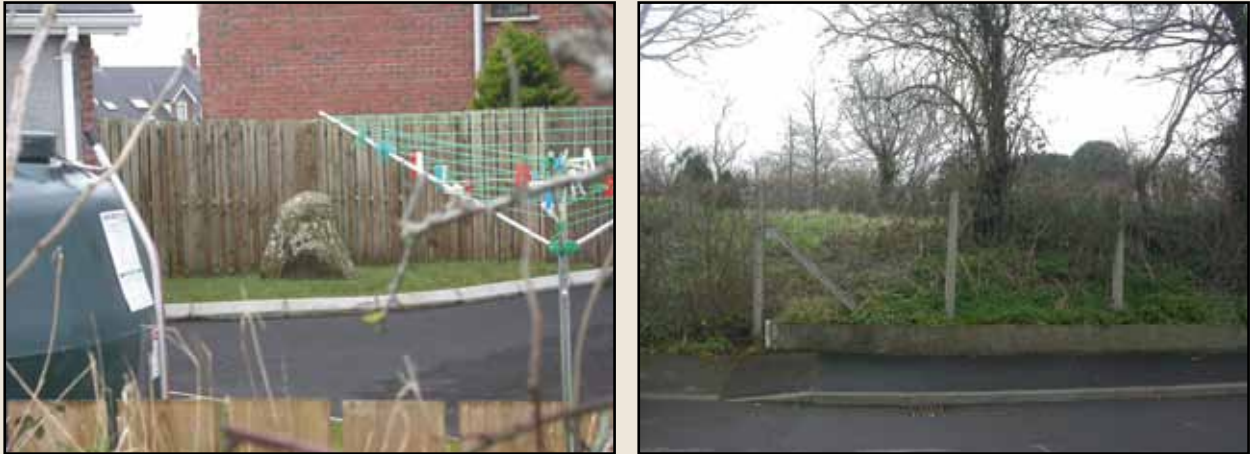
**Plate 3 South Mullaghcall standing stone (LDY003:072) and Ballintine rath (DOW 014:037) both survive within modern housing developments.**

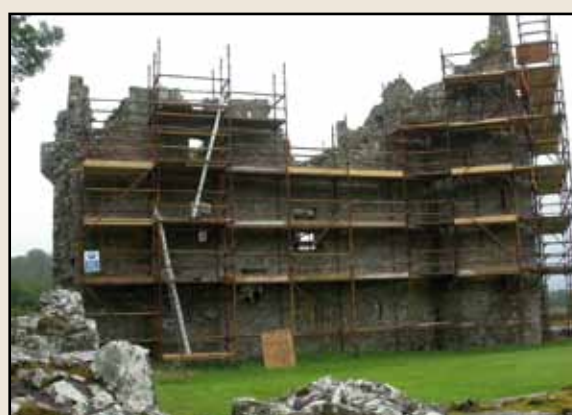
**Plate 5 Monea Castle (FER 191:061) is a State Care Monument, and is maintained to allow public access. It has recently undergone a programme of conservation work by NIEA.**

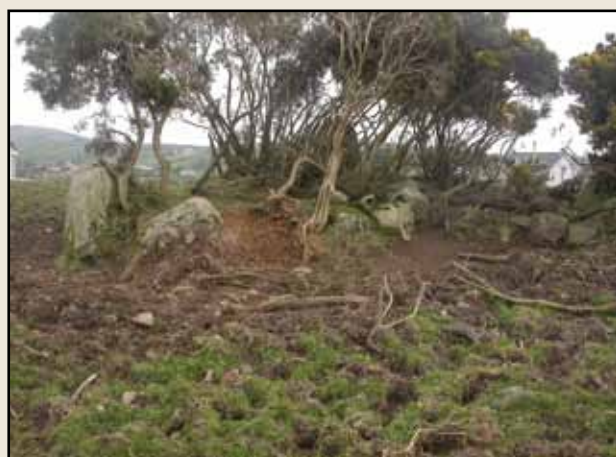
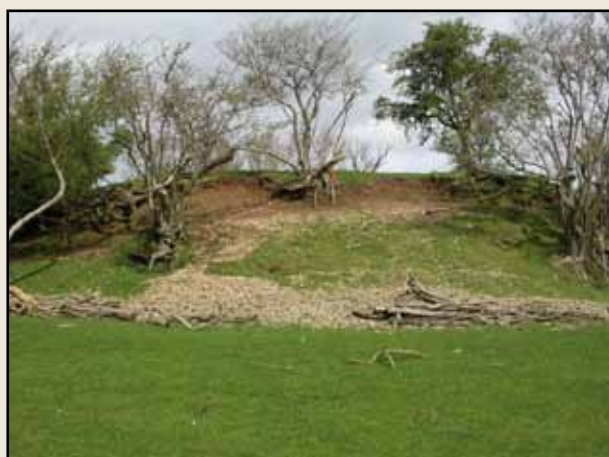
**Plate 7 (left) Clonlum court tomb (ARM 029:004) is in a poor condition due to scrub growth and severe livestock trampling. (right) The possible raised rath at Fofannyreagh (DOW 042 038) is in poor condition due to a combination of livestock erosion and burrowing animals.**

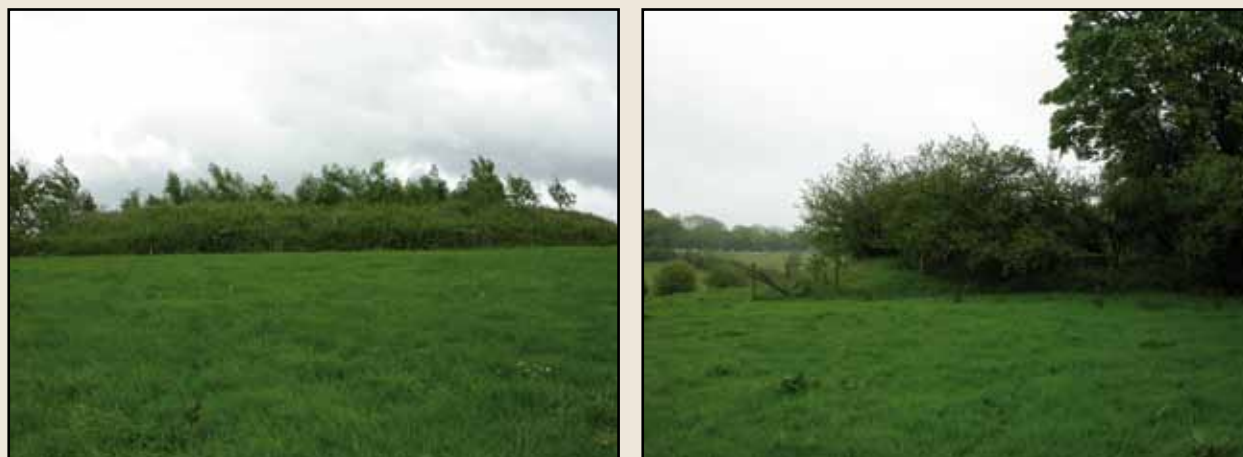
On the other hand, in many cases it was found that where a site had been fenced-off to prevent further damage from, for example, cattle trampling, vegetation can rapidly engulf it unless it is also occasionally grazed. Of the 89 fenced sites 32 (35.95%) have been damaged recently, in most cases by scrub encroachment (Plate 8). This highlights the need for regular, but controlled grazing at such sites. NIEA and DARD management agreements routinely require the effective control of vegetation, with light grazing proposed as the most effective method. When this is not possible it is essential that vegetation is manually cleared to ground level every few years. Ballymarlagh dual court tomb (Plate 8), for example, was last cleared of scrub in 1995, but the monument was, at the time of the CAMSAR survey engulfed again with scrub vegetation, clearly indicating the importance of routine maintenance. Temporary electric fencing was not observed at any of the sites visited in the CAMSAR survey.

**Plate 8 (left) Derryhowlaght East rath (FER 230:055) and (right) Ballymarlagh dual court tomb (ANT 038:002) have both been fenced off from the surrounding field and are now extremely overgrown and difficult to access.**

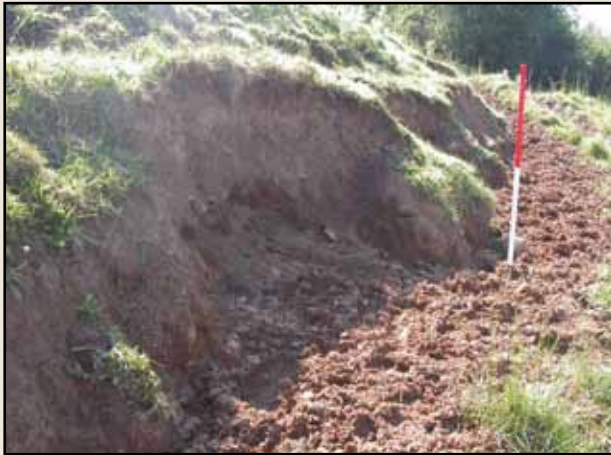
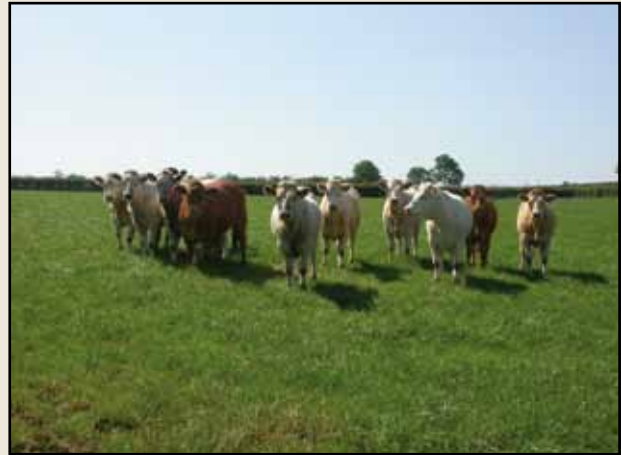
**Plate 10 Mount Hamilton large enclosure (ANT 023:016) has been damaged by livestock recently.**

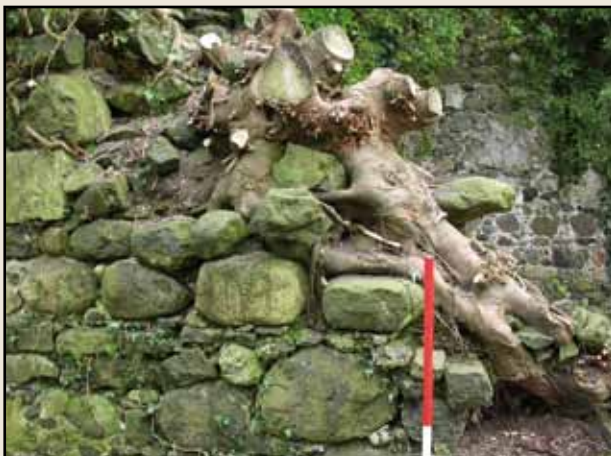
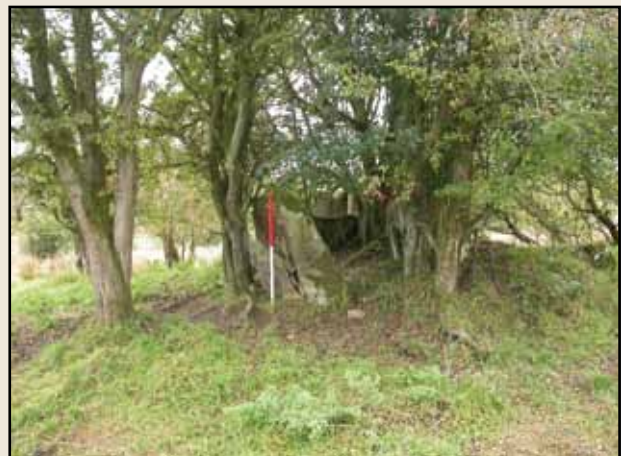
**Plate 11 Magherafelt church and graveyard (LDY 042:016), showing damage caused by root action. Bullock Park portal tomb (TYR 024:029) overgrown and damaged as a consequence of root action.**

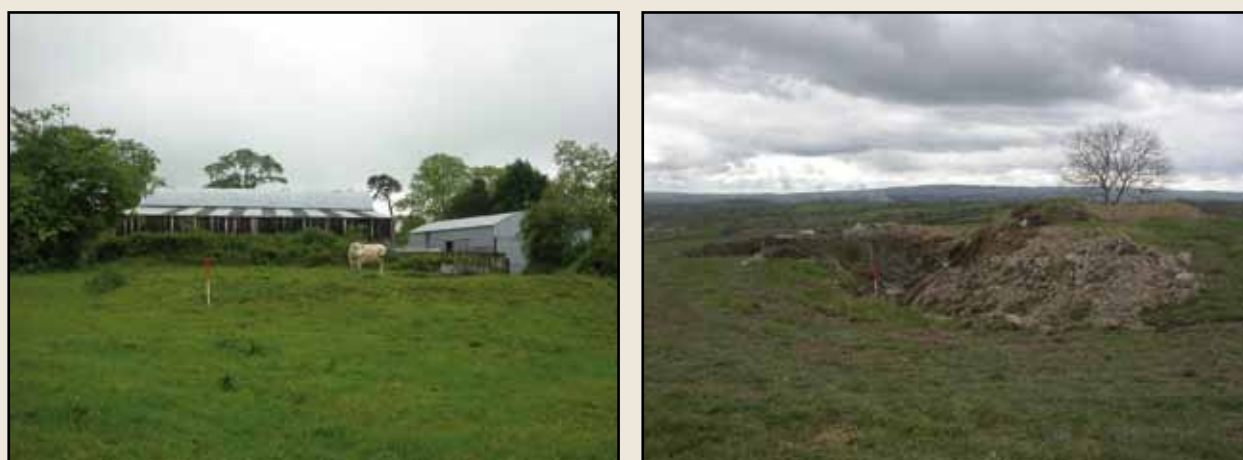
This damage can often be further extended when livestock are allowed access to the areas already exposed. Other types of recent damage encountered included cultivation (which accounted for 6.5% of the instances of damage), dumping (3%) and agricultural traffic (2%). Tree planting and the damage caused by the collapse of unstable and diseased trees blown down during gales accounts for almost 6% of the cases of recent damage. Archaeological layers are disturbed when the ground is prepared for tree planting, and growing tree roots will further disturb features and objects. When trees blow over they can lift large amounts of earth with their root-plates, leaving wide holes and further exposing that portion of a site to natural erosion (Plate 12).

**Plate 12 Examples of sites which were found to have been damaged recently.**

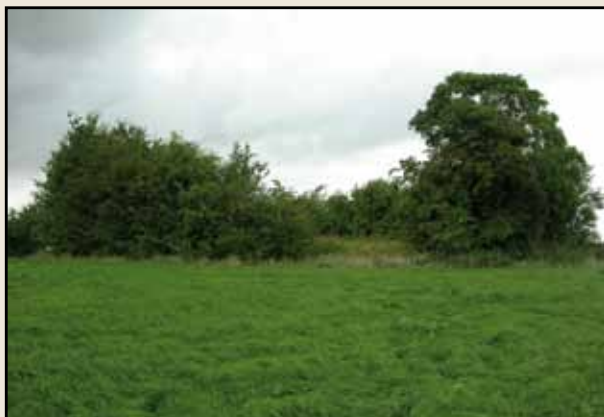
Drummack rath (FER 230:062). The perimeter is overgrown with bushes and trees.

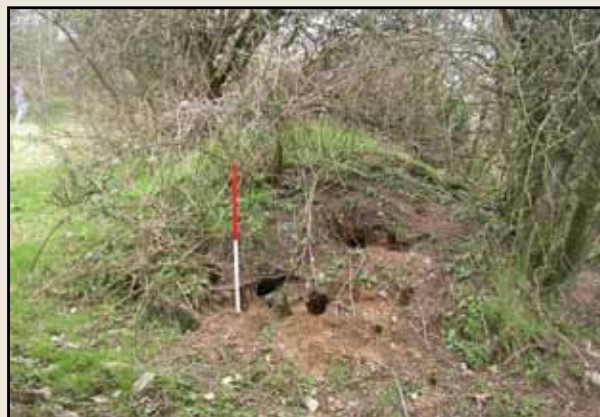
Dungonnell mound (ANT 054:008), where material has been dumped in the ditch to make it level with the surrounding ground.

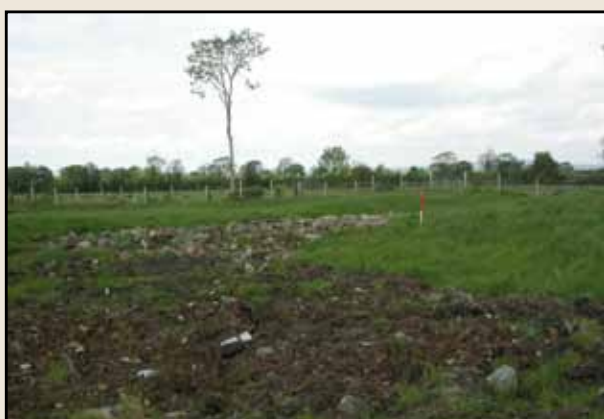
The bank at Tullydonnell rath (ARM 031:003) has suffered from rabbit burrow damage.

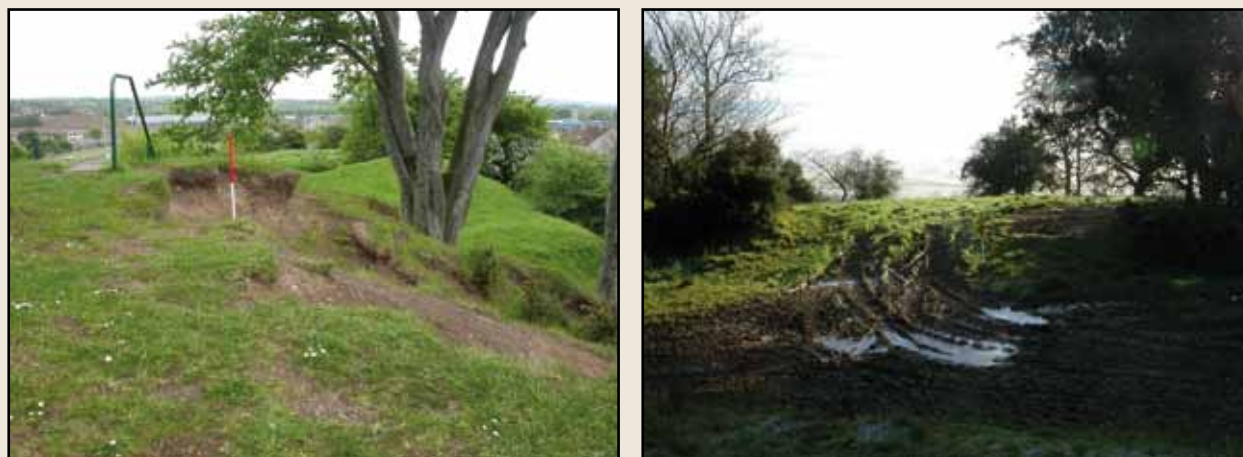
**Plate 14 (left) Damage by visitors using a much worn path is causing erosion at Harryville motte and bailey (ANT 037:022), a State Care Monument. (right) Greenan platform rath (TYR 041:004) has been damaged recently by agricultural traffic.**
