# Condition and Management Survey of the Archaeological Resource in Northern Ireland

## CAMSAR Report

**AUTHORS:** Sarah Gormley, Colm Donnelly, Barrie Hartwell, Janet Bell

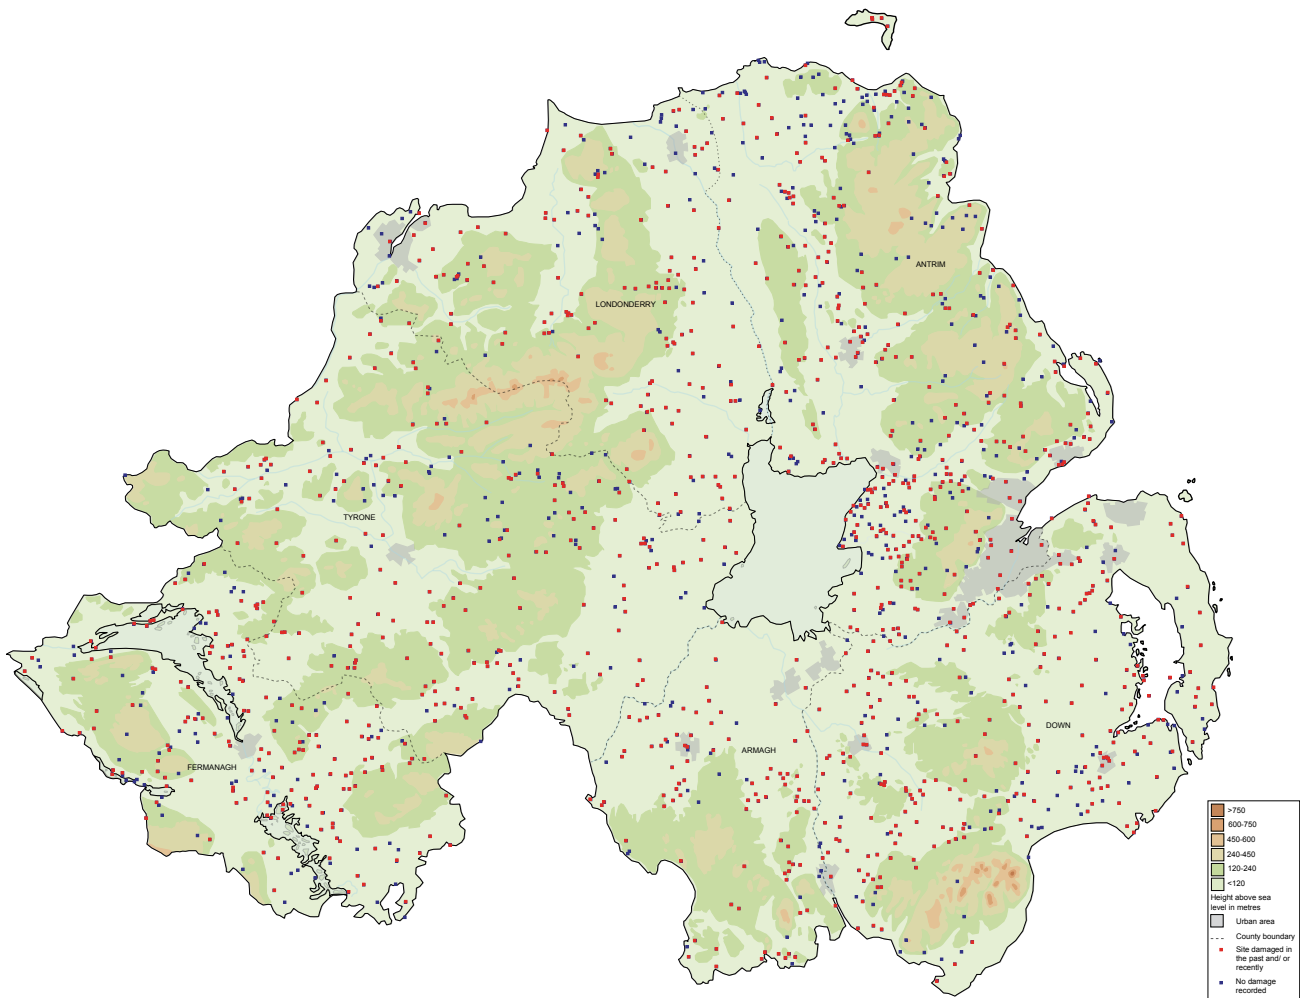
**Figure 9 Distribution of sites which have been damaged.**

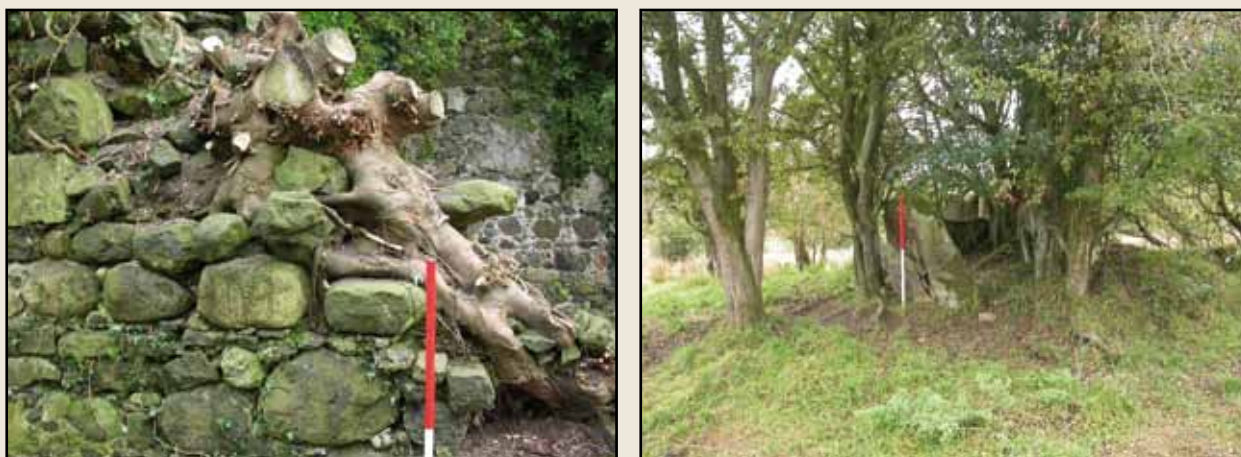
**Plate 11 Magherafelt church and graveyard (LDY 042:016), showing damage caused by root action. Bullock Park portal tomb (TYR 024:029) overgrown and damaged as a consequence of root action.**
