Condition and Management Survey of the Archaeological Resource in Northern Ireland (CAMSAR)

Condition and Management Survey of the Archaeological Resource in Northern Ireland

A report commissioned by the Northern Ireland Environment Agency
(formerly Environment and Heritage Service)

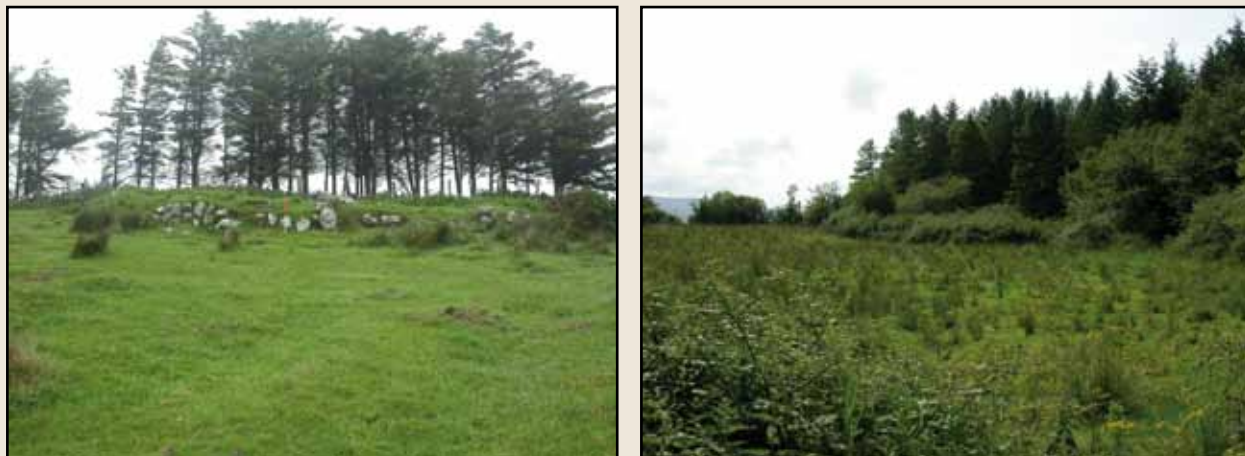
Plate 2 Ballyreagh Lower/Ballyvoy Cashel (ANT 009:010) has been part-planted with conifers. Tonardrum/Cavantreeduff Rath (FERM 228:011) has been part-planted with conifers.

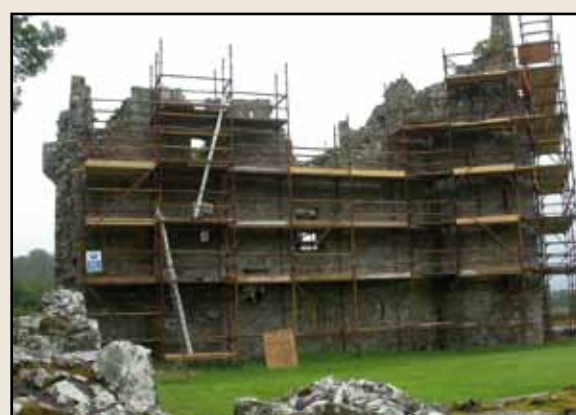
Plate 5 Monea Castle (FER 191:061) is a State Care Monument, and is maintained to allow public access. It has recently undergone a programme of conservation work by NIEA.

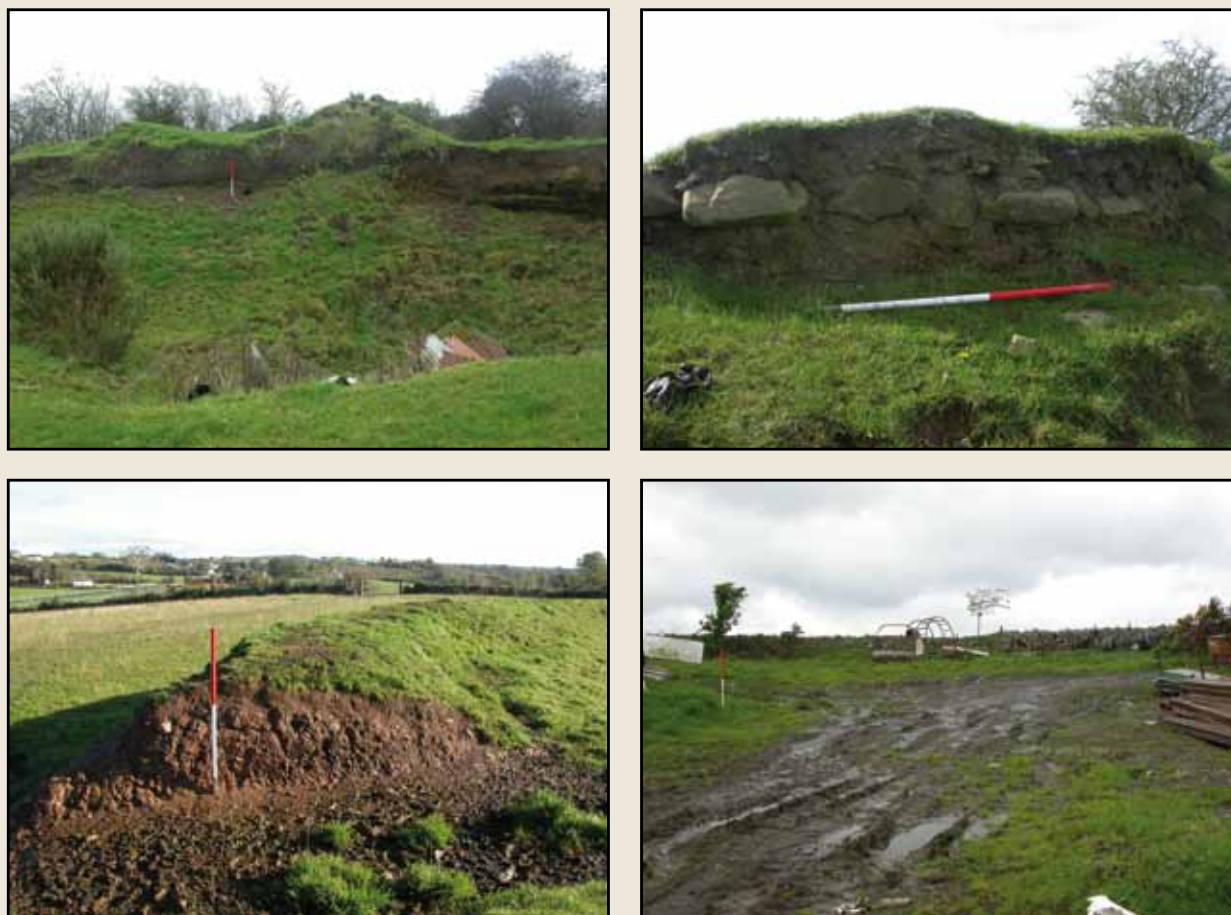
Plate 6 Sites recorded as being in poor condition (clockwise from top left). Drumman Rath (TYR 006:010) has been extensively quarried and is still actively eroding. At Ballymacarron Rath (DOW 024:013) archaeological layers are visible in the eroding profiles. Aghliscnafin Cashel (DOW 043:009) has had its interior damaged by agricultural traffic and dumping. Lisdoon Rath (TYR 049 014) is eroding due to stock paths and livestock trampling.

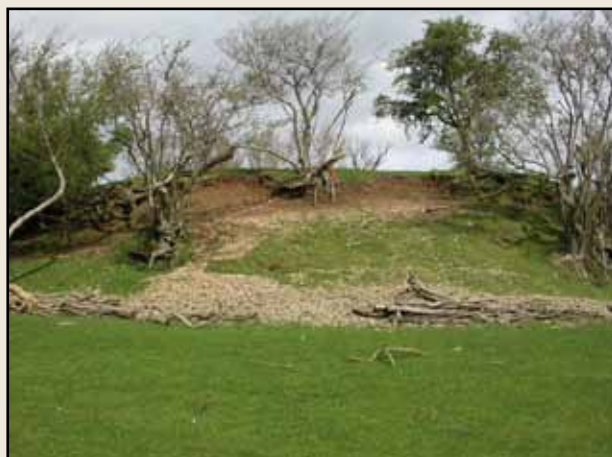
Plate 7 (left) Clonlum court tomb (ARM 029:004) is in a poor condition due to scrub growth and severe livestock trampling. (right) The possible raised rath at Fofannyreagh (DOW 042 038) is in poor condition due to a combination of livestock erosion and burrowing animals.

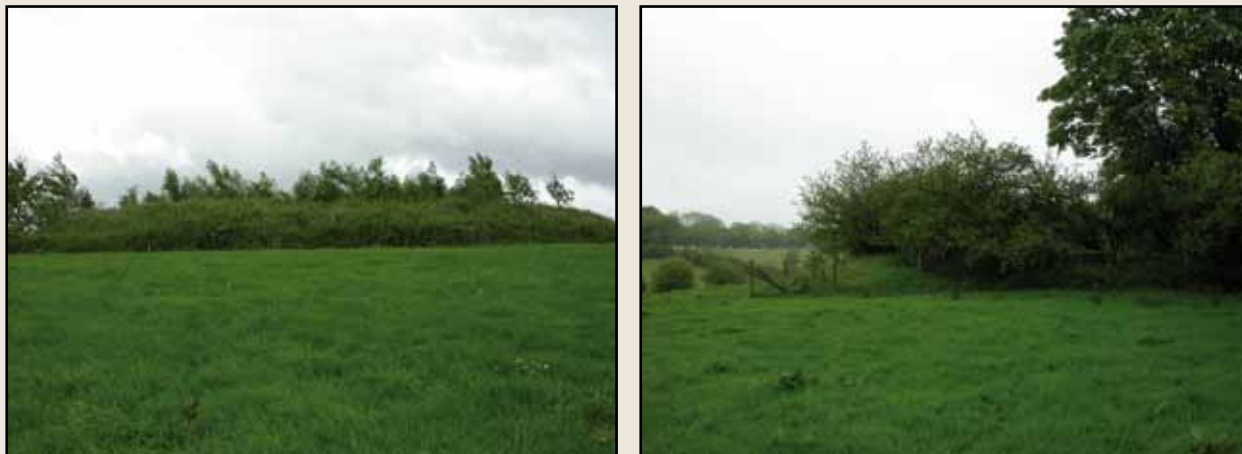
Plate 8 (left) Derryhowlaght East rath (FER 230:055) and (right) Ballymarlagh dual court tomb (ANT 038:002) have both been fenced off from the surrounding field and are now extremely overgrown and difficult to access.

On the other hand, in many cases it was found that where a site had been fenced-off to prevent further damage from, for example, cattle trampling, vegetation can rapidly engulf it unless it is also occasionally grazed. Of the 89 fenced sites 32 (35.95%) have been damaged recently, in most cases by scrub encroachment (Plate 8). This highlights the need for regular, but controlled grazing at such sites. NIEA and DARD management agreements routinely require the effective control of vegetation, with light grazing proposed as the most effective method. When this is not possible it is essential that vegetation is manually cleared to ground level every few years. Ballymarlagh dual court tomb (Plate 8), for example, was last cleared of scrub in 1995, but the monument was, at the time of the CAMSAR survey engulfed again with scrub vegetation, clearly indicating the importance of routine maintenance. Temporary electric fencing was not observed at any of the sites visited in the CAMSAR survey.

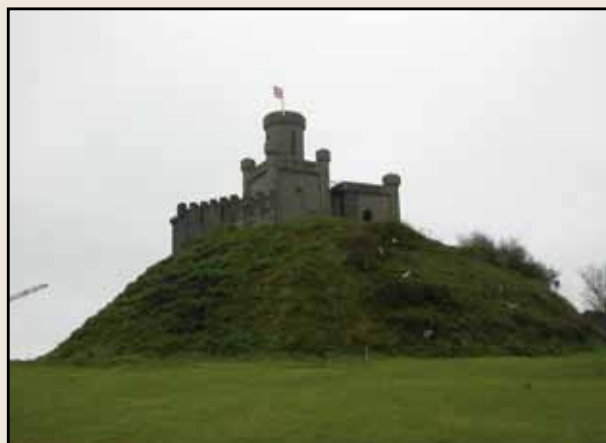
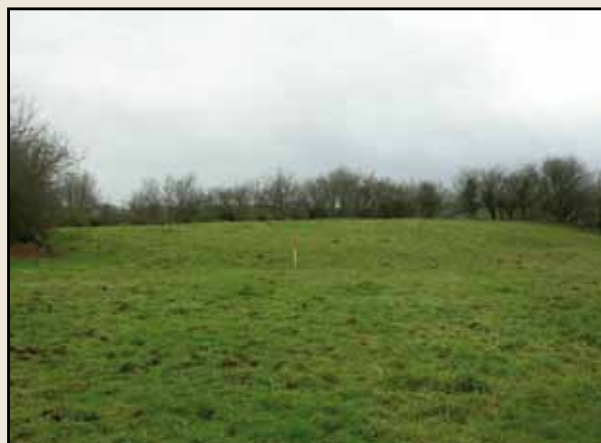
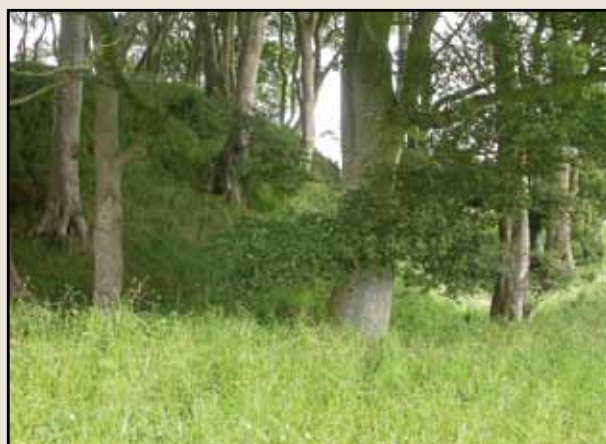
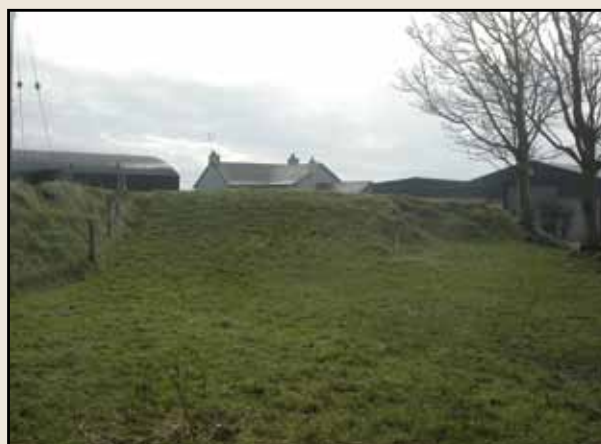
Plate 9 Clockwise from left: Donaghadee motte (DOW 003:003) was damaged in the past by the construction of a powder magazine. Lisnagleer platform rath (TYR 046:018) was damaged by cultivation. Dundooan rath and souterrain (LDY 003:014) was built over by a farmyard and buildings. Tree planting has damaged Dundermot motte (ANT 027:010).

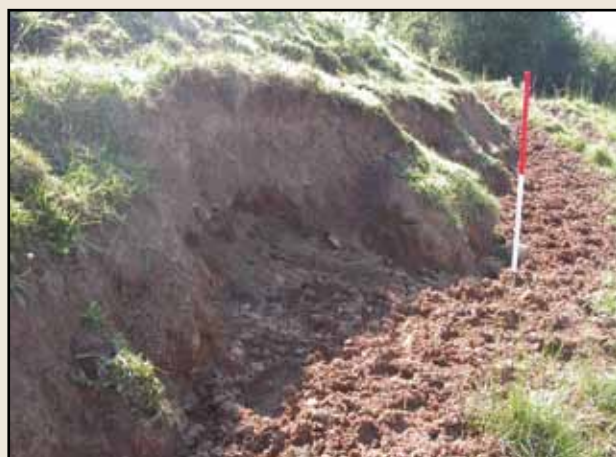
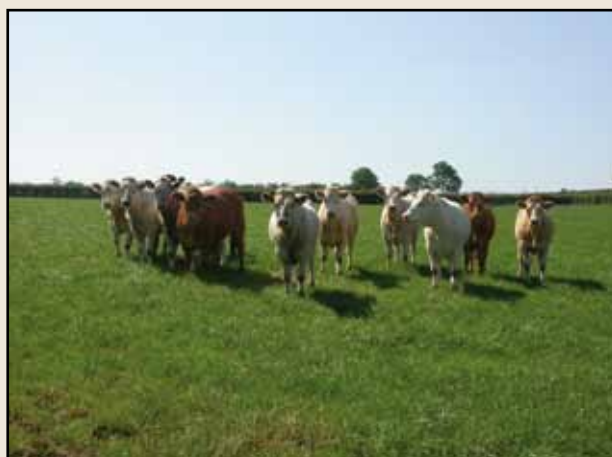
Plate 10 Mount Hamilton large enclosure (ANT 023:016) has been damaged by livestock recently.

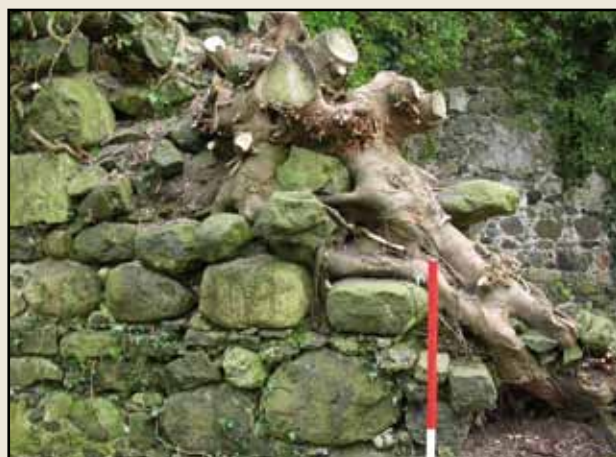
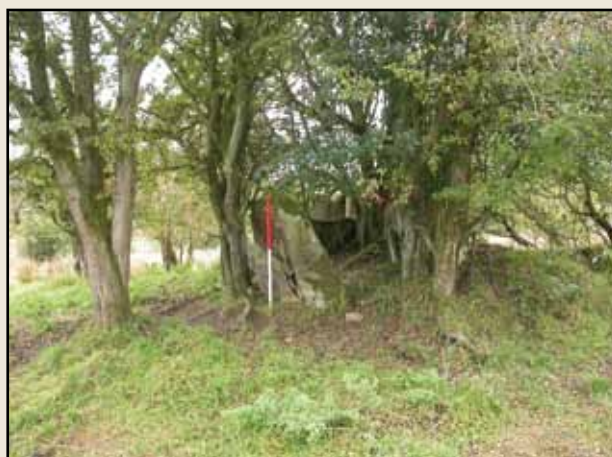
Plate 11 Magherafelt church and graveyard (LDY 042:016), showing damage caused by root action. Bullock Park portal tomb (TYR 024:029) overgrown and damaged as a consequence of root action.

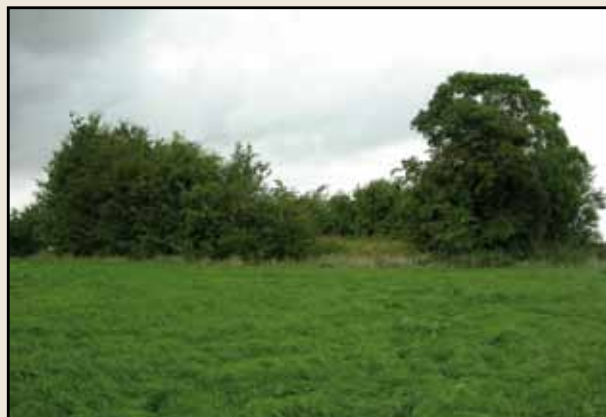
Drummack rath (FER 230:062). The perimeter is overgrown with bushes and trees.

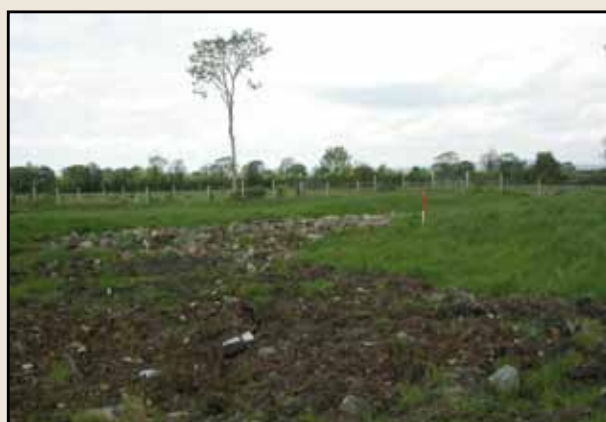
The bank at Tullydonnell rath (ARM 031:003) has suffered from rabbit burrow damage.

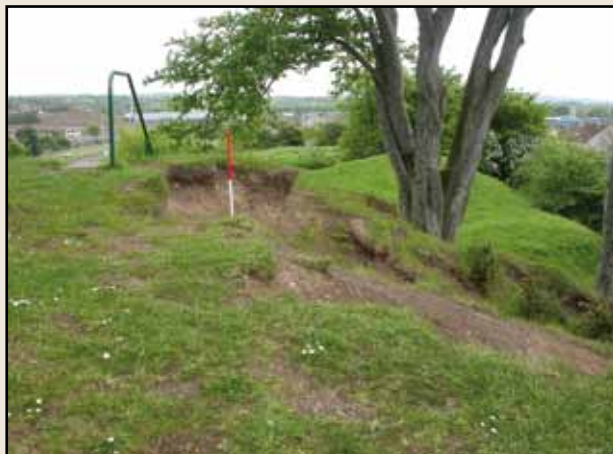
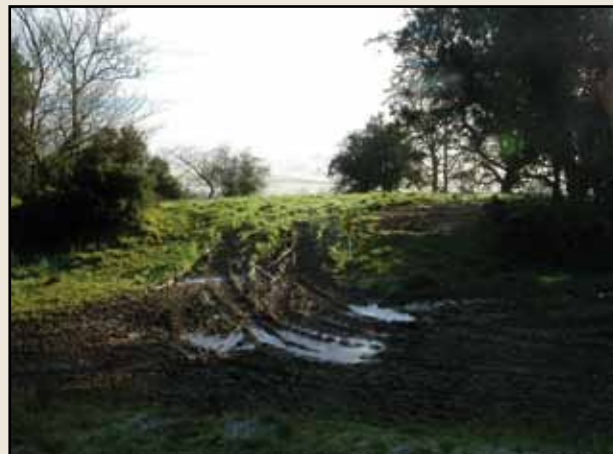
Plate 14 (left) Damage by visitors using a much worn path is causing erosion at Harryville motte and bailey (ANT 037:022), a State Care Monument. (right) Greenan platform rath (TYR 041:004) has been damaged recently by agricultural traffic.
