## **Condition and Management Survey of the Archaeological Resource in Northern Ireland (CAMSAR)**

# Condition and Management Survey of the Archaeological Resource in Northern Ireland

## CAMSAR Report

**AUTHORS:** Sarah Gormley, Colm Donnelly, Barrie Hartwell, Janet Bell

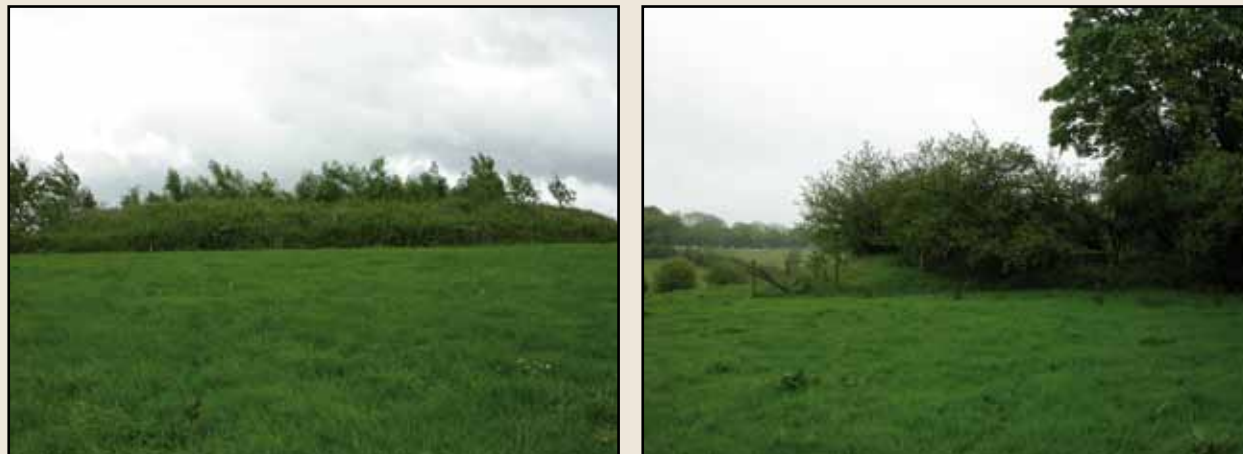
**Plate 8 (left) Derryhowlaght East rath (FER 230:055) and (right) Ballymarlagh dual court tomb (ANT 038:002) have both been fenced off from the surrounding field and are now extremely overgrown and difficult to access.**
