## **Condition and Management Survey of the Archaeological Resource in Northern Ireland (CAMSAR)**

# Condition and Management Survey of the Archaeological Resource in Northern Ireland

## CAMSAR Report

A report commissioned by the Northern Ireland Environment Agency  
(formerly Environment and Heritage Service)

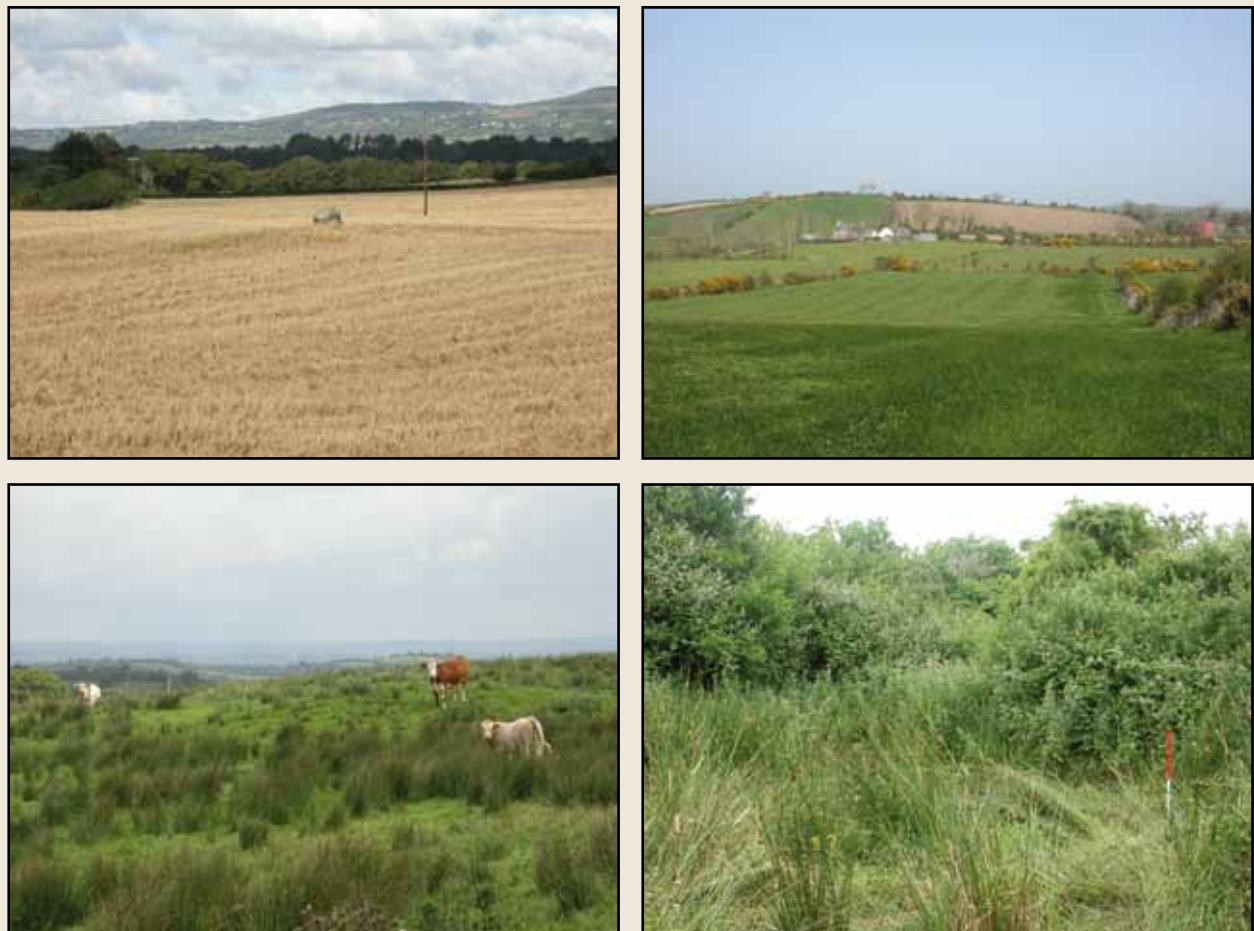
**Plate 1 Examples of land use.**  
**Clockwise from top left - arable, improved grassland, scrub, and rough grazing.**
