# Condition and Management Survey of the Archaeological Resource in Northern Ireland

## CAMSAR Report

**AUTHORS:** Sarah Gormley, Colm Donnelly, Barrie Hartwell, Janet Bell

A report commissioned by the Northern Ireland Environment Agency  
(formerly Environment and Heritage Service)

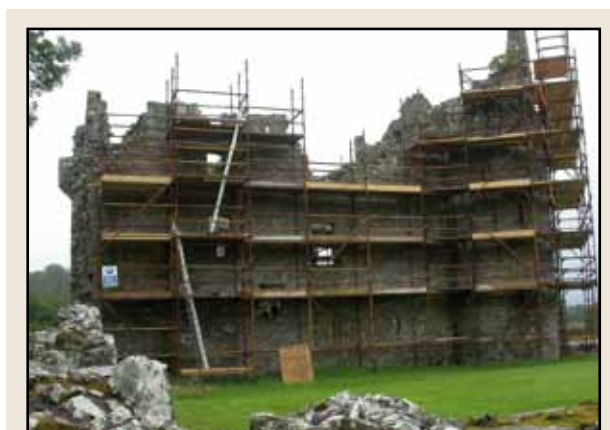
**Plate 5 Monea Castle (FER 191:061) is a State Care Monument, and is maintained to allow public access. It has recently undergone a programme of conservation work by NIEA.**

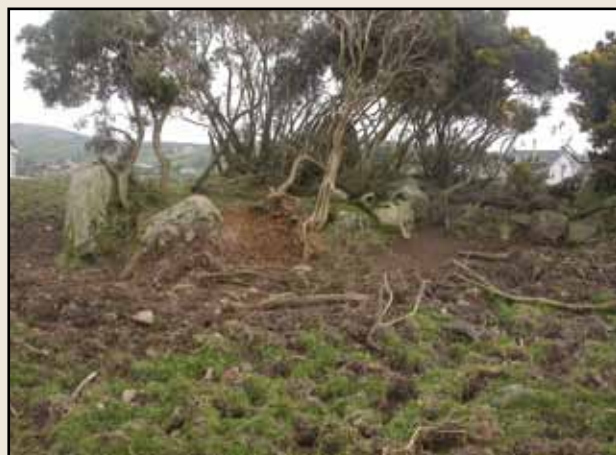
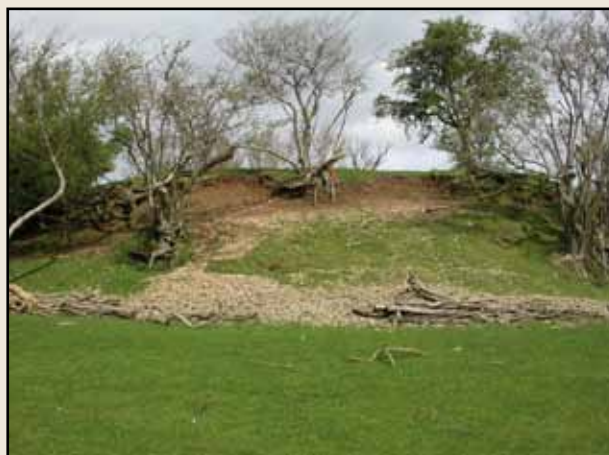
**Plate 7 (left) Clonlum court tomb (ARM 029:004) is in a poor condition due to scrub growth and severe livestock trampling. (right) The possible raised rath at Fofannyreagh (DOW 042 038) is in poor condition due to a combination of livestock erosion and burrowing animals.**

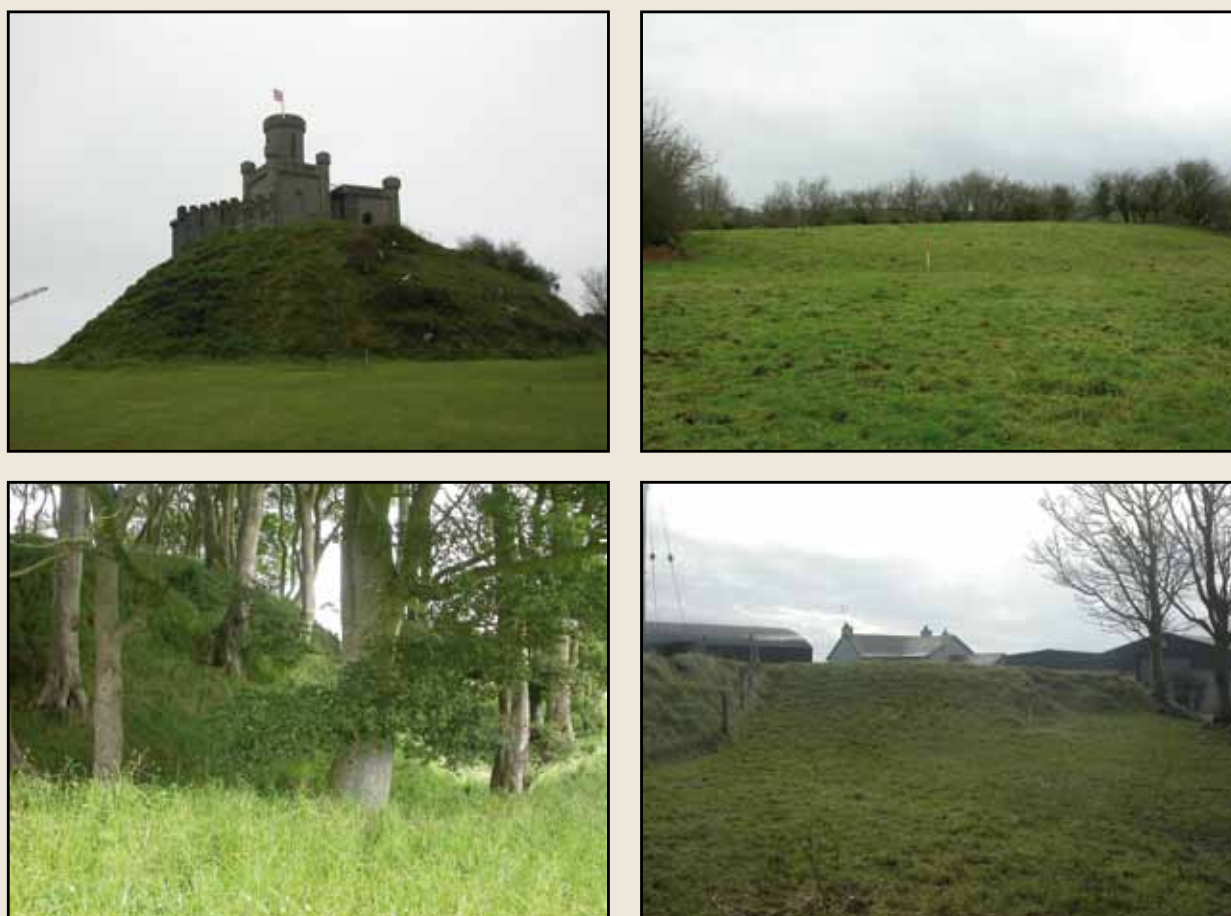
**Plate 9 Clockwise from left: Donaghadee motte (DOW 003:003) was damaged in the past by the construction of a powder magazine. Lisnagleer platform rath (TYR 046:018) was damaged by cultivation. Dundoonan rath and souterrain (LDY 003:014) was built over by a farmyard and buildings. Tree planting has damaged Dundermot motte (ANT 027:010).**

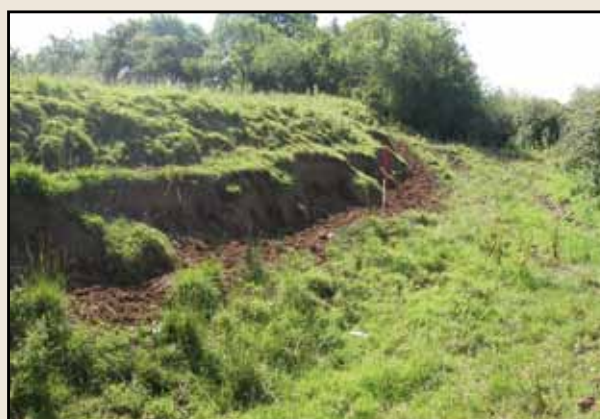
Large enclosure at Mount Hamilton (ANT 023:016), recently damaged by livestock.
