Condition and Management Survey of the Archaeological Resource in Northern Ireland

CAMSAR Report

A report commissioned by the Northern Ireland Environment Agency
(formerly Environment and Heritage Service)

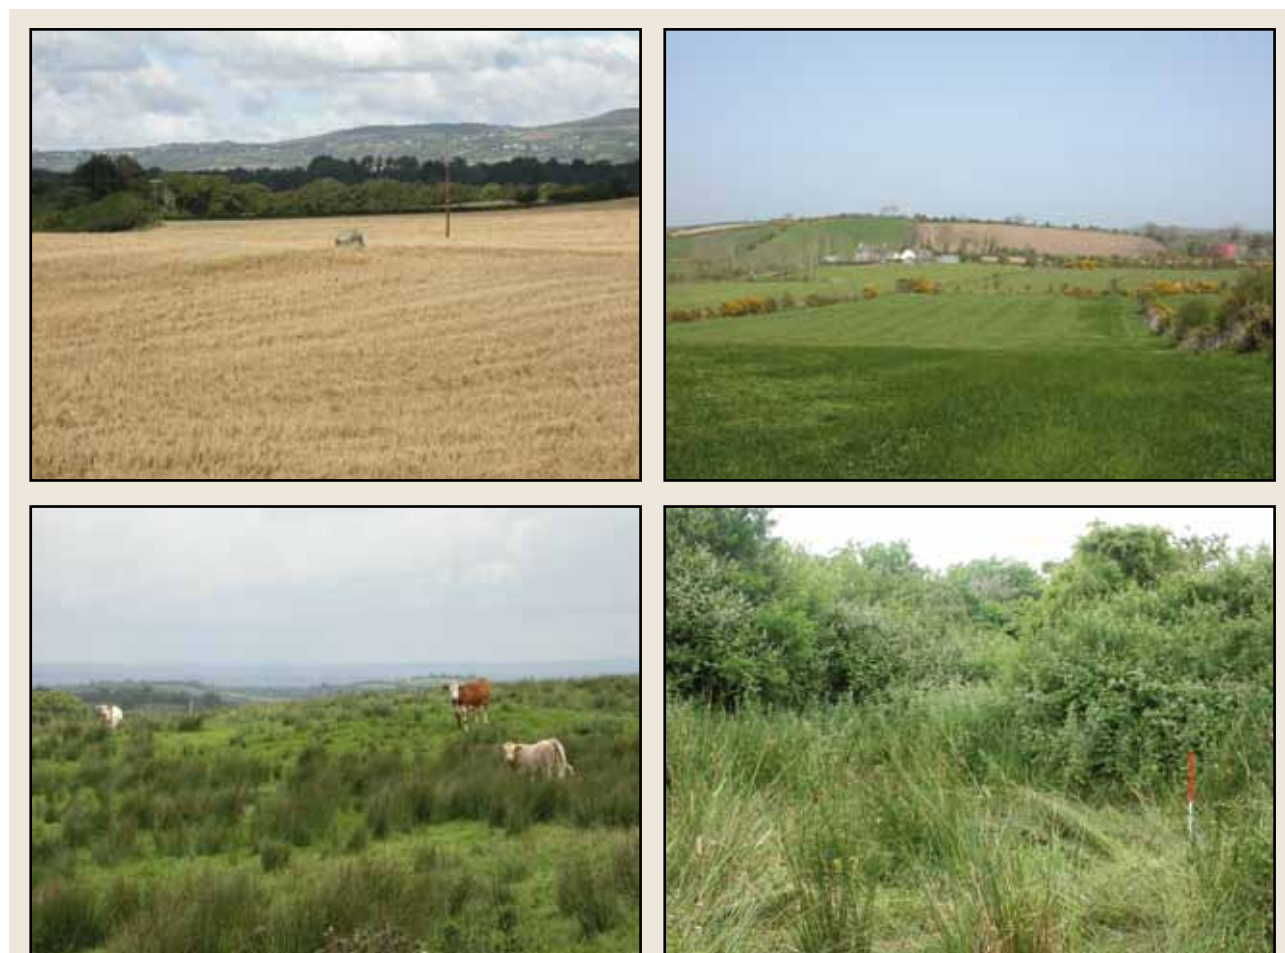
Plate 1 Examples of land use.
Clockwise from top left - arable, improved grassland, scrub, and rough grazing.

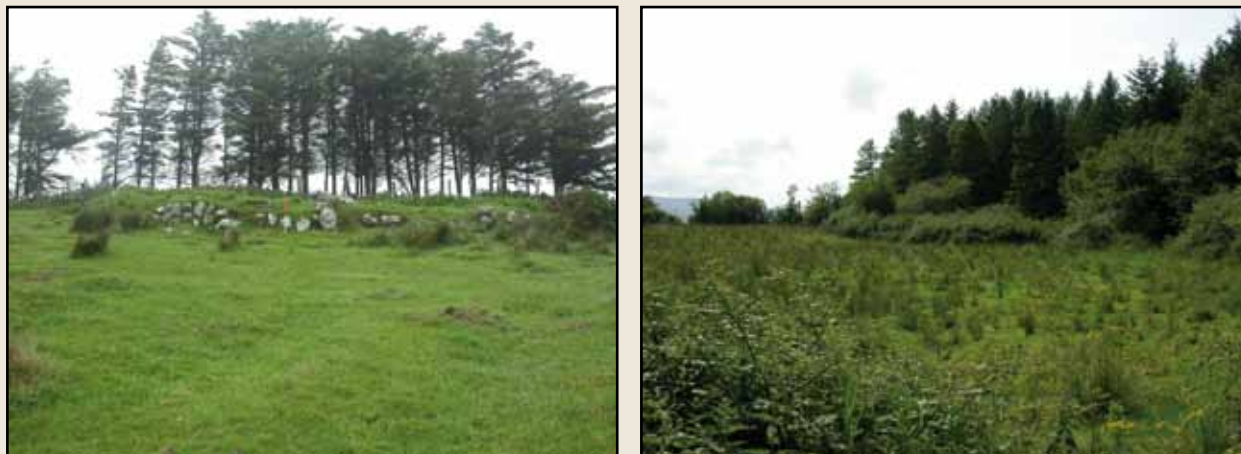
Plate 2 Ballyreagh Lower/Ballyvoy Cashel (ANT 009:010) has been part-planted with conifers. Tonardrum/Cavantreeduff Rath (FERM 228:011) has been part-planted with conifers.

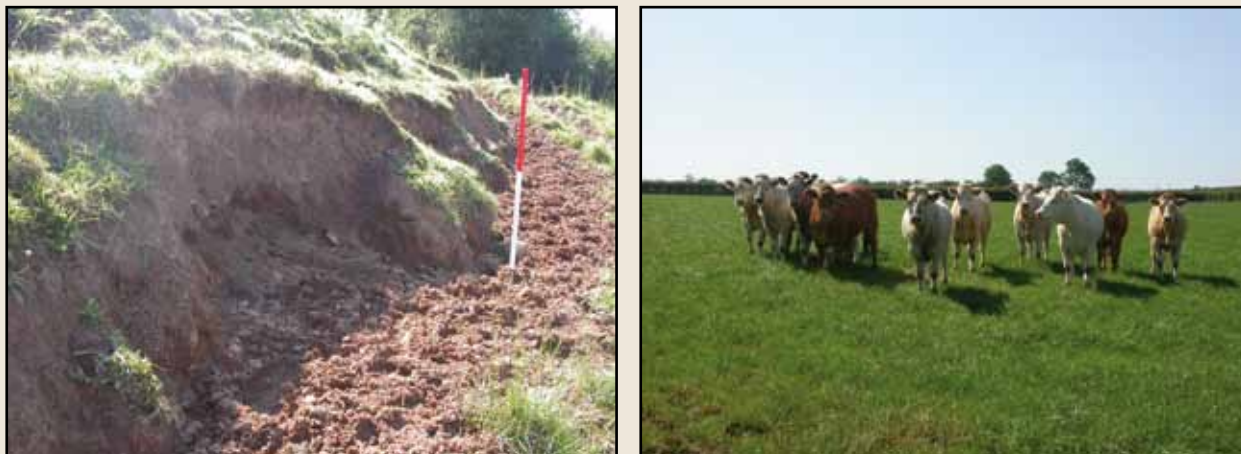
Plate 10 Mount Hamilton large enclosure (ANT 023:016) has been damaged by livestock recently.
