## **Condition and Management Survey of the Archaeological Resource in Northern Ireland (CAMSAR)**

# Condition and Management Survey of the Archaeological Resource in Northern Ireland

## CAMSAR Report

This Condition and Management Survey of the Archaeological Resource Northern Ireland (CAMSAR) was conducted in 2004 and 2005, with some minor revision in 2007. It set out to study the current survival and condition of sites and monuments in Northern Ireland. Specifically, it focused on sites and monuments earlier than 1700 AD as recorded in the Northern Ireland Sites and Monuments Record, a resource maintained by the Built Heritage Directorate of the Northern Ireland Environment Agency (formally the Environment and Heritage Service), an agency within the Department of the Environment in Northern Ireland.

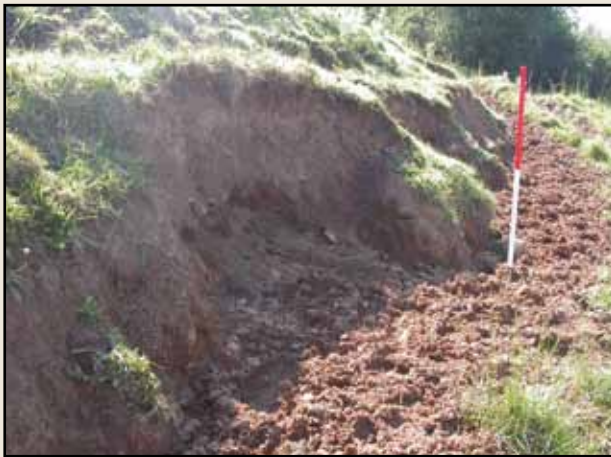
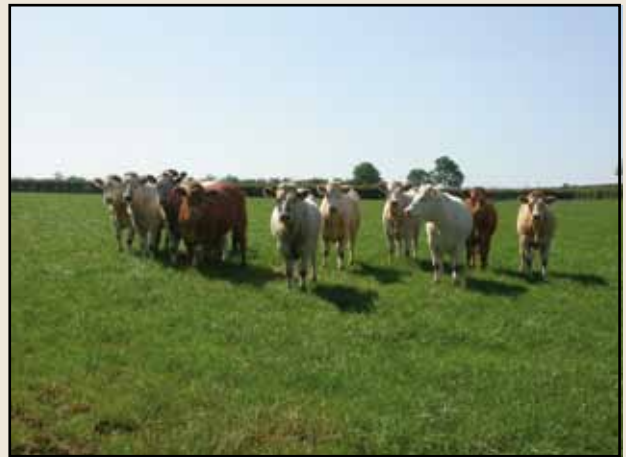
**Plate 10 Mount Hamilton large enclosure (ANT 023:016) has been damaged by livestock recently.**

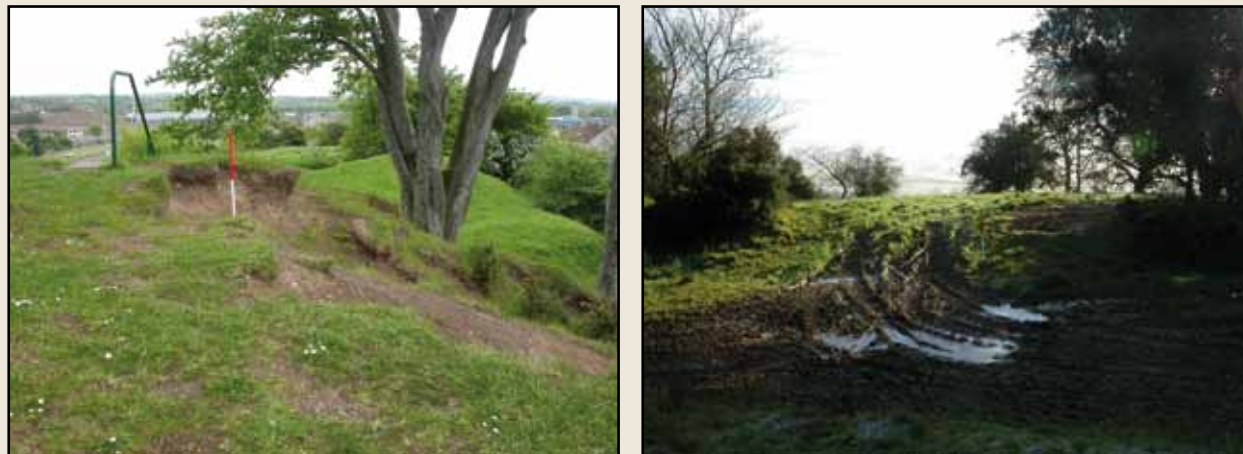
**Plate 14 (left) Damage by visitors using a much worn path is causing erosion at Harryville motte and bailey (ANT 037:022), a State Care Monument. (right) Greenan platform rath (TYR 041:004) has been damaged recently by agricultural traffic.**
