## **Condition and Management Survey of the Archaeological Resource in Northern Ireland (CAMSAR)**

# Condition and Management Survey of the Archaeological Resource in Northern Ireland

## CAMSAR Report

A report commissioned by the Northern Ireland Environment Agency  
(formerly Environment and Heritage Service)

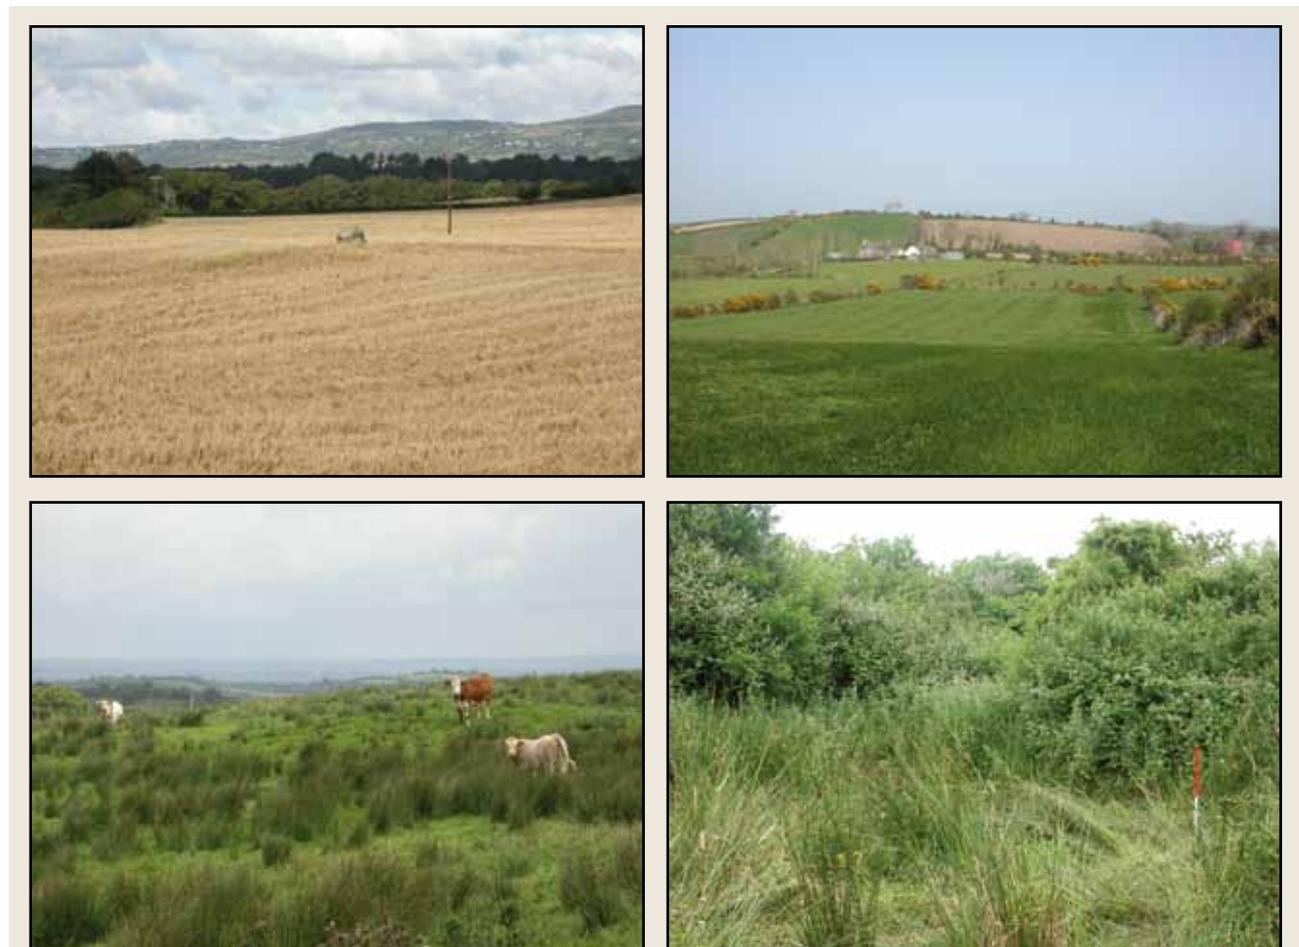
**Plate 1 Examples of land use.**  
**Clockwise from top left - arable, improved grassland, scrub, and rough grazing.**

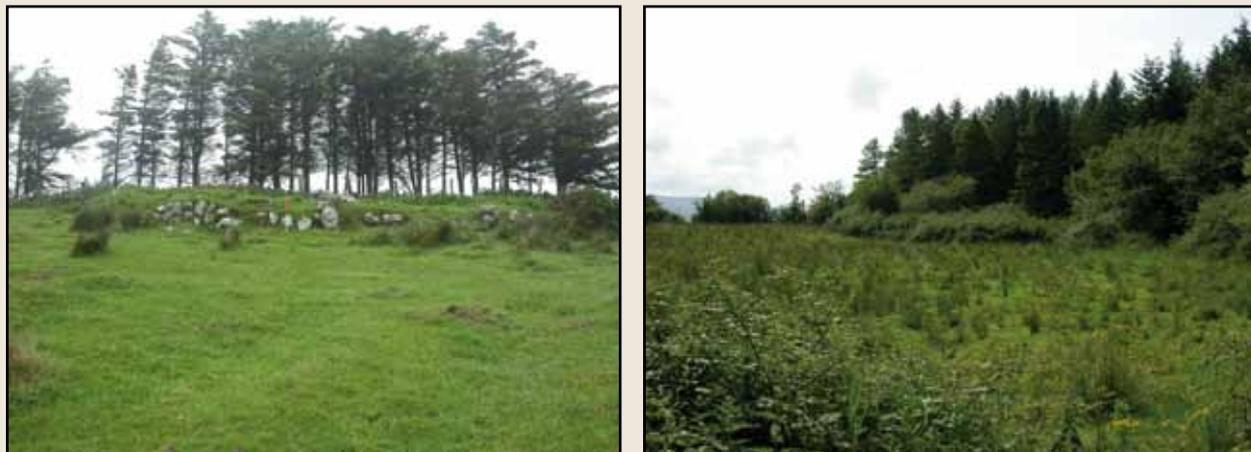
**Plate 2 Ballyreagh Lower/Ballyvoy Cashel (ANT 009:010) has been part-planted with conifers. Tonardrum/Cavantreeduff Rath (FERM 228:011) has been part-planted with conifers.**

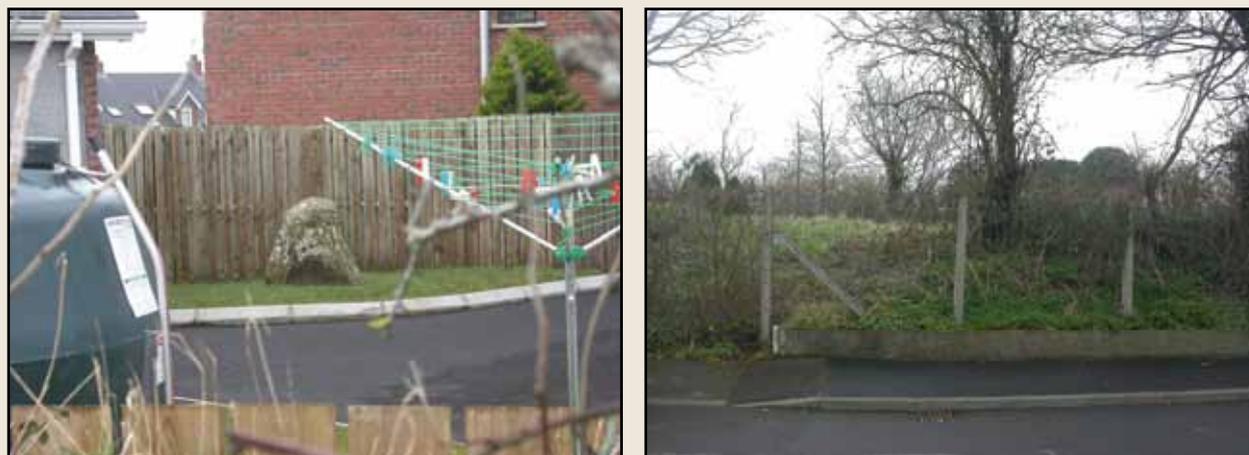
**Plate 3 South Mullaghcall standing stone (LDY003:072) and Ballintine rath (DOW 014:037) both survive within modern housing developments.**

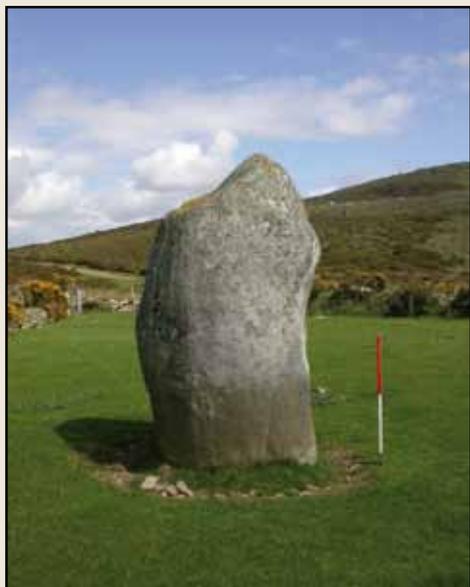
Orthostatic monument: standing stone (Tamnaharry, Down DOW 051:059).

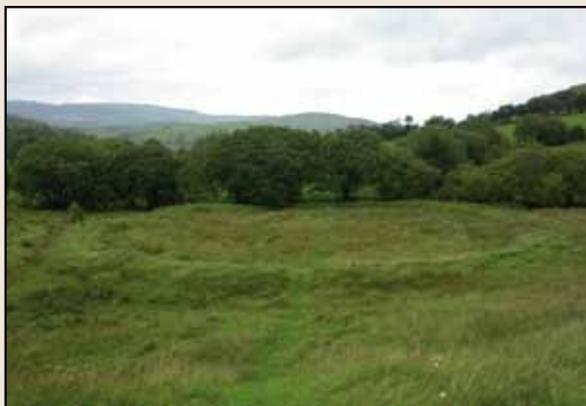
Earthwork: henge (Knock Beg, Fermanagh FER 191:039).

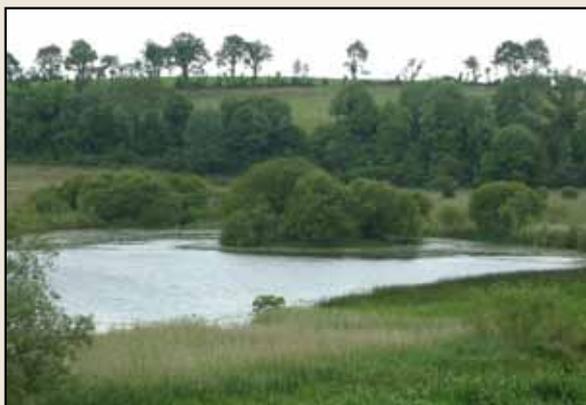
Freshwater structure: crannog (Lisnadurk Glebe North, Fermanagh FER 191:039).

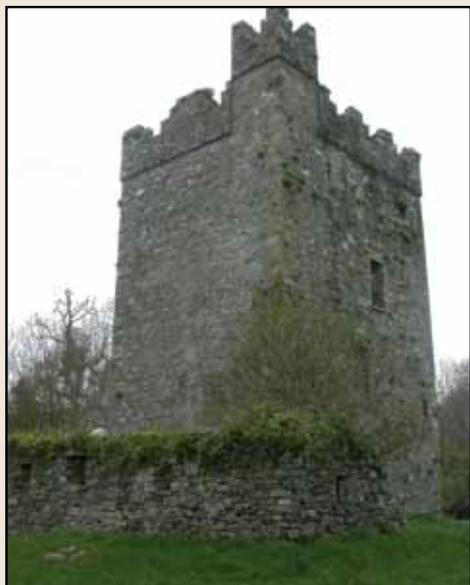
Masonry structure: tower house (Walshestown, Down DOW)

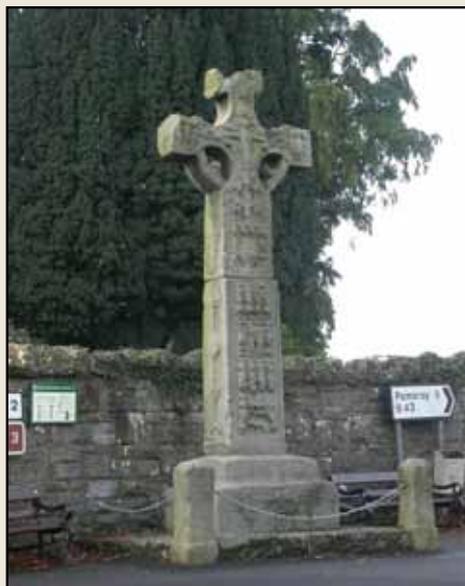
Carved stone: high cross (Donaghmore, Tyrone TYR 046:011).

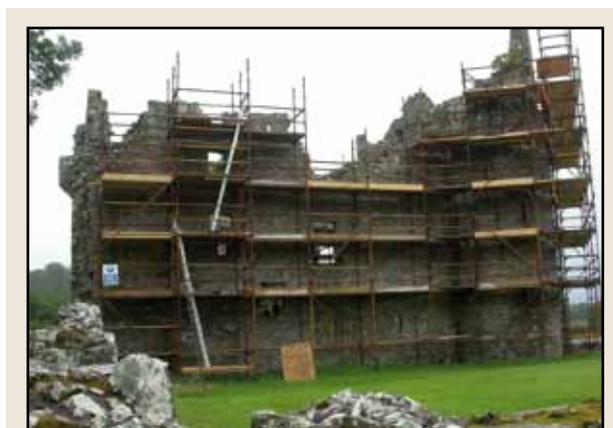
**Plate 5 Monea Castle (FER 191:061) is a State Care Monument, and is maintained to allow public access. It has recently undergone a programme of conservation work by NIEA.**

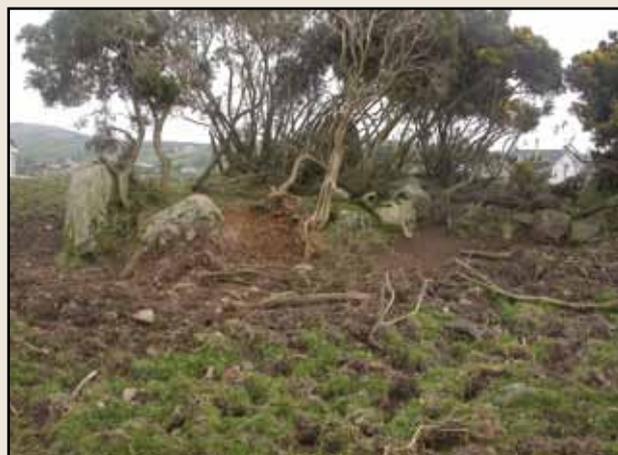
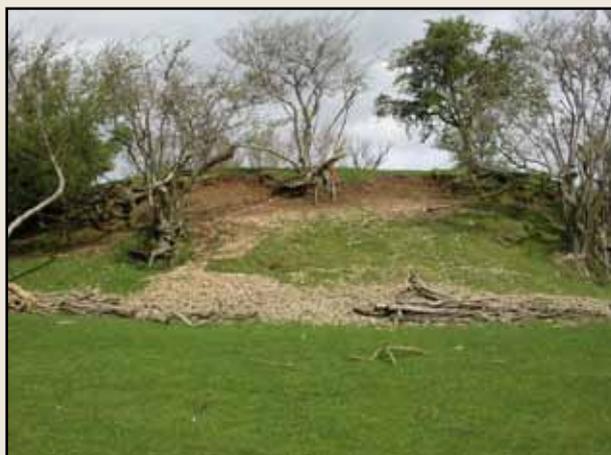
**Plate 7 (left) Clonlum court tomb (ARM 029:004) is in a poor condition due to scrub growth and severe livestock trampling. (right) The possible raised rath at Fofannyreagh (DOW 042 038) is in poor condition due to a combination of livestock erosion and burrowing animals.**

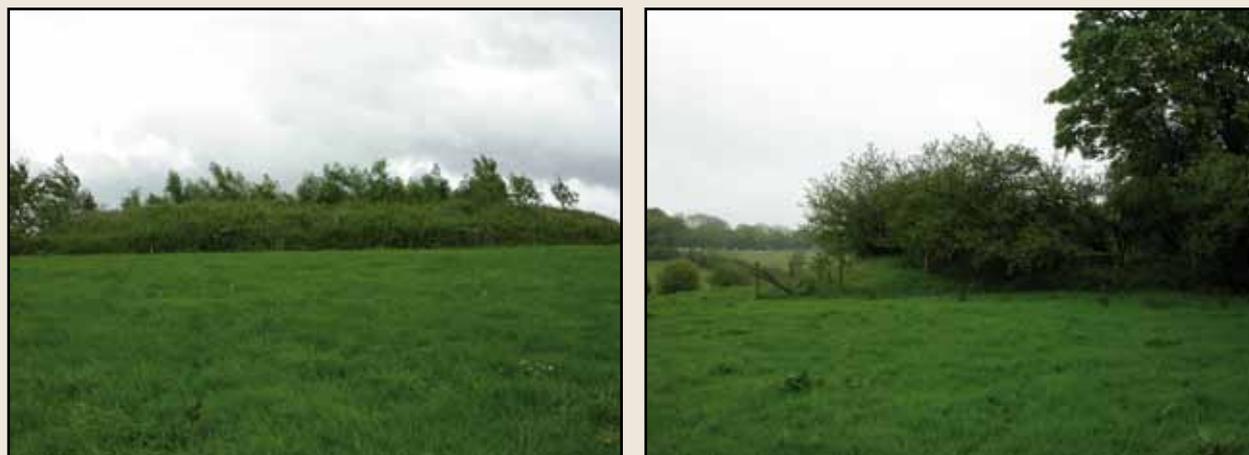
**Plate 8 (left) Derryhowlaght East rath (FER 230:055) and (right) Ballymarlagh dual court tomb (ANT 038:002) have both been fenced off from the surrounding field and are now extremely overgrown and difficult to access.**

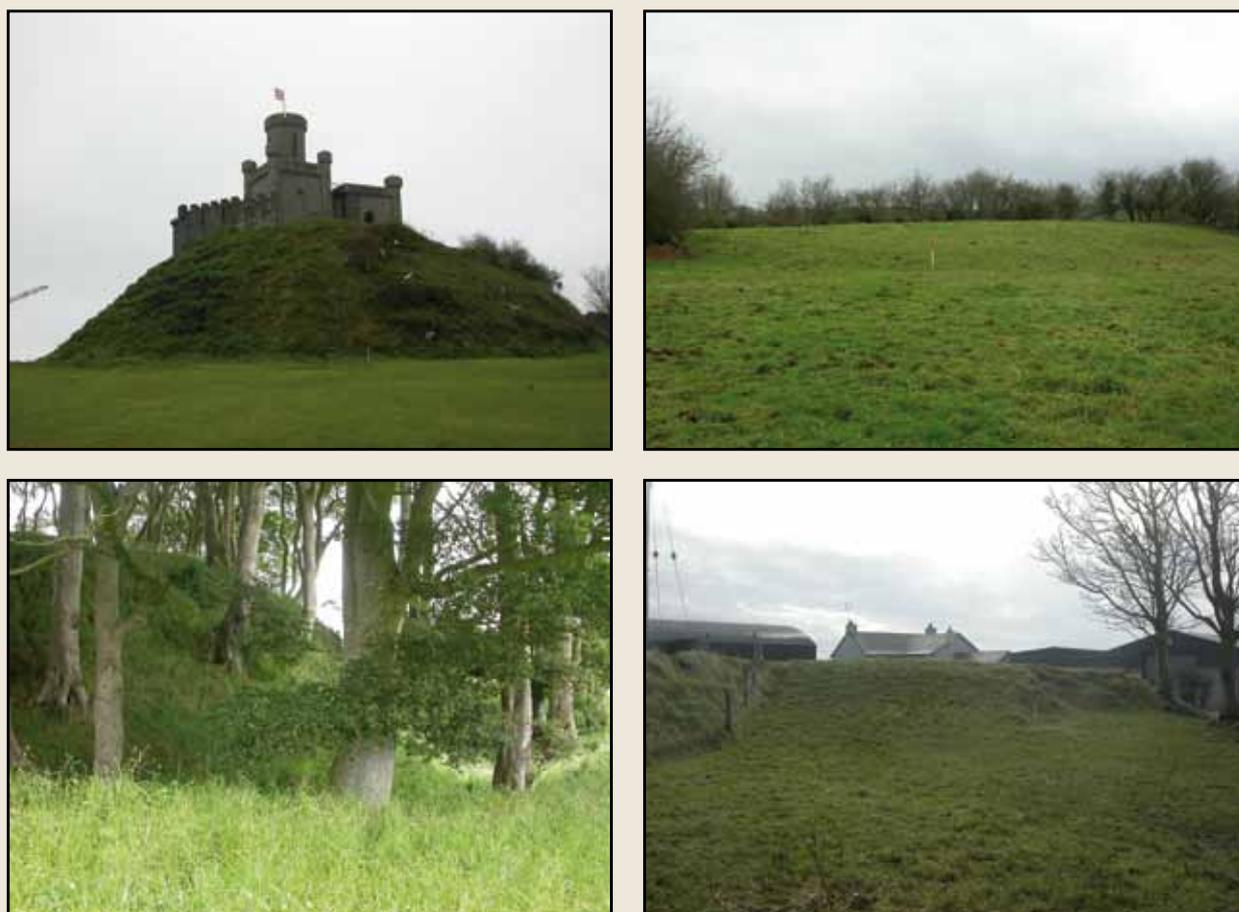
**Plate 9 Clockwise from left: Donaghadee motte (DOW 003:003) was damaged in the past by the construction of a powder magazine. Lisnagleer platform rath (TYR 046:018) was damaged by cultivation. Dundoonan rath and souterrain (LDY 003:014) was built over by a farmyard and buildings. Tree planting has damaged Dundermot motte (ANT 027:010).**

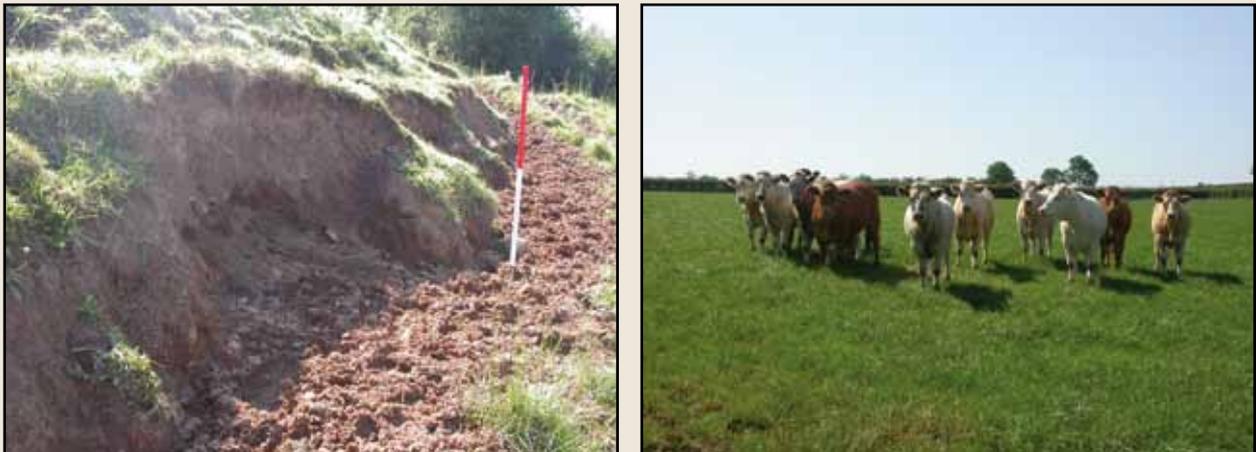
**Plate 10 Mount Hamilton large enclosure (ANT 023:016) has been damaged by livestock recently.**

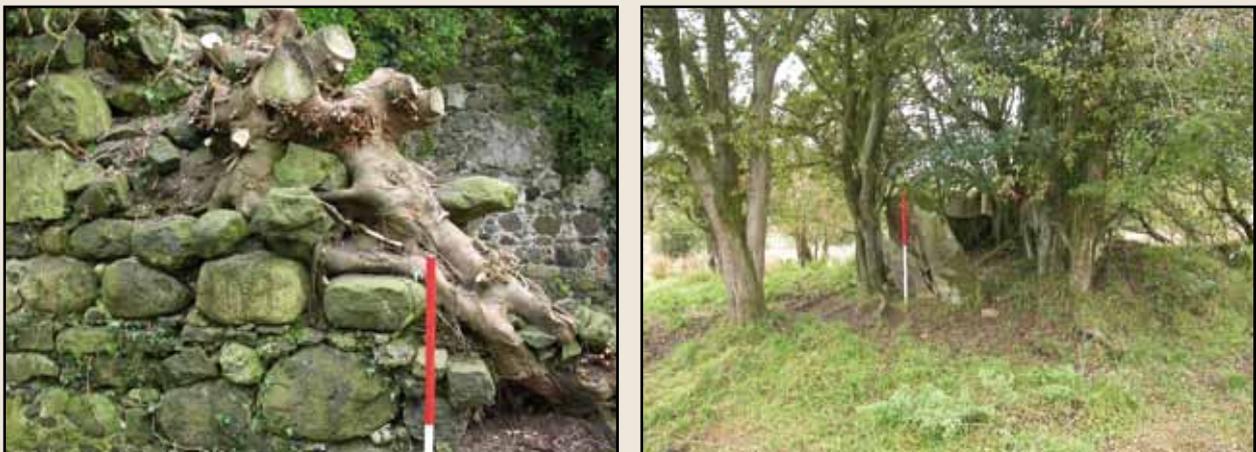
**Plate 11 Magherafelt church and graveyard (LDY 042:016), showing damage caused by root action. Bullock Park portal tomb (TYR 024:029) overgrown and damaged as a consequence of root action.**

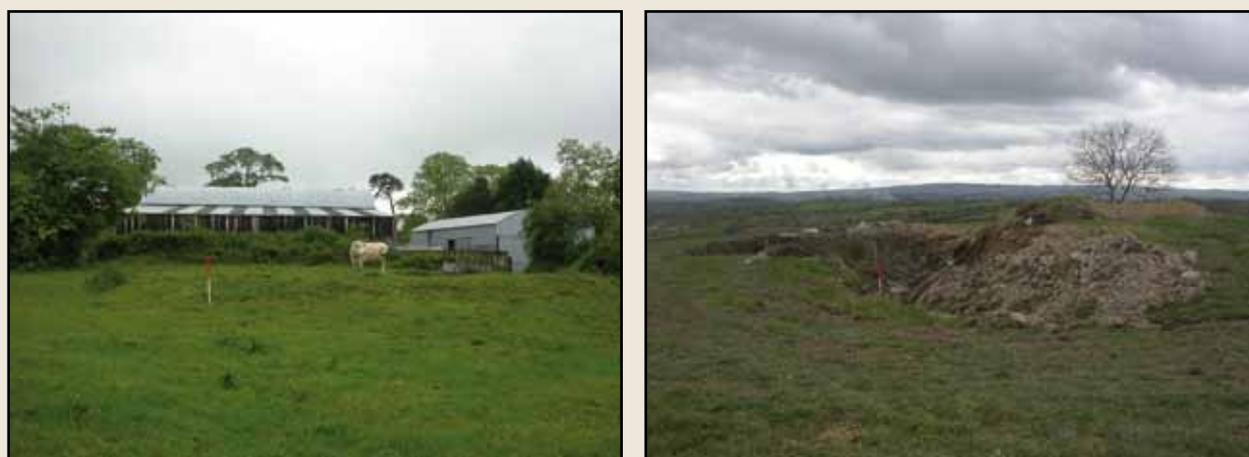
**Plate 12** Examples of sites which were found to have been damaged recently.

This damage can often be further extended when livestock are allowed access to the areas already exposed. Other types of recent damage encountered included cultivation (which accounted for 6.5% of the instances of damage), dumping (3%) and agricultural traffic (2%). Tree planting and the damage caused by the collapse of unstable and diseased trees blown down during gales accounts for almost 6% of the cases of recent damage. Archaeological layers are disturbed when the ground is prepared for tree planting, and growing tree roots will further disturb features and objects. When trees blow over they can lift large amounts of earth with their root-plates, leaving wide holes and further exposing that portion of a site to natural erosion (Plate 12).

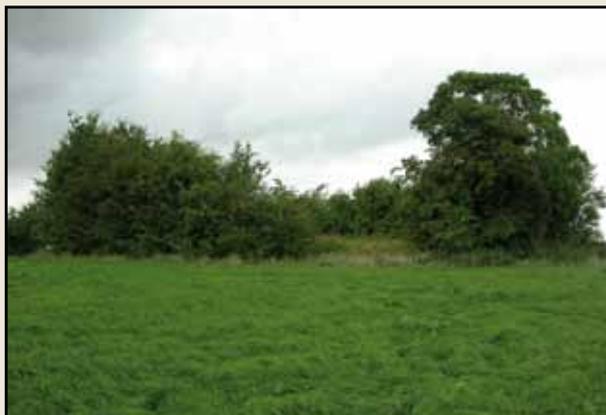
Drummack rath (FER 230:062). The perimeter is overgrown with bushes and trees.

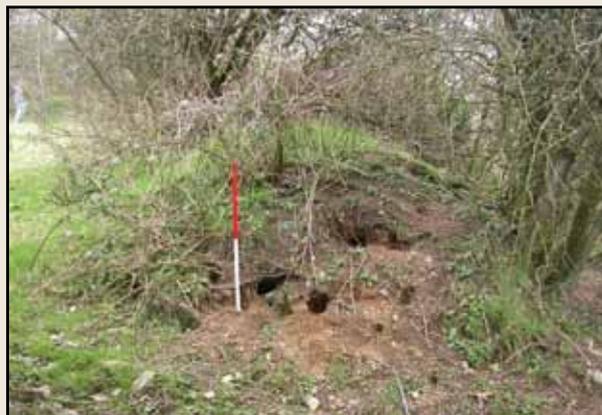
Dungonnell mound (ANT 054:008), where material has been dumped in the ditch to make it level with the surrounding ground.

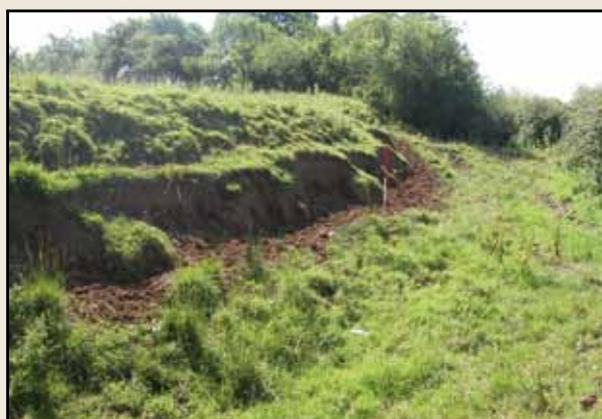
Large enclosure at Mount Hamilton (ANT 023:016), recently damaged by livestock.

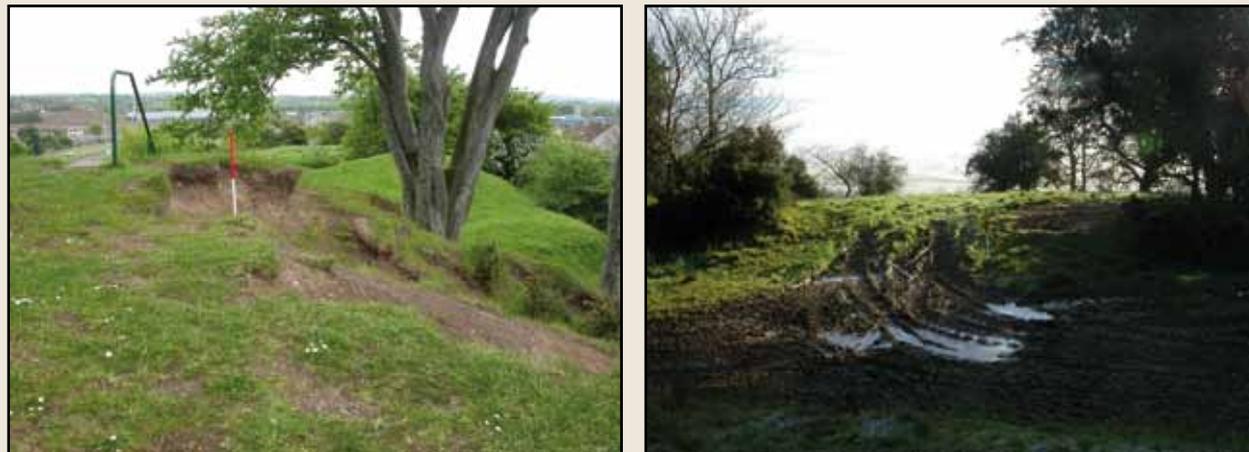
**Plate 14 (left) Damage by visitors using a much worn path is causing erosion at Harryville motte and bailey (ANT 037:022), a State Care Monument. (right) Greenan platform rath (TYR 041:004) has been damaged recently by agricultural traffic.**
