Condition and Management Survey of the Archaeological Resource in Northern Ireland

CAMSAR Report

AUTHORS: Sarah Gormley, Colm Donnelly, Barrie Hartwell, Janet Bell

A report commissioned by the Northern Ireland Environment Agency
(formerly Environment and Heritage Service)

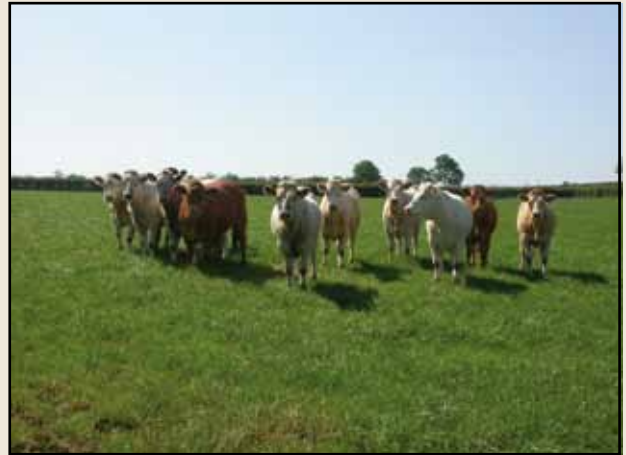
Plate 10 Mount Hamilton large enclosure (ANT 023:016) has been damaged by livestock recently.

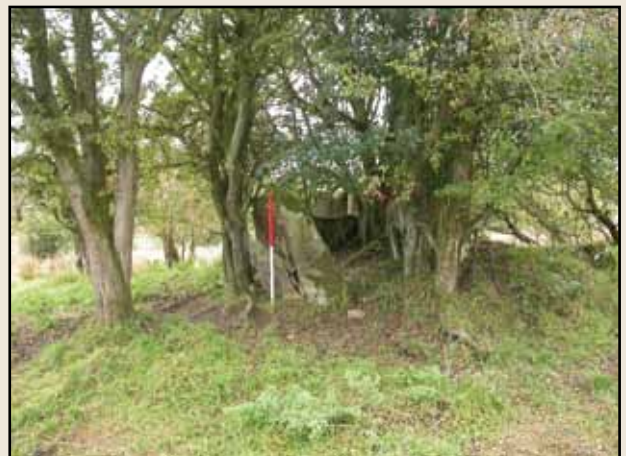
Plate 11 Magherafelt church and graveyard (LDY 042:016), showing damage caused by root action. Bullock Park portal tomb (TYR 024:029) overgrown and damaged as a consequence of root action.
