Condition and Management Survey of the Archaeological Resource in Northern Ireland

CAMSAR Report

A report commissioned by the Northern Ireland Environment Agency
(formerly Environment and Heritage Service)

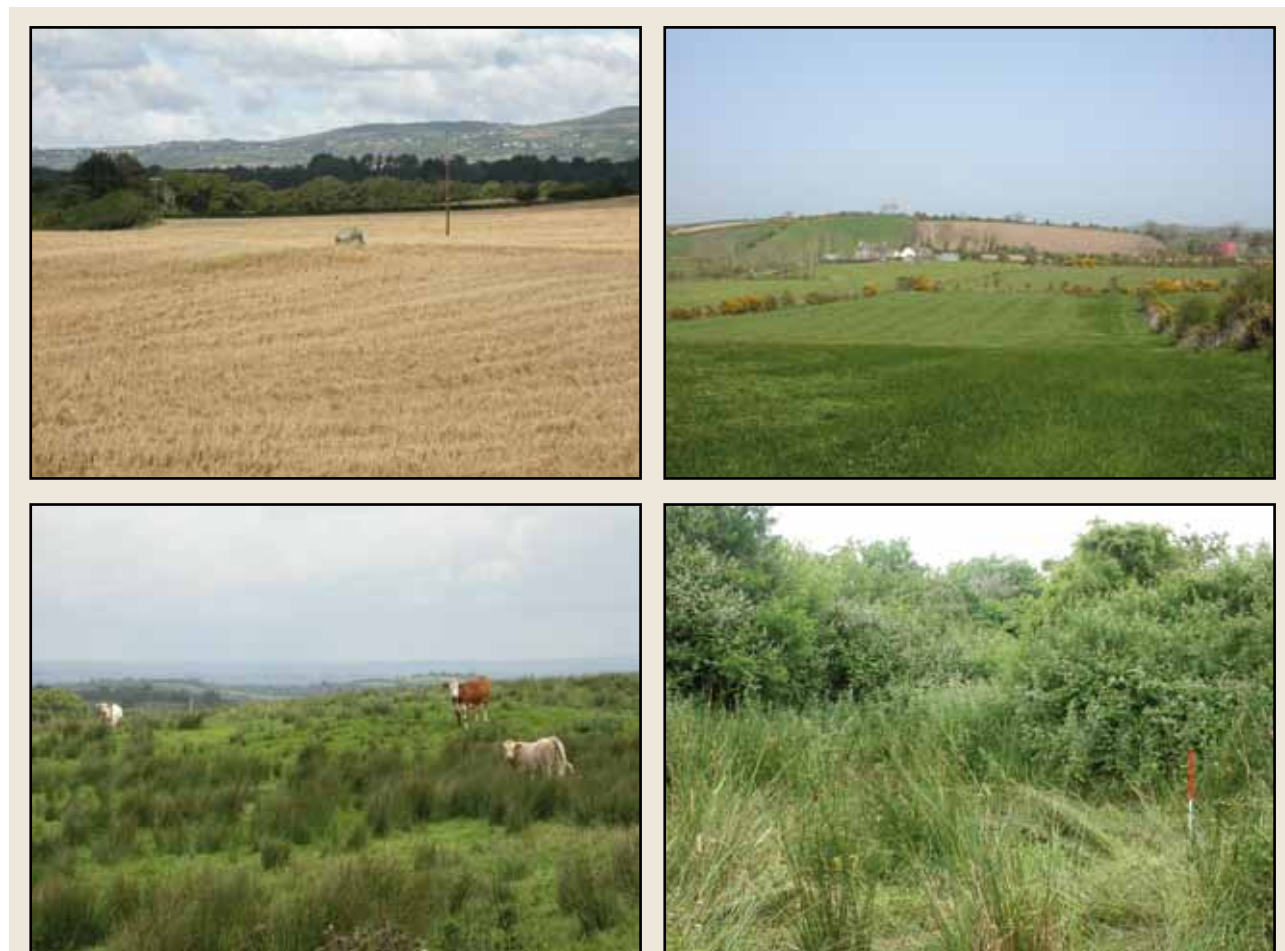
Plate 1 Examples of land use.
Clockwise from top left - arable, improved grassland, scrub, and rough grazing.
