Condition and Management Survey of the Archaeological Resource in Northern Ireland

CAMSAR Report

A report commissioned by the Northern Ireland Environment Agency
(formerly Environment and Heritage Service)

This Condition and Management Survey of the Archaeological Resource Northern Ireland (CAMSAR) was conducted in 2004 and 2005, with some minor revision in 2007. It set out to study the current survival and condition of sites and monuments in Northern Ireland. Specifically, it focused on sites and monuments earlier than 1700 AD as recorded in the Northern Ireland Sites and Monuments Record, a resource maintained by the Built Heritage Directorate of the Northern Ireland Environment Agency (formally the Environment and Heritage Service), an agency within the Department of the Environment in Northern Ireland.

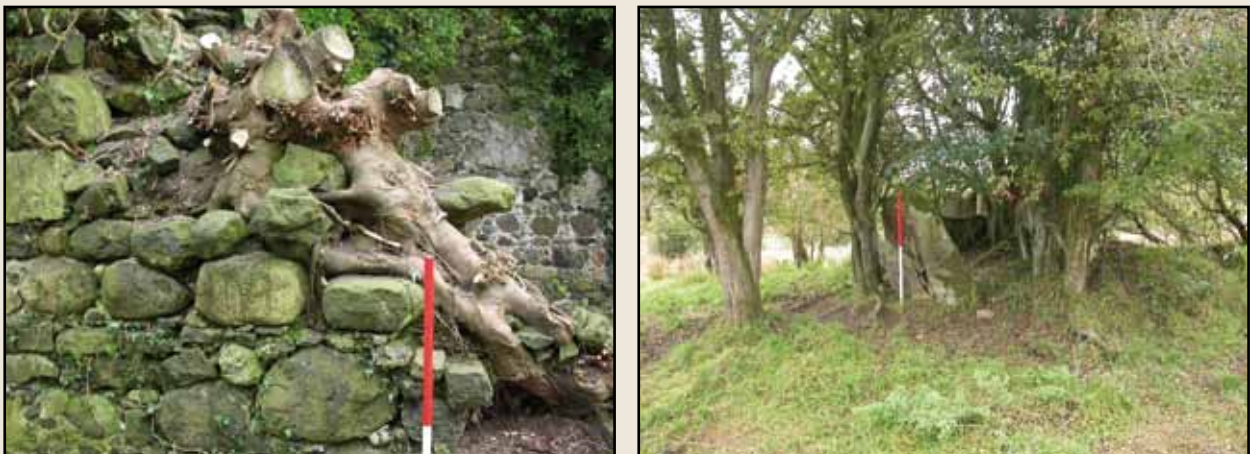
Plate 11 Magherafelt church and graveyard (LDY 042:016), showing damage caused by root action. Bullock Park portal tomb (TYR 024:029) overgrown and damaged as a consequence of root action.
