Condition and Management Survey of the Archaeological Resource in Northern Ireland (CAMSAR)

Condition and Management Survey of the Archaeological Resource in Northern Ireland

CAMSAR Report

A report commissioned by the Northern Ireland Environment Agency
(formerly Environment and Heritage Service)

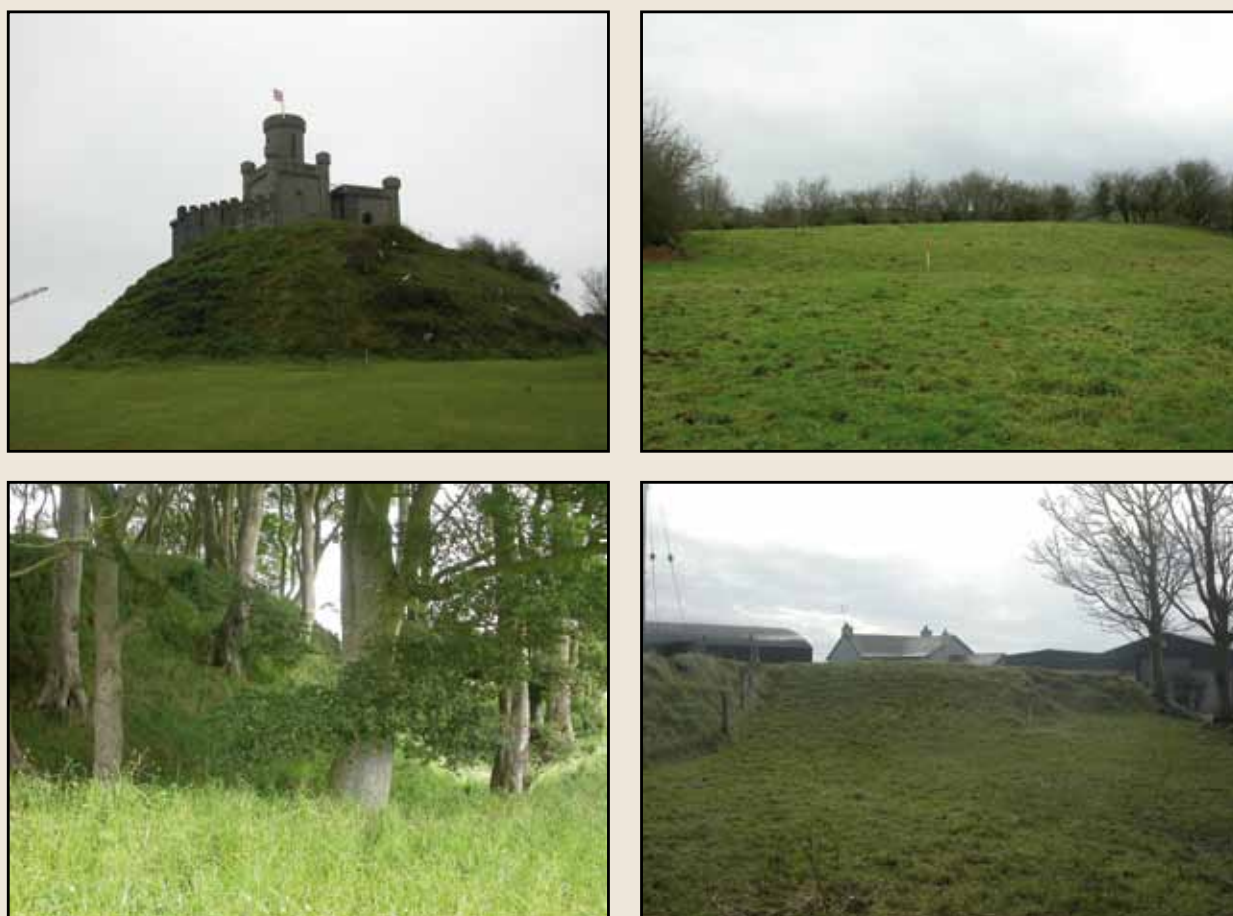
Plate 9 Clockwise from left: Donaghadee motte (DOW 003:003) was damaged in the past by the construction of a powder magazine. Lisnagleer platform rath (TYR 046:018) was damaged by cultivation. Dundoonan rath and souterrain (LDY 003:014) was built over by a farmyard and buildings. Tree planting has damaged Dundermot motte (ANT 027:010).

- Plate 9 Clockwise from left: Donaghadee motte (Down 003:003) was damaged in the past by the construction of a powder magazine. Lisnagleer platform rath (Tyr 046:018) was damaged by cultivation. Dundooan rath and souterrain (Ldy 003:014) was built over by a farmyard and buildings. Tree planting has damaged Dundermot motte (Ant 027:010).

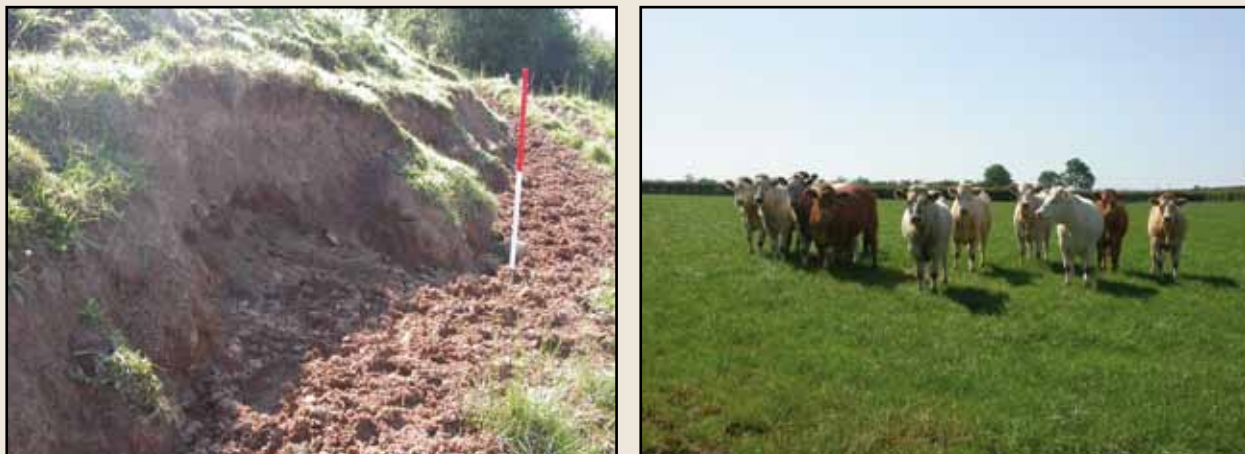
Plate 10 Mount Hamilton large enclosure (ANT 023:016) has been damaged by livestock recently.

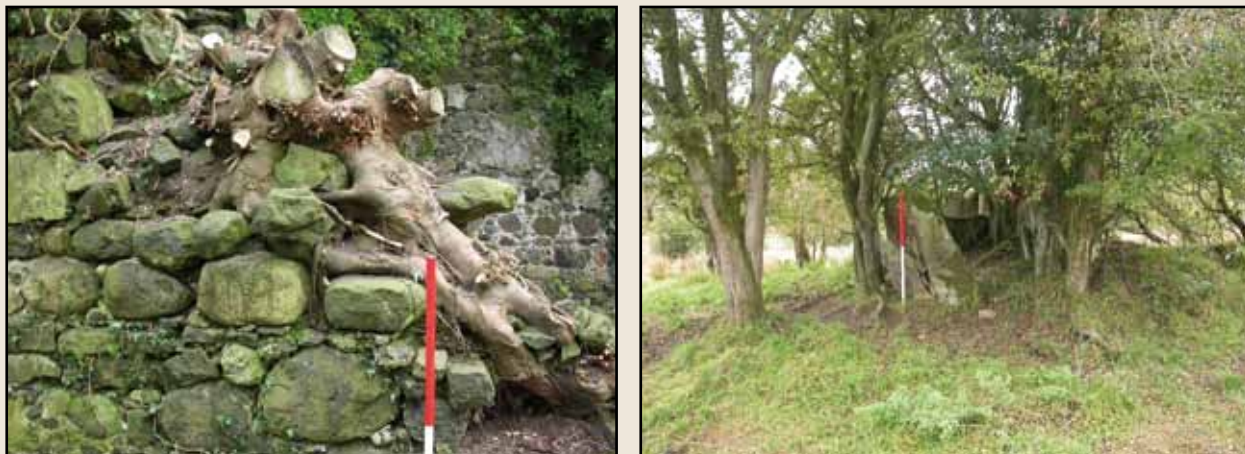
Plate 11 Magherafelt church and graveyard (LDY 042:016), showing damage caused by root action. Bullock Park portal tomb (TYR 024:029) overgrown and damaged as a consequence of root action.

Scrub encroachment leading to overgrowth was also recorded as a problem. A total of 126 cases of this type of recent damage was noted, affecting 8% of the sample. This type of damage causes a number of problems. The most obvious is the harm caused to a monument by root penetration particularly on earthworks. Trees on or around structures and megalithic tombs are very destructive (Plate 11), causing disturbance of layers and even collapse. Excavation work at a prehistoric roundhouse on Dartmoor has also demonstrated the extent of the serious physical and chemical damage caused to archaeological remains by the root systems of bracken, which had displaced and damaged up to 20% of the archaeological deposits⁵⁰. Scrub can also act as shading, preventing grass from growing and leading to soil

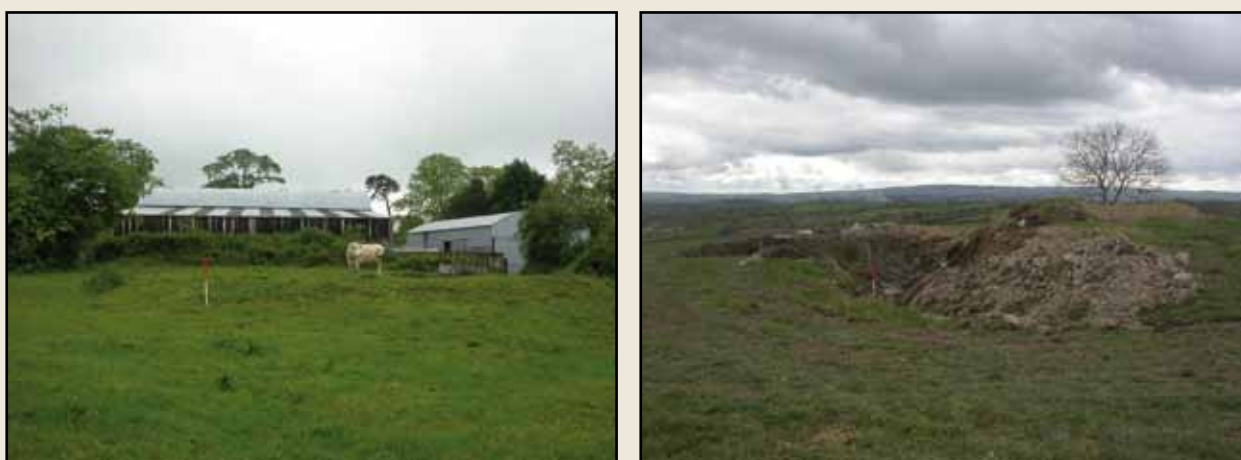
Plate 12 Examples of sites which were found to have been damaged recently.

This damage can often be further extended when livestock are allowed access to the areas already exposed. Other types of recent damage encountered included cultivation (which accounted for 6.5% of the instances of damage), dumping (3%) and agricultural traffic (2%). Tree planting and the damage caused by the collapse of unstable and diseased trees blown down during gales accounts for almost 6% of the cases of recent damage. Archaeological layers are disturbed when the ground is prepared for tree planting, and growing tree roots will further disturb features and objects. When trees blow over they can lift large amounts of earth with their root-plates, leaving wide holes and further exposing that portion of a site to natural erosion (Plate 12).
