Condition and Management Survey of the Archaeological Resource in Northern Ireland

CAMSAR Report

CAMSAR: A Condition and Management Survey of the
Archaeological Resource in Northern Ireland

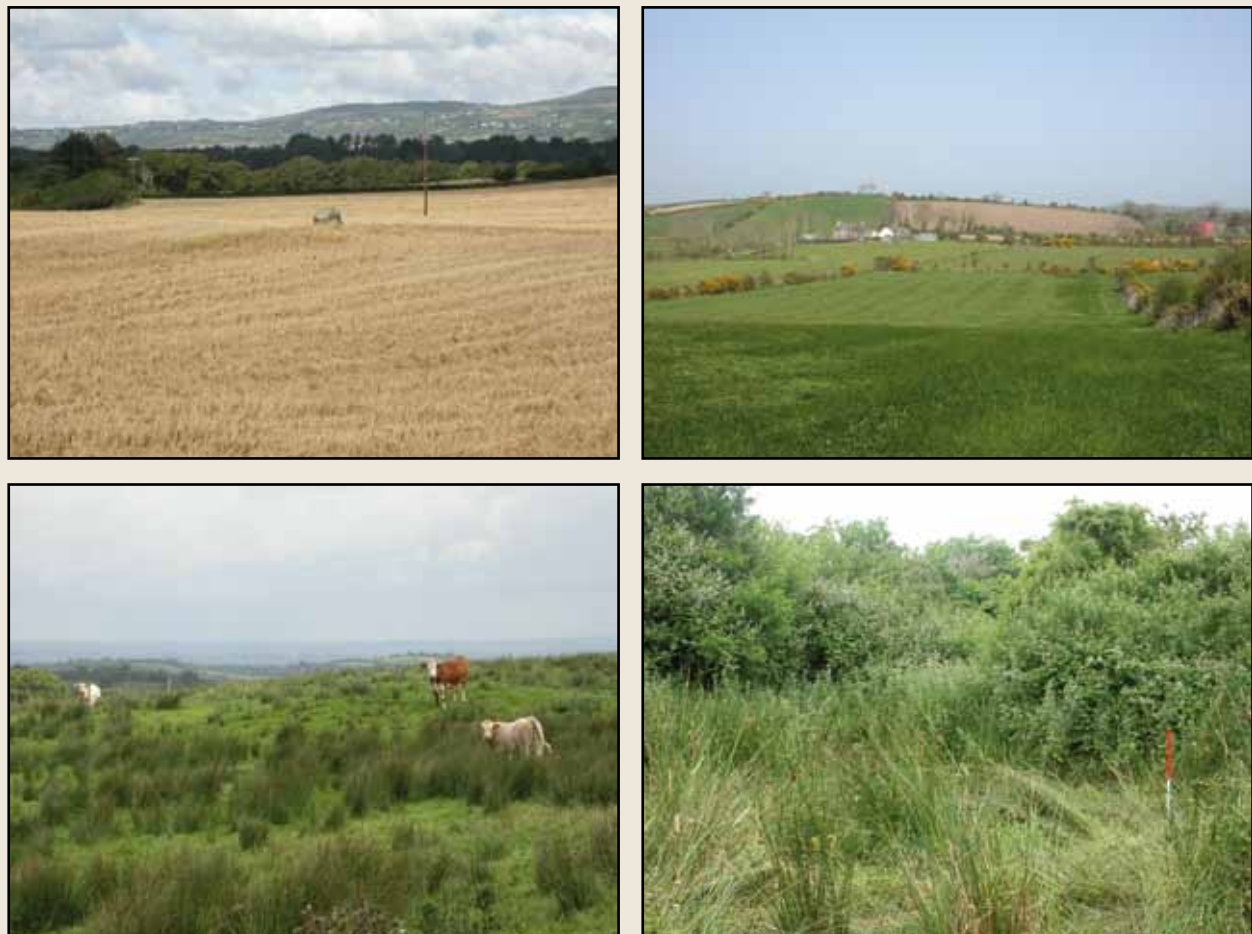
Plate 1 Examples of land use.
Clockwise from top left - arable, improved grassland, scrub, and rough grazing.

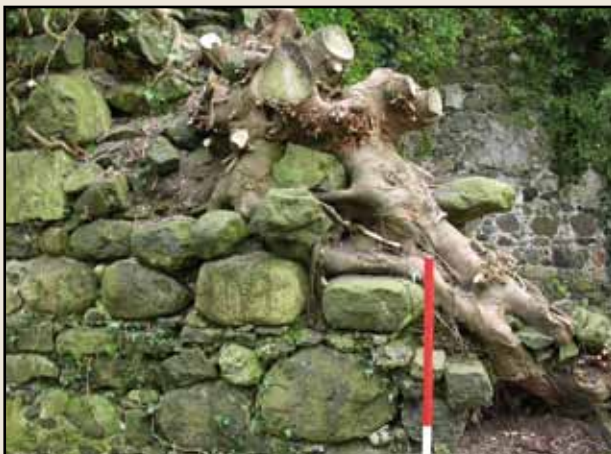
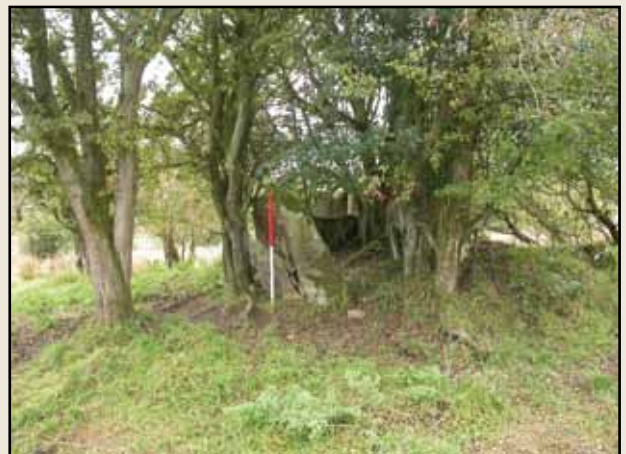
Plate 11 Magherafelt church and graveyard (LDY 042:016), showing damage caused by root action. Bullock Park portal tomb (TYR 024:029) overgrown and damaged as a consequence of root action.
