Condition and Management Survey of the Archaeological Resource in Northern Ireland (CAMSAR)

Condition and Management Survey of the Archaeological Resource in Northern Ireland

CAMSAR Report

AUTHORS: Sarah Gormley, Colm Donnelly, Barrie Hartwell, Janet Bell

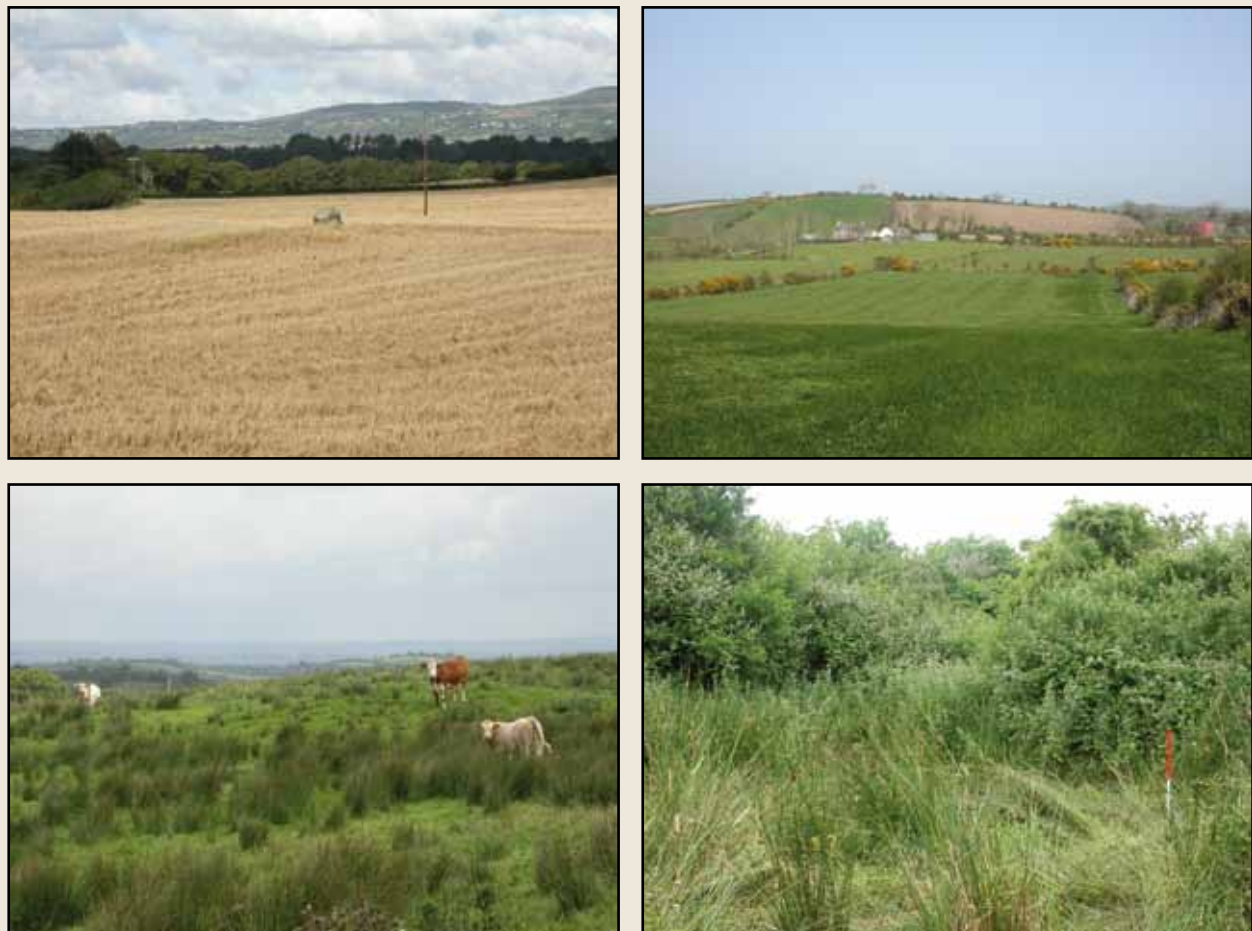
Plate 1 Examples of land use.
Clockwise from top left - arable, improved grassland, scrub, and rough grazing.

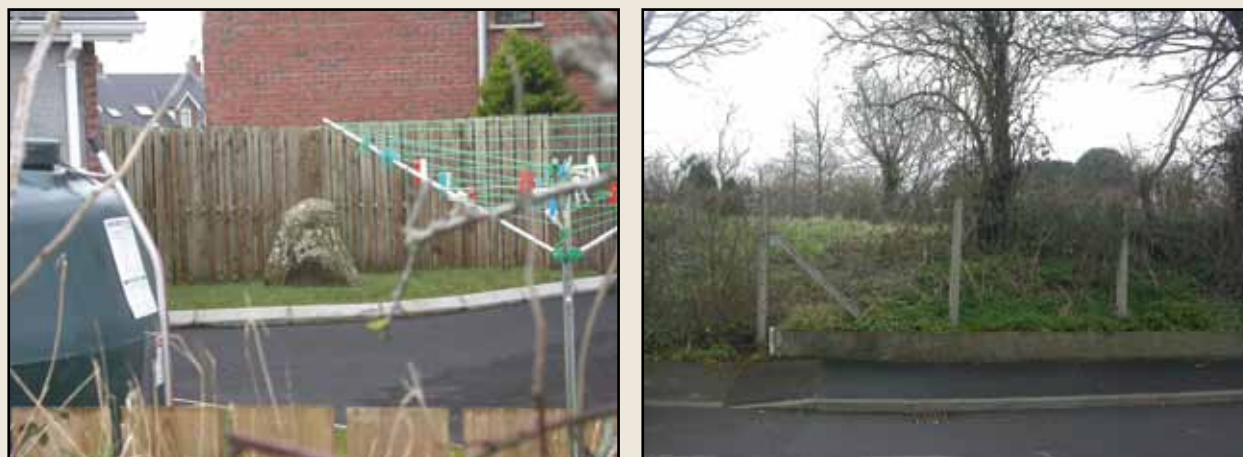
Plate 3 South Mullaghcall standing stone (LDY003:072) and Ballintine rath (DOW 014:037) both survive within modern housing developments.

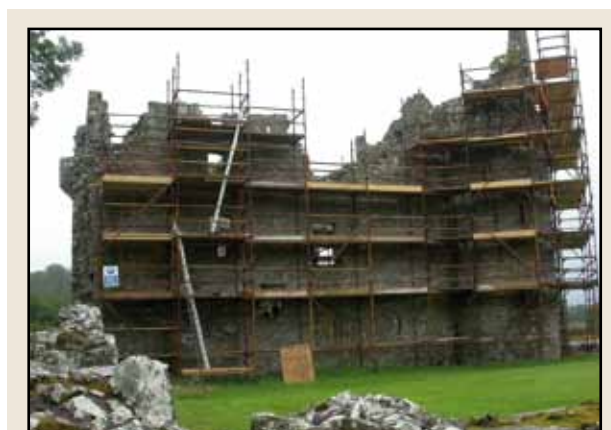
Plate 5 Monea Castle (FER 191:061) is a State Care Monument, and is maintained to allow public access. It has recently undergone a programme of conservation work by NIEA.

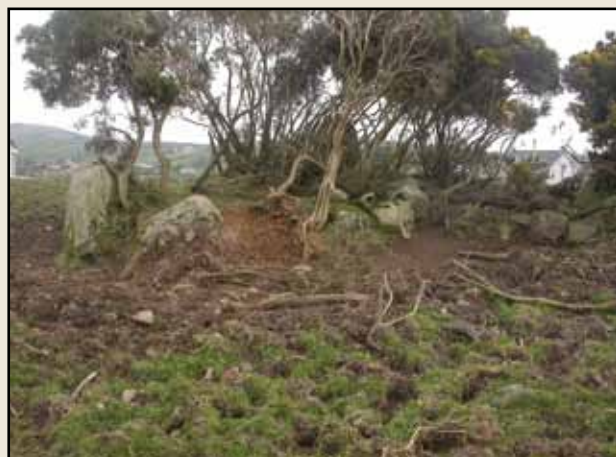
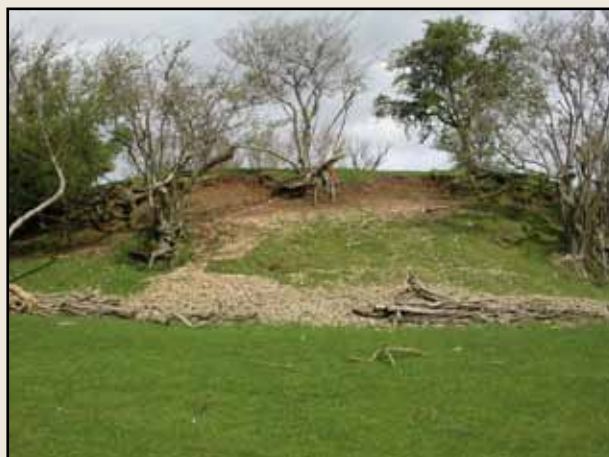
Plate 7 (left) Clonlum court tomb (ARM 029:004) is in a poor condition due to scrub growth and severe livestock trampling. (right) The possible raised rath at Fofannyreagh (DOW 042 038) is in poor condition due to a combination of livestock erosion and burrowing animals.

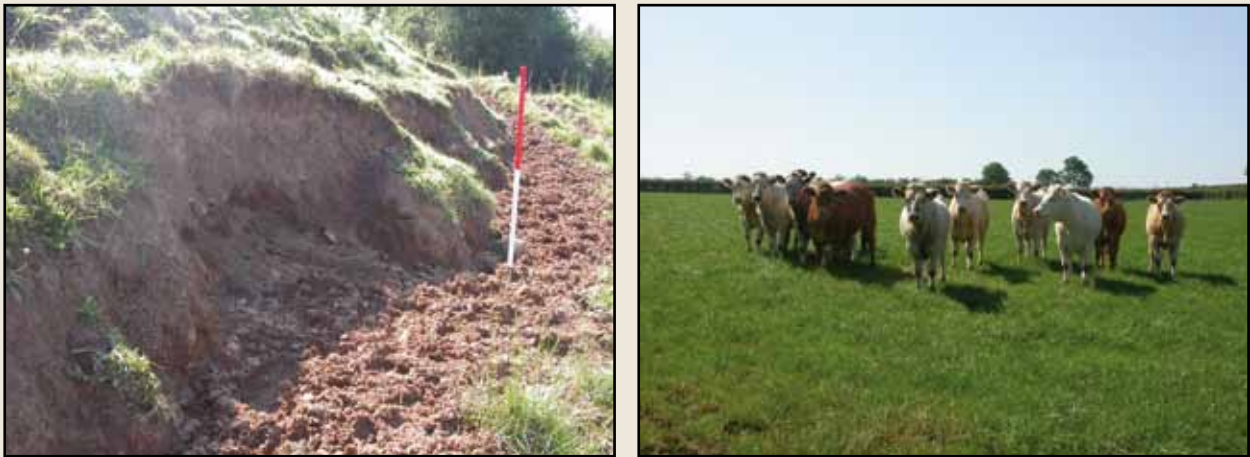
Plate 10 Mount Hamilton large enclosure (ANT 023:016) has been damaged by livestock recently.

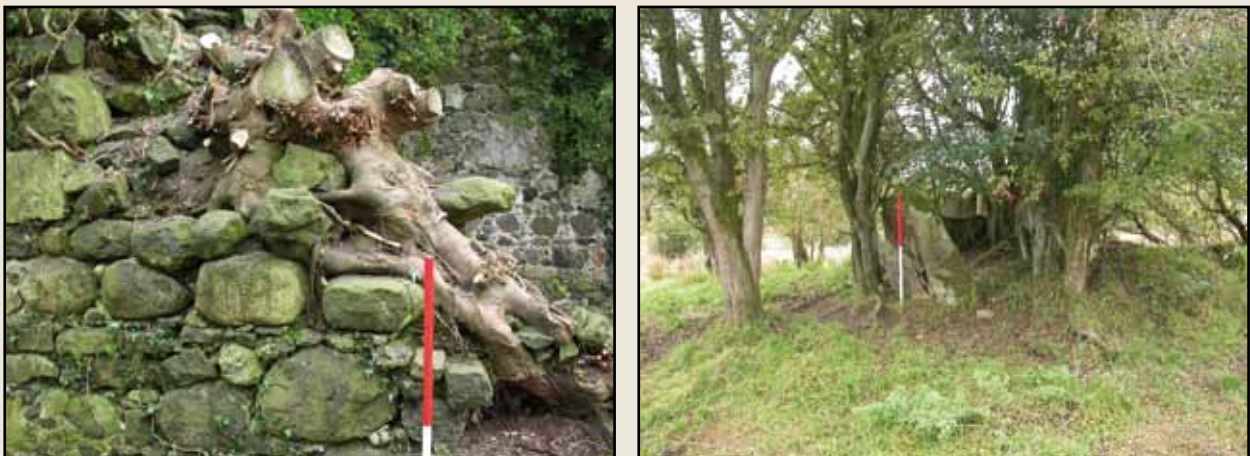
Scrub encroachment leading to overgrowth was also recorded as a problem. A total of 126 cases of this type of recent damage was noted, affecting 8% of the sample. This type of damage causes a number of problems. The most obvious is the harm caused to a monument by root penetration particularly on earthworks. Trees on or around structures and megalithic tombs are very destructive (Plate 11), causing disturbance of layers and even collapse. Excavation work at a prehistoric roundhouse on Dartmoor has also demonstrated the extent of the serious physical and chemical damage caused to archaeological remains by the root systems of bracken, which had displaced and damaged up to 20% of the archaeological deposits⁵⁰. Scrub can also act as shading, preventing grass from growing and leading to soil

Plate 11 Magherafelt church and graveyard (LDY 042:016), showing damage caused by root action. Bullock Park portal tomb (TYR 024:029) overgrown and damaged as a consequence of root action.

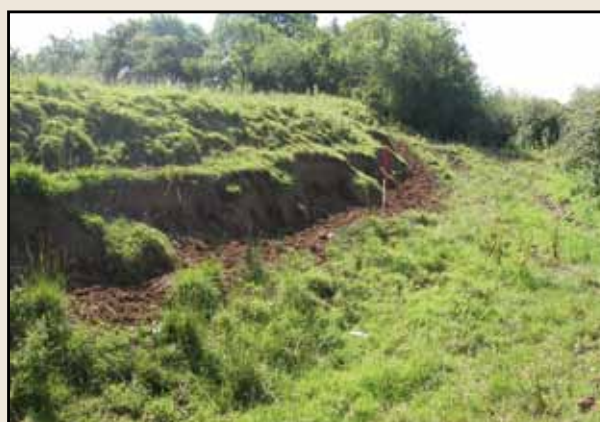
Large enclosure at Mount Hamilton (ANT 023:016), recently damaged by livestock.
