## **Condition and Management Survey of the Archaeological Resource in Northern Ireland (CAMSAR)**

## CAMSAR Report

**AUTHORS:** Sarah Gormley, Colm Donnelly, Barrie Hartwell, Janet Bell

A report commissioned by the Northern Ireland Environment Agency  
(formerly Environment and Heritage Service)

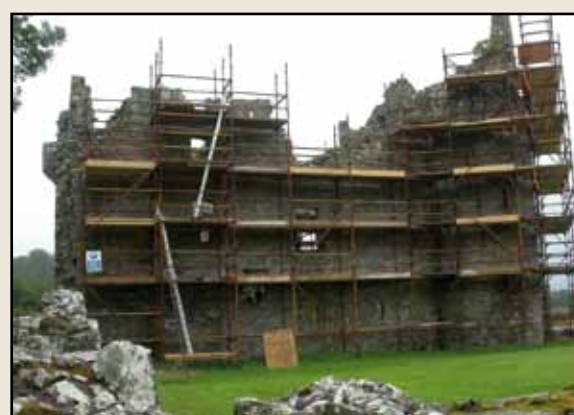
**Plate 5 Monea Castle (FER 191:061) is a State Care Monument, and is maintained to allow public access. It has recently undergone a programme of conservation work by NIEA.**
