Condition and Management Survey of the Archaeological Resource in Northern Ireland (CAMSAR)

CAMSAR Report

CAMSAR: A Condition and Management Survey of the
Archaeological Resource in Northern Ireland

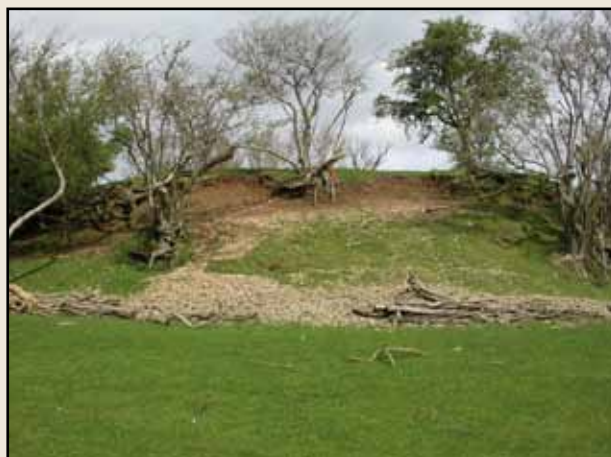
Plate 7 (left) Clonlum court tomb (ARM 029:004) is in a poor condition due to scrub growth and severe livestock trampling. (right) The possible raised rath at Fofannyreagh (DOW 042 038) is in poor condition due to a combination of livestock erosion and burrowing animals.

- Plate 7 (left) Clonlum court tomb (Arm 029:004) is in a poor condition due to scrub growth and severe livestock trampling. (right) The possible raised rath at Fofannyreagh (Down 042 038) is in poor condition due to a combination of livestock erosion and burrowing animals.
