Condition and Management Survey of the Archaeological Resource in Northern Ireland (CAMSAR)

Condition and Management Survey of the Archaeological Resource in Northern Ireland

CAMSAR Report

A report commissioned by the Northern Ireland Environment Agency
(formerly Environment and Heritage Service)

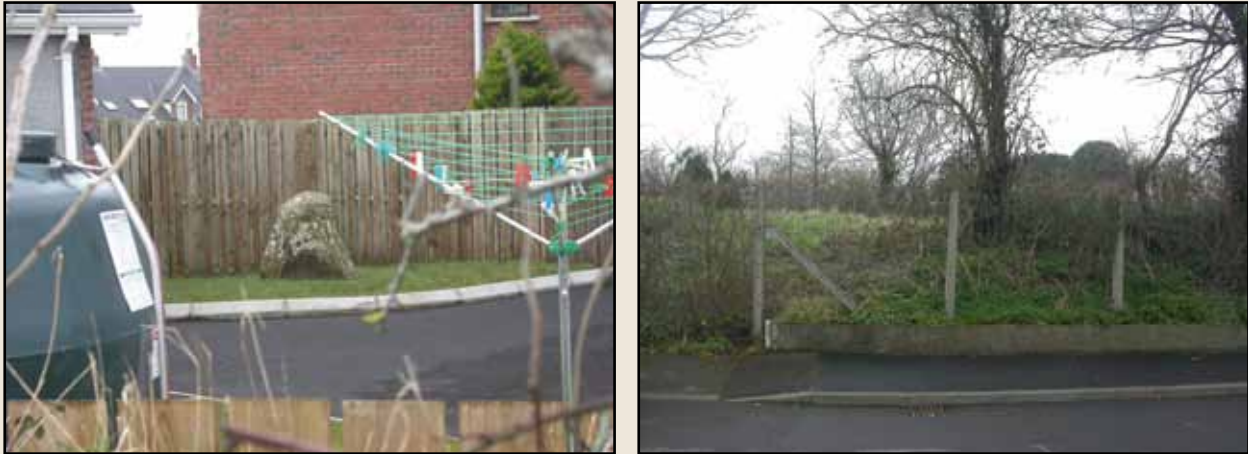
Plate 3 South Mullaghcall standing stone (LDY003:072) and Ballintine rath (DOW 014:037) both survive within modern housing developments.
