Condition and Management Survey of the Archaeological Resource in Northern Ireland (CAMSAR)

Condition and Management Survey of the Archaeological Resource in Northern Ireland

CAMSAR Report

A report commissioned by the Northern Ireland Environment Agency
(formerly Environment and Heritage Service)

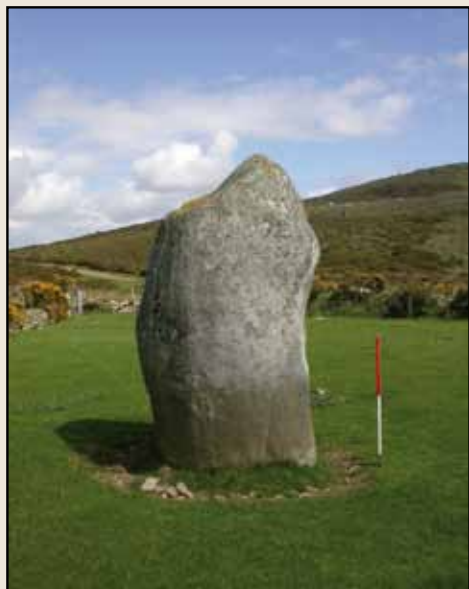
Orthostatic monument: standing stone (Tamnaharry, Down DOW 051:059).

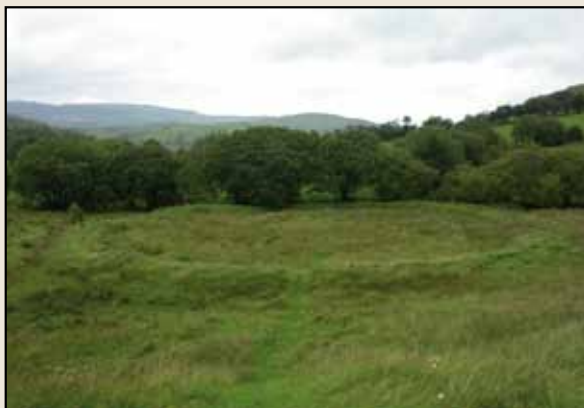
Earthwork: henge (Knock Beg, Fermanagh FER 191:039).

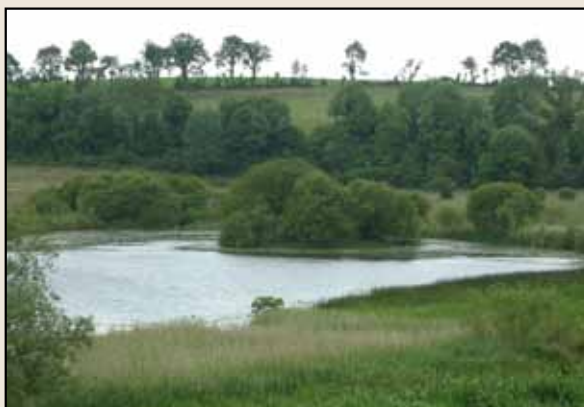
Freshwater structure: crannog (Lisnadurk Glebe North, Fermanagh FER 191:039).

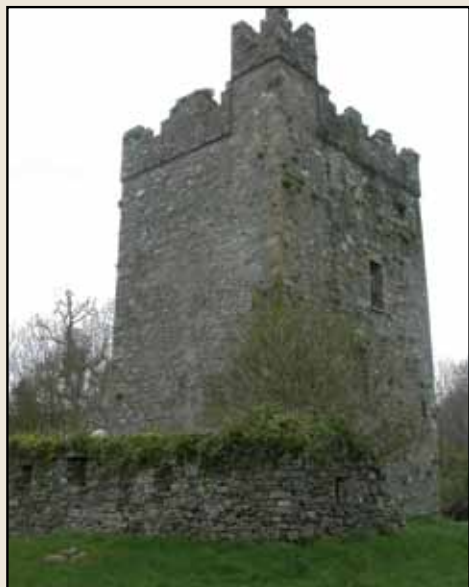
Masonry structure: tower house (Walshestown, Down DOW)

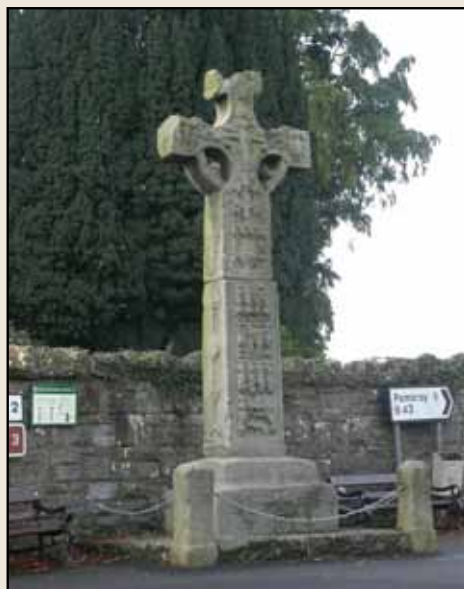
Carved stone: high cross (Donaghmore, Tyrone TYR 046:011).
