Condition and Management Survey of the Archaeological Resource in Northern Ireland

CAMSAR Report

AUTHORS: Sarah Gormley, Colm Donnelly, Barrie Hartwell, Janet Bell

A report commissioned by the Northern Ireland Environment Agency
(formerly Environment and Heritage Service)

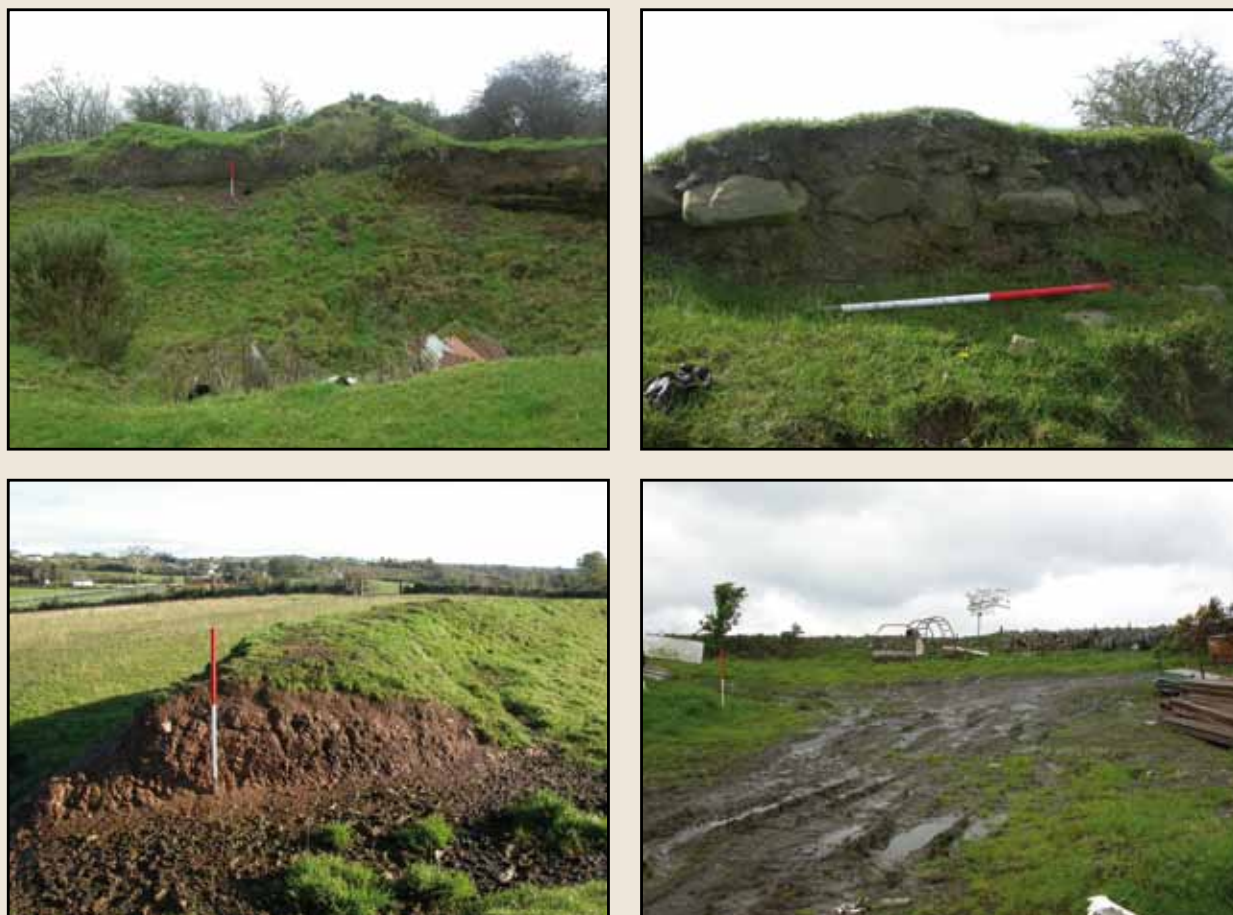
Plate 6 Sites recorded as being in poor condition (clockwise from top left). Drumman Rath (TYR 006:010) has been extensively quarried and is still actively eroding. At Ballymacarron Rath (DOW 024:013) archaeological layers are visible in the eroding profiles. Aghlisnafin Cashel (DOW 043:009) has had its interior damaged by agricultural traffic and dumping. Lisdoon Rath (TYR 049 014) is eroding due to stock paths and livestock trampling.

A small proportion of the sample (2%: 30 sites) was recorded as being in poor condition at the time of survey. These were sites that were unstable, and the fabric of the monument was being actively damaged (Plate 6). Sites were only classed as being in a poor condition when the damage was severe and required urgent remedial action, or where the remains seemed likely to further deteriorate rapidly, potentially resulting in much greater loss.

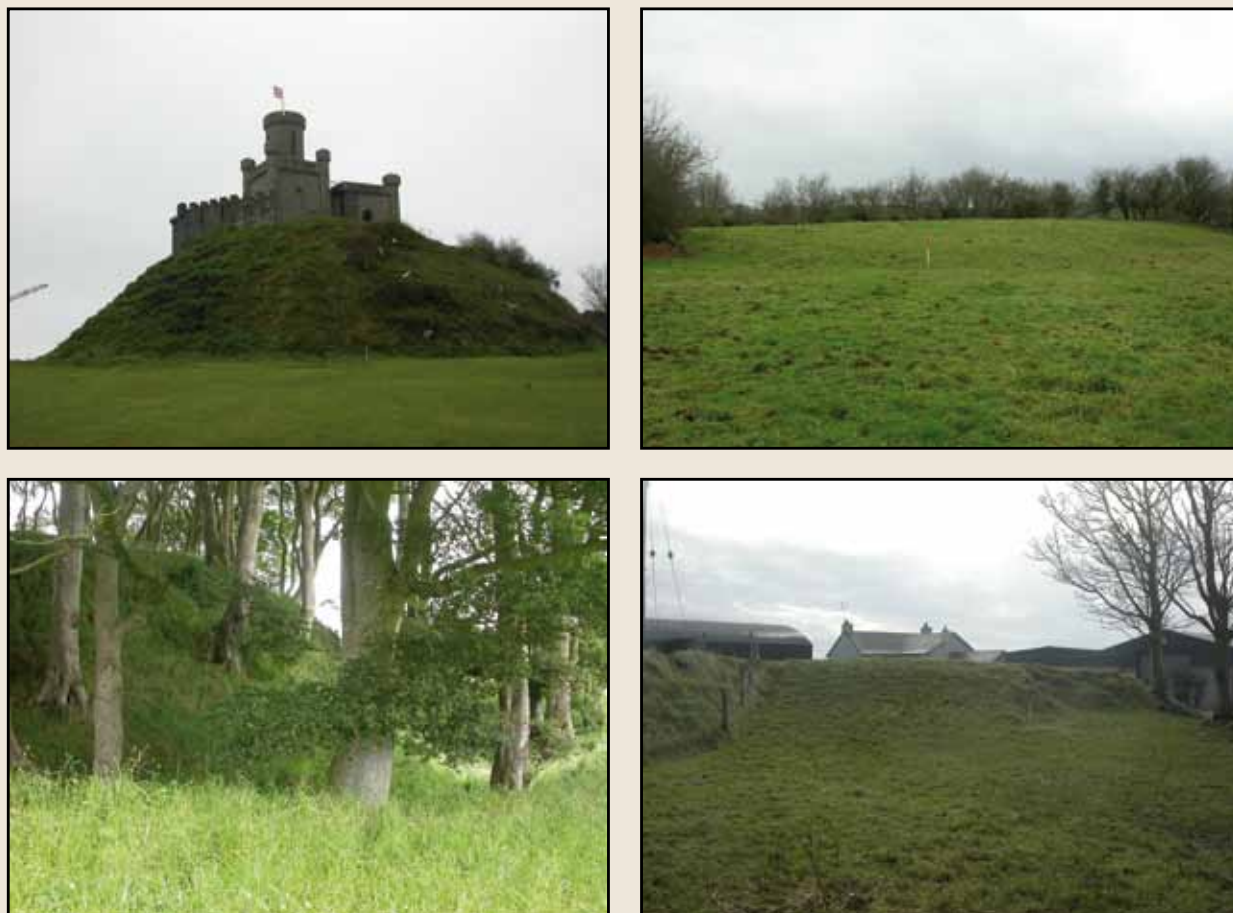
Plate 9 Clockwise from left: Donaghadee motte (DOW 003:003) was damaged in the past by the construction of a powder magazine. Lisnagleer platform rath (TYR 046:018) was damaged by cultivation. Dundoonan rath and souterrain (LDY 003:014) was built over by a farmyard and buildings. Tree planting has damaged Dundermot motte (ANT 027:010).
